Geotechnical Investigation

National Capital Business Park
4055 & 4120 Russell Road
Ottawa, Ontario

August 13, 2020

Report: PG4854-1
Revision 4

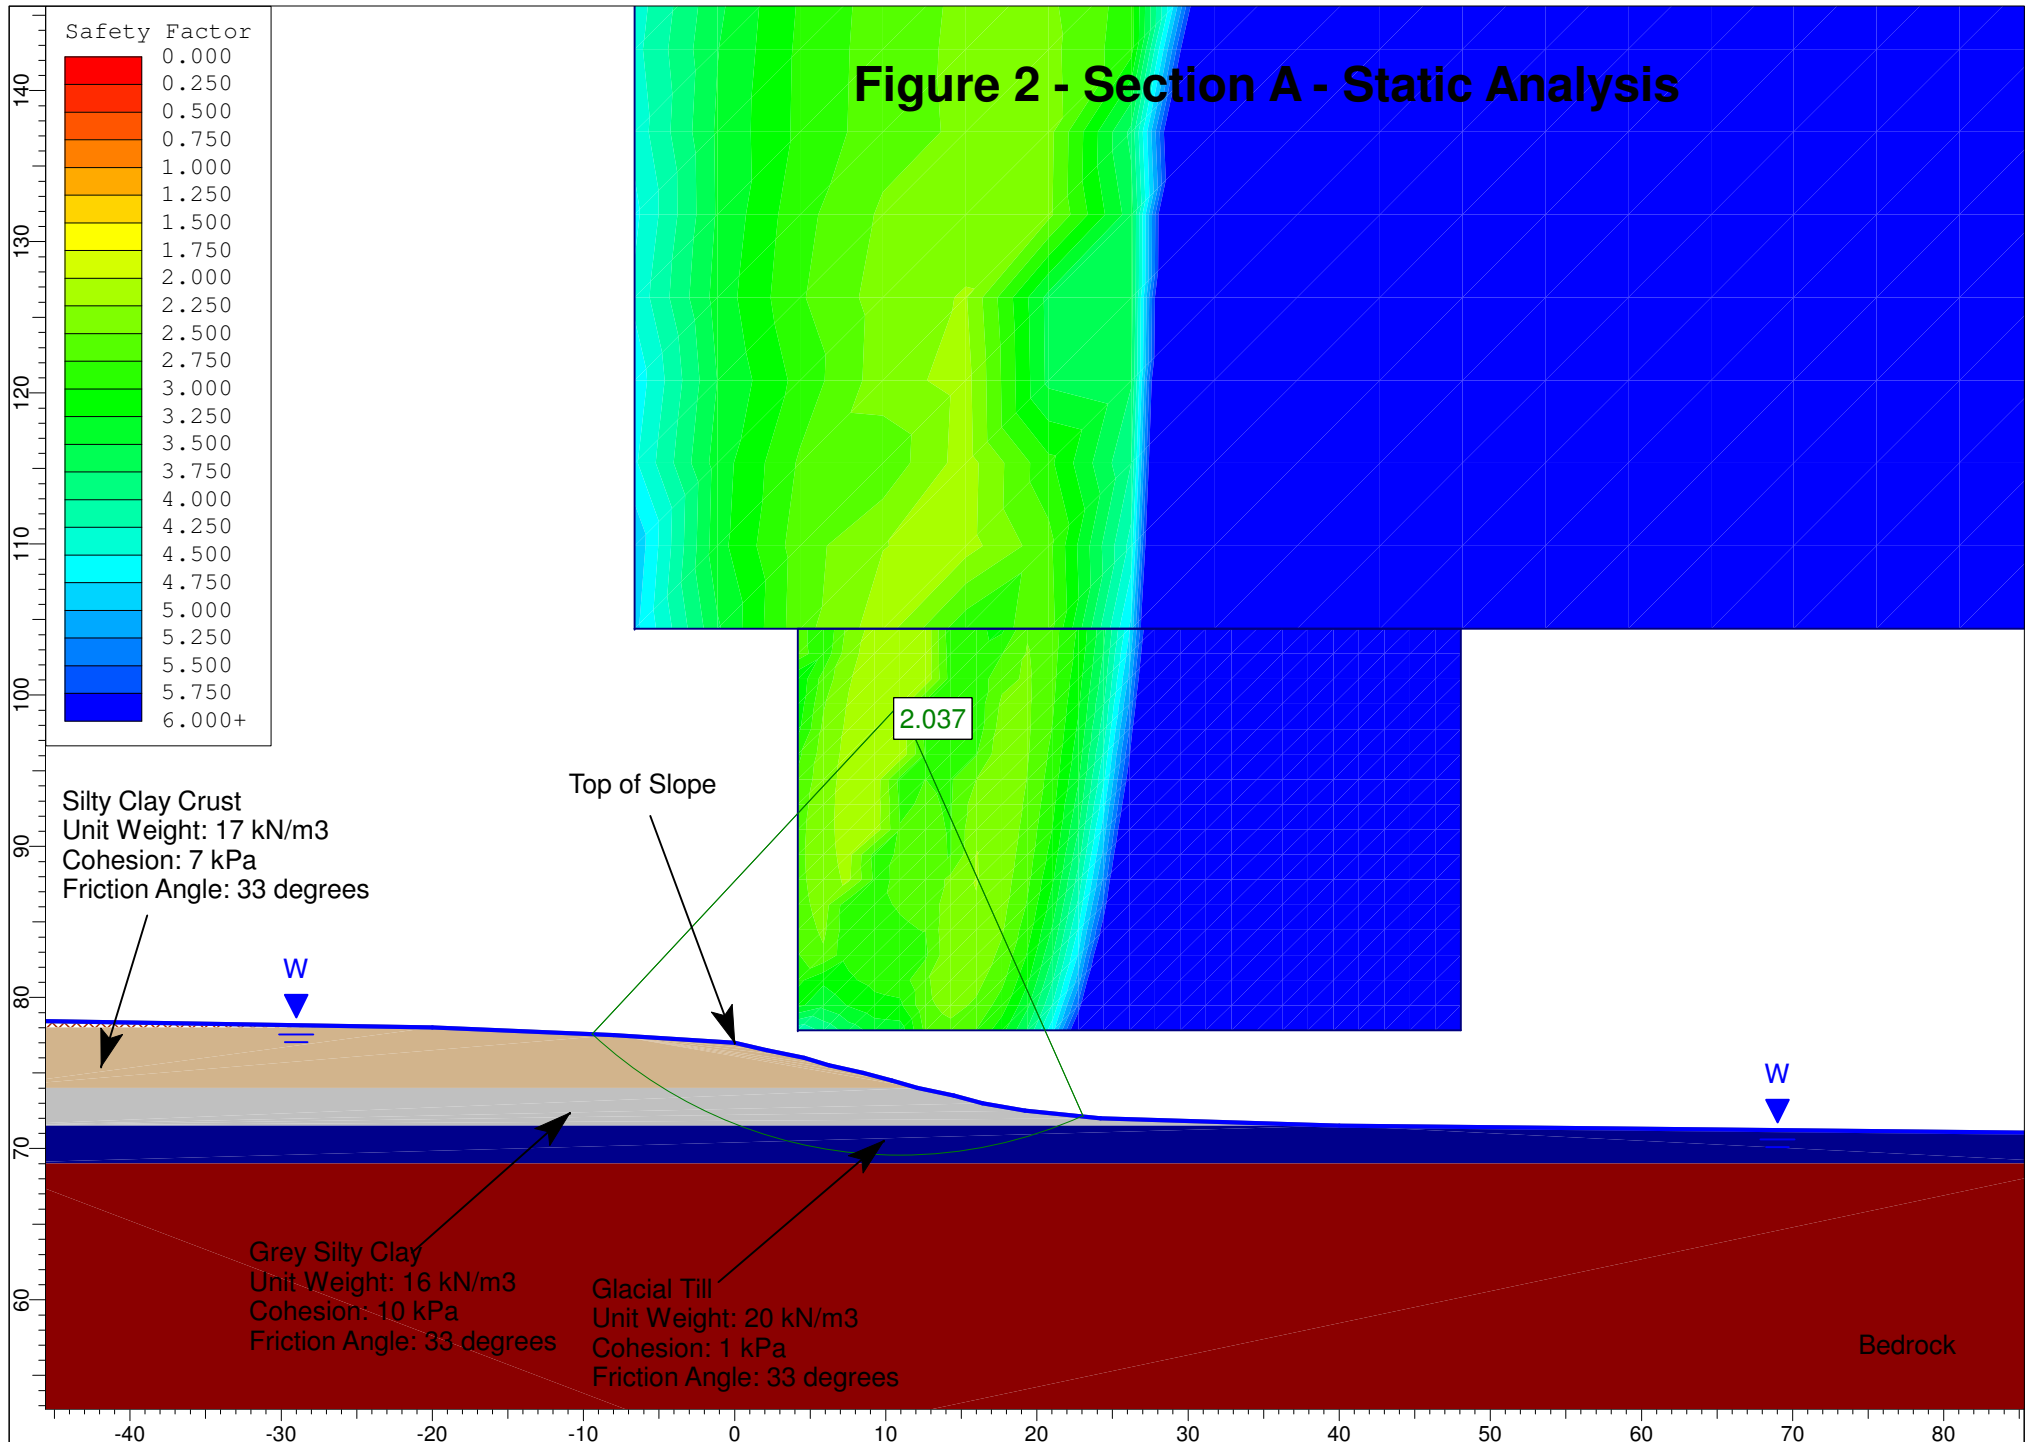
Figure 2 - Section A - Static Analysis

The slope stability analysis was modeled in SLIDE, a computer program which permits a two-dimensional slope stability analysis calculating several methods including the Bishop's method, which is a widely accepted slope analysis method. The program calculates a factor of safety, which represents the ratio of the forces resisting failure to forces favoring failure. Theoretically, a factor of safety of 1.0 represents a condition where the slope is stable.

However, due to intrinsic limitations of the calculation methods and the variability of the subsurface soil and groundwater conditions, a factor of safety greater than 1.0 is generally required for the failure risk to be considered acceptable. A minimum factor of safety of 1.5 is generally recommended for conditions where the slope failure would comprise permanent structures. An analysis considering seismic loading was also completed. A horizontal acceleration of 0.16g was considered for the sections for the seismic loading condition. A factor of safety of 1.1 is considered to be satisfactory for stability analyses including seismic loading.

Two (2) slope cross-sections (Sections A and B) were studied as the worst case scenarios. The cross section locations are presented on Drawing PG4854-3 - Limit of Hazard Lands in Appendix 2. It should be noted that details of the slope height and slope angle at the cross-section locations are presented in Figures 2 through 5 in Appendix 2, and are based on the topographic data provided on Drawing PG4854-1 - Test Hole Location Plan in Appendix 2.

As the slopes were determined to be stable under static and seismic conditions for the sections analyzed, a stable slope allowance is not considered to be required for the limit of hazard lands setback.

For the 5 to 6 m slope in the southwestern portion of the site (Section A), given that no watercourse is present near the toe of the slope and no signs of active erosion were observed, toe erosion and erosion access allowances are not considered to be required for this slope.
