Phase I-Environmental Site Assessment

406 Bank Street
Ottawa, Ontario

December 4, 2020

Report: PE5088-1

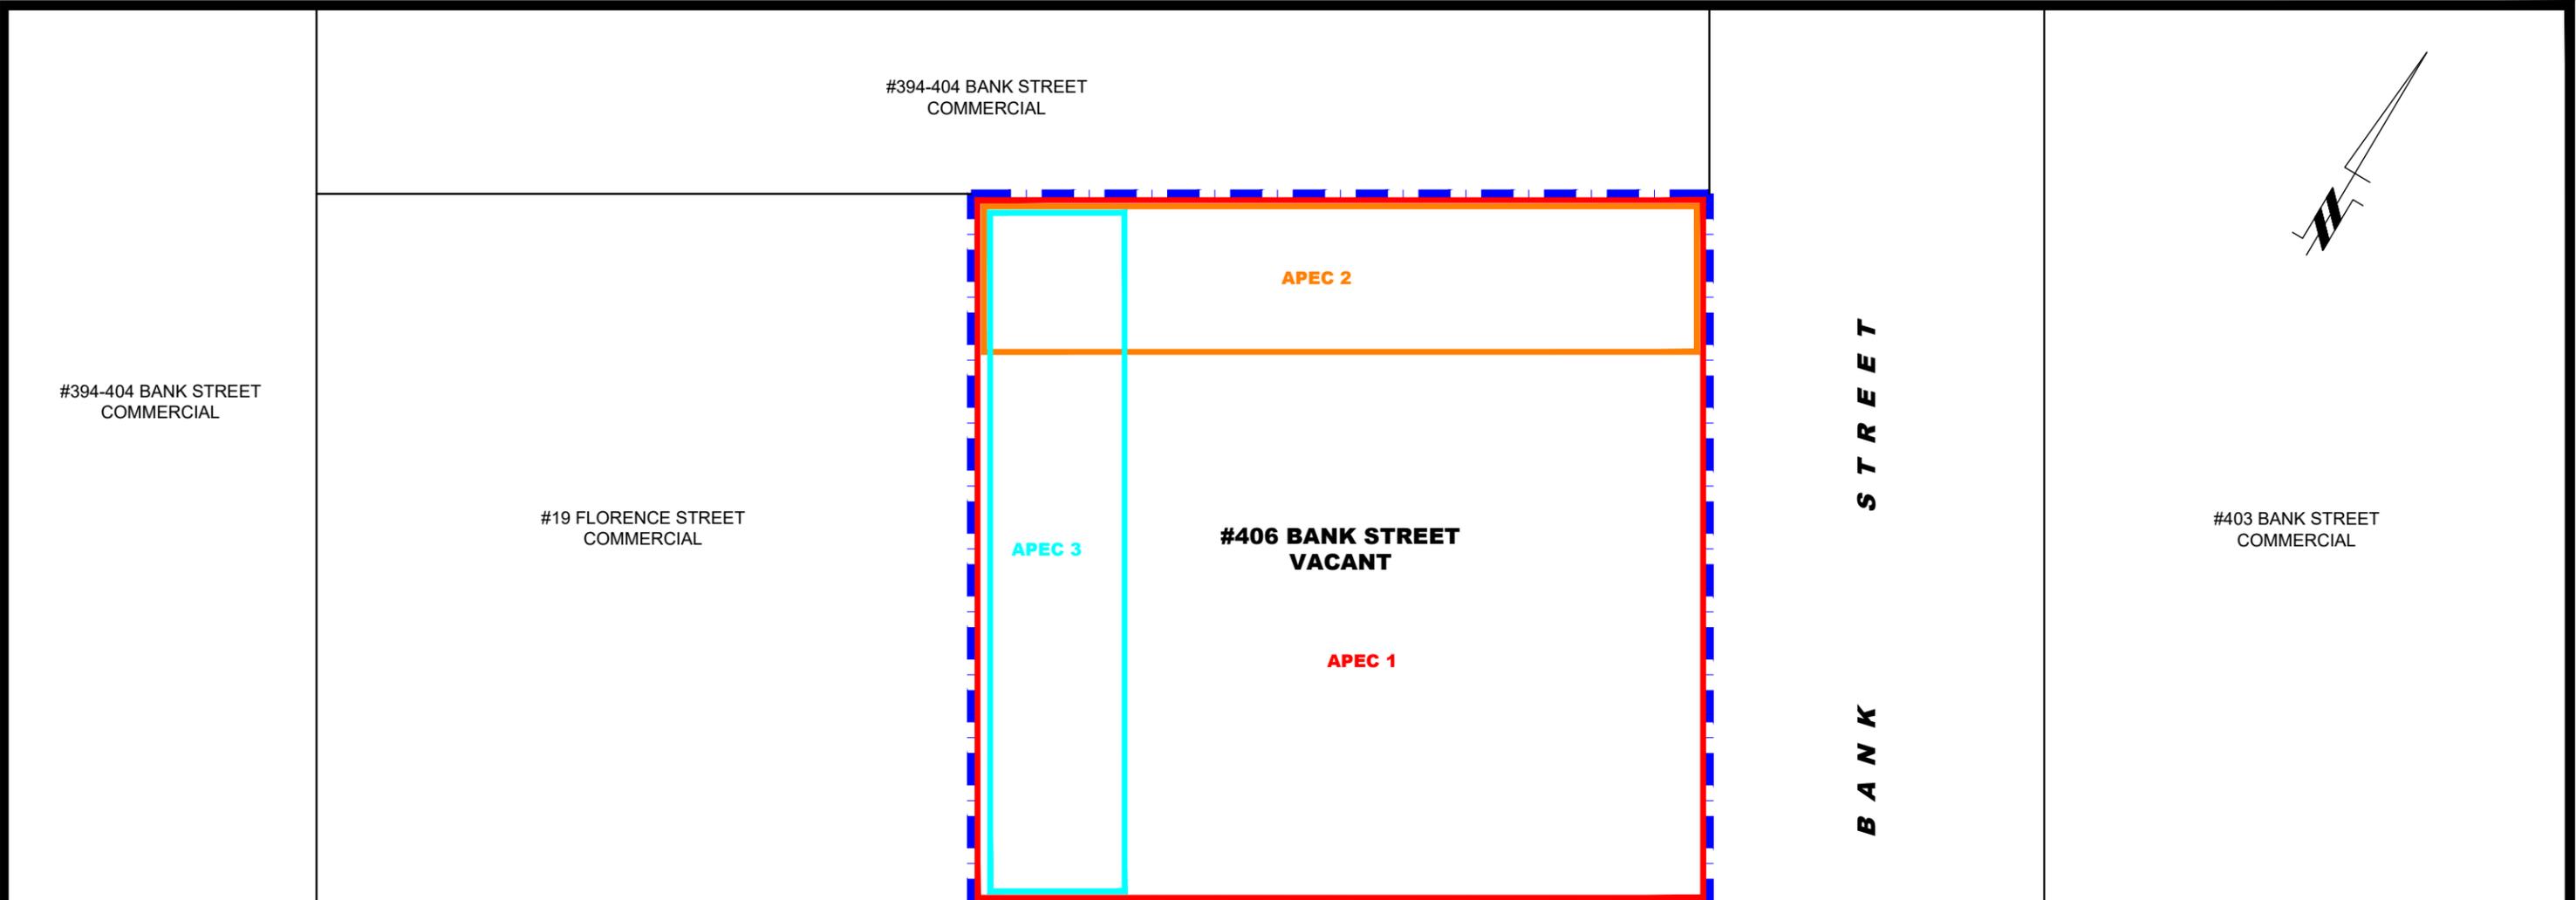
DRAWING PE5088-1 – SITE PLAN

- 1. **FILL MATERIAL OF UNKNOWN QUALITY ON SITE (PCA 30)**
- 2. **396-404 BANK STREET - FORMER PAINT AND OIL STORES**
- 3. **7-11 FLORENCE STREET - FORMER AUTO REPAIR GARAGE WITH 1 UNDERGROUND STORAGE TANK (PCA 52)**

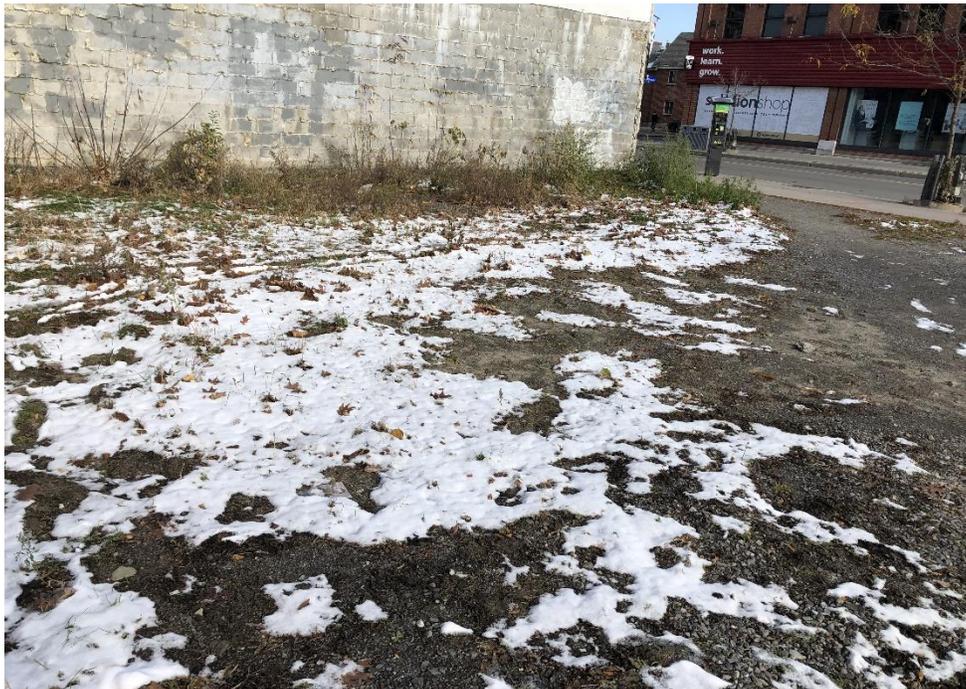
Photograph 1: View of the vacant lot at 406 Bank Street, looking northeast onto Bank Street.

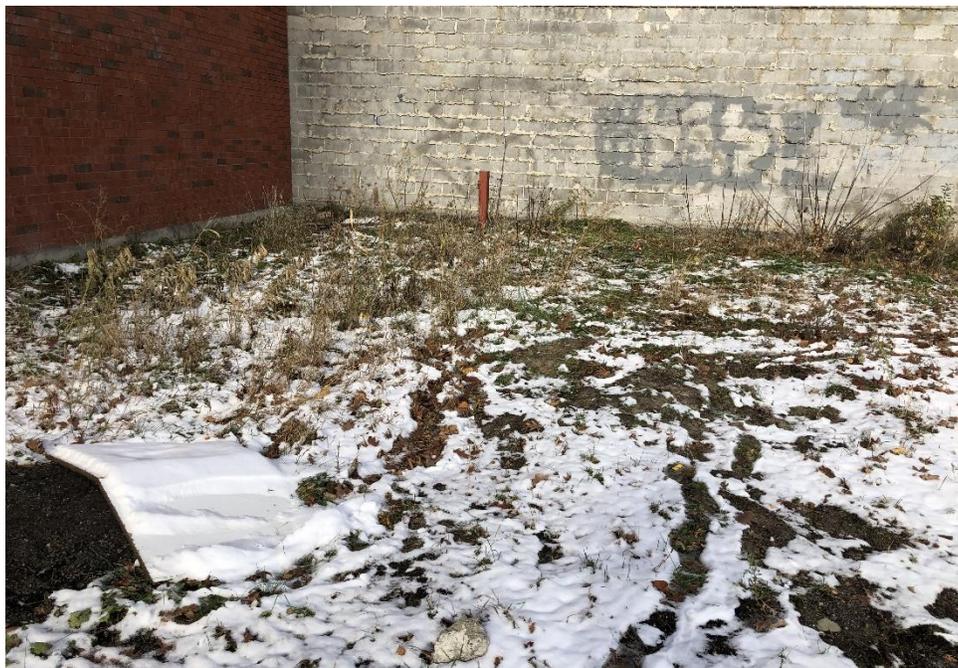
The Phase I Property is a vacant lot covered by gravel and sand with visible remnants of the former on-site building. One groundwater monitoring well was noted on the northwest side corner of the subject land, which was previously drill by DST in 2007.

Fill material consisting of fragments of demolition debris was noted at the time of the site visit. As previously discussed in this report, the unknown quality of the fill material present on the site, due to the former fire and subsequent demolition of the subject building, represents an APEC on the Phase I Property.

Photograph 2: View of northwest corner of the vacant lot. The photograph shows fill material and demolition debris as well as previously drilled groundwater monitoring well.
