Geotechnical Investigation

Proposed 10 Unit Residential Development
1164-1166 Highcroft Drive
Manotick, Ontario
Revision 2

LRL File No.: 180783

February, 2019, *Revised March 2021*

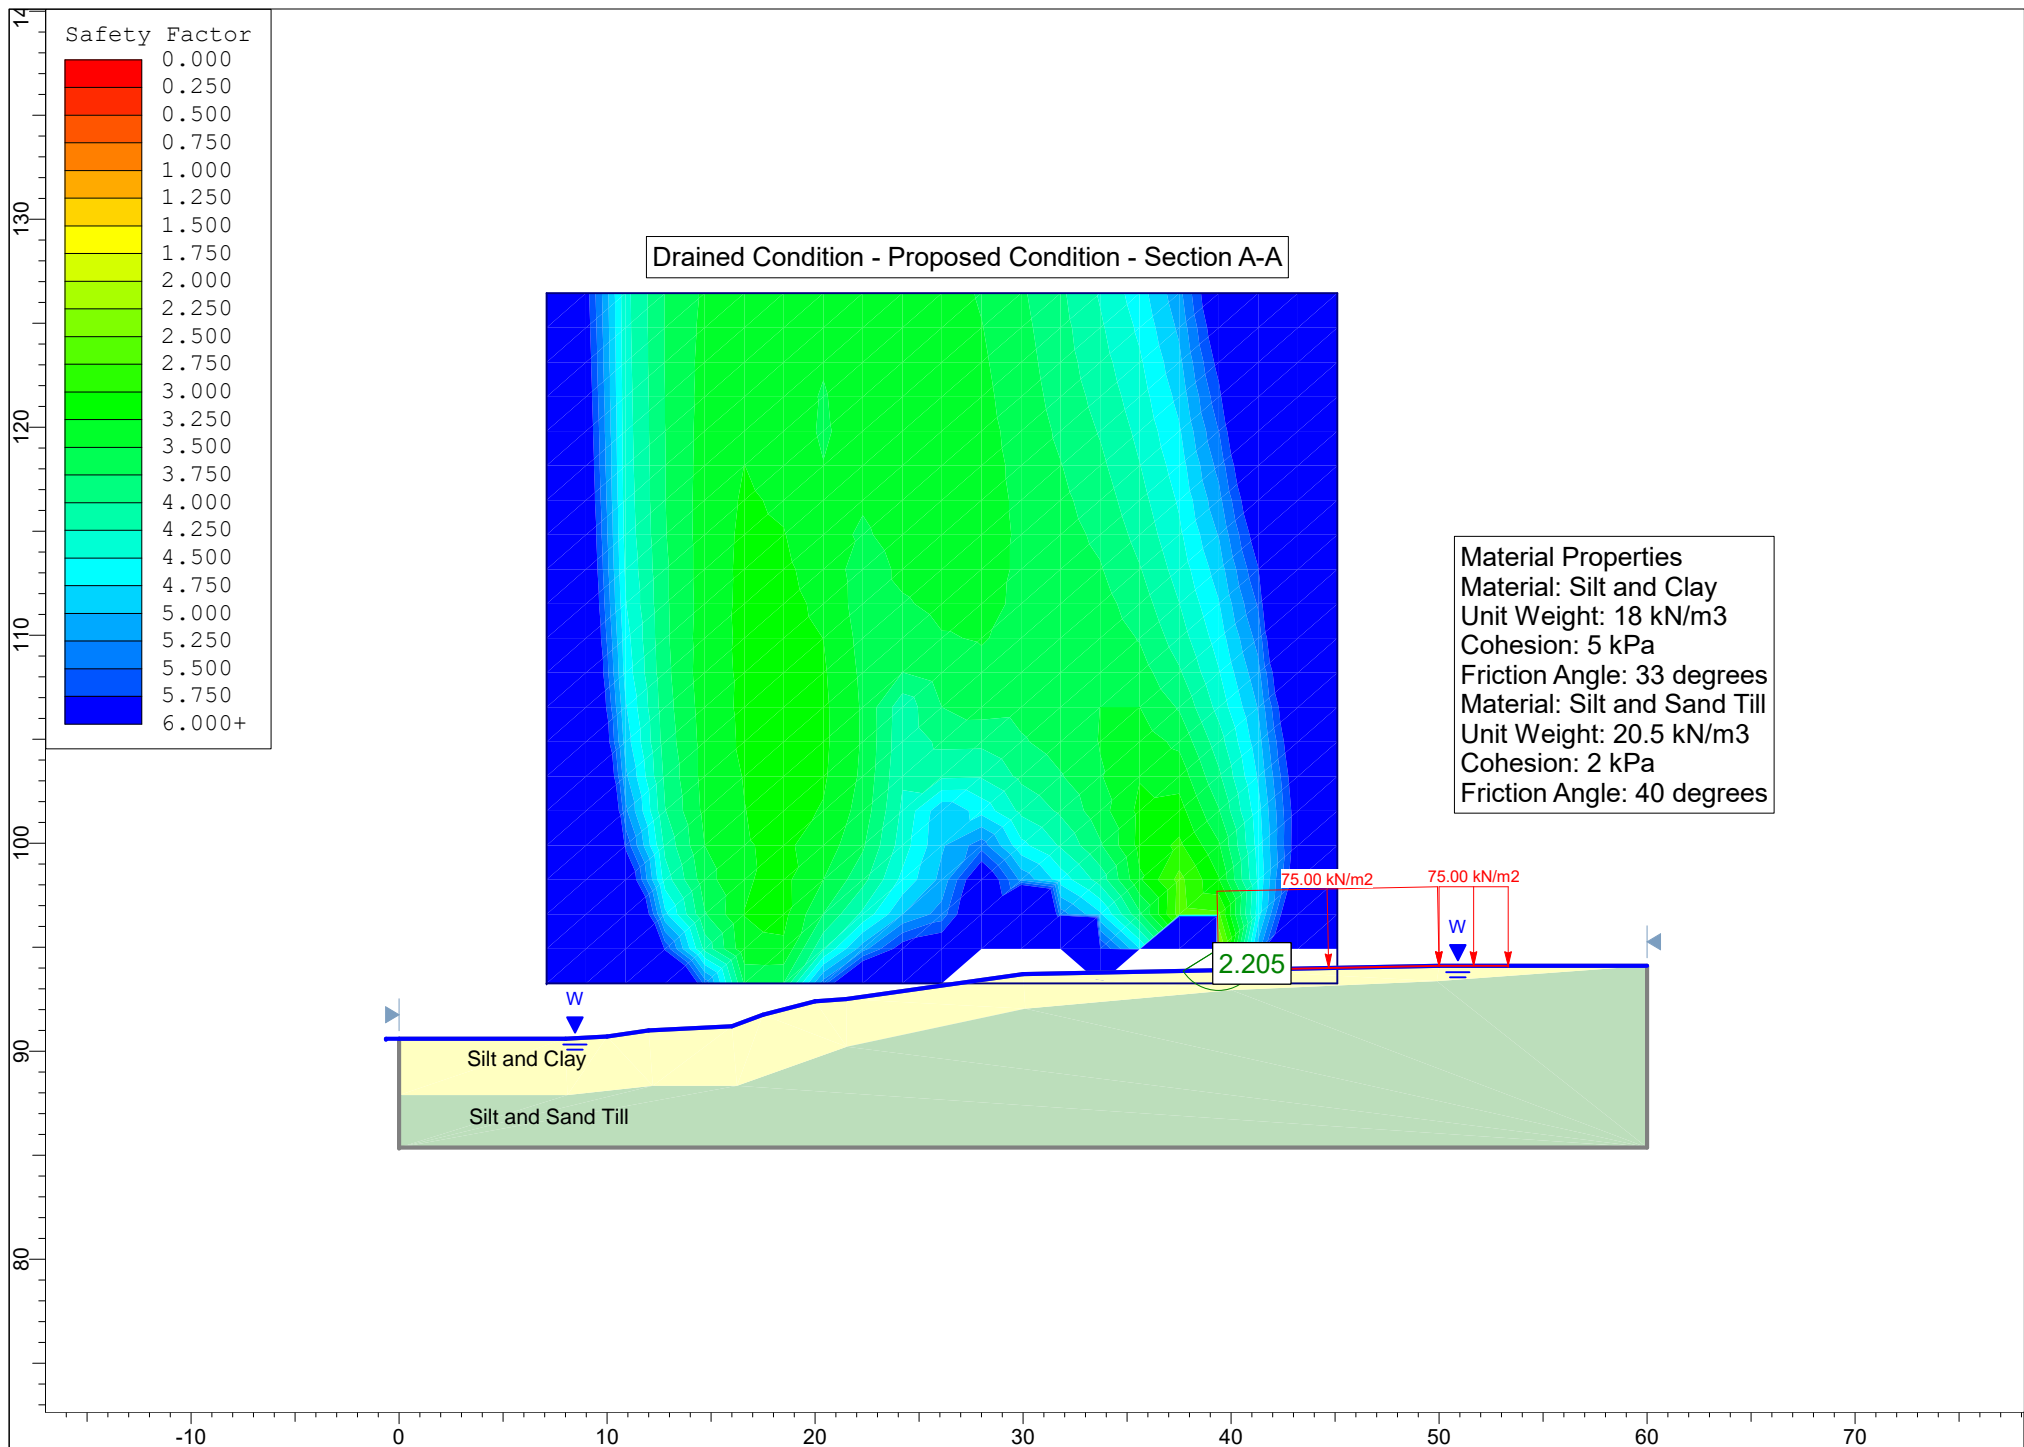
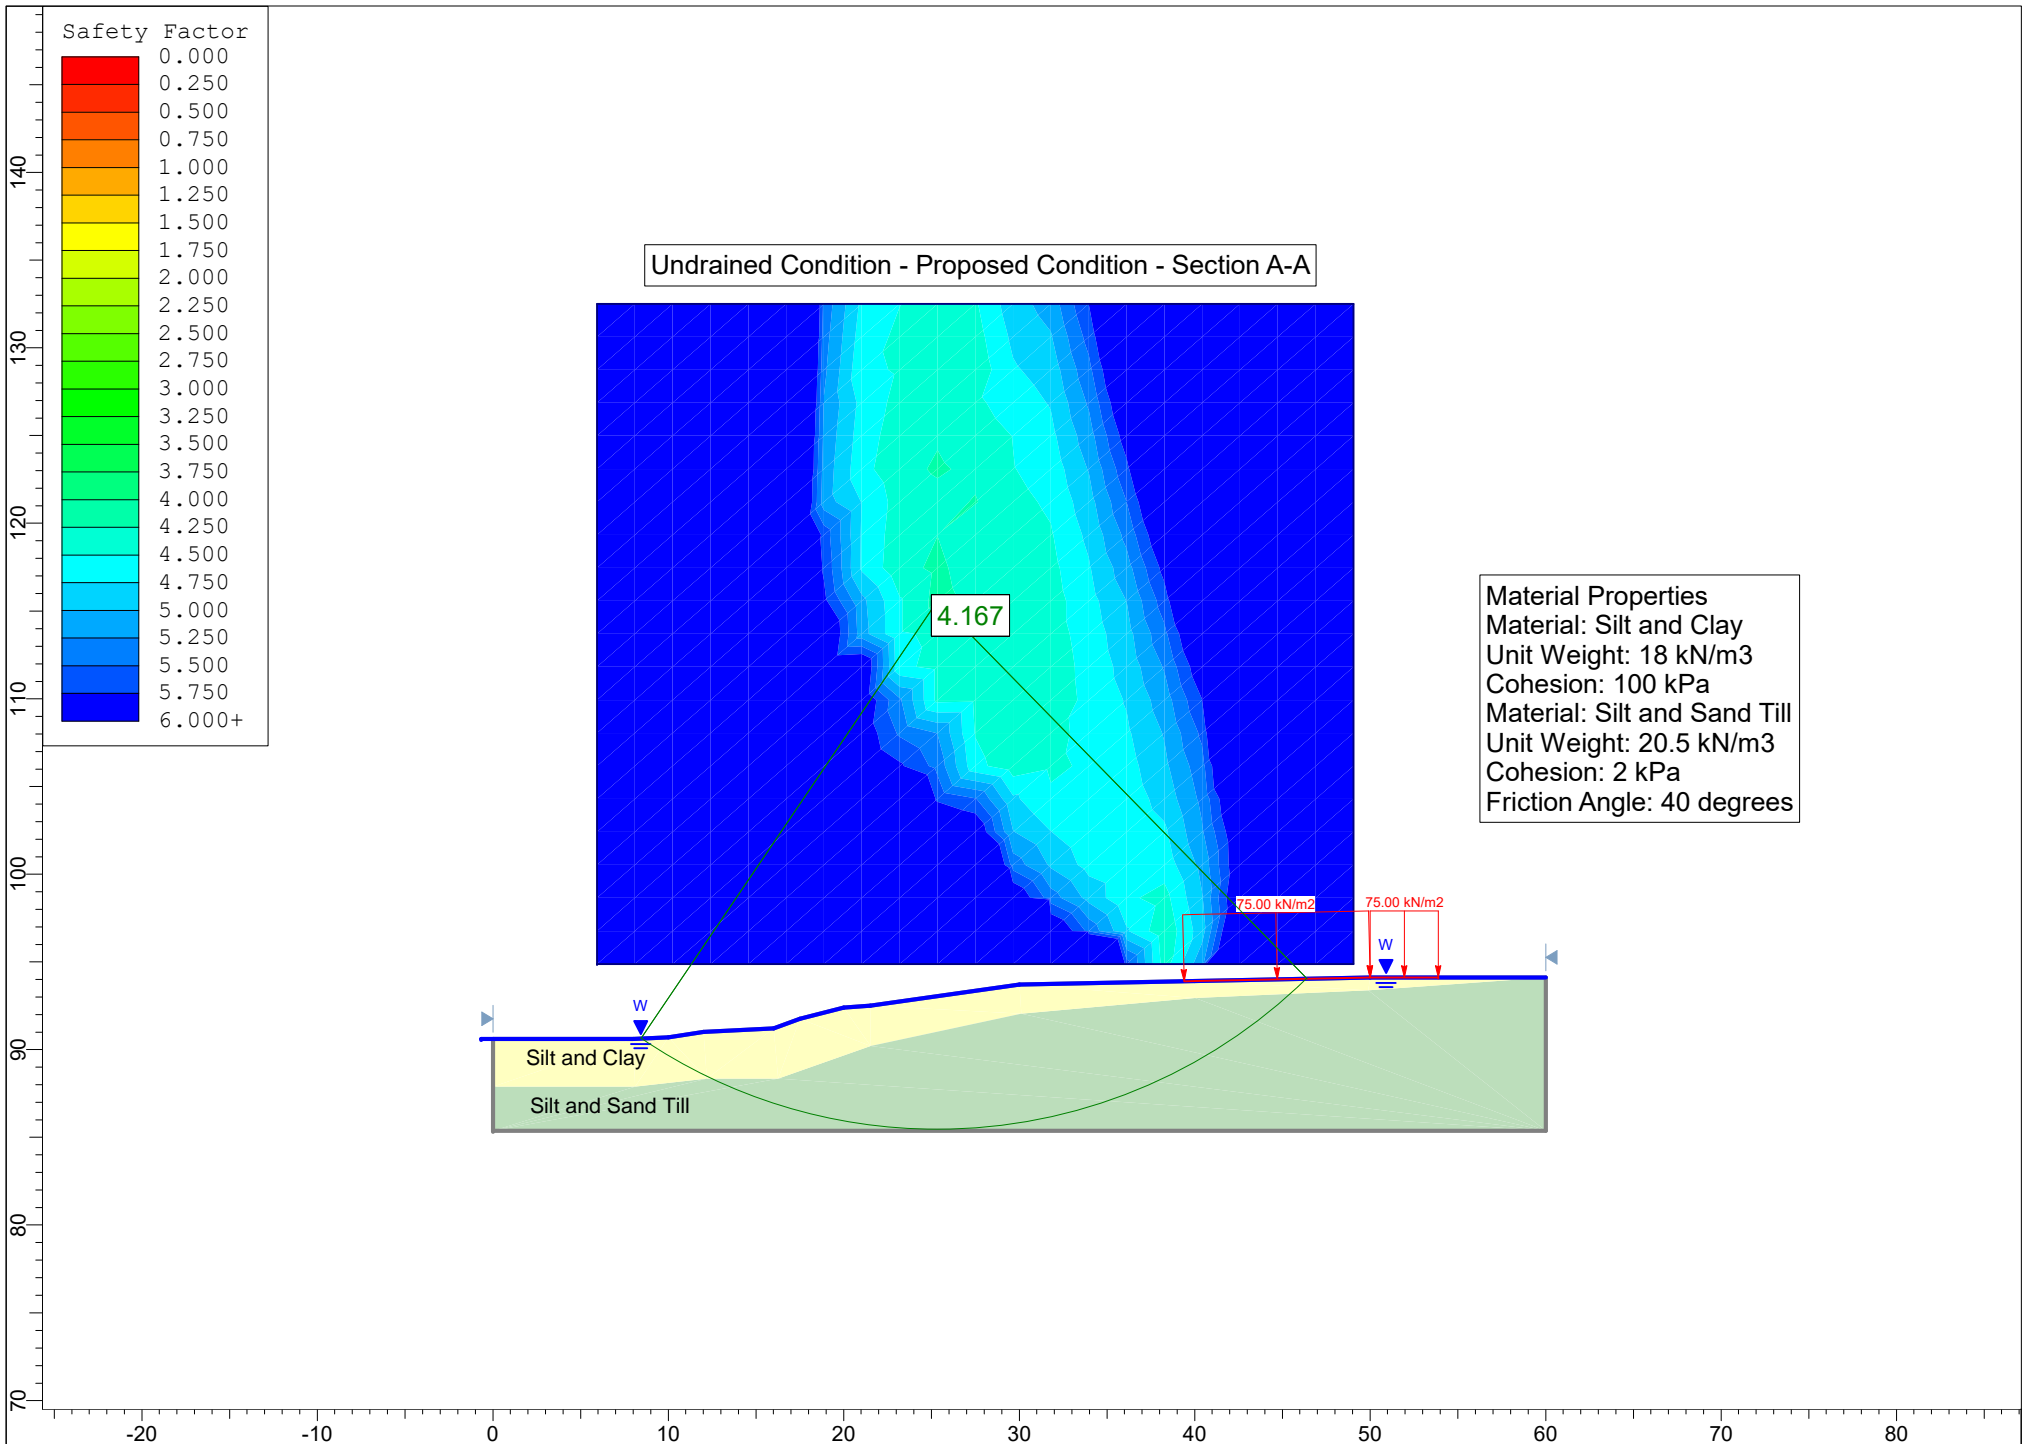
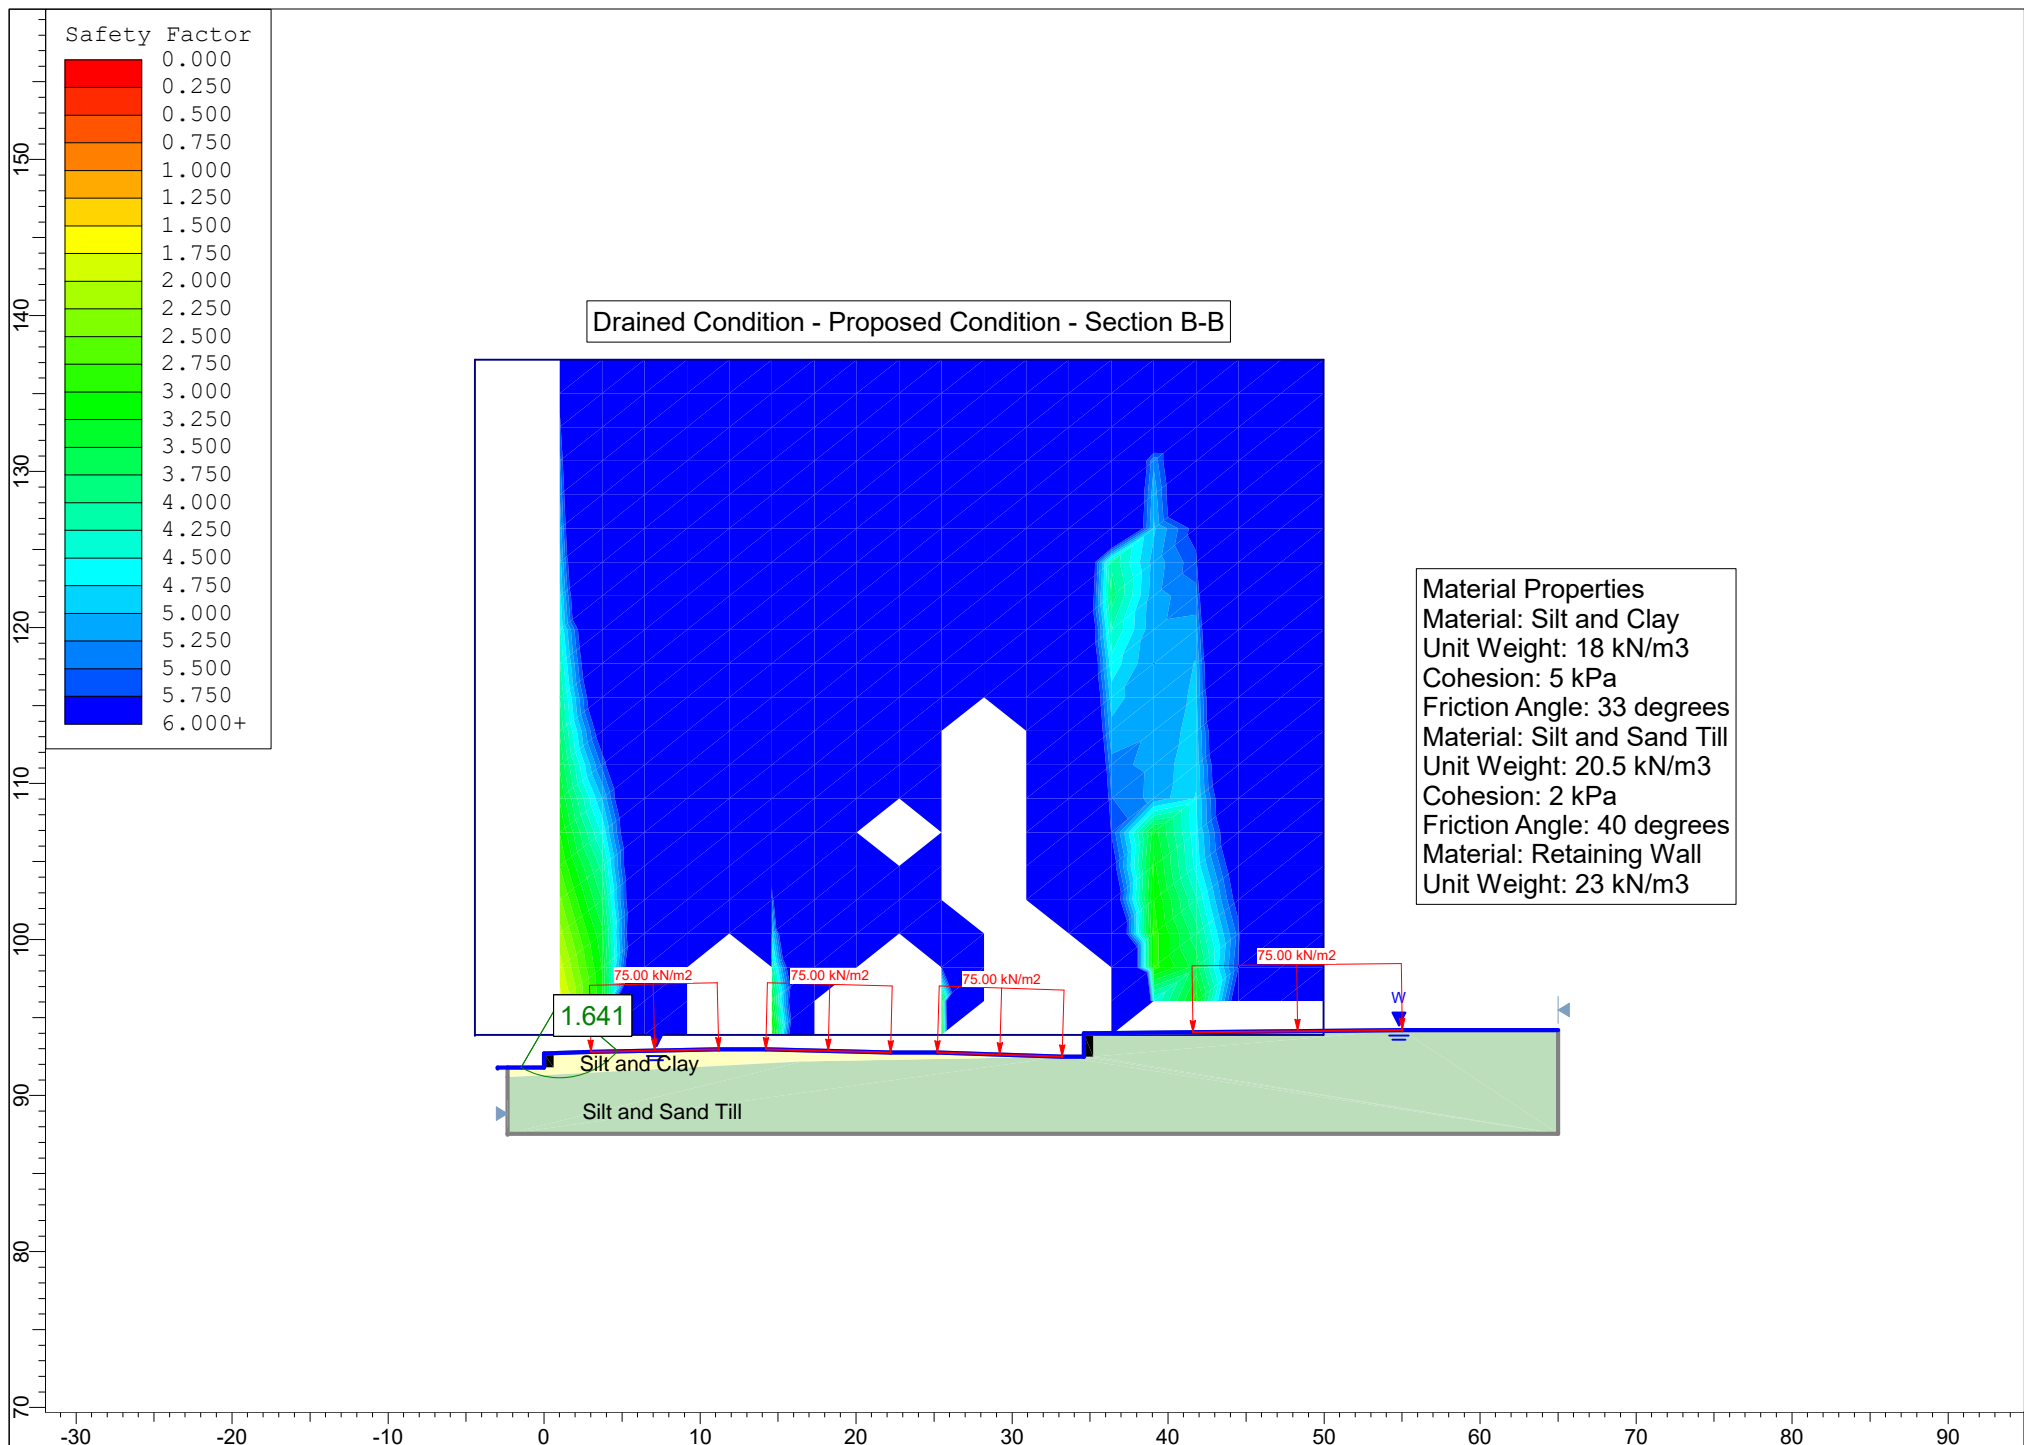
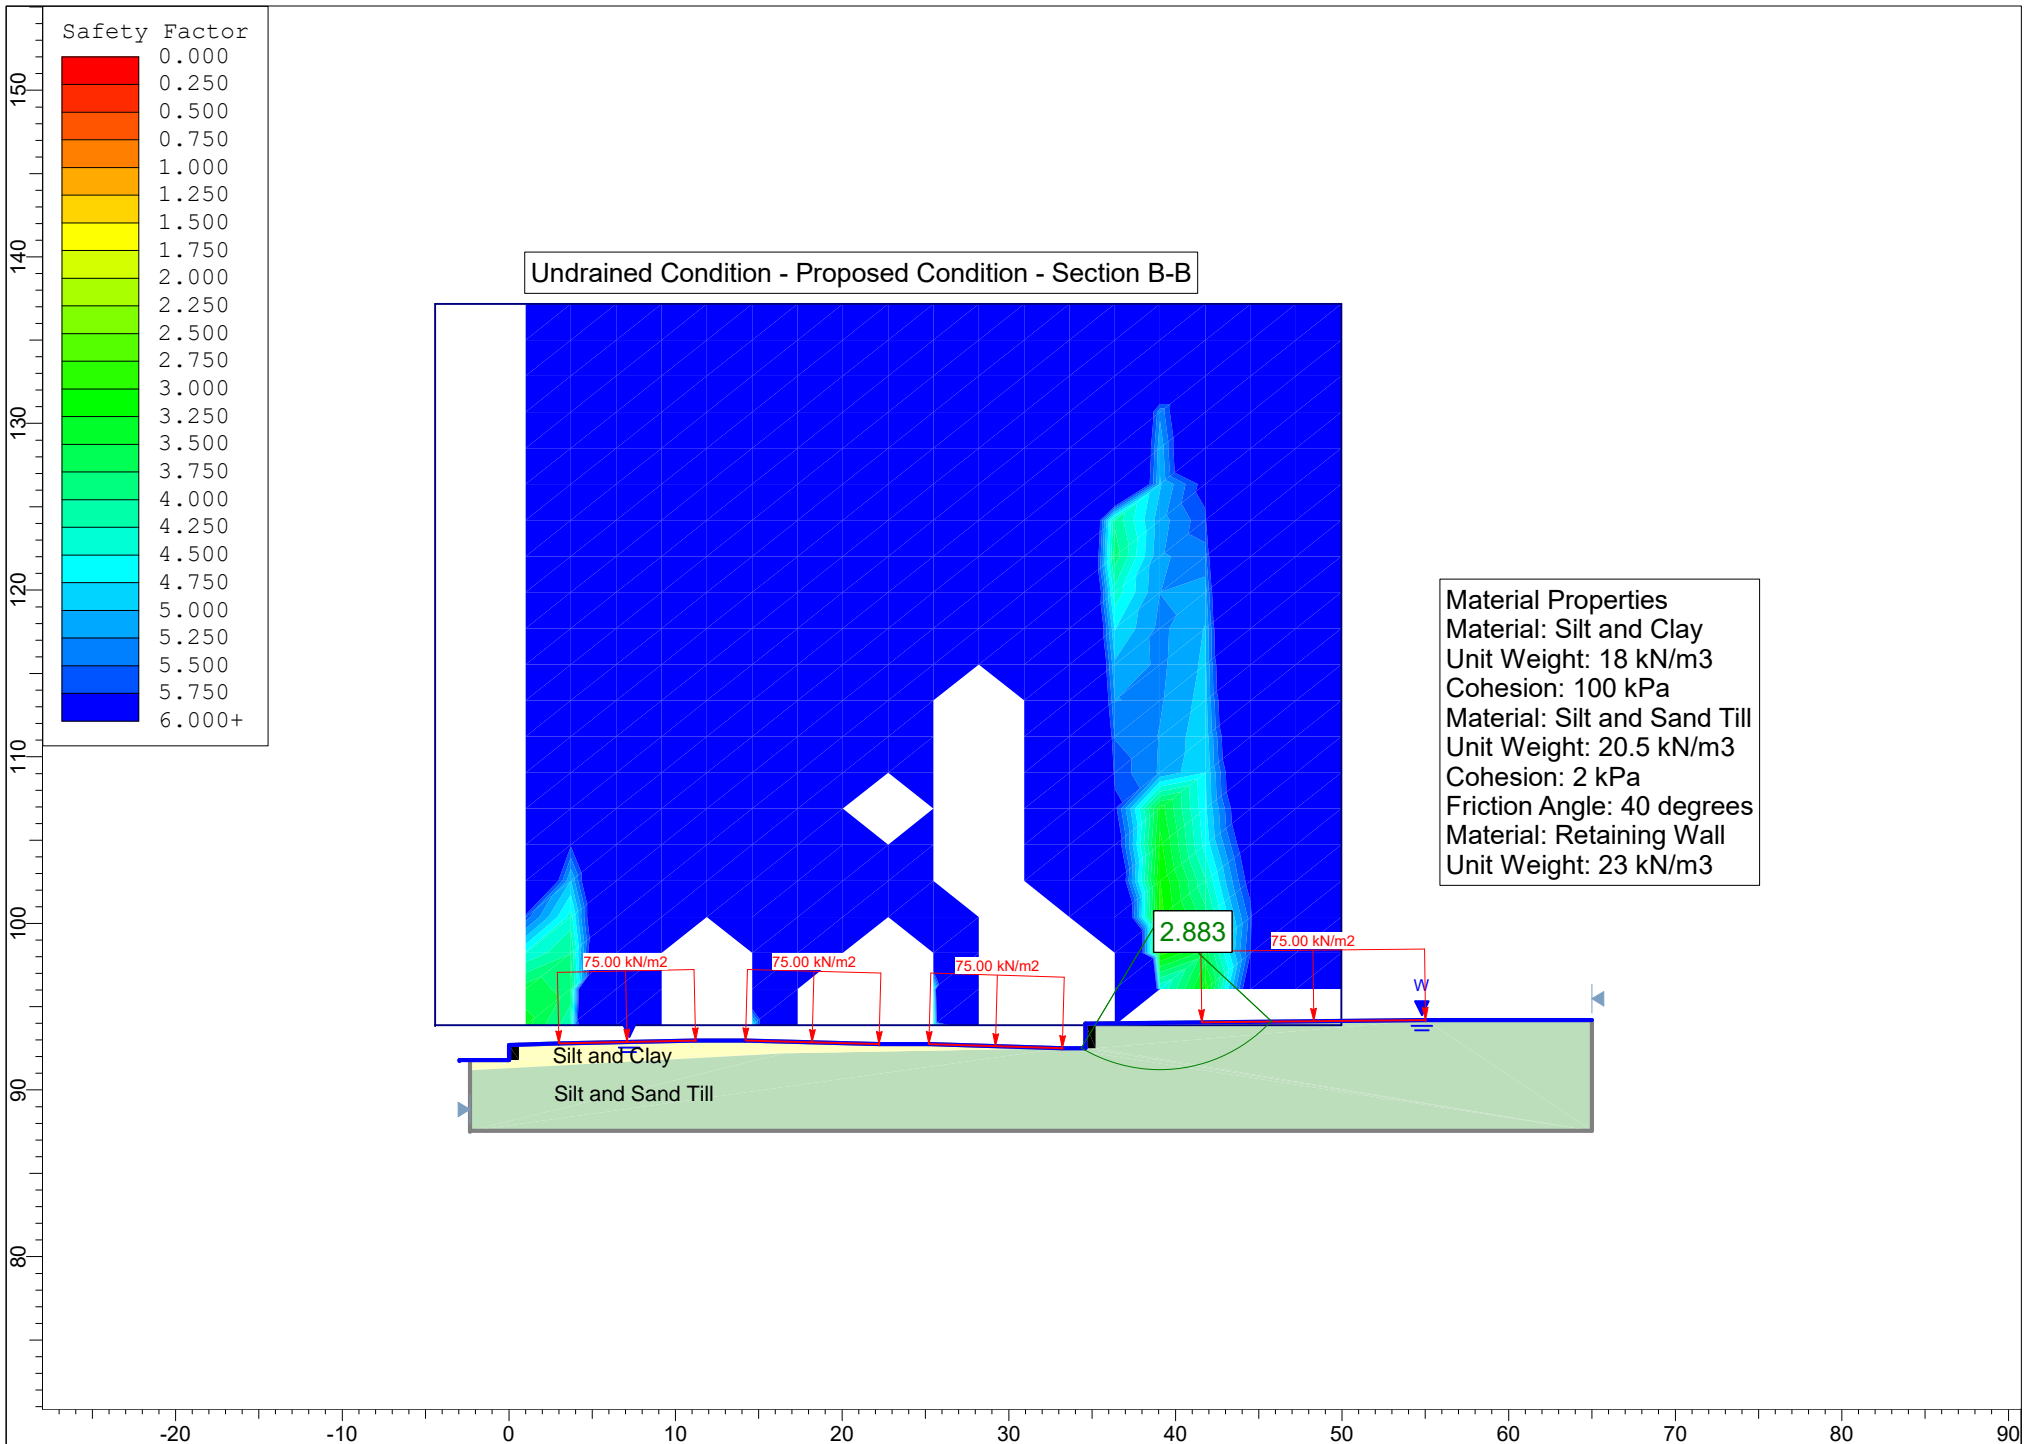
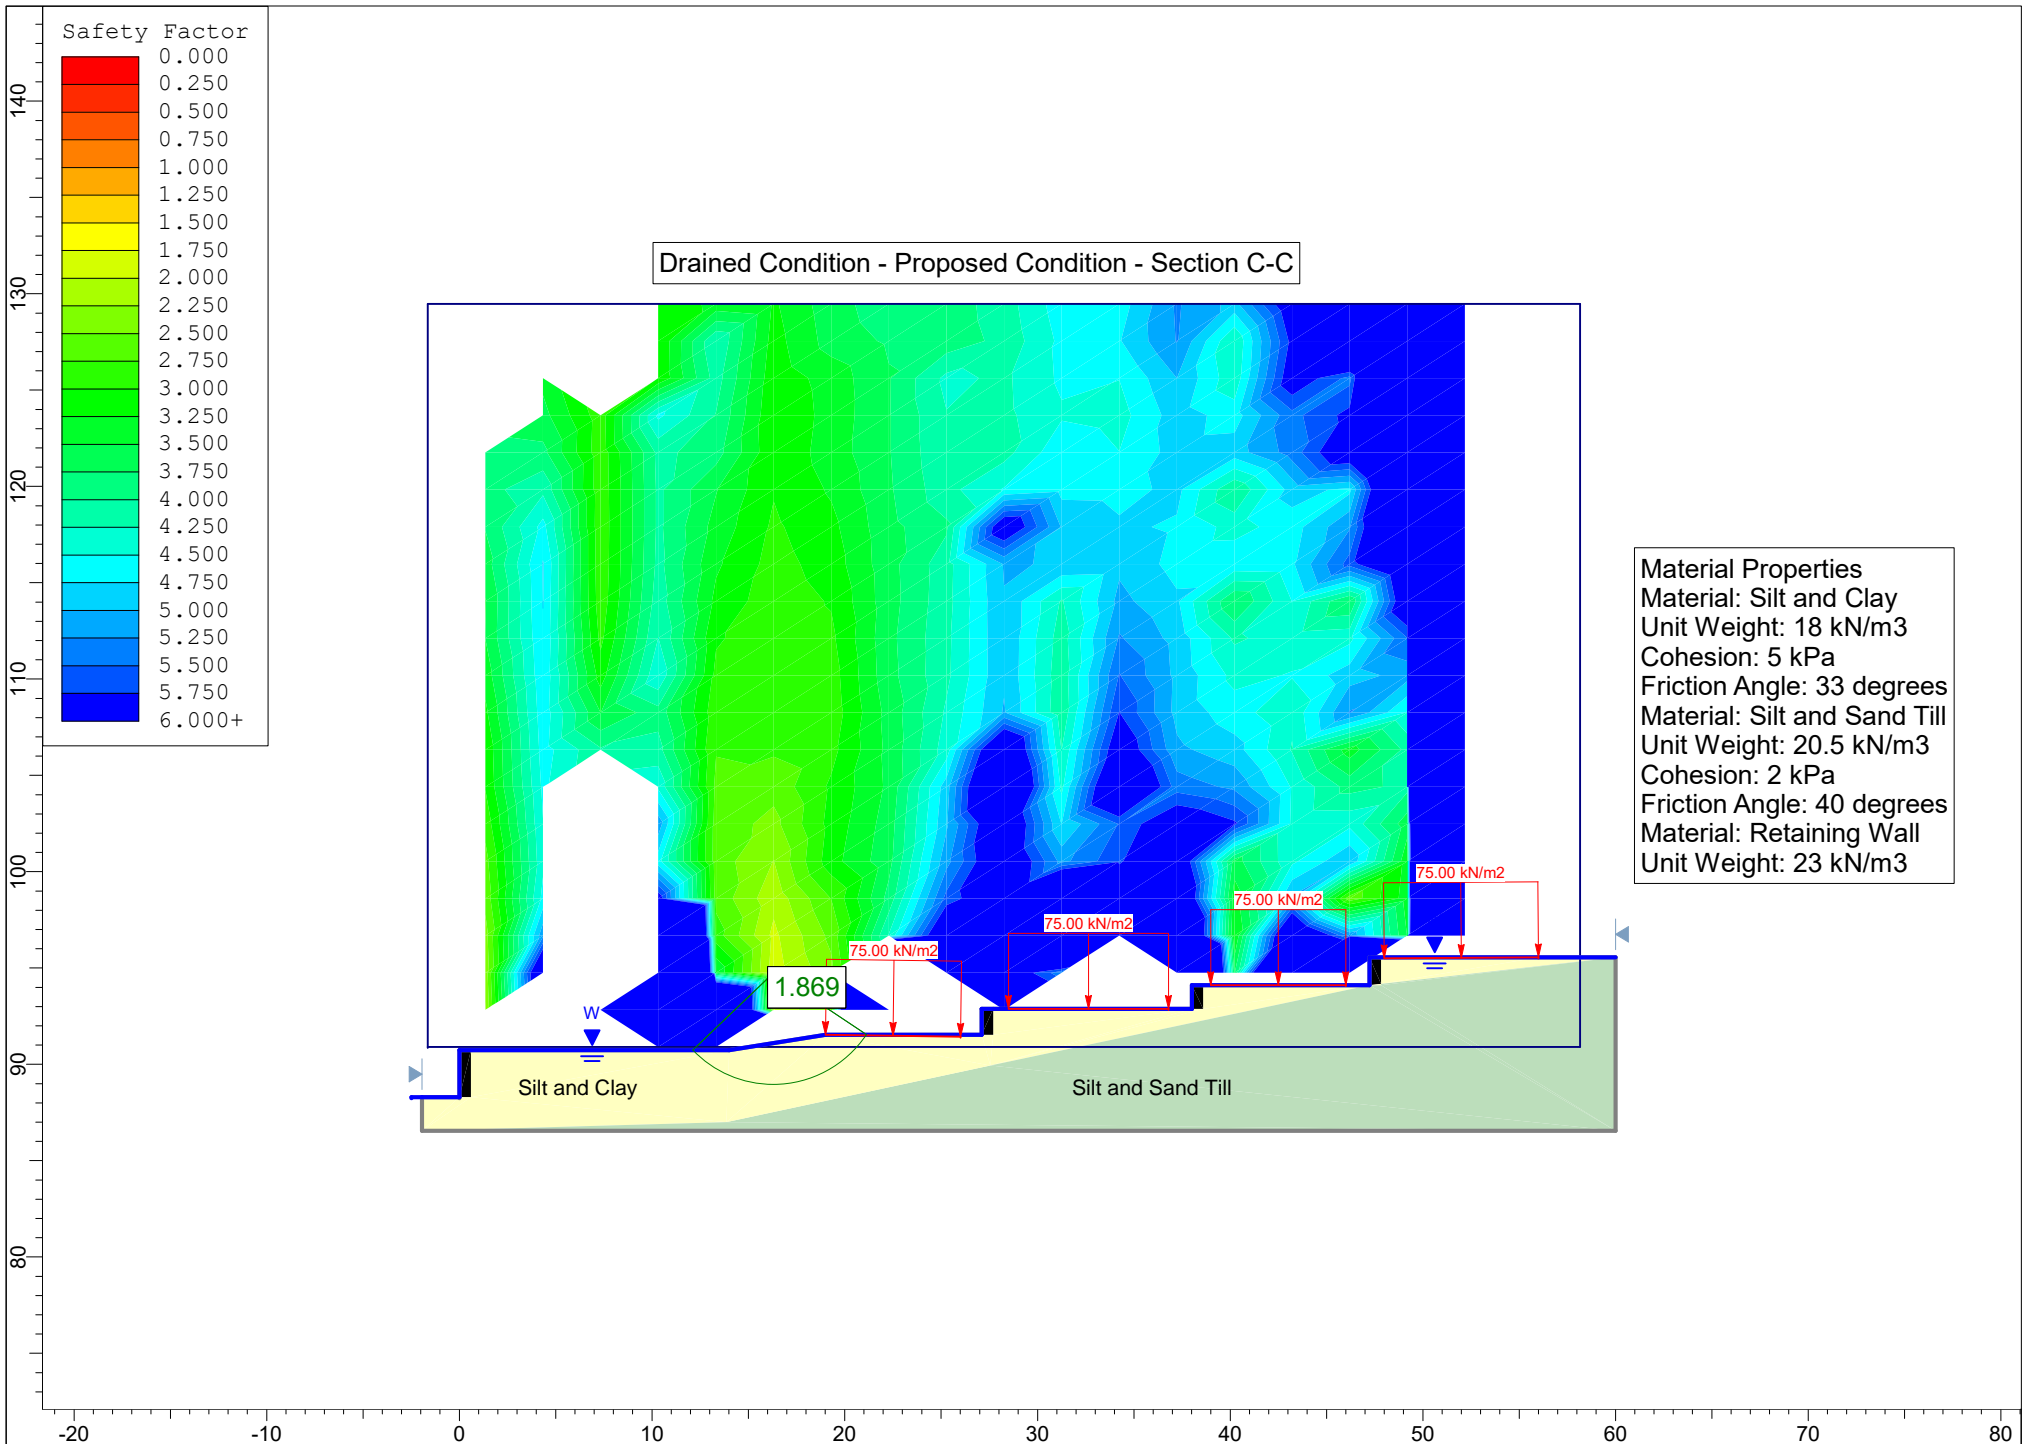
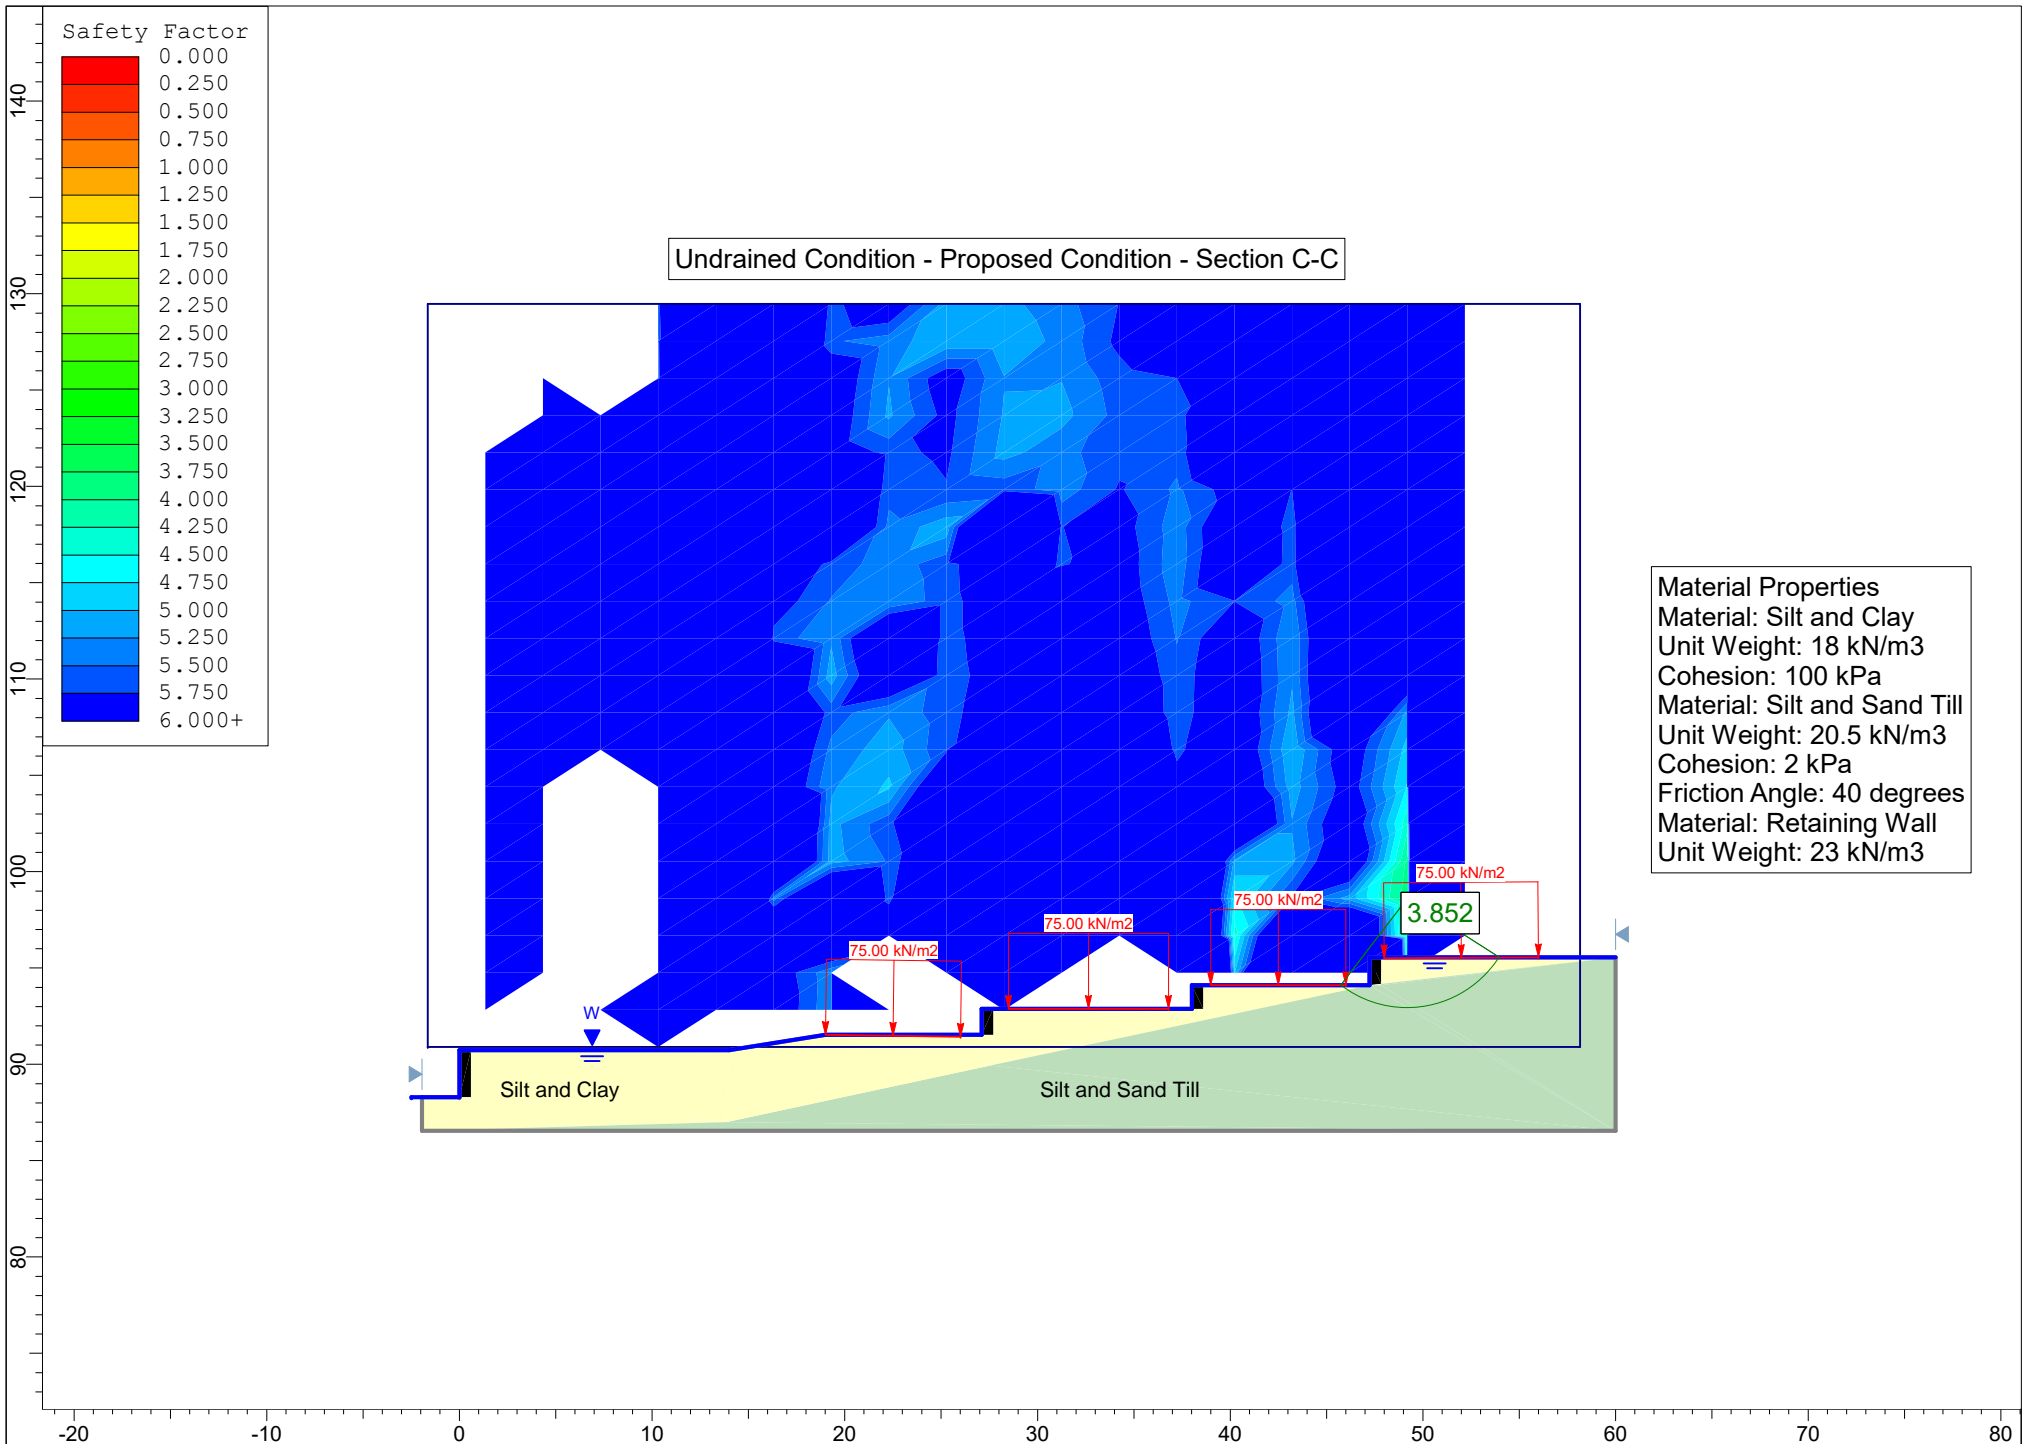
APPENDIX F
Slope Stability Analysis Results

The factor of safety (FoS) against slope failure was run with the additional loading for the residential units for the undrained and drained condition. The FoS values were found ranging between 1.64 and 4.17. A FoS of 1.5 or greater is considered to be safe with regards to slope stability. The designed load was not provided (design bearing pressure at serviceability limit state) while generating this report. However a typical value assumed to be 75 kPa for similar type of residential construction was included within the model.

The slope modelling program, Slide 5.0 (Rocscience), was used to implement the Bishop simplified method of slices. Three (3) slope profiles were selected for the proposed condition and modeled to check the conditions of the slope. The proposed loading for the residential units and retaining walls were included in the models. The slope was analyzed under both the undrained (short term failure) and drained (long term failure) conditions.
