**Developpements Proximi-T Inc.  
3500 Atwater, Suite 6  
Montreal, Qc  
H3H 1Y5**

**Phase II Environmental Site Assessment  
971 Montreal Road  
Ottawa, Ontario**

**MM2320**

**July 31, 2020**

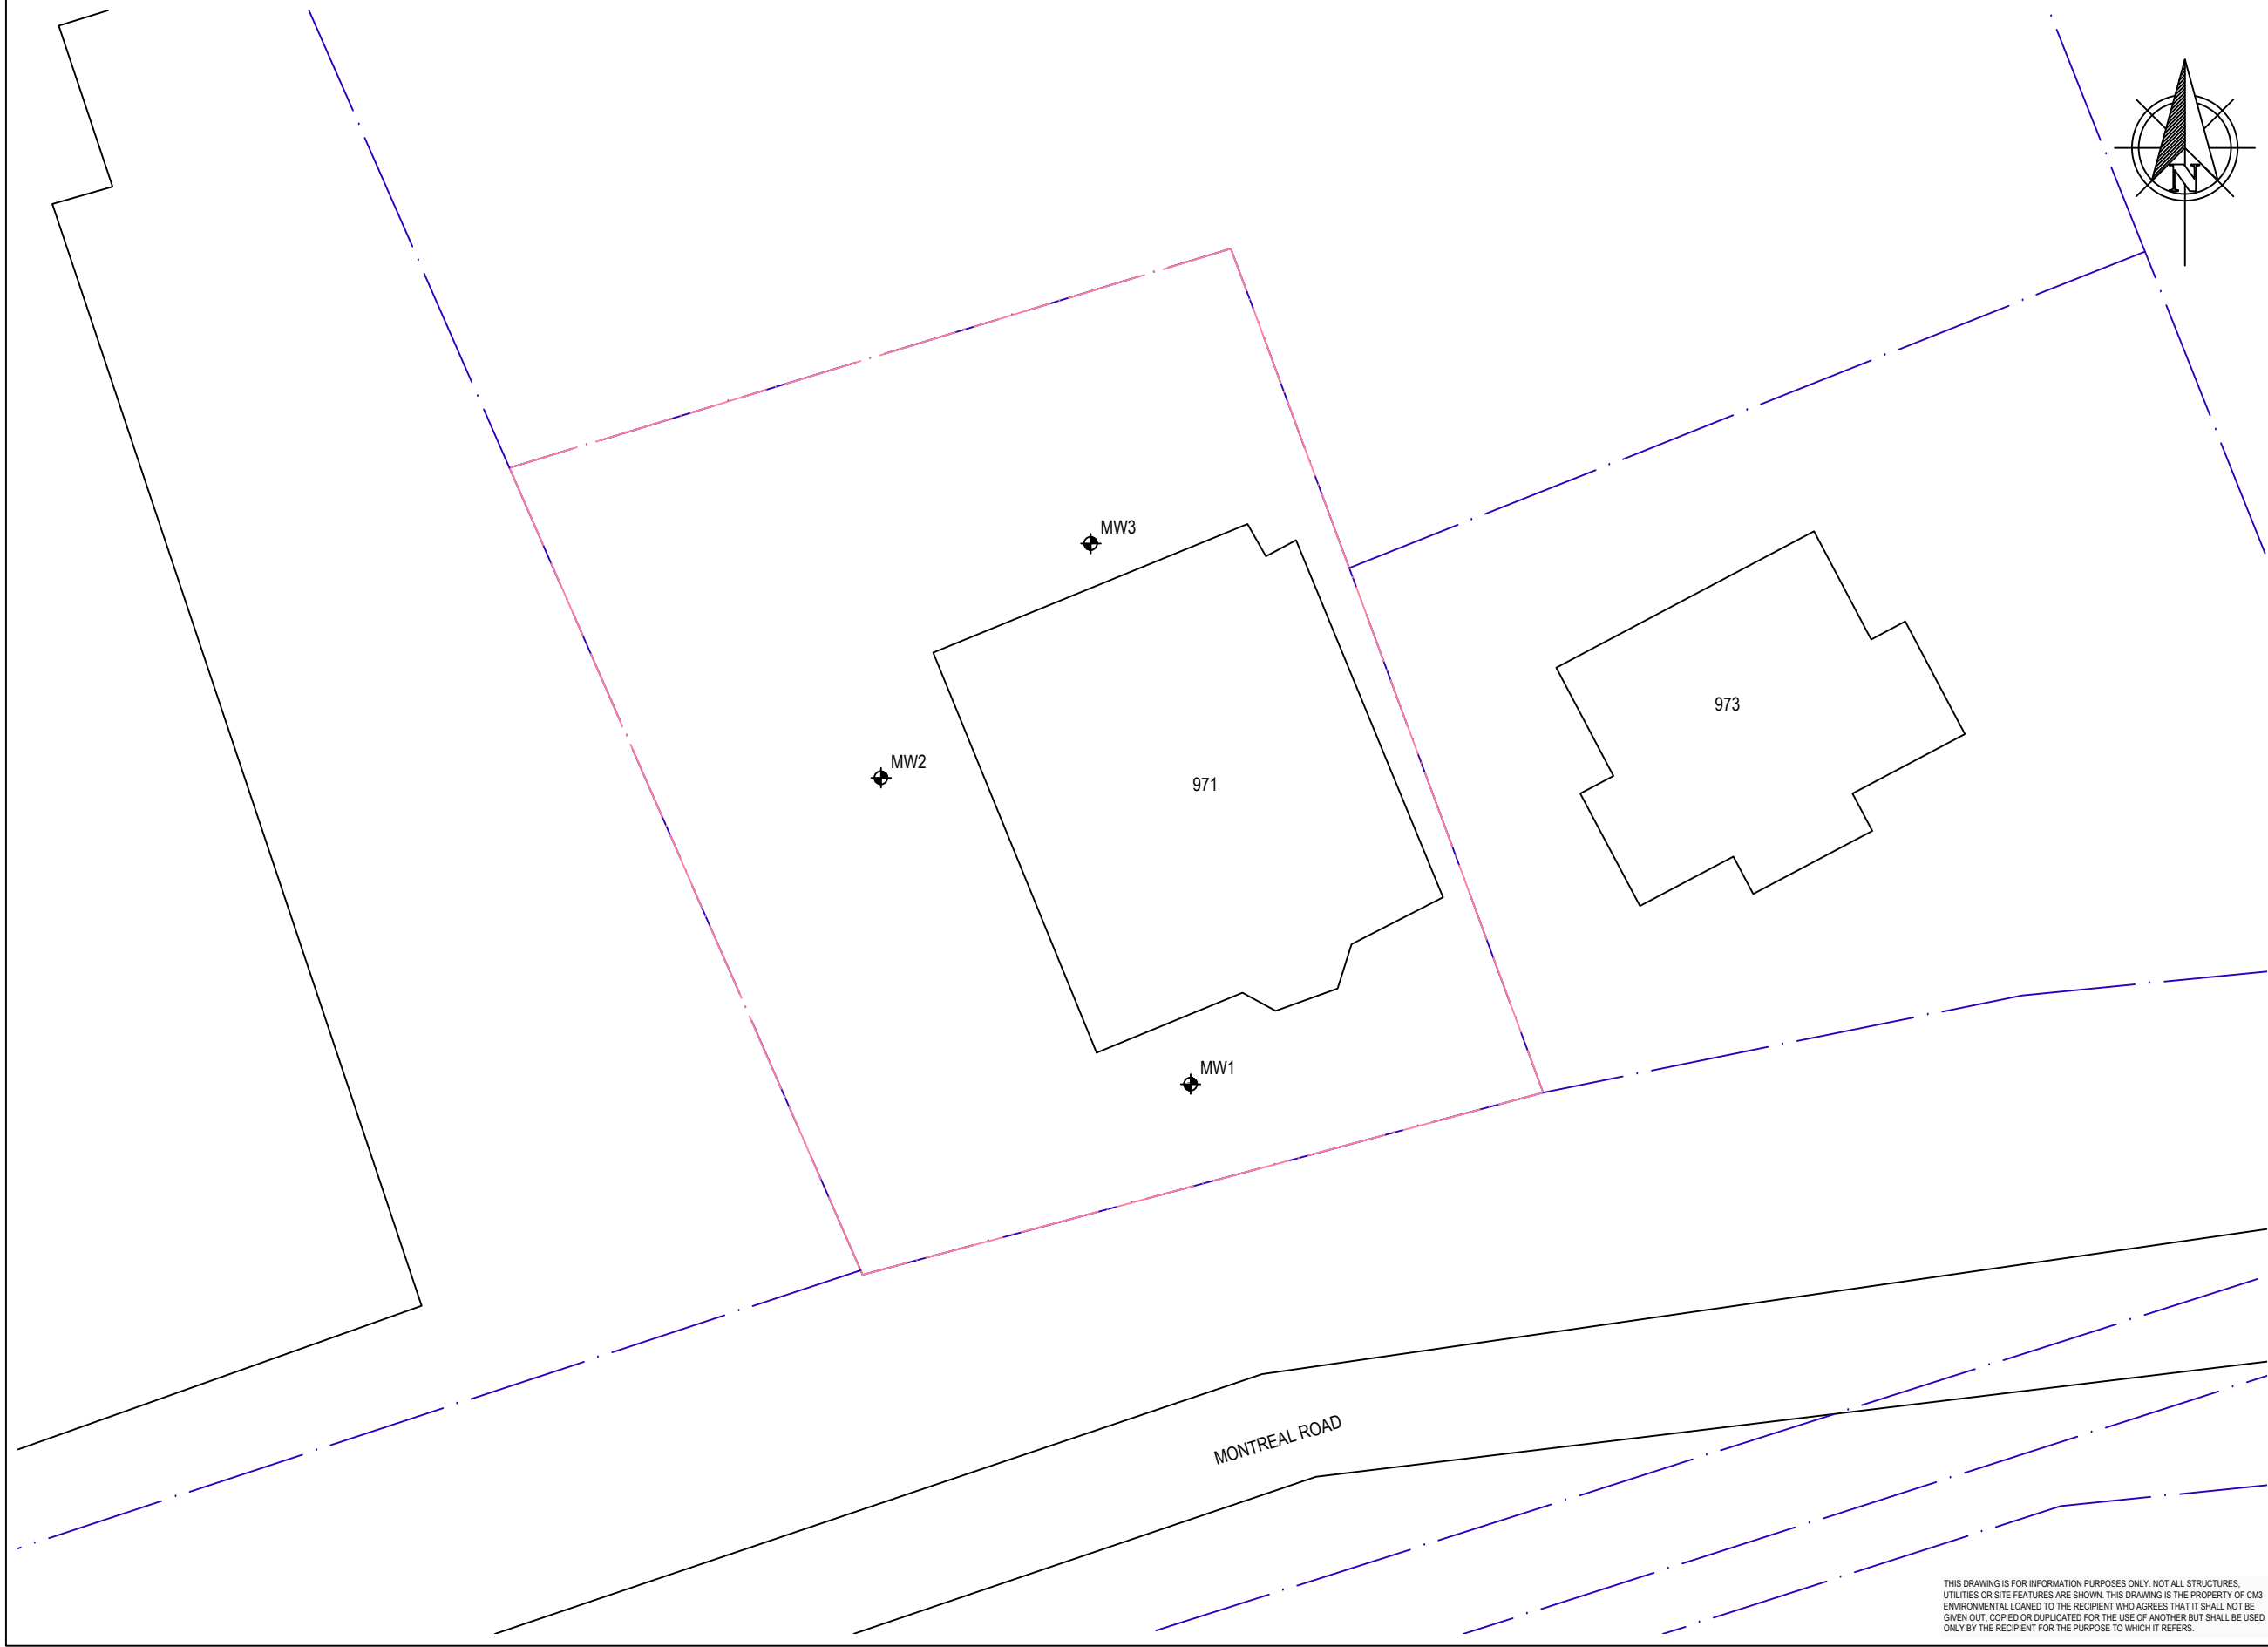
PHASE II ENVIRONMENTAL SITE  
ASSESSMENT  
971 MONTREAL ROAD  
OTTAWA, ONTARIO  
SITE PLAN

A total of three boreholes (MW1 to MW3) were completed on July 10<sup>th</sup>, 2020, under the supervision of CM3. Boreholes were advanced by Forage Downing Drilling from Hawkesbury, Ontario. All boreholes were advanced in the parking lot on the south, west and north side of the building. The borehole locations are provided on **Figure 2**.

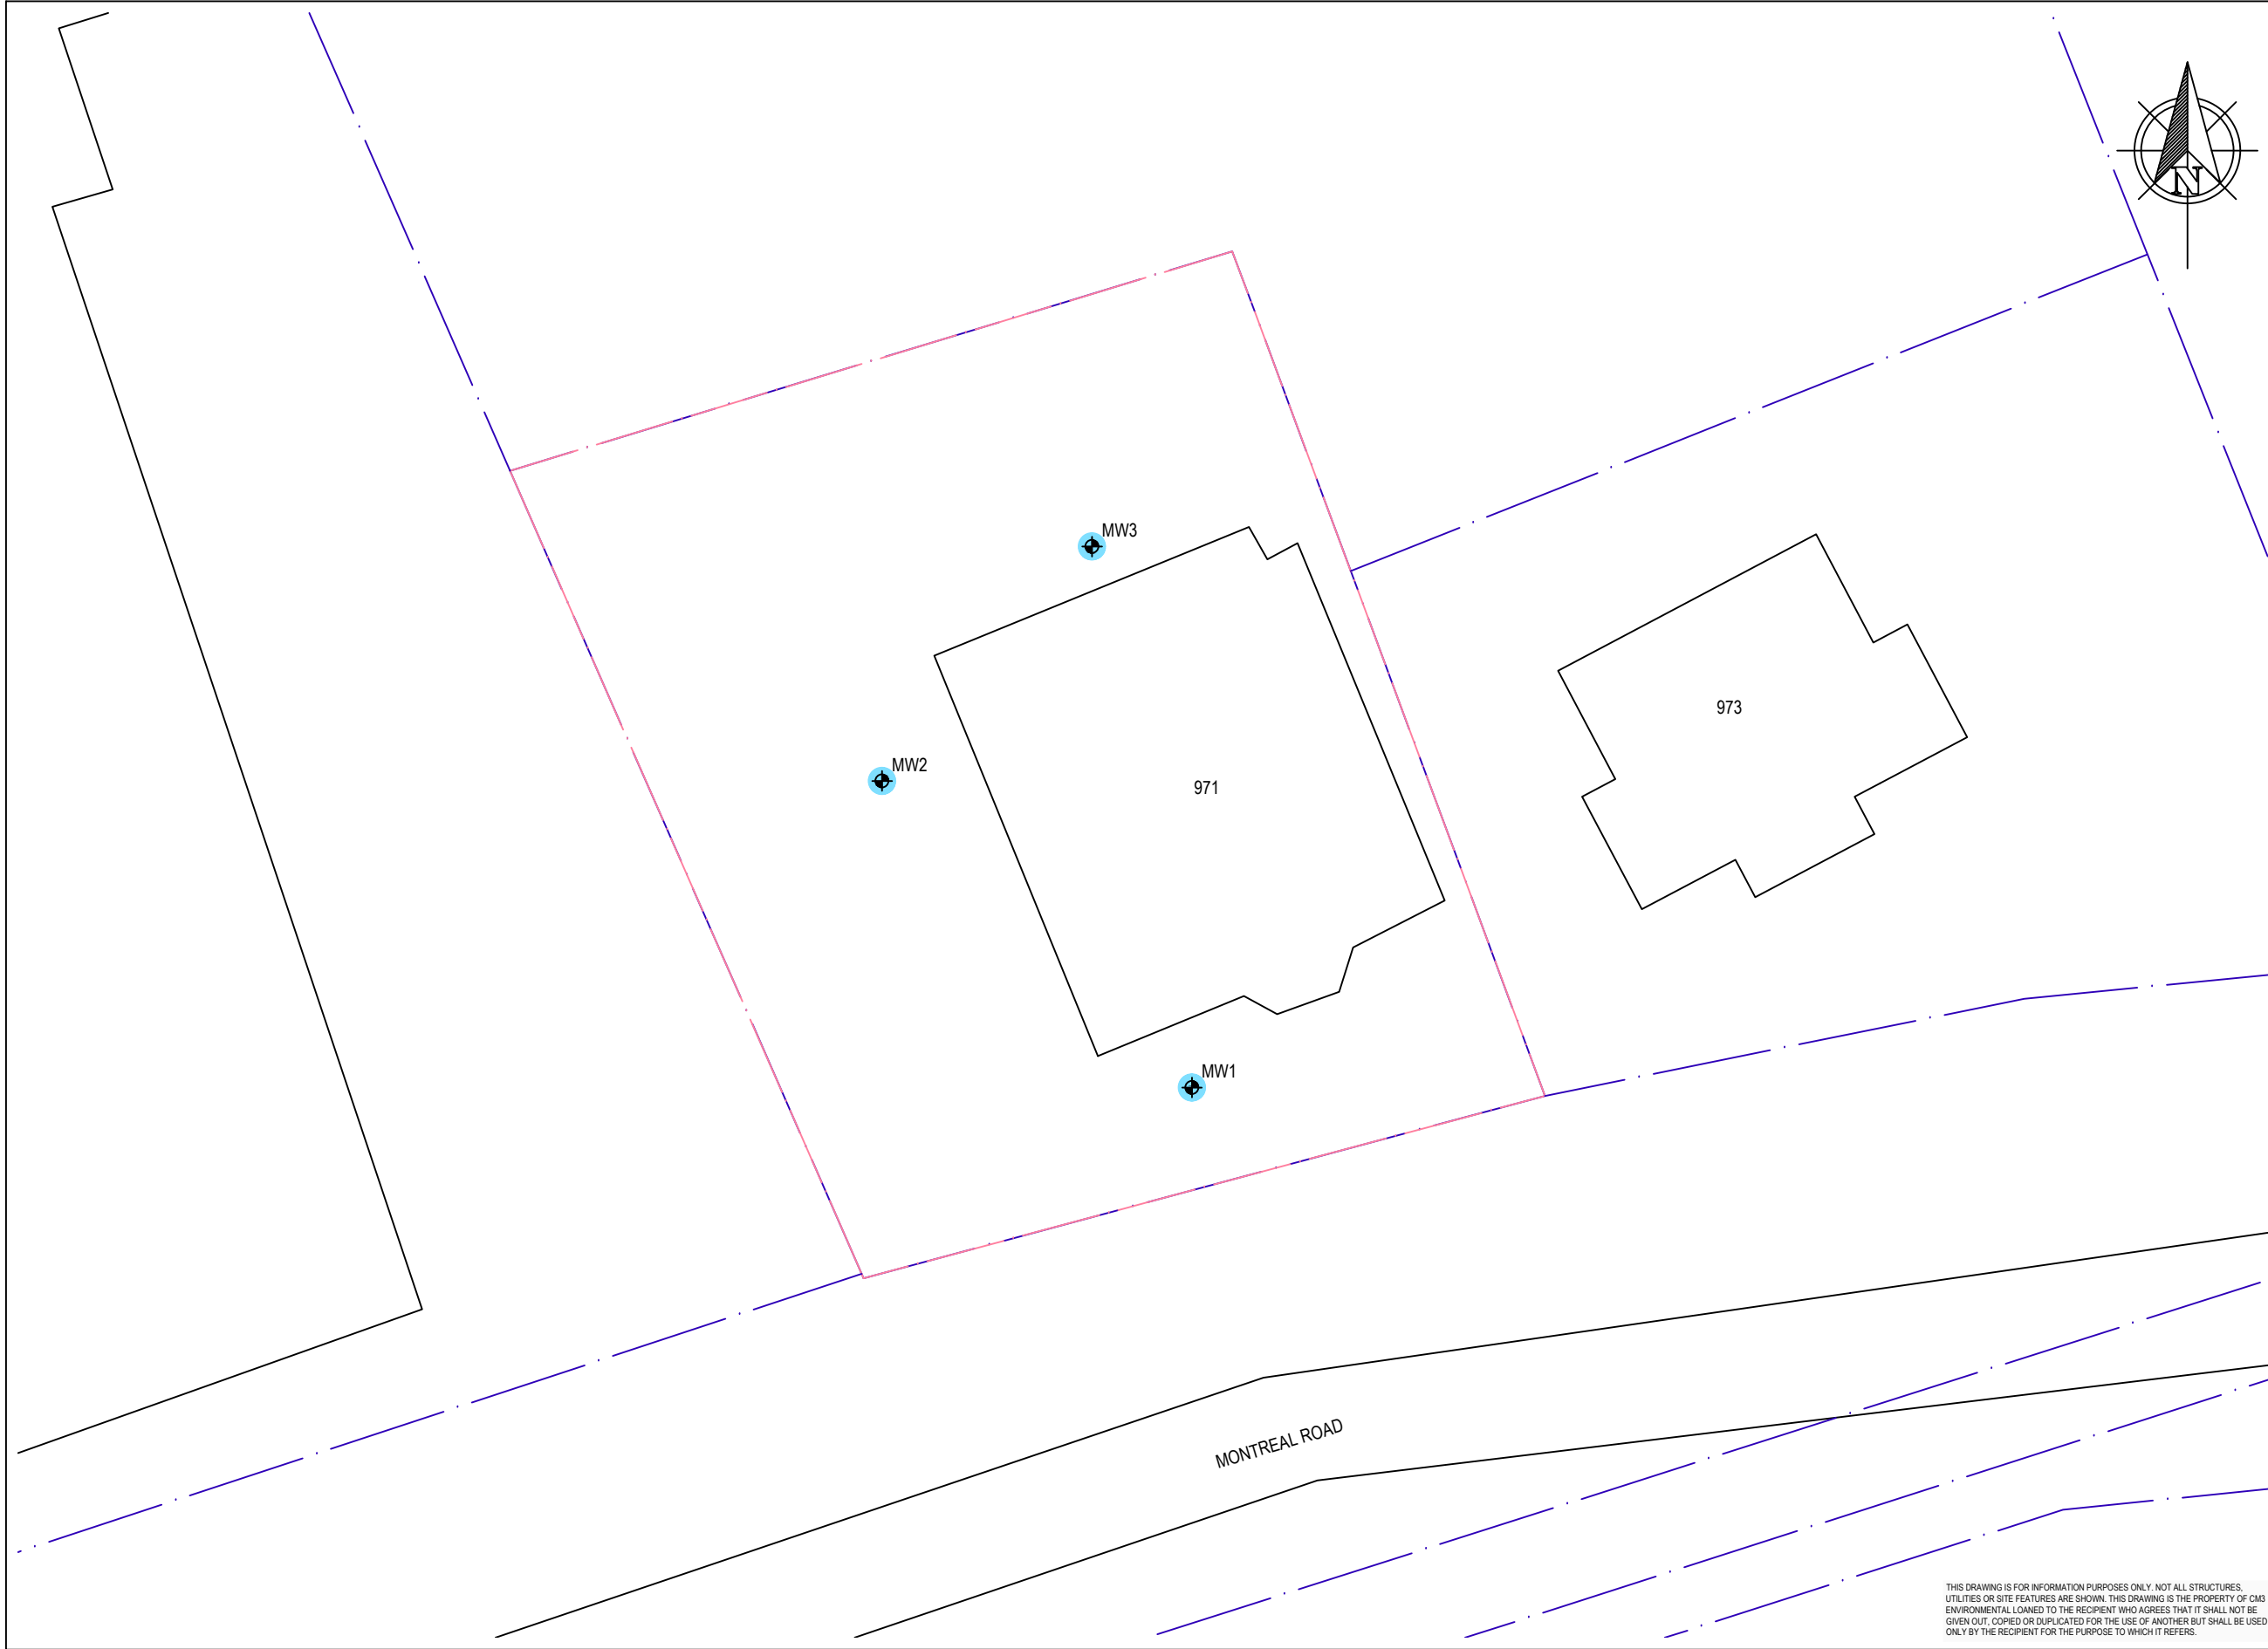
SOIL QUALITY

The concentrations of all soil samples submitted for laboratory analysis (PHCs F1-F4 fractions, VOCs and metals) were below the MECP Table 7 SCS and as such, are acceptable for the current land use.

The soil sample analytical results are summarized in **Table 2** through **Table 4**. The borehole soil sample locations and soil quality are provided on **Figure 3**. The soil sample laboratory reports are provided in **Appendix B**.

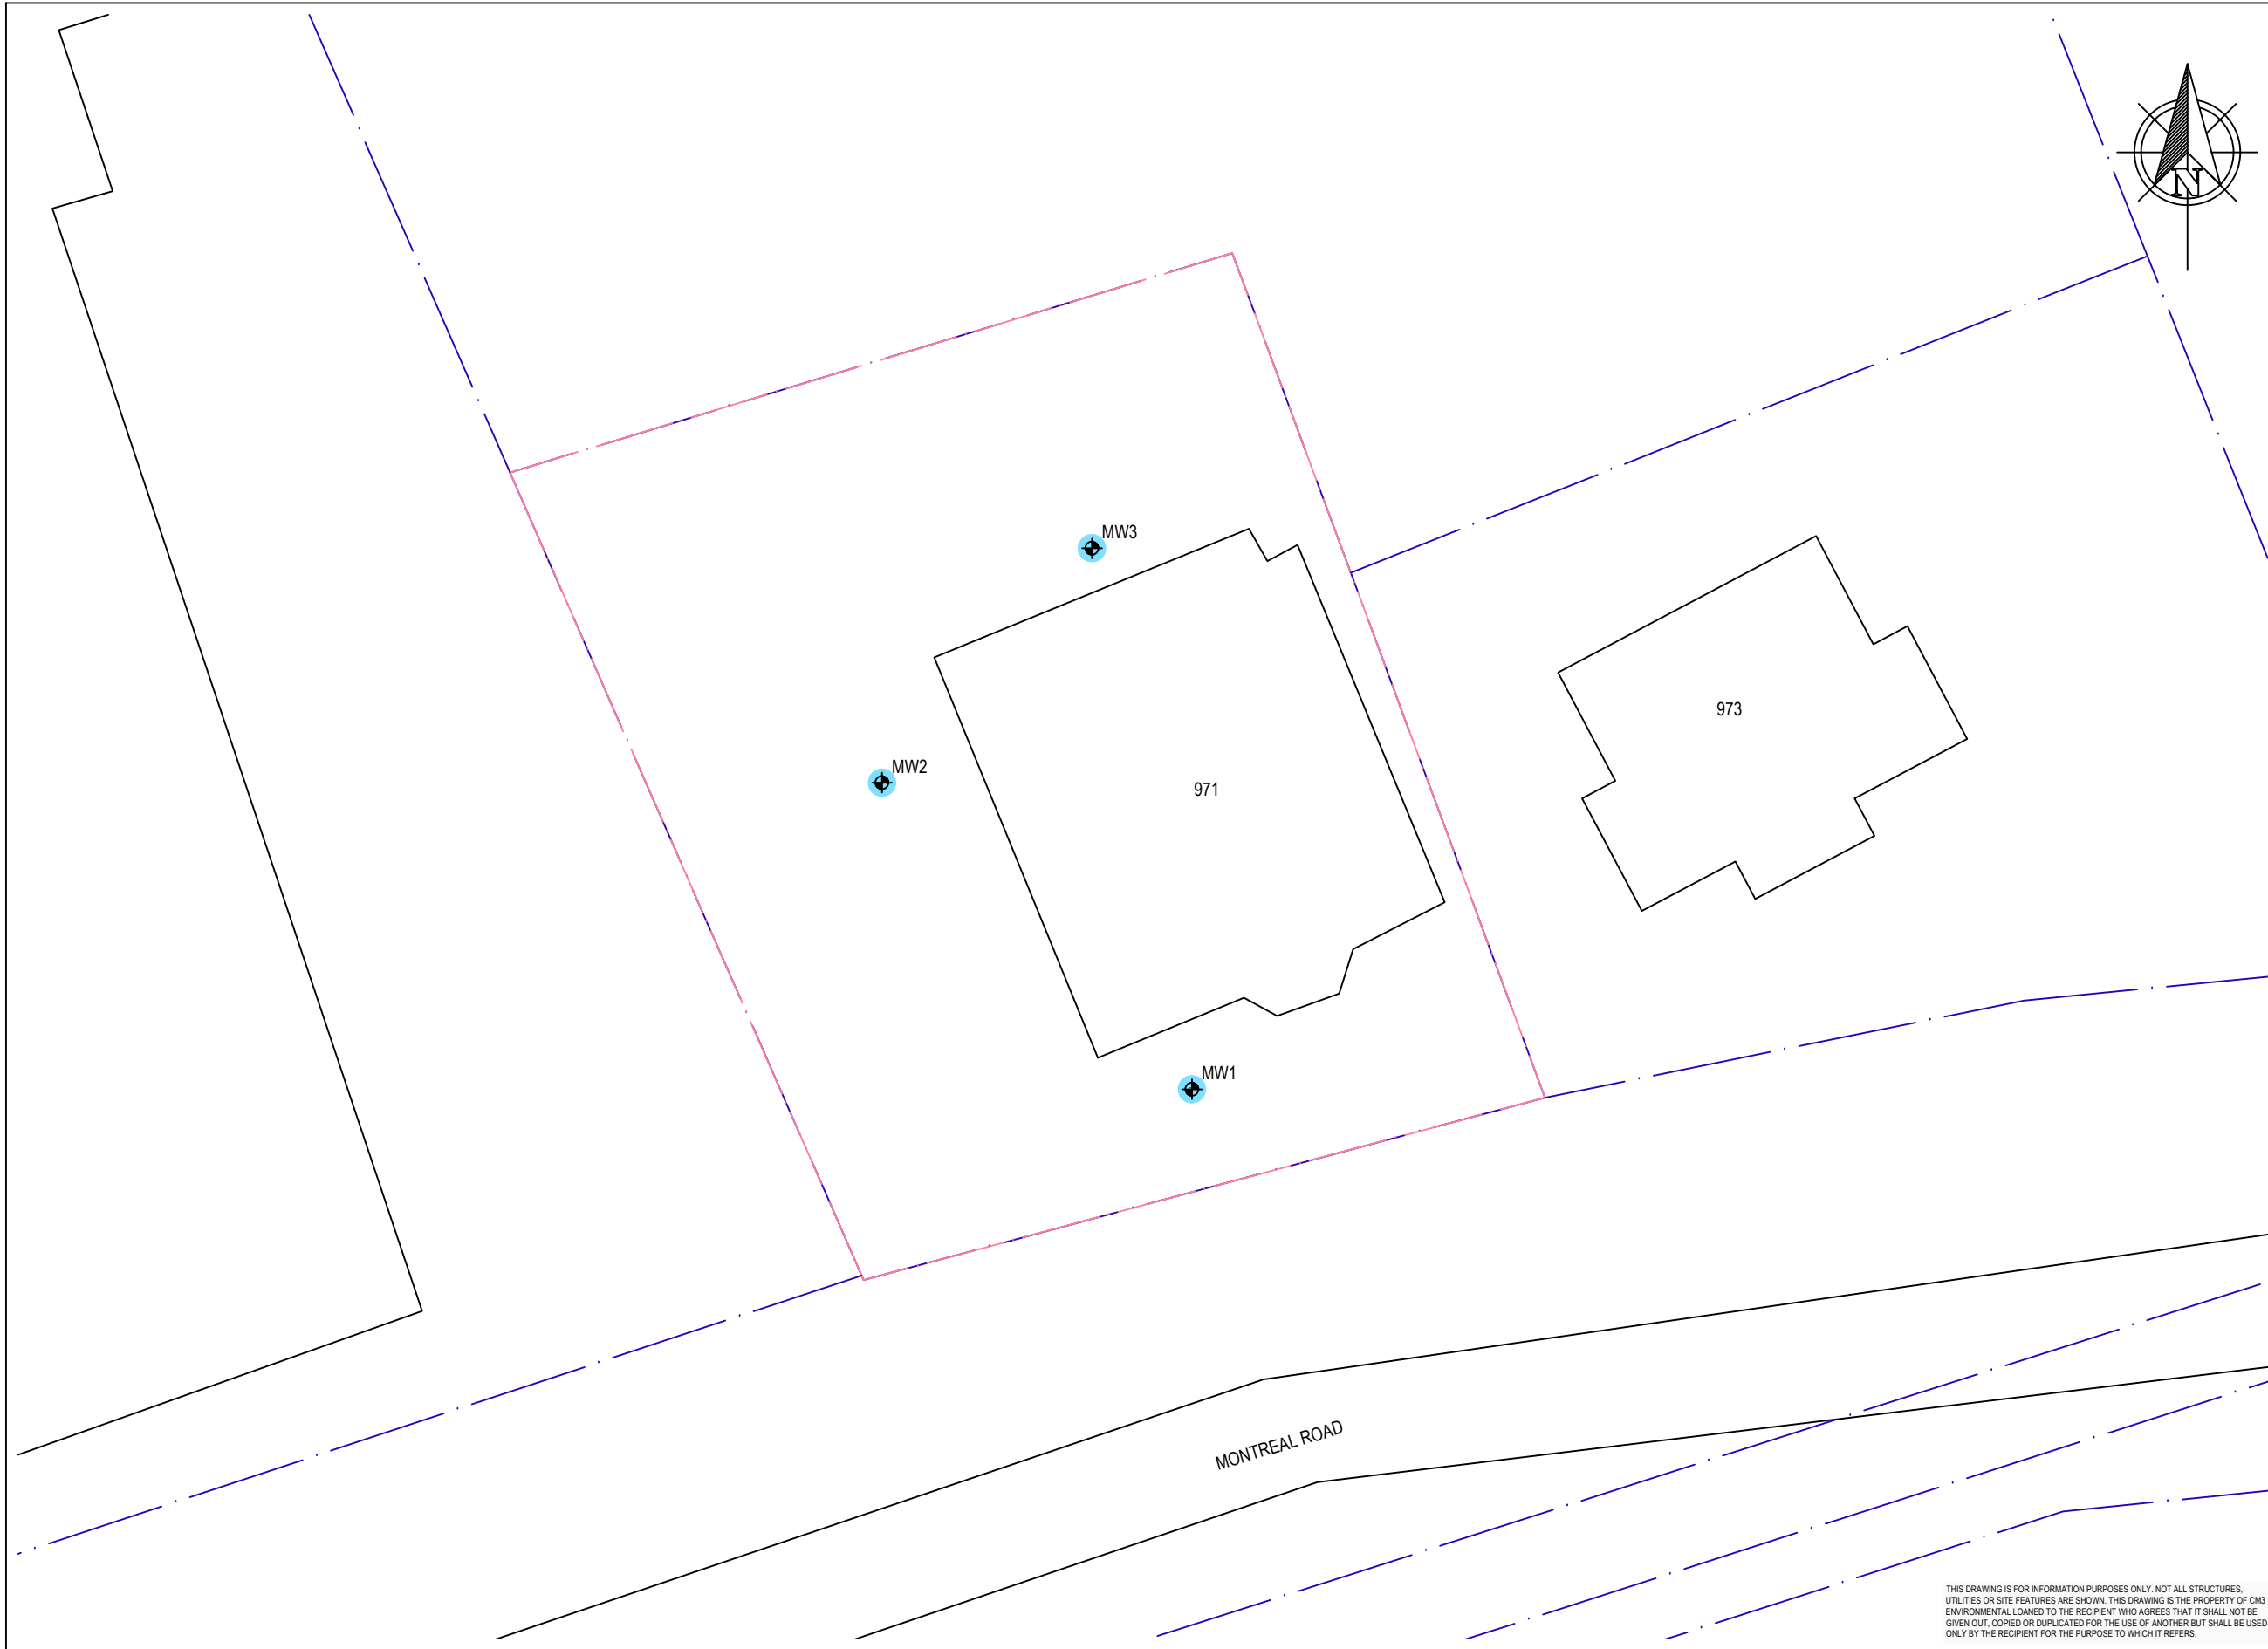
GROUNDWATER QUALITY

The concentrations of all groundwater samples submitted for laboratory analysis (PHCs F1-F4 fractions, VOCs and metals) from July 16th, 2020 were at or below the MECP Table 7 SCS with the exception of chloroform which was slightly over the SCS.

CM3 returned to collect additional groundwater samples from MW1, MW2 and MW3 on July 23<sup>rd</sup>, 2020 for chloroform analysis. The samples were found to be at or below the MECP Table 7 SCS for chloroform levels.

It is unclear at this time why chloroform levels were slightly elevated on the first sampling event. It may possibly be due to the addition of chlorinated municipal water during the bedrock coring process. No sources of chloroform were found in the Phase I ESA. It does not appear that chloroform is a significant concern based on the investigation(s).

The groundwater sample analytical results are summarized in **Table 5** through **Table 7**. The monitoring well locations and groundwater quality are provided on **Figure 4**. The groundwater sample laboratory reports are provided in **Appendix B**.

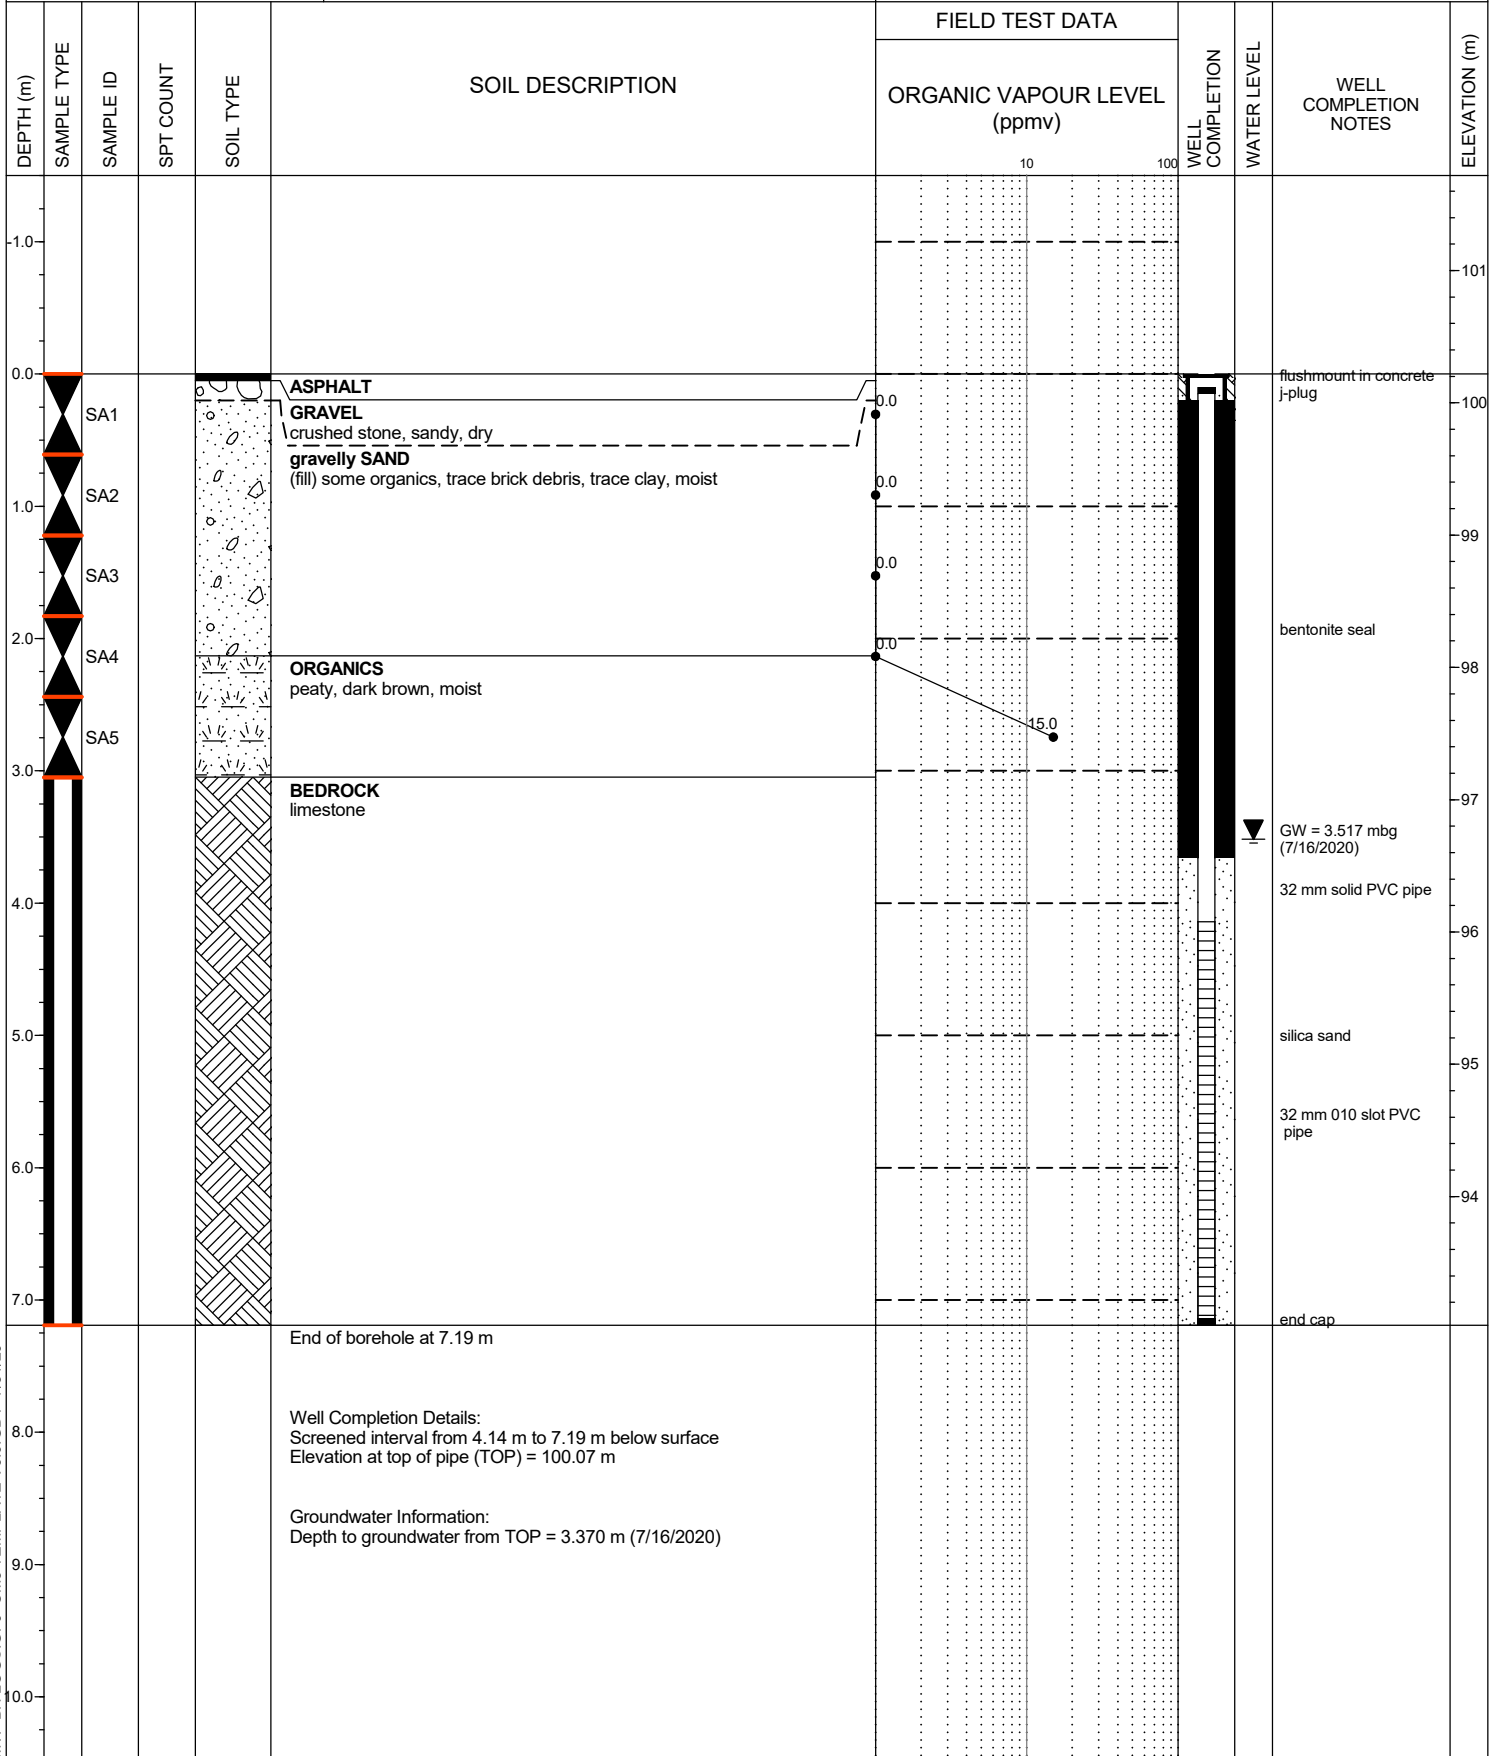
DRILL DATE: July 10, 2020

| DEPTH (m) | SAMPLE TYPE | SAMPLE ID | SPT COUNT | SOIL TYPE | SOIL DESCRIPTION | FIELD TEST DATA | | WELL COMPLETION | WATER LEVEL | WELL COMPLETION NOTES | ELEVATION (m) |
|---|---|---|---|---|---|---|---|---|---|---|---|
| 1.0 | | SA2 | | | TOPSOIL<br>trace sand and gravel, moist | | | | | | |
| | | SA3 | | | silty SAND<br>some gravel, trace clay, moist | | | | | bentonite seal | |
