September 24, 2020  
File: PE4791-LET.01

**Exit 96 Developments (2019) Inc.**  
236 Metcalfe Street, Suite 206  
Ottawa, Ontario  
K2P 1R3

Subject: **Phase I - Environmental Site Assessment Update  
5638 Boundary Road and 6150 Thunder Road  
Ottawa, Ontario**

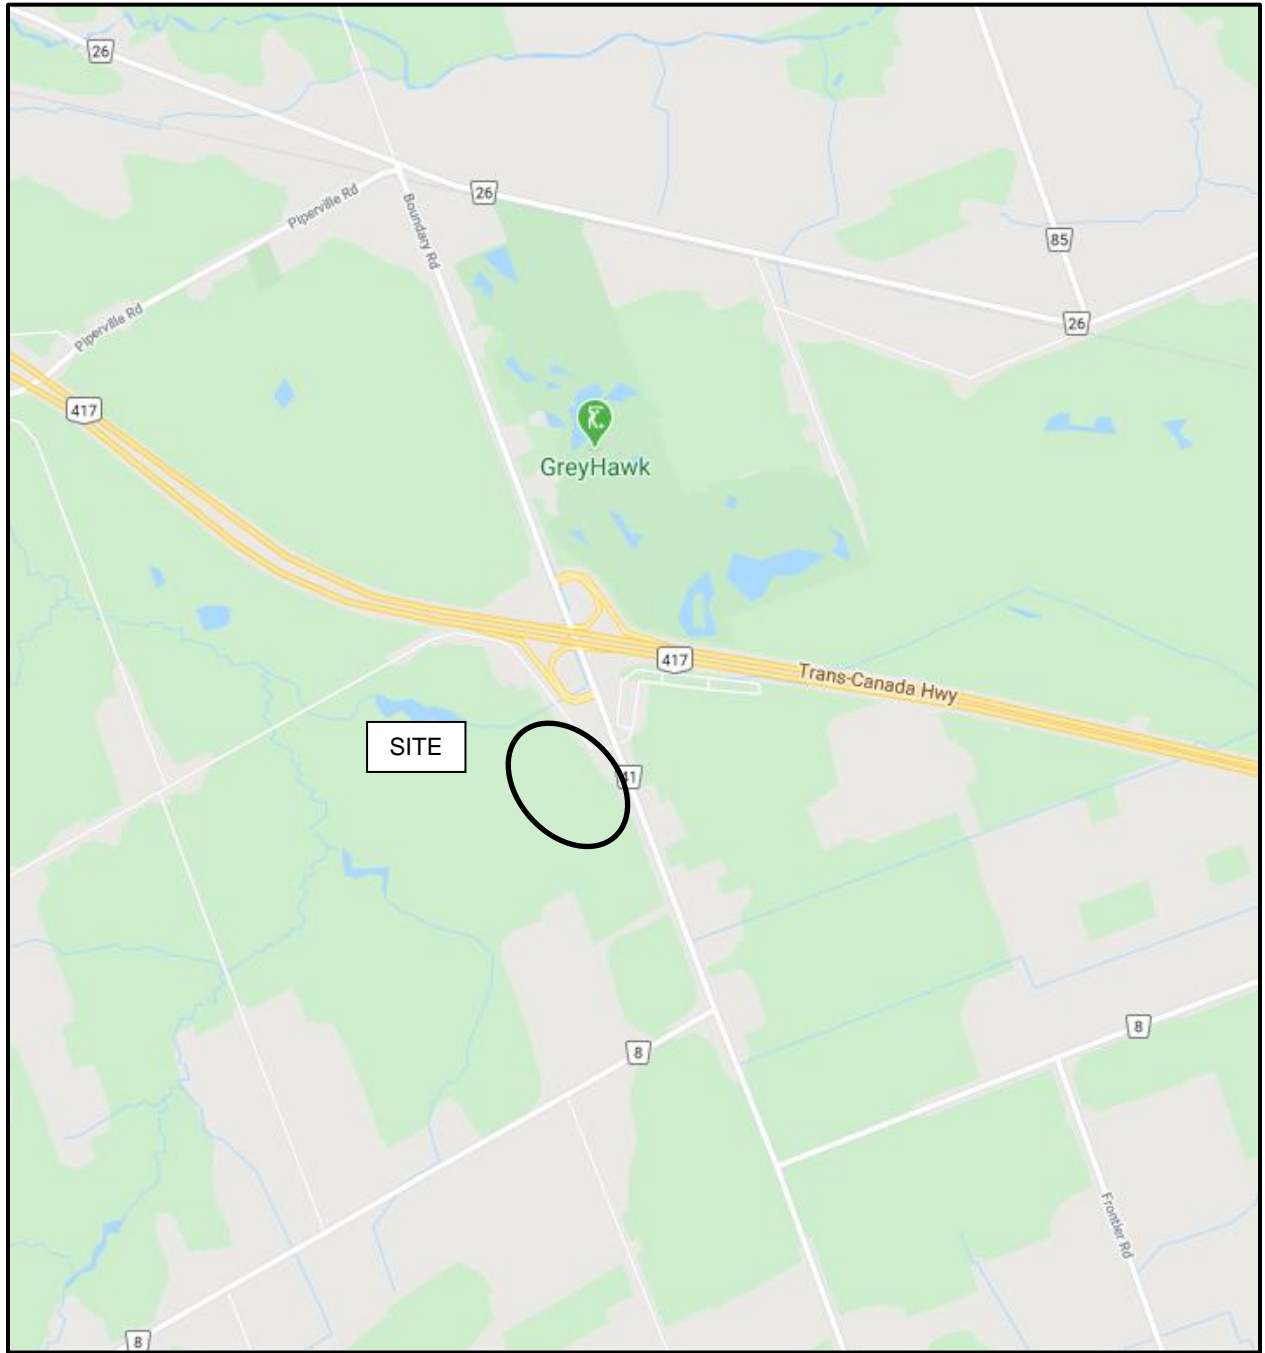
# FIGURE 1

## KEY PLAN

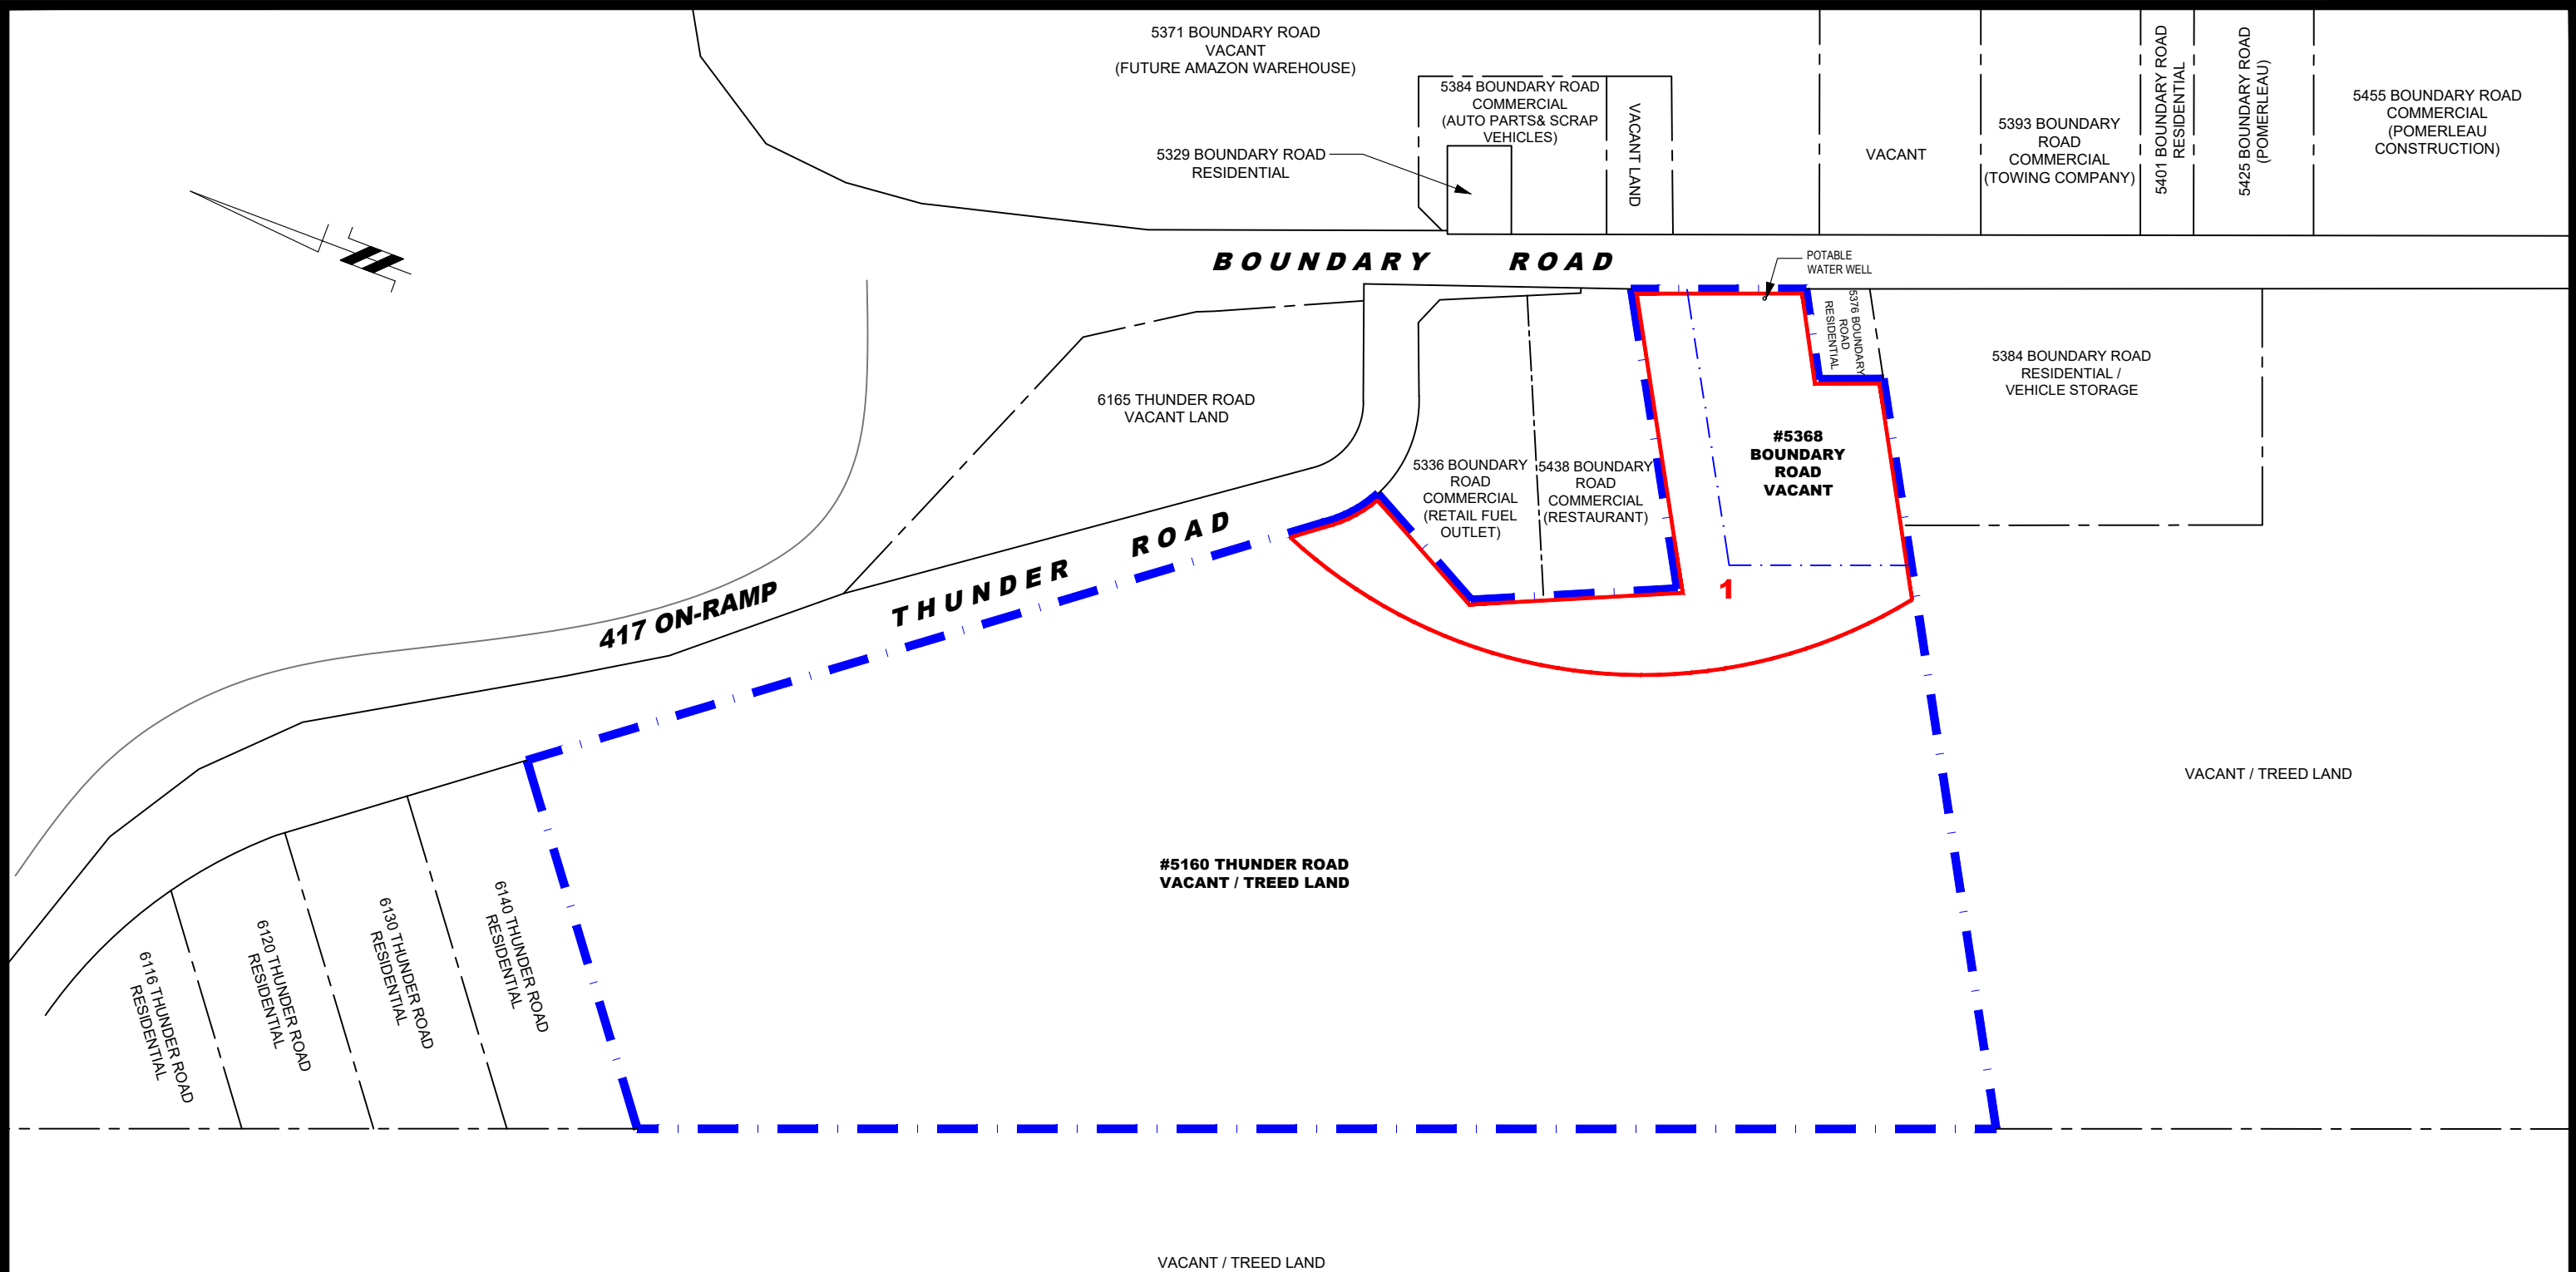
Scale:	1:3000	Date:	09/2020
Drawn by:	RCG	Report No.:	PE4791-1
Checked by:	MW	Dwg. No.:	<b>PE4791-1</b>
Approved by:	MSD	Revision No.:	0

**AREA OF POTENTIAL ENVIRONMENTAL CONCERN:**

- 1. 5336 BOUNDARY ROAD - RETAIL FUEL OUTLET (PETRO CANADA)

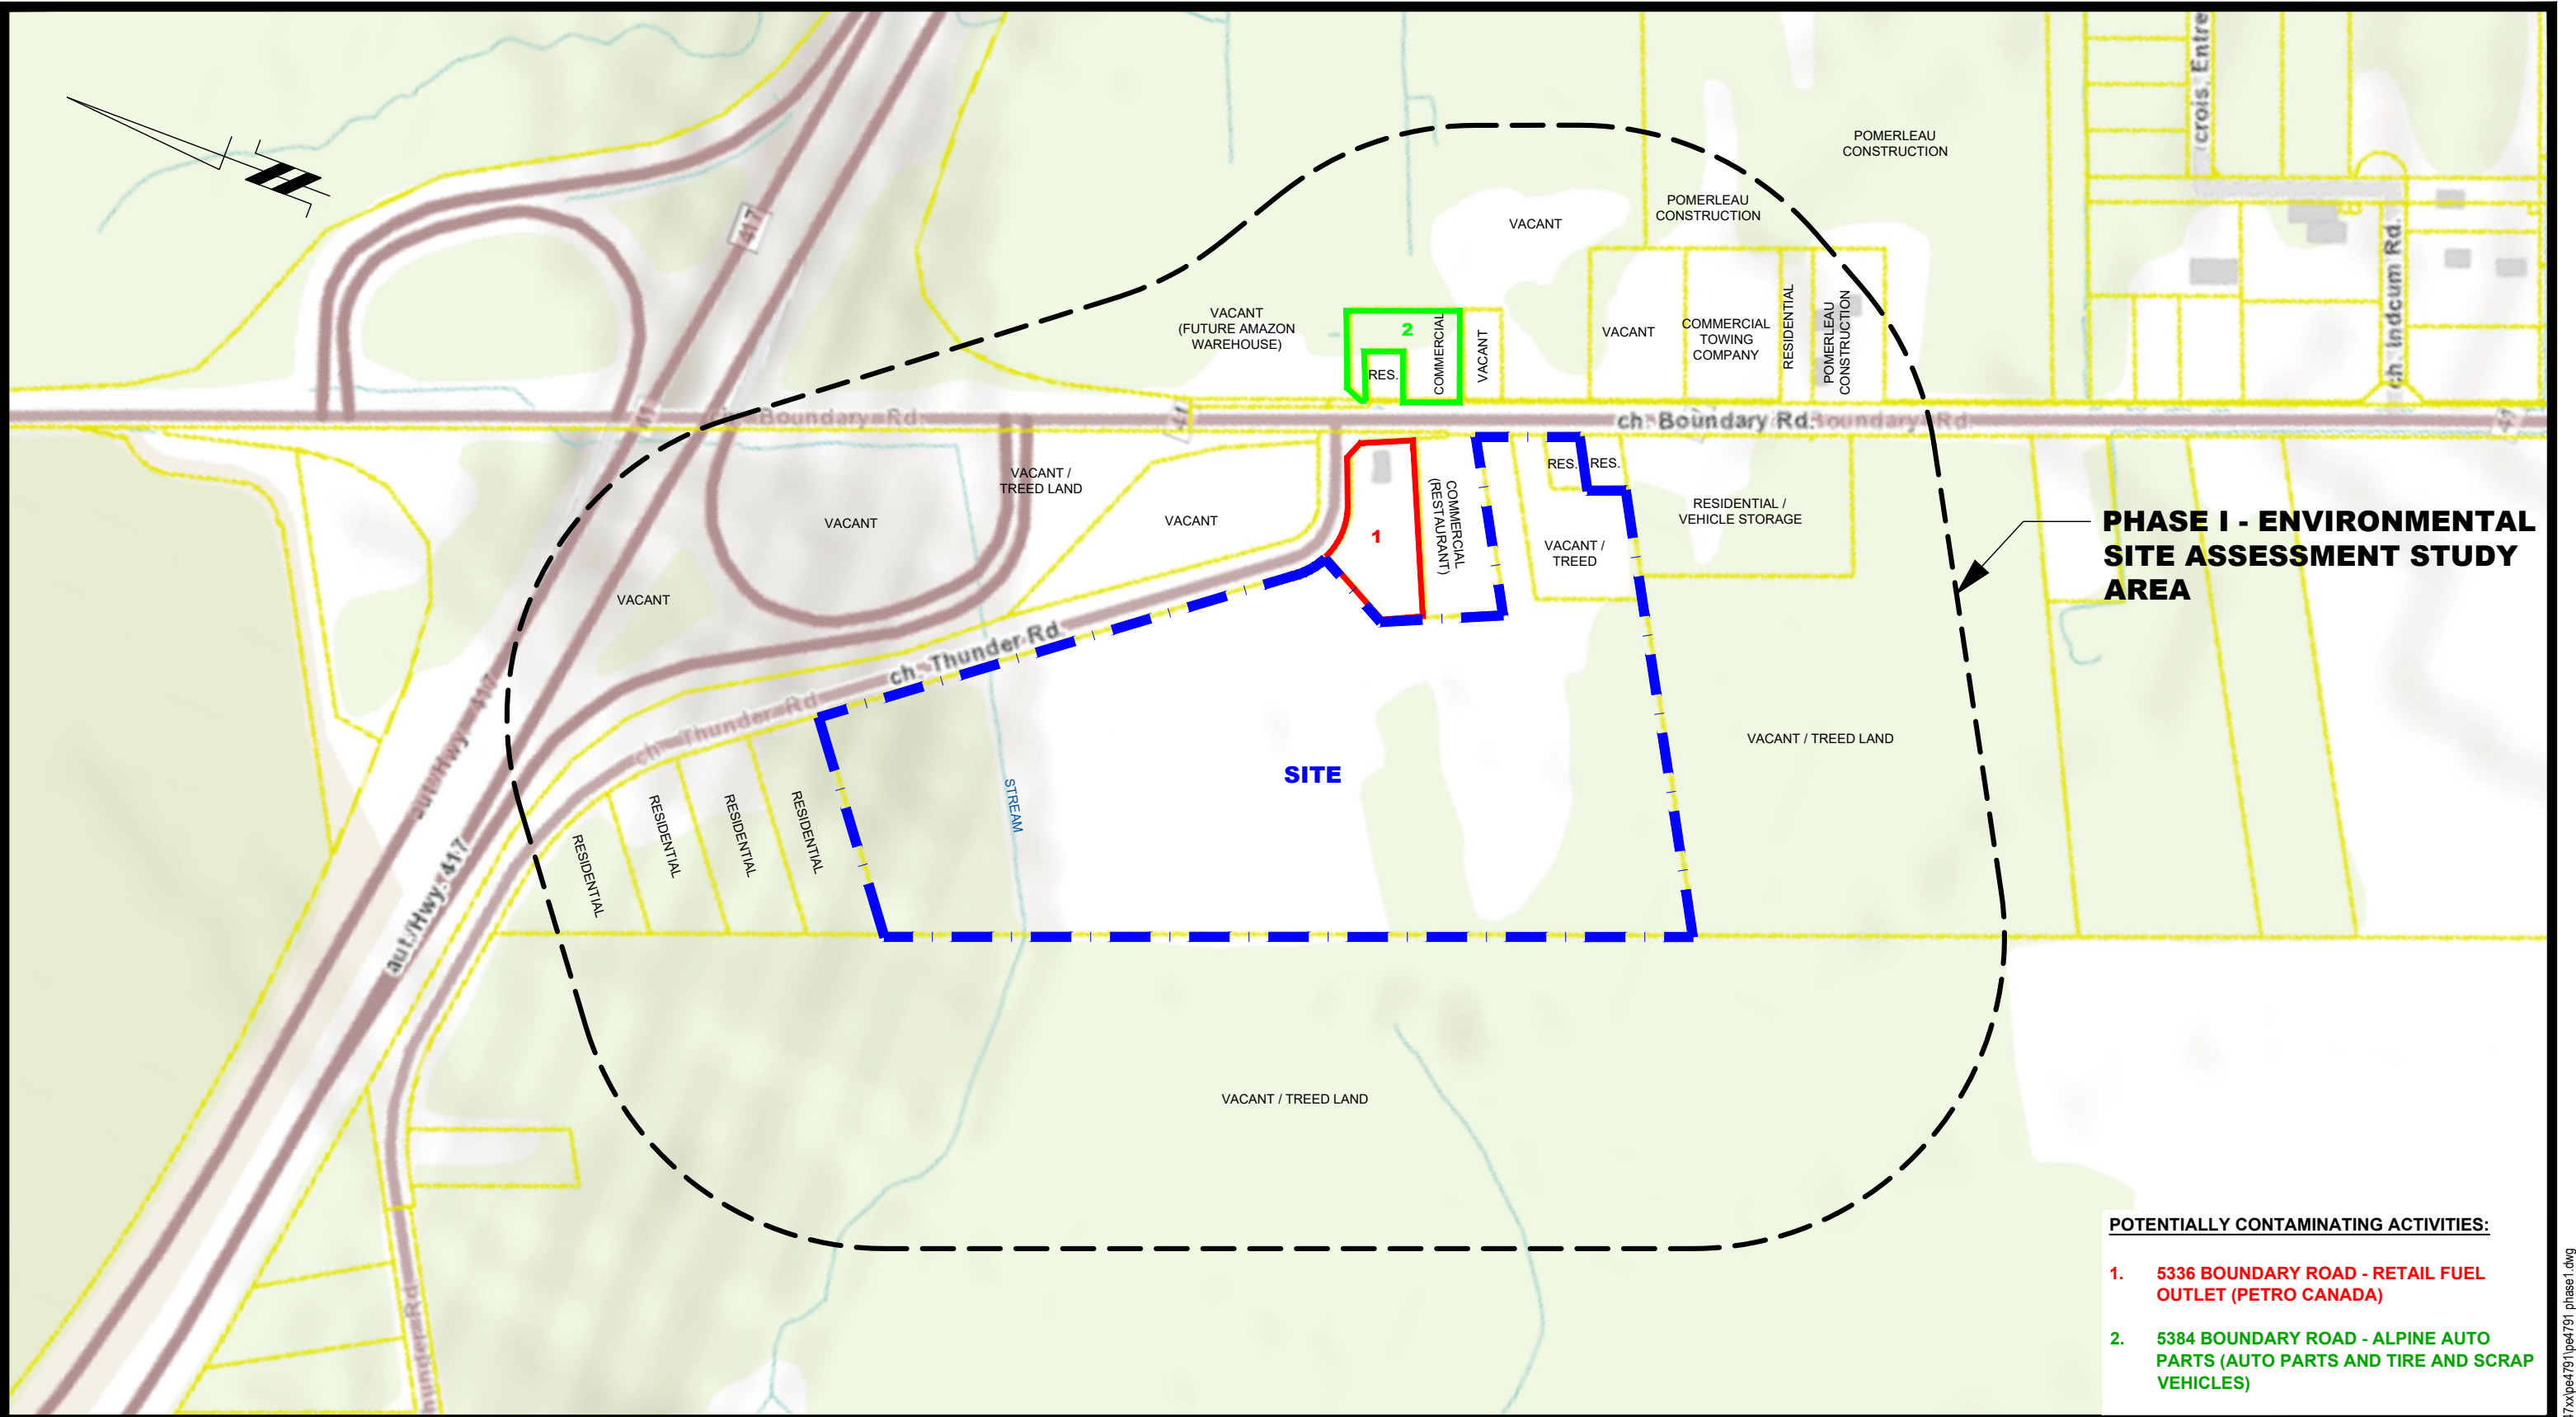
**PHASE I - ENVIRONMENTAL SITE ASSESSMENT STUDY AREA**

- POTENTIALLY CONTAMINATING ACTIVITIES:**
1. 5336 BOUNDARY ROAD - RETAIL FUEL OUTLET (PETRO CANADA)
  2. 5384 BOUNDARY ROAD - ALPINE AUTO PARTS (AUTO PARTS AND TIRE AND SCRAP VEHICLES)
