# Geotechnical Investigation – Proposed Residential Development

Heron Gate 5, Ottawa, Ontario

Pinchin File: 288344.001

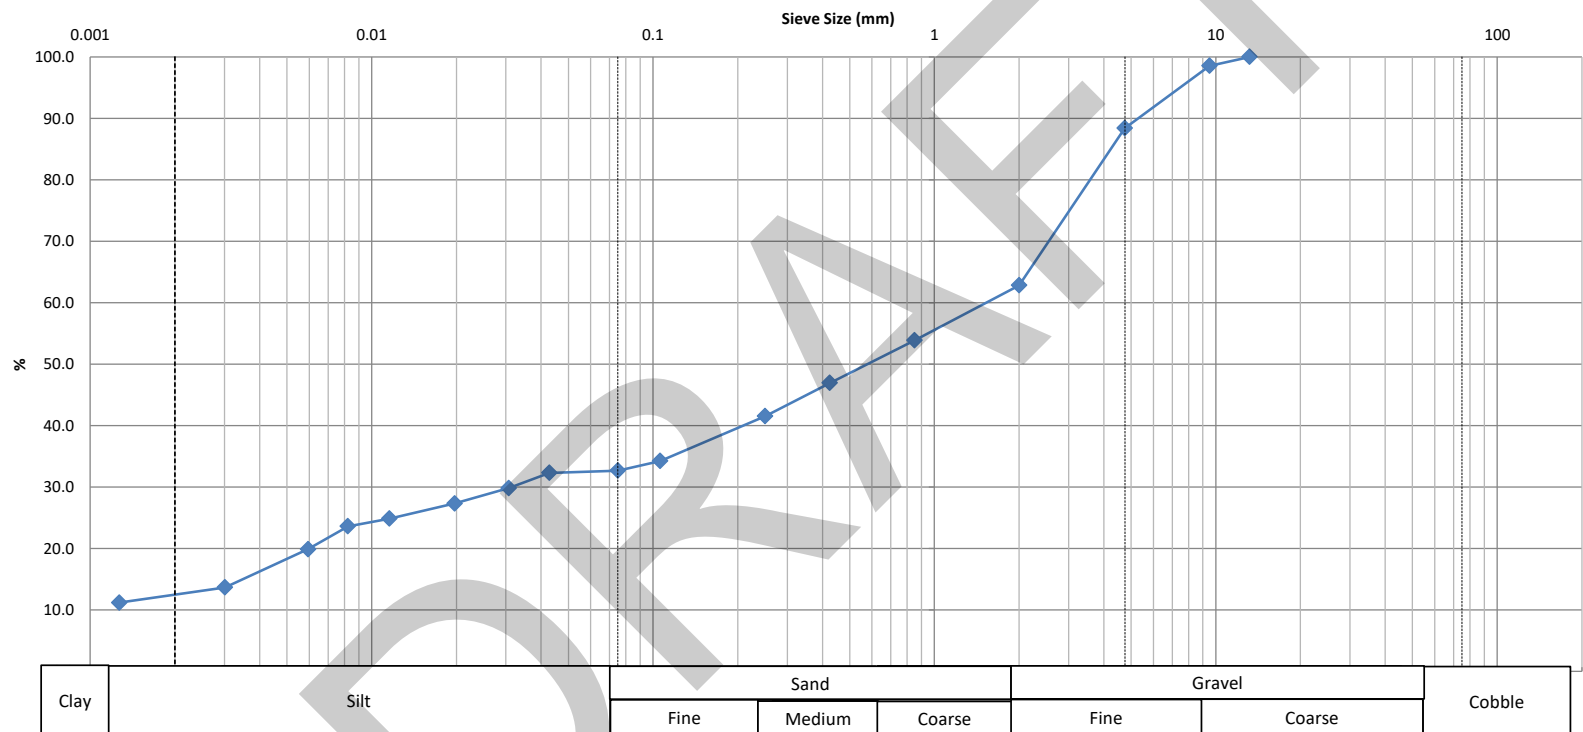
| Identification | Soil Classification | | | | | MC(%) | LL | PL | PI | Cc | Cu |
| | | | | | | 7.8 | | | | | |

Glacial till was encountered at depths ranging between approximately 0.2 to 2.3 mbgs and extended to maximum borehole refusal depth of approximately 7.6 mbgs. The glacial till was noted to range in soil matrix from sand containing some gravel, some silt, and some clay, to gravelly silty sand containing some clay. The non-cohesive glacial till material had a loose to very dense relative density based SPT 'N' values of 6 to greater than 50 blows per 300 mm penetration of a split spoon sampler. The results of four particle size distribution analyses completed on samples of the glacial till indicate that the samples contain 12 to 23% gravel, 42 to 56% sand, 17 to 22% silt, and 8 to 14% clay sized particles. The moisture content of the samples tested ranged from 7.3 to 9.3% indicating a damp to moist condition.
