PROJECT NAME
CIRCLE K STORES INC.
R&R No. 5287
NEPEAN
ONTARIO
1545 WOODROFFE AVENUE
NEPEAN, ON, CANADA
K2G 1W2

PROPOSED DEVELOPMENT
CONSERVED VEGETATION
PLAN

L1.1

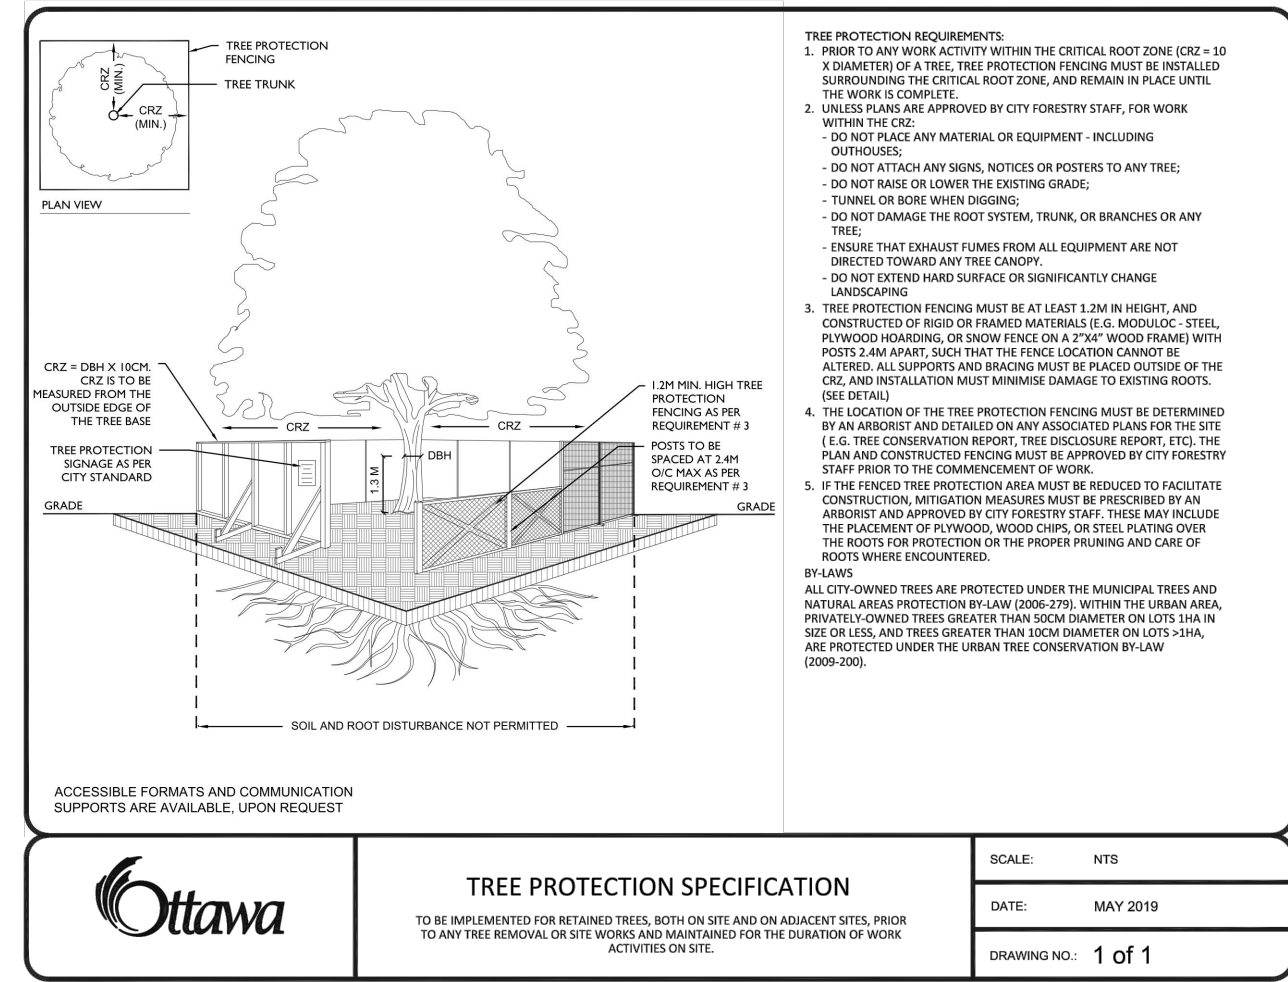
SPECIFICATIONS FOR THE PROTECTION AND PRESERVATION OF EXISTING TREES

- ALL EXISTING TREES WHICH ARE TO REMAIN SHALL BE FULLY PROTECTED WITH FENCING ERRECTED AROUND THE ENTIRE PERIMETER OF THE TREE PROTECTION ZONE IN ACCORDANCE WITH THE MINIMUM DISTANCE REQUIREMENTS, GROUPS OF TREES AND OTHER EXISTING PLANTINGS TO BE PROTECTED, SHALL BE DONE IN A LIKE MANNER WITH FENCING AROUND THE ENTIRE CLUMPS(S).

- AREAS WITHIN THE PROTECTIVE FENCING SHALL REMAIN UNDISTURBED AND SHALL NOT BE USED FOR THE STORAGE OF BUILDING MATERIALS OR EQUIPMENT.
- THIS WORK SHALL BE COMPLETED, TO THE SATISFACTION OF THE COMMISSIONER OF DEVELOPMENT SERVICES, PRIOR TO THE ISSUANCE OF BUILDING PERMITS FOR THE SITE DEVELOPMENT. THE DEVELOPER OR HIS/HER AGENT SHALL TAKE EVERY PRECAUTION NECESSARY TO PREVENT DAMAGE TO TREES OR SHRUBS TO BE RETAINED.

- NO RIGGING CABLES SHALL BE WRAPPED AROUND OR INSTALLED IN TREES; AND SURPLUS SOIL, EQUIPMENT, DEBRIS OR MATERIALS SHALL NOT BE PLACED OVER ROOT SYSTEMS OF THE TREES WITHIN THE PROTECTIVE FENCING. NO CONTAMINANTS WILL BE DUMPED OR FLUSHED WHERE FEEDER ROOTS OF TREES EXIST.

- WHERE LIMBS OR PORTIONS OF TREES ARE REMOVED TO ACCOMMODATE CONSTRUCTION WORK, THEY WILL BE CAREFULLY REMOVED BY AN ISA CERTIFIED ARBORIST.
- WHERE ROOT SYSTEMS OF PROTECTED TREES ARE EXPOSED DIRECTLY ADJACENT TO OR DAMAGED BY CONSTRUCTION WORK, THEY SHALL BE TRIMMED NEARLY BY A QUALIFIED ARBORIST AND THE AREA BACK FILLED WITH APPROPRIATE MATERIAL TO PREVENT DESICCATION.

- IF GRADES AROUND TREES TO BE PRESERVED ARE LIKELY TO CHANGE, THE DEVELOPER SHALL BE REQUIRED TO TAKE SUCH PRECAUTION AS DRY WELLING AND ROOT FEEDING TO THE SATISFACTION OF THE COMMISSIONER OF DEVELOPMENT SERVICES.

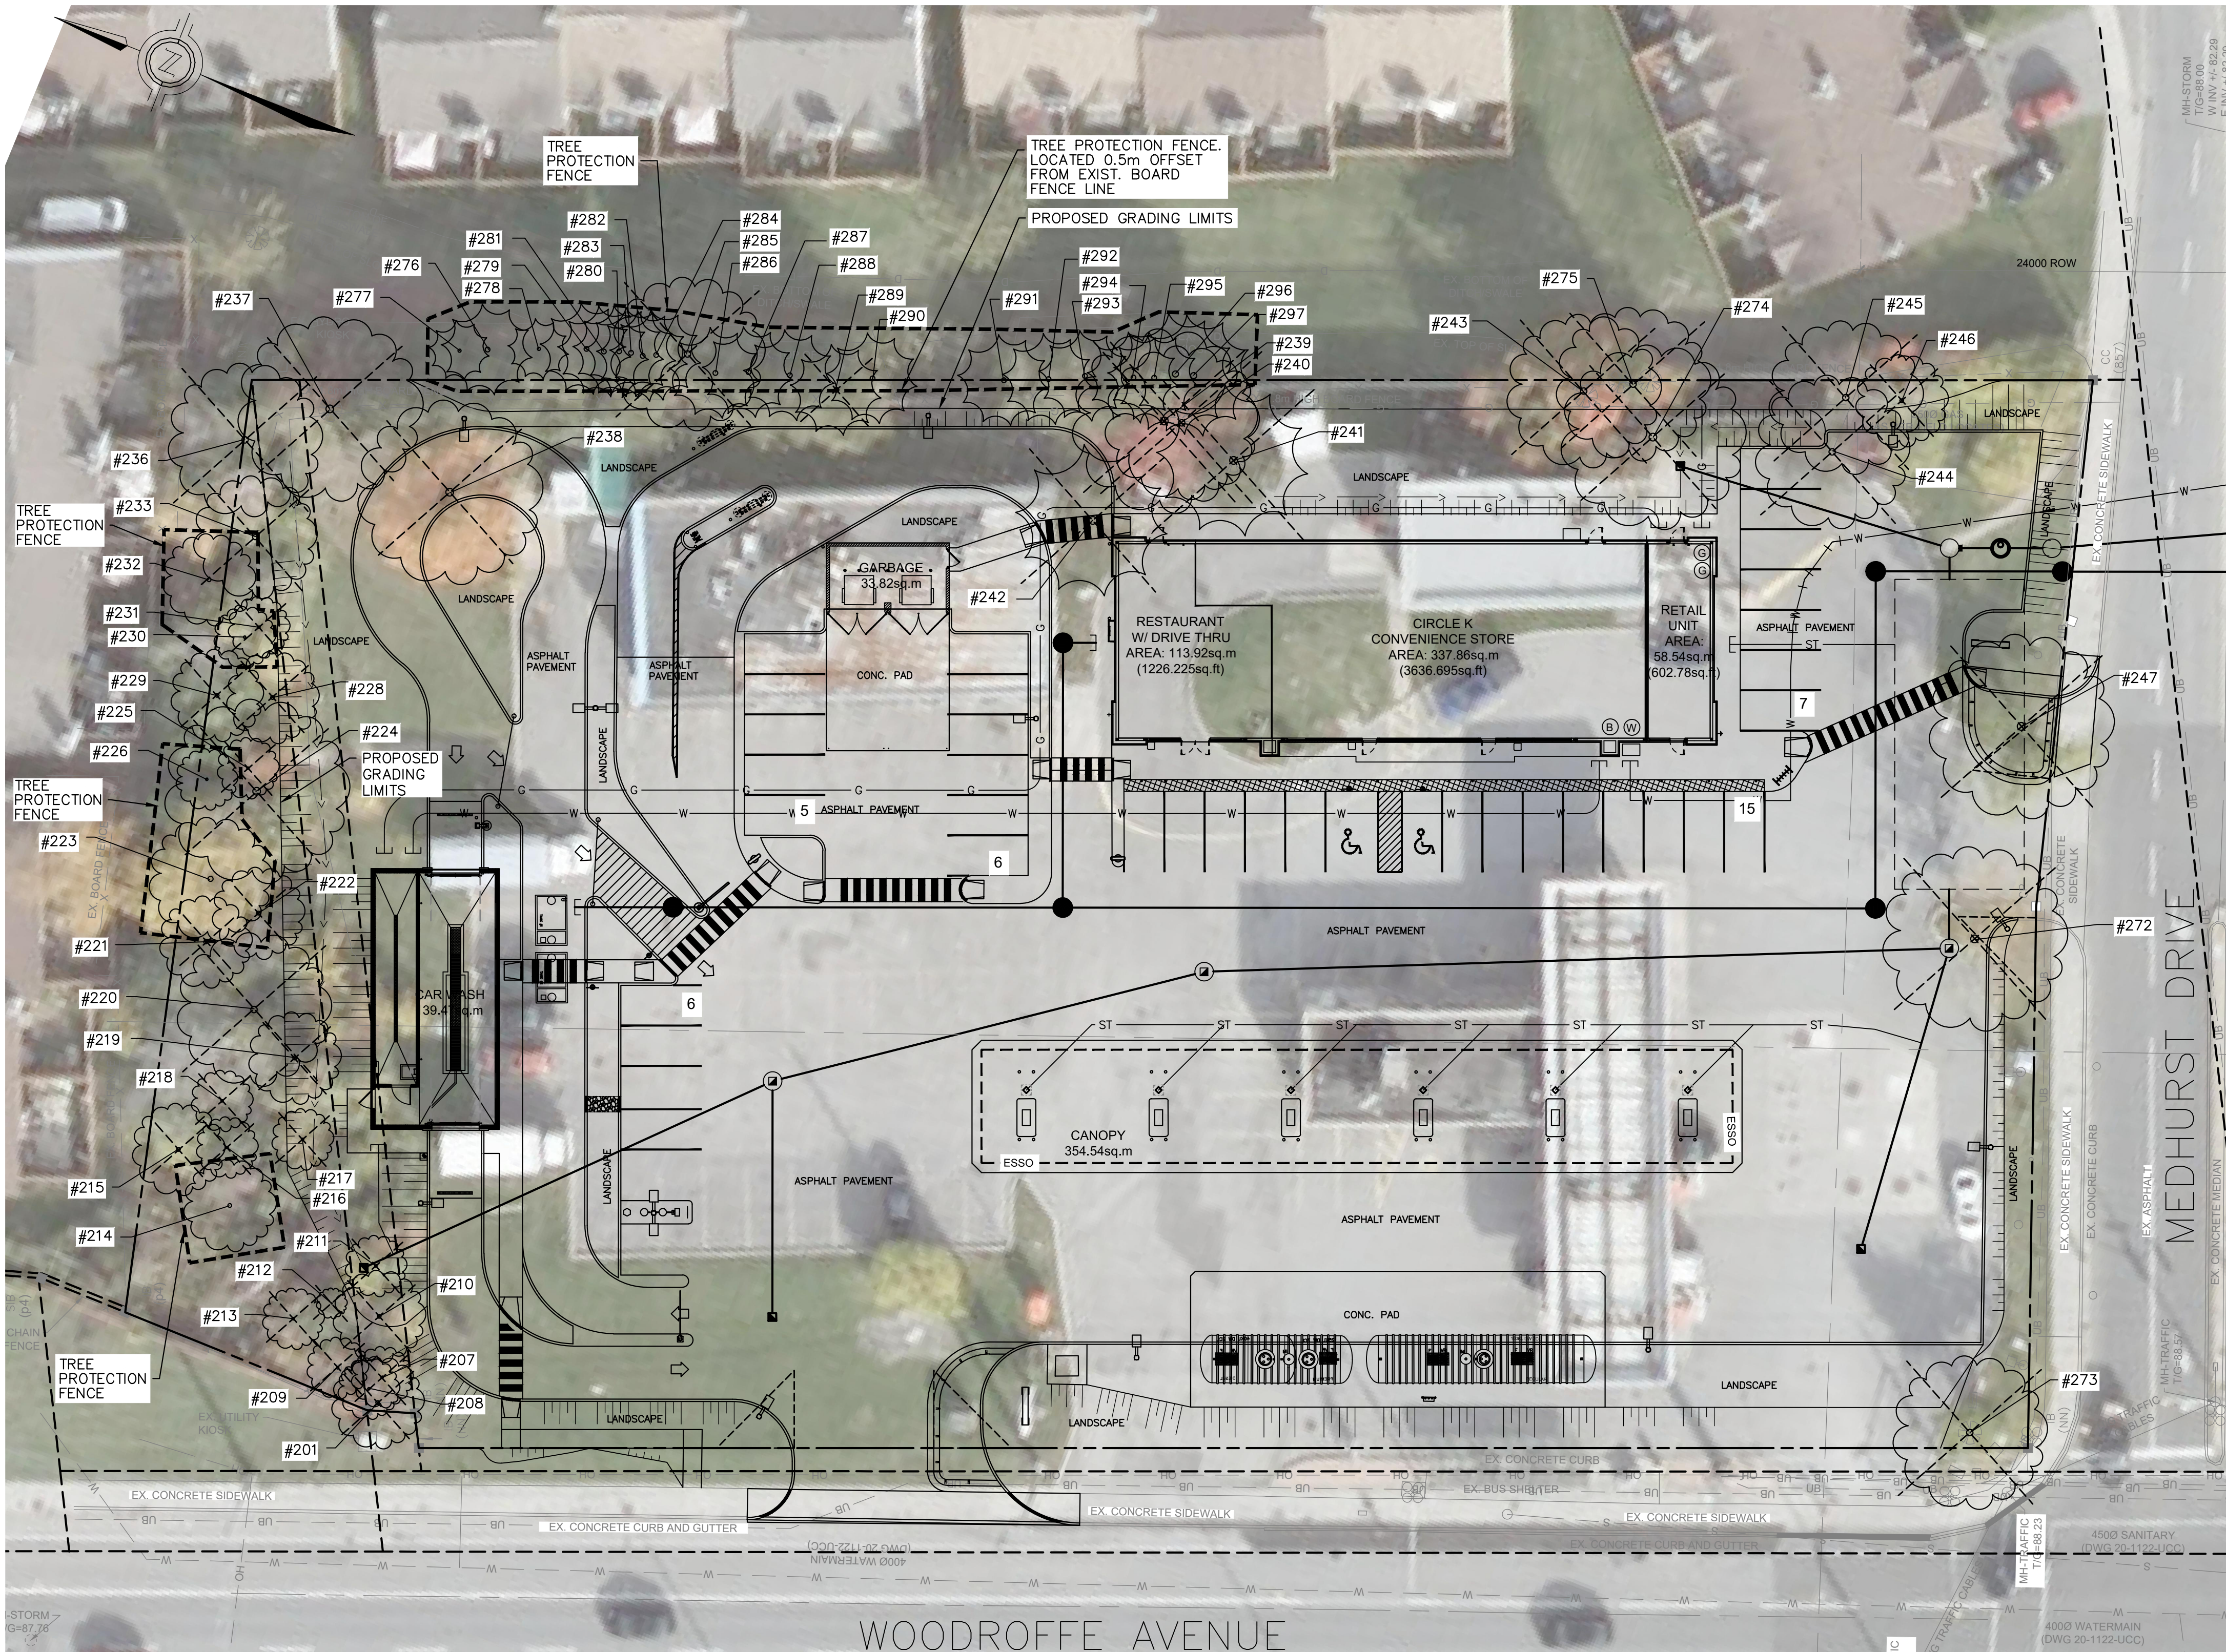
- DENOTES SURVEYED LOCATION OF EXISTING TREES, & # SPECIES / CALIPER / CONDITIONS / REMARKS AS AS NOTED IN ARBORIST REPORT & TREE INVENTORY LIST
- TREE PRESERVATION FENCE, PER OTTAWA TREE PROTECTION SPECIFICATION DETAIL
- DENOTES EXISTING TREES TO BE REMOVED FOR DEVELOPMENT, AS NOTED, SEE ARBORIST REPORT
