Geotechnical Investigation

Proposed Dog Kennel
5969 Ottawa Street
Richmond, Ontario

LRL File No.: 210341

October, 2021

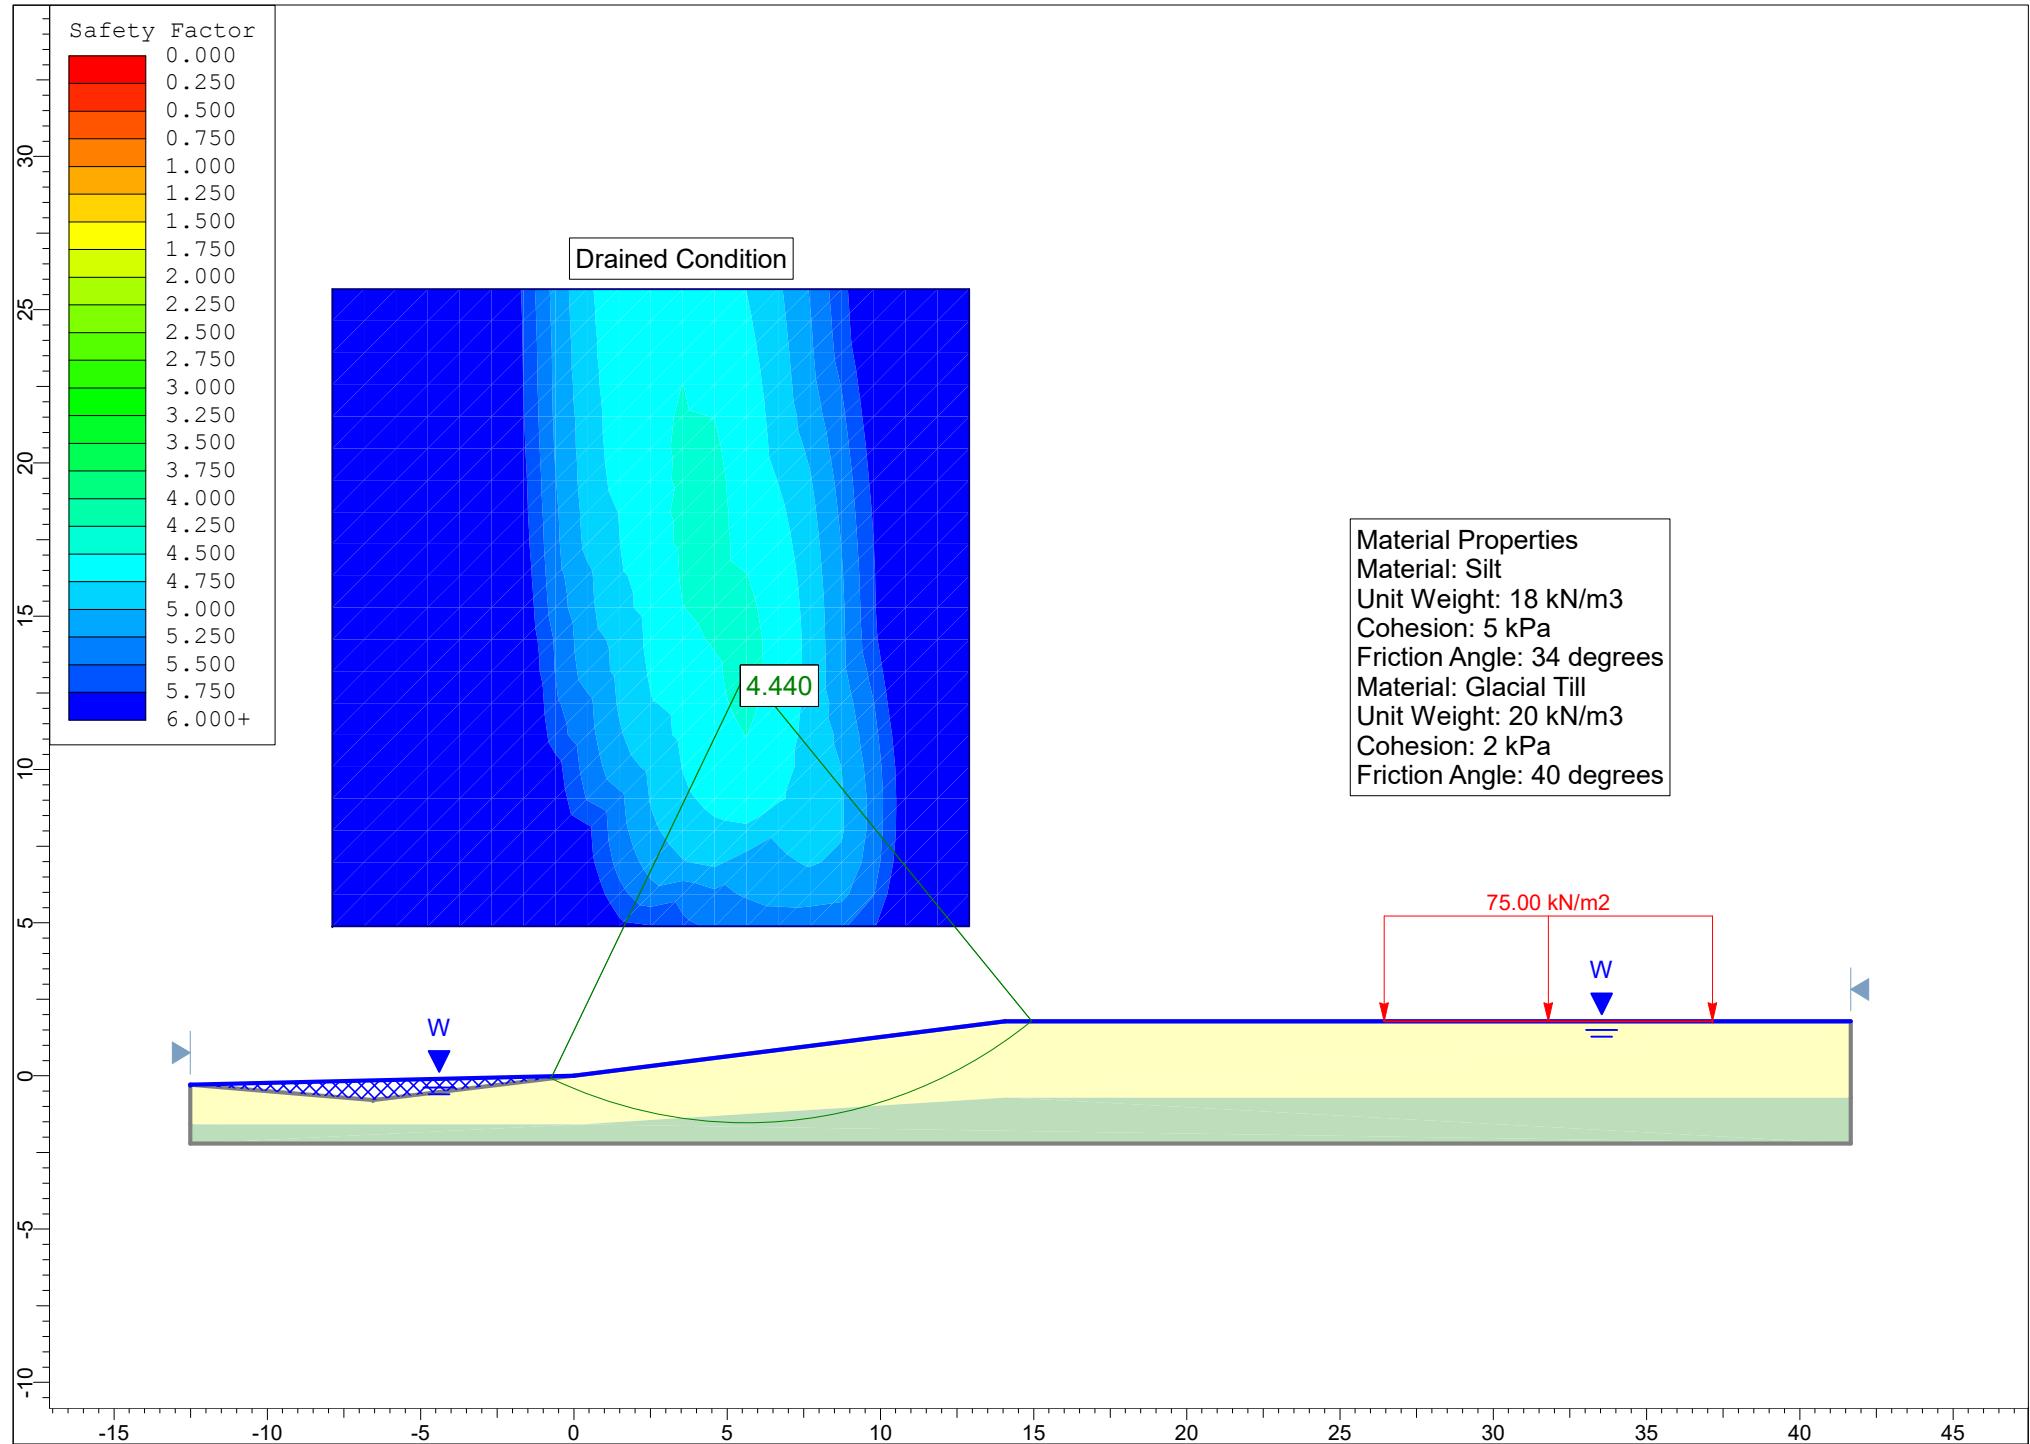
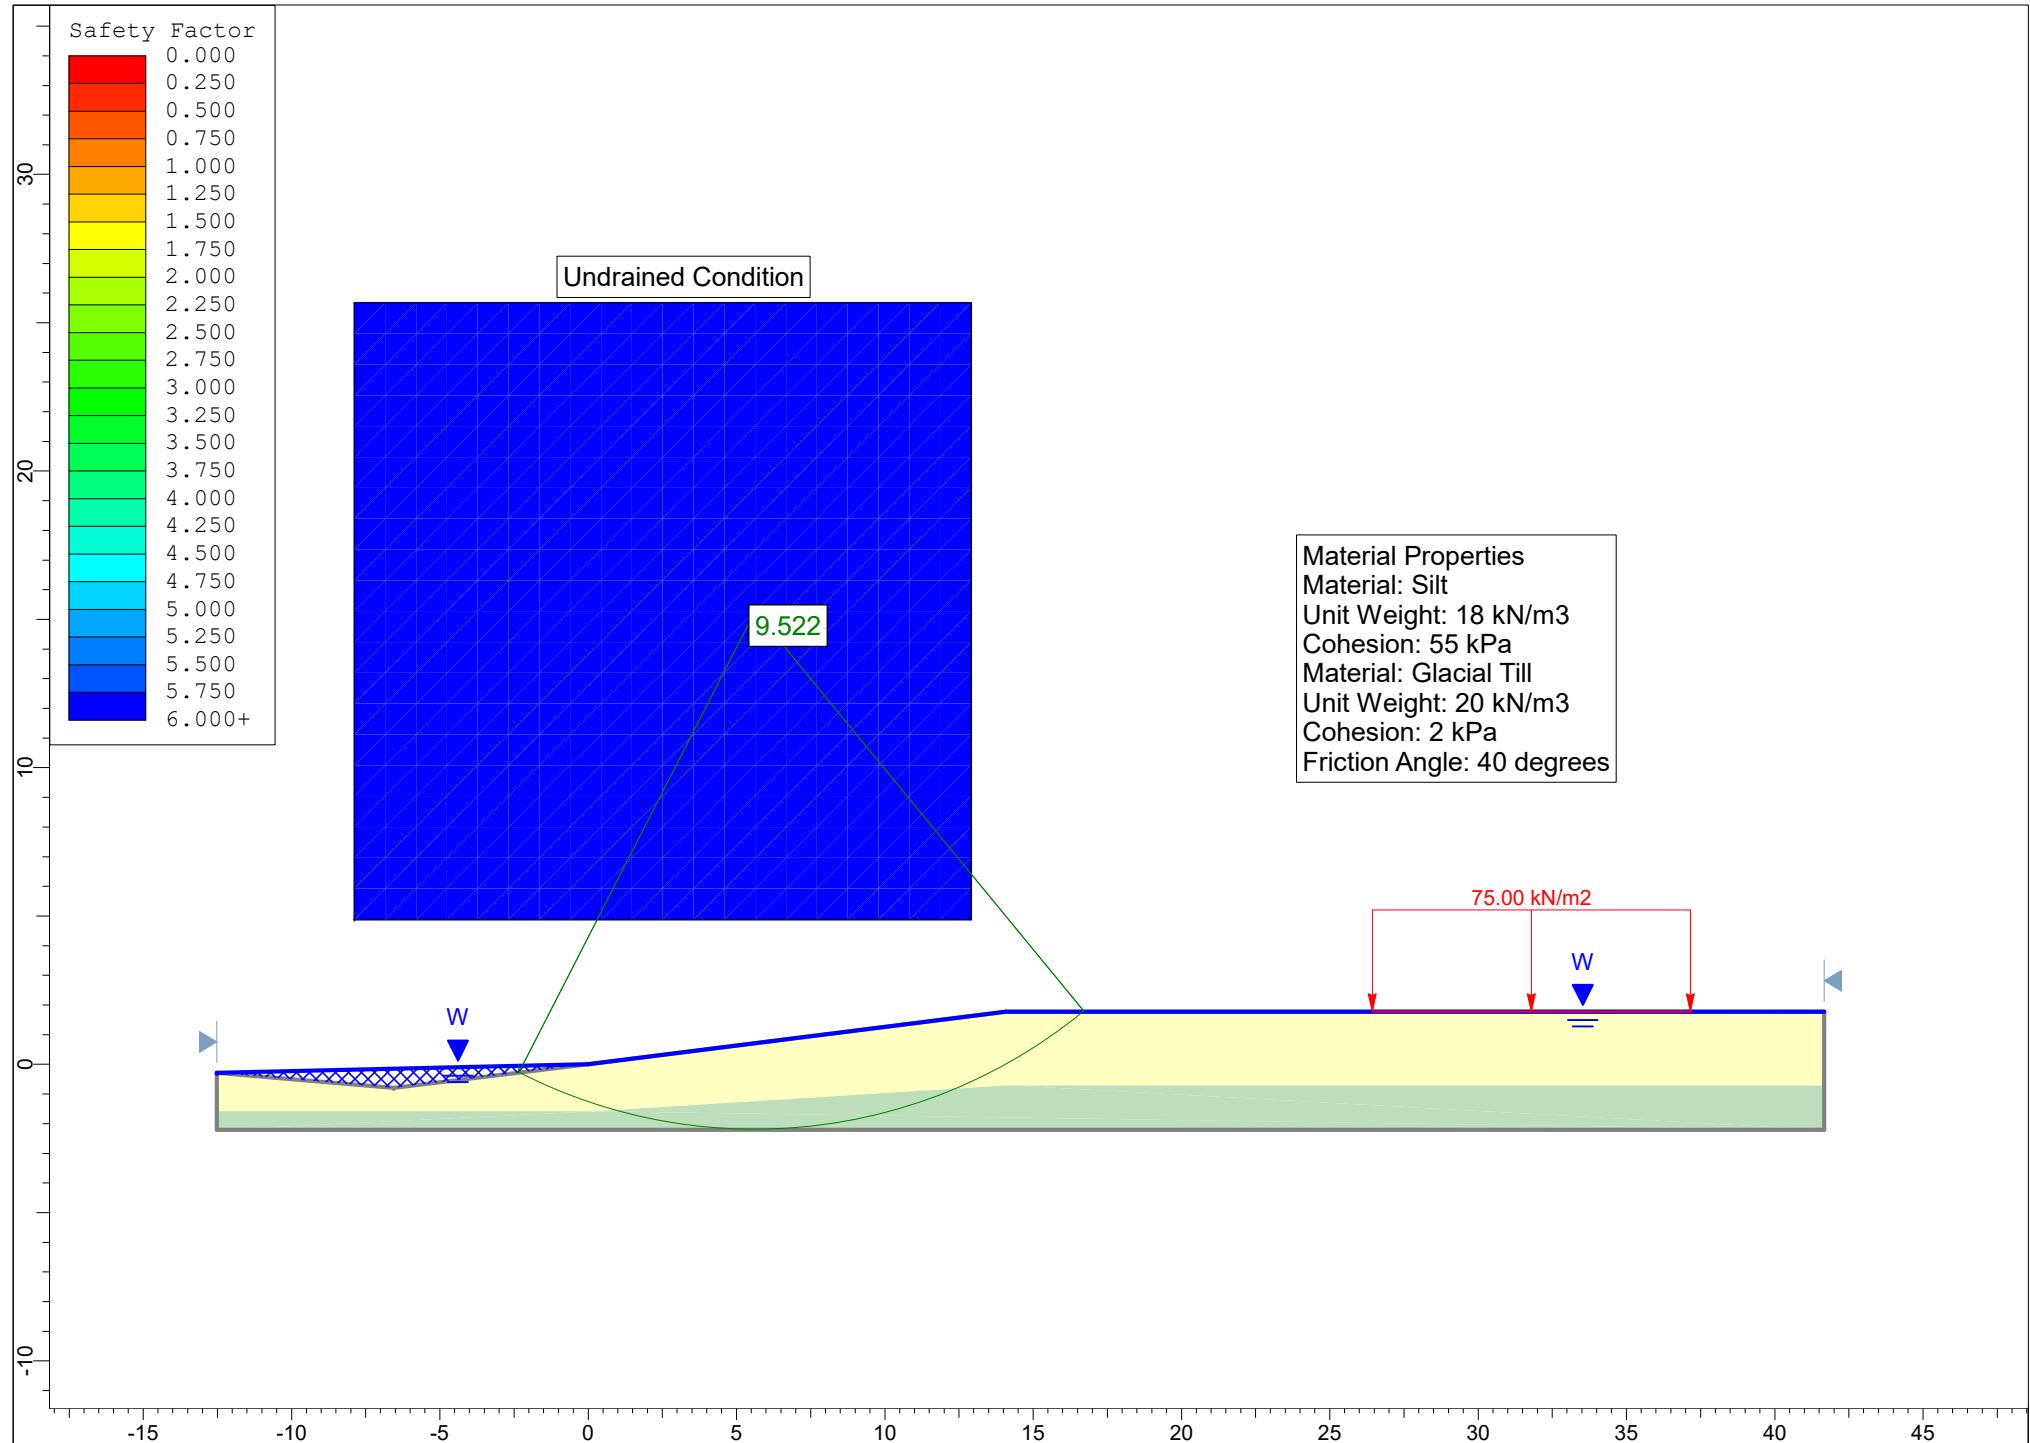
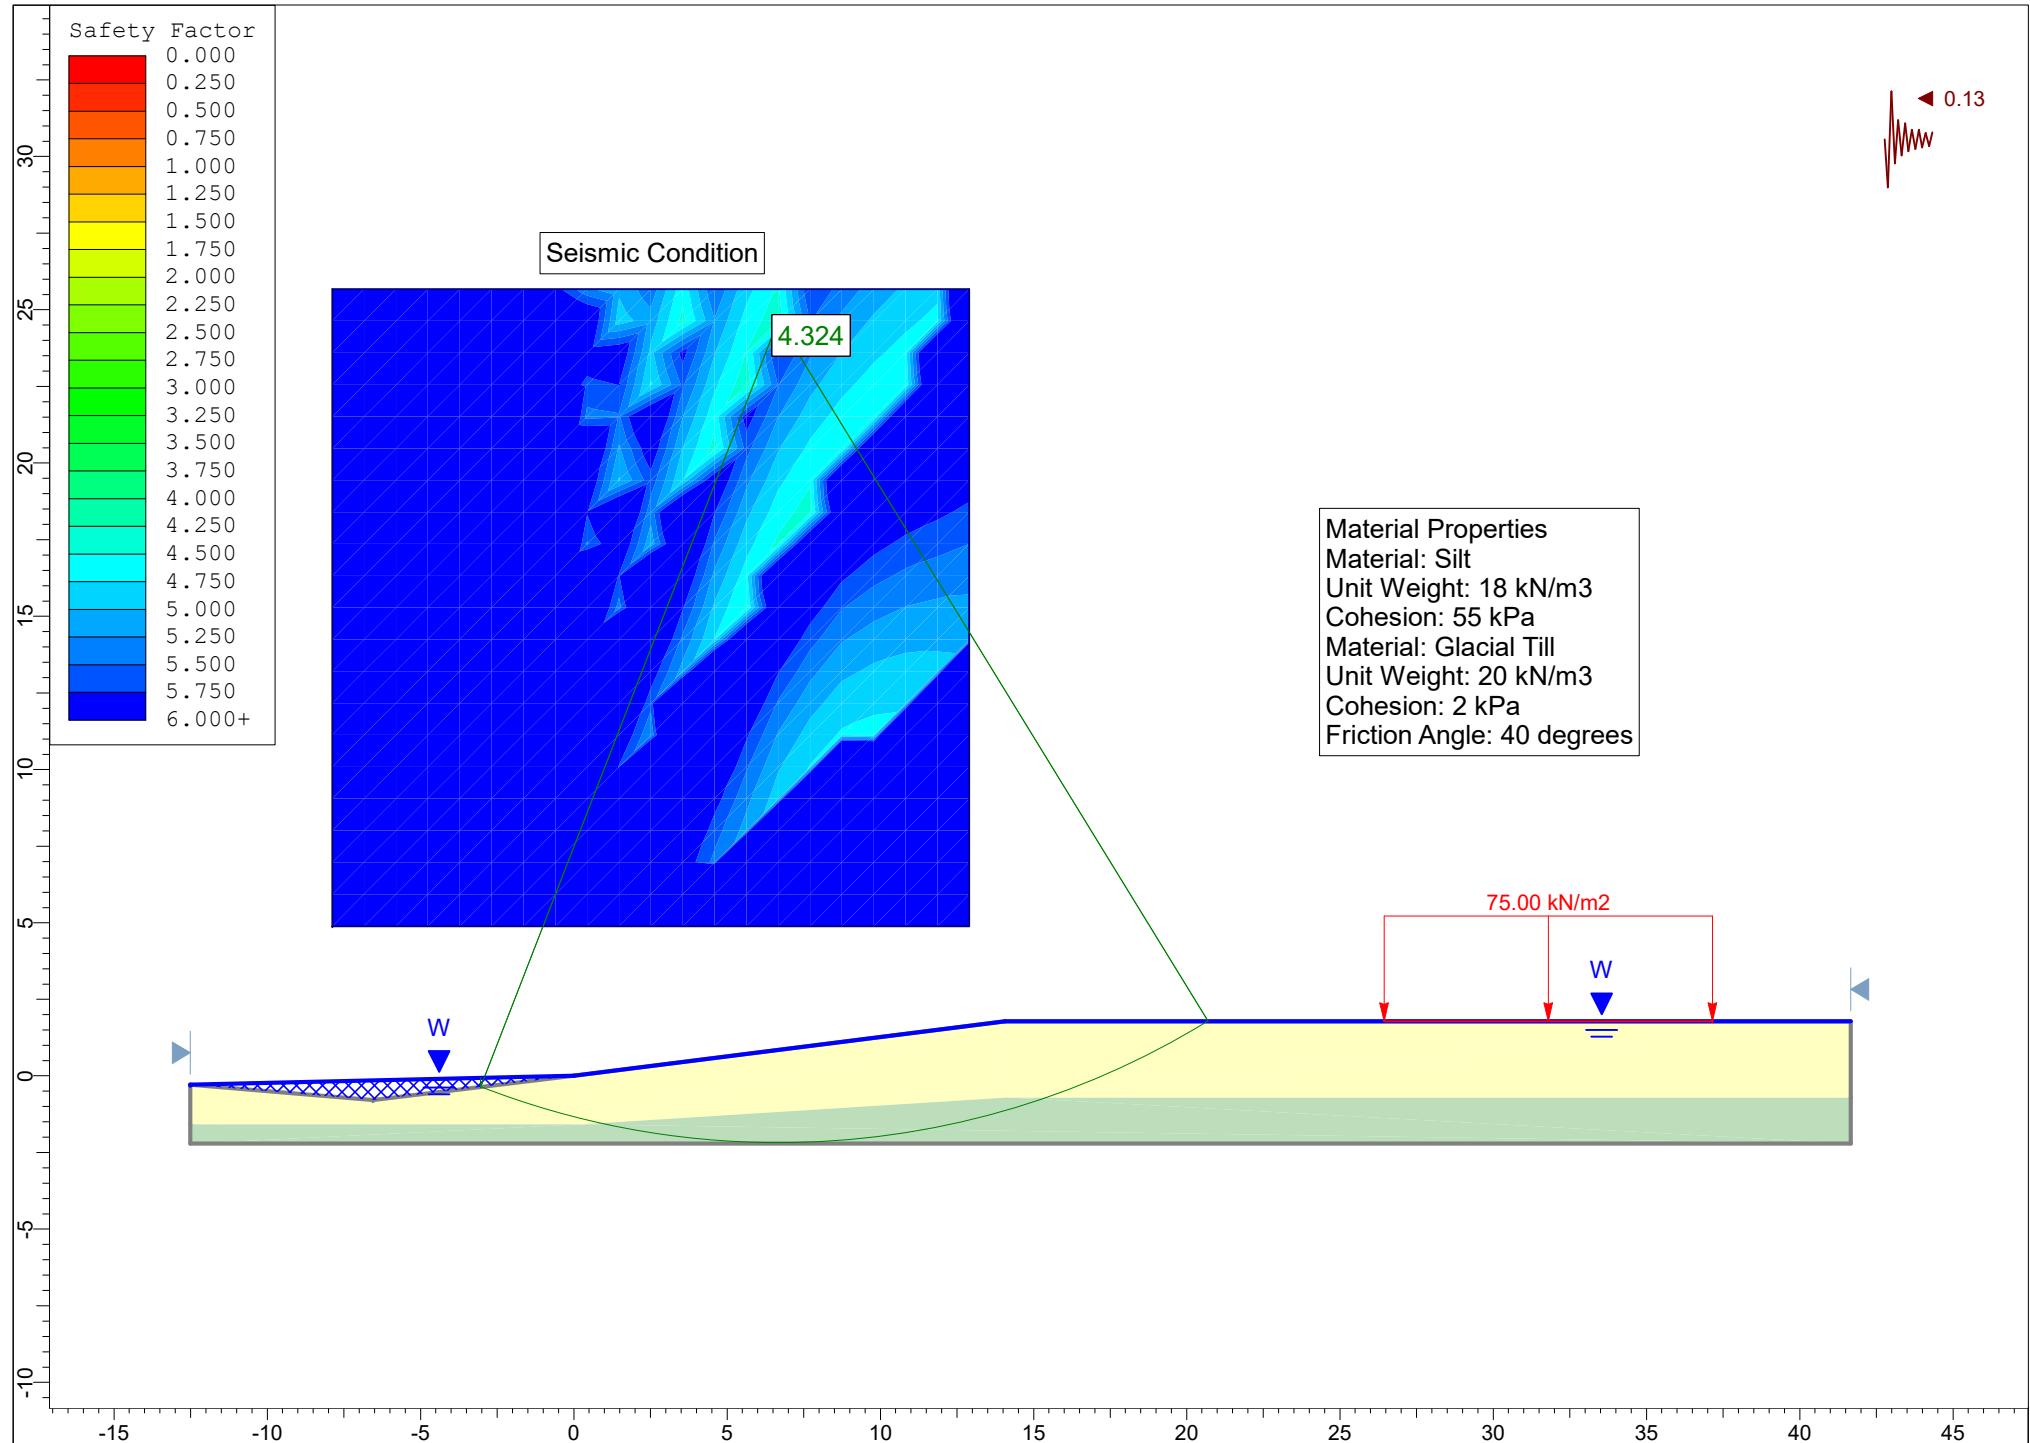
APPENDIX E
Slope Stability Analysis Results

The slope modelling program, Slide 5.0 (Rocscience), was used to implement the Bishop simplified method of slices. One (1) slope profile was chosen which was considered to be the worst case scenario. The proposed loading for the building was included in the models. The slope was analyzed under both the undrained (short term failure) and drained (long term failure) conditions.

The FoS against slope failure for the selected slope profile was determined to be 4.44, 9.52, and 4.32 for the drained, undrained, and seismic conditions respectively. A FoS of 1.50 or greater is considered to be safe with regards to slope stability.

The seismic analysis was performed by incorporating the seismic coefficient (k_h) into the modelling. The peak ground acceleration (PGA) for this area is equal to 0.26 for the 2% in 50 year probability of exceedance as per the NBC 2015. The value for k_h was taken as 50% of the PGA, which equates to 0.13. The minimum factor of safety (FoS) with regards to seismic condition is 1.10.

The results of the analyses are potentially dependent on the assumption of groundwater condition. During the development of this report, no information on the groundwater level was available throughout the year. However, as a conservative approach the analysis was completed assuming full saturation throughout the slope profile.
