Geotechnical Investigation

Geotechnical Investigation Corkery Community Centre Expansion 3447 Old Almonte Road, Carp, Ontario

OTT-21010977-A0

2021-07-20

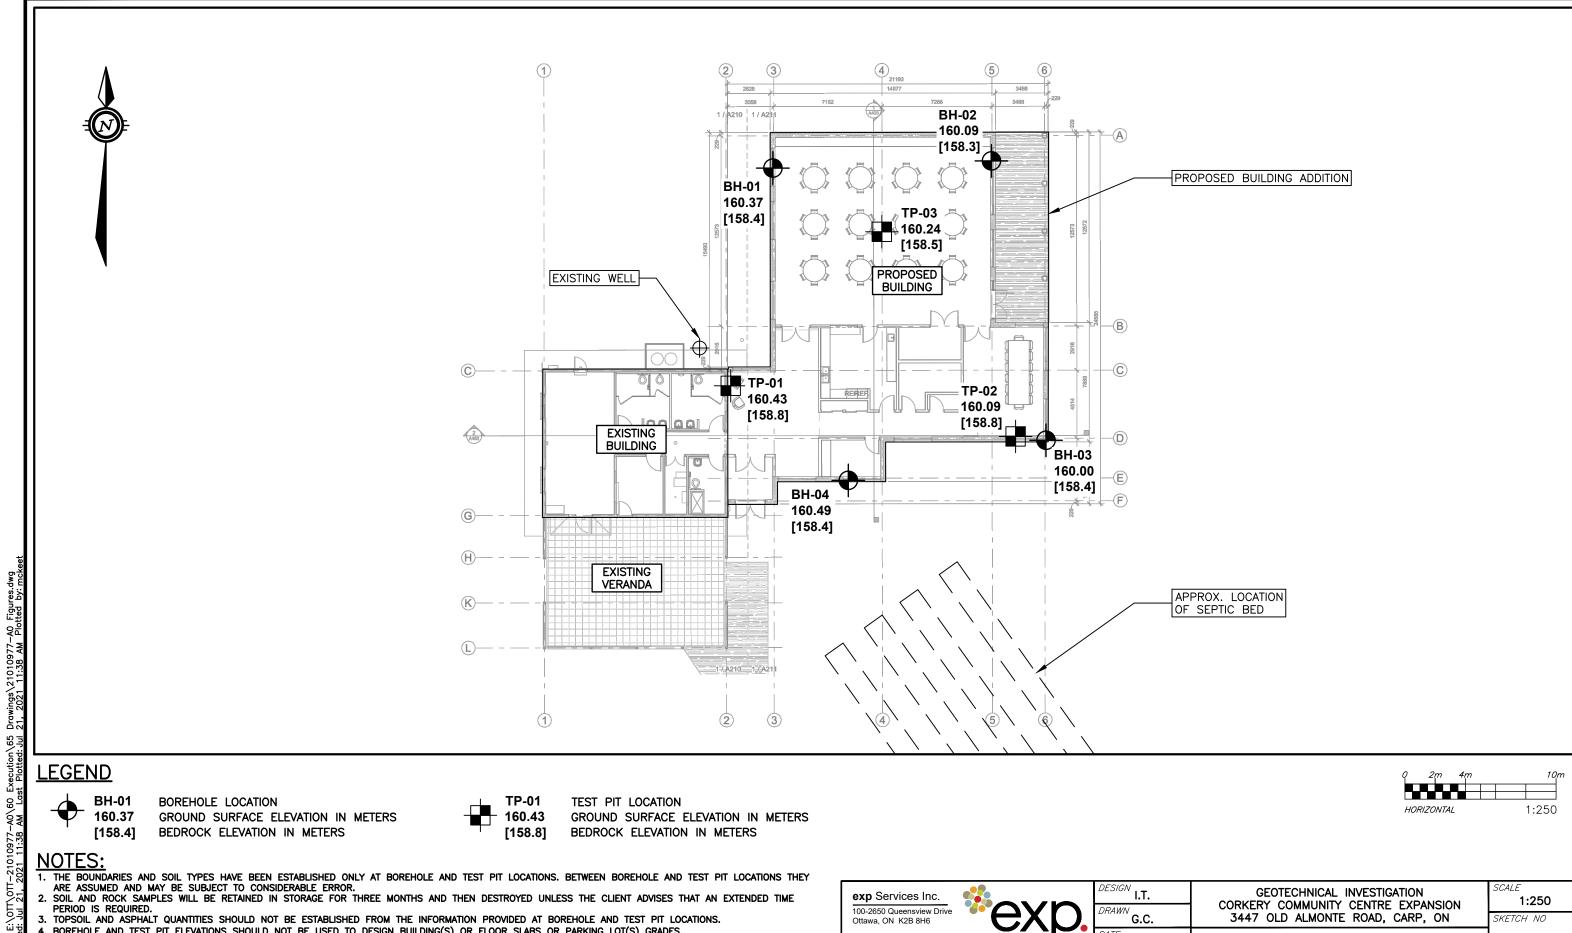
Prior to the start of the fieldwork, the borehole and test pit locations were cleared of private and public underground services. The geodetic elevation of the test holes was determined by a survey crew from EXP who also determined the geodetic elevation of the floor slab of the existing building to be at Elevation 160.48 m (to be confirmed by a topographical survey prepared by an Ontario Land Surveyor). The borehole and test pit locations are shown in Figure No. 2.

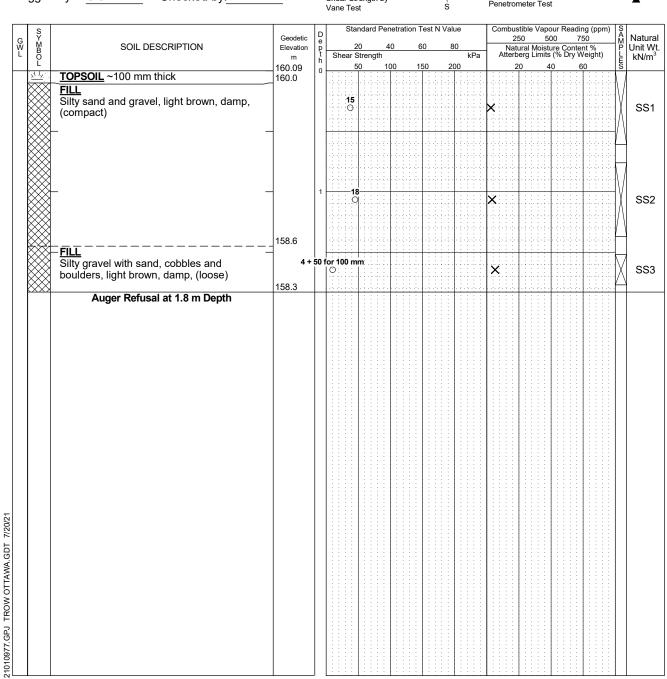
Project No:	OTT-21010977-A0			_	CV
Project:	Corkery Community Centre Expansion			Figure No5_ Page. 1 of 1	
Location:	3447 Old Almonte Road, Carp, ON			Page. <u>1</u> of <u>1</u>	-
Date Drilled:	'June 17, 2021	Split Spoon Sample	\boxtimes	Combustible Vapour Reading	
Drill Type:	CME 45 Track-Mounted Drill Rig	Auger Sample SPT (N) Value	I	Natural Moisture Content Atterberg Limits	×
Datum:	Geodetic Elevation	Dynamic Cone Test Shelby Tube	_	Undrained Triaxial at % Strain at Failure	\oplus
Logged by:	G.C. Checked by: I.T.	Shear Strength by	-	Shear Strength by	•

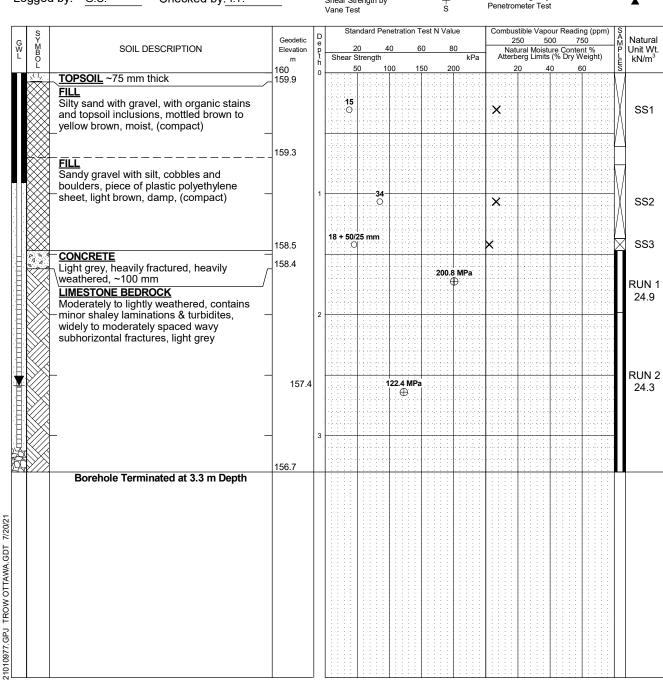
rehole <u>BH-</u>	<u>)4</u>	exp.
Project No:	OTT-21010977-A0_		Figure No. 6	٠,١٥٠
Project:	Corkery Community Centre Expansion		Figure No6_ Page. 1 of	I 1
Location:	3447 Old Almonte Road, Carp, ON		- age. <u>1</u> 01 _	<u> </u>
Date Drilled:	'June 17, 2021	Split Spoon Sample	Combustible Vapour Reading	
Drill Type:	CME 45 Track-Mounted Drill Rig	Auger Sample SPT (N) Value	Natural Moisture Content Atterberg Limits	× ⊷
Datum:	Geodetic Elevation	Dynamic Cone Test Shelby Tube	Undrained Triaxial at % Strain at Failure	\oplus
Logged by:	G.C. Checked by: I.T.	Shear Strength by + Vane Test S	Shear Strength by Penetrometer Test	A

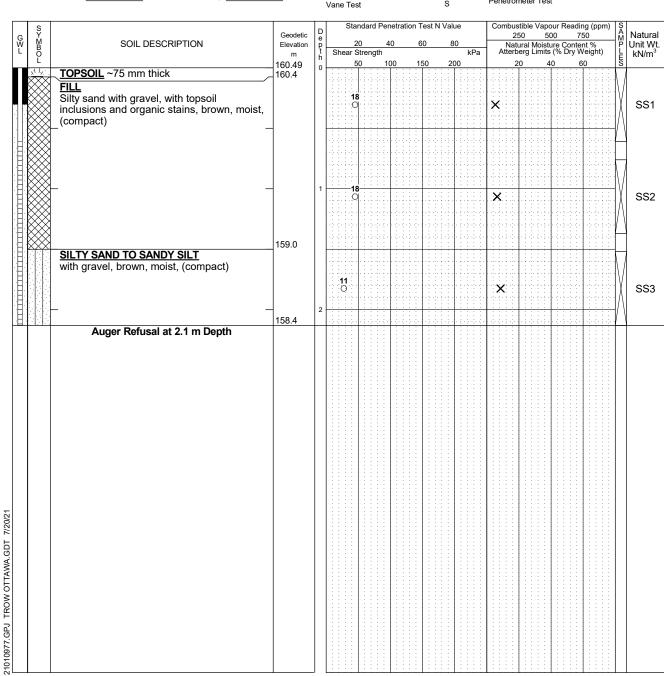
Log of	Bo	ľ	ehole _	TP-01				Vľ
Project No:	OTT-21010977-A0			_		_	7		<u>'</u>
Project:	Corkery Community Centre Expansion					Figure No.	1 1		ı
Location:	3447 Old Almonte Road, Carp, ON					Page.	_1_ of _1_	-	
Date Drilled:	'June 23, 2021			Split Spoon Sample	\boxtimes	Combustible \	/apour Reading		
Drill Type:	Caterpillar 415 Backhoe			Auger Sample		Natural Moistu			×
Datum:	Geodetic Elevation			SPT (N) Value Dynamic Cone Test Shelby Tube	<u> </u>	Atterberg Limi Undrained Tri % Strain at Fa	axial at		⊕
Logged by:	G.C. Checked by: I.T.	_		Shear Strength by Vane Test	+ s	Shear Strengt Penetrometer			A
G M B O	SOIL DESCRIPTION	Geodetic Elevation m	D e p t	Standard Penetration 20 40 Shear Strength	60 80	250 Natural M	Vapour Reading (pp 500 750 loisture Content % imits (% Dry Weight	A M P	Natura Unit Wt kN/m³

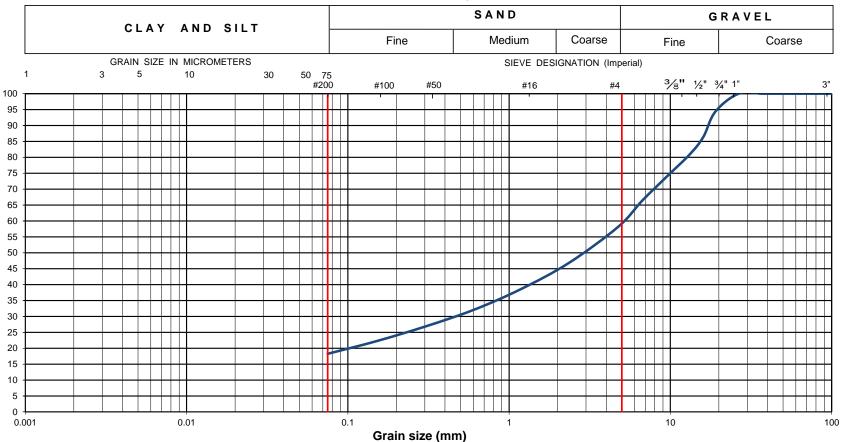
EXP Project No.:	OTT-21010977-A0	Project Name :	roject Name : Corkery Community Centre Expansion						
Client :	City of Ottawa	Project Location	oject Location : 3447 Old Almonte Road. Carp, Ottawa, ON						
Date Sampled :	June 17, 2021	Borehole No:		BH2 Sample: SS3		SS3	Depth (m):	1.5-1.8	
Sample Composition :		Gravel (%)	42	Sand (%)	40	Silt & Clay (%)	18	Figure :	10
Sample Description : FILL: Silty Gravel with Sand (GM)						rigure :	10

The results of grain-size analysis conducted on two (2) selected samples of the fill are summarized in Table II and the grain-size distribution curves are shown in Figures 10 and 11.

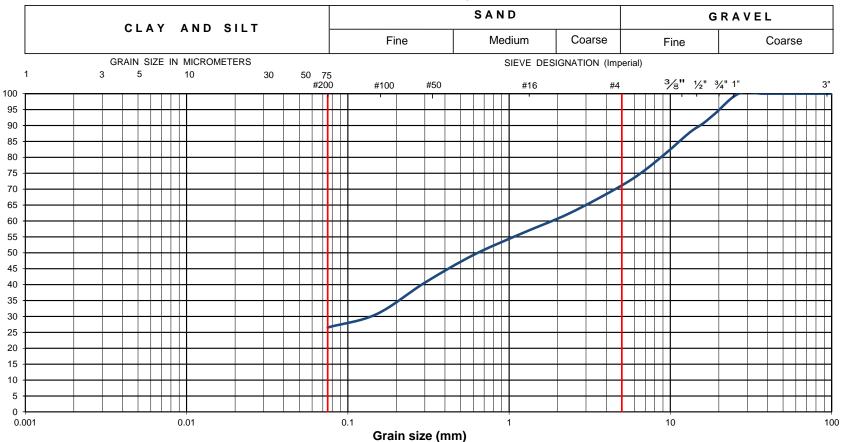
EXP Project No.:	OTT-21010977-A0	Project Name :	oject Name : Corkery Community Centre Expansion						
Client :	City of Ottawa	Project Location	oject Location: 3447 Old Almonte Road. Carp, Ottawa, ON						
Date Sampled :	June 17, 2021	Borehole No:		BH4 Sample: SS2		S2	Depth (m):	1.1 - 1.4	
Sample Composition :		Gravel (%)	30	Sand (%)	43	Silt & Clay (%)	27	Figure :	11
Sample Description :		FILL: Silty Sand with Gravel (SM)				rigule:	11

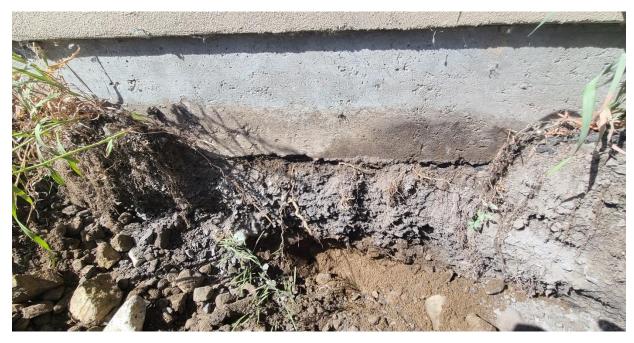
Photograph No. 2: Detailed view of thickened structural slab and subbase materials in Test Pit No. 1

Examination of the existing exposed foundation revealed that the building is likely constructed on a 300 mm thickened or slab on grade foundation founded on compacted granular material placed on top of bedrock contacted at a depth of 1.6 m . Photographs of the exposed 'as-built' details are shown I Appendix A.

Based on a review of our observations of the 'as-built' details exposed in the test pit, it is recommended that the thickened concrete slab that appears to be supporting the existing building be confirmed by conducting additional test pits around the existing building. Based on the findings from the additional test pits, this report may need to be updated.

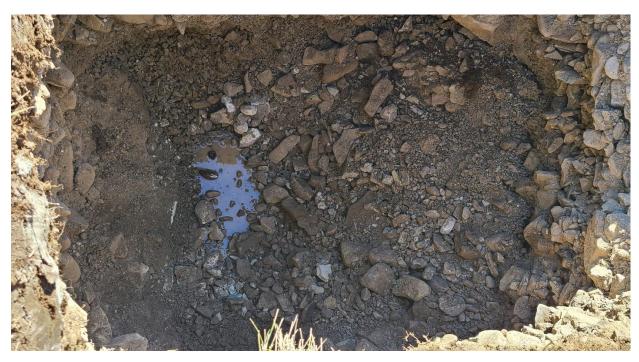
Photograph No. 3: Exposed subsurface soil conditions in Test Pit No. 3

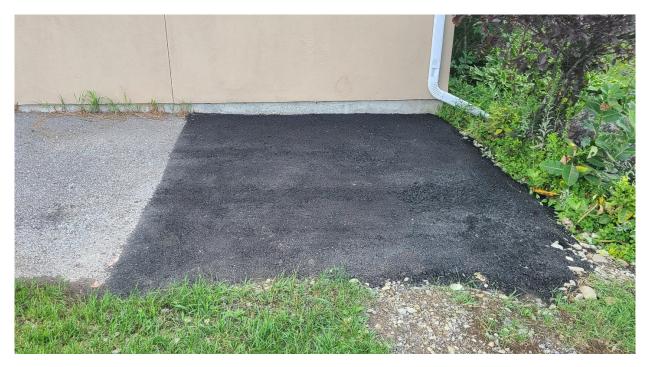
Photograph No. 4: Reinstated pavement conditions at Test Pit No. 1 location

The test pits were excavated using a rubber-tired backhoe. A grab sample of the different soil types exposed in the test pits was taken from the side walls of the test pit during excavation. In Test Pit No. 1 located next to the existing building, the type of foundation and founding material were examined and recorded. Groundwater observations were also made in the open test pits. Upon completion of excavation, the test pits were backfilled and the backfill nominally packed in place with the backhoe bucket. The asphalt surface at the location of Test Pit No.1 was re-instated.
