### **Geotechnical Investigation**

Proposed Church Building 102 Bill Leathem Drive Ottawa, Ontario

Report PG3792-1 Revision 1

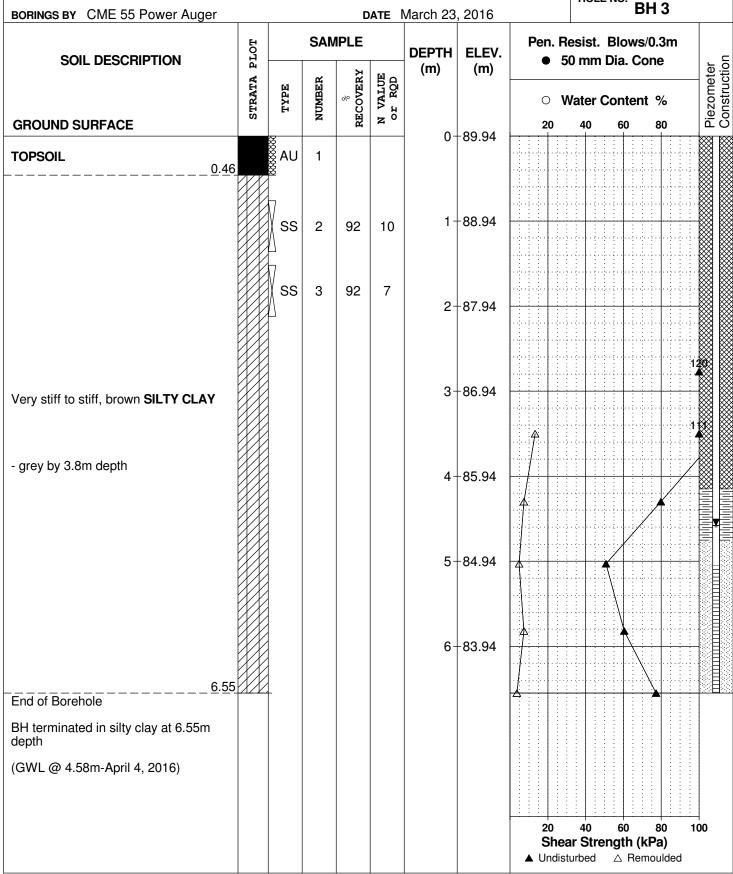
HOLE NO.

SOIL PROFILE AND TEST DATA

Geotechnical Investigation **Proposed Salvation Army Barrhaven Church** 102 Bill Leathern Drive, Ottawa, Ontario

The subsurface conditions observed in the boreholes were recorded in detail in the field. The soil profiles are presented on the Soil Profile and Test Data sheets in Appendix 1 of this report.

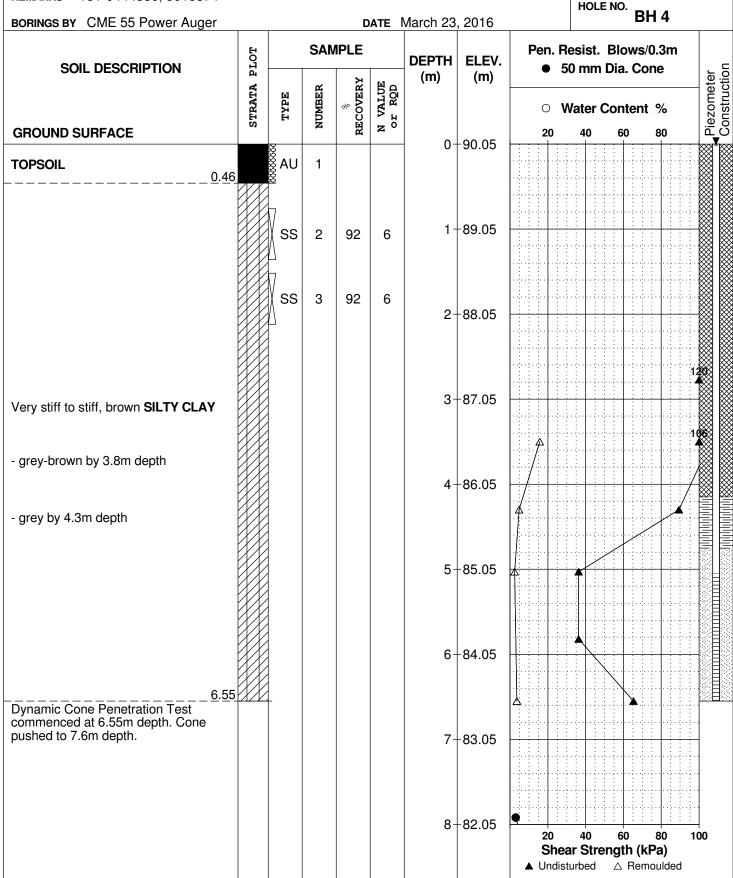
FILE NO. **PG3792**

**SOIL PROFILE AND TEST DATA**

Geotechnical Investigation Proposed Salvation Army Barrhaven Church 102 Bill Leathem Drive, Ottawa, Ontario

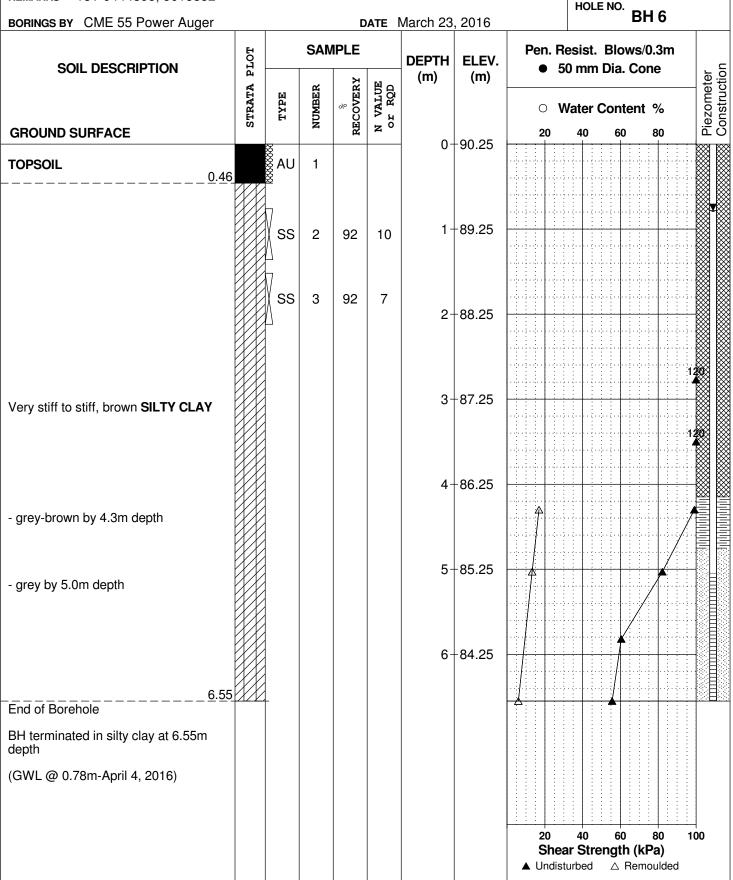
FILE NO. PG3792

SOIL PROFILE AND TEST DATA

Geotechnical Investigation **Proposed Salvation Army Barrhaven Church** 102 Bill Leathern Drive, Ottawa, Ontario

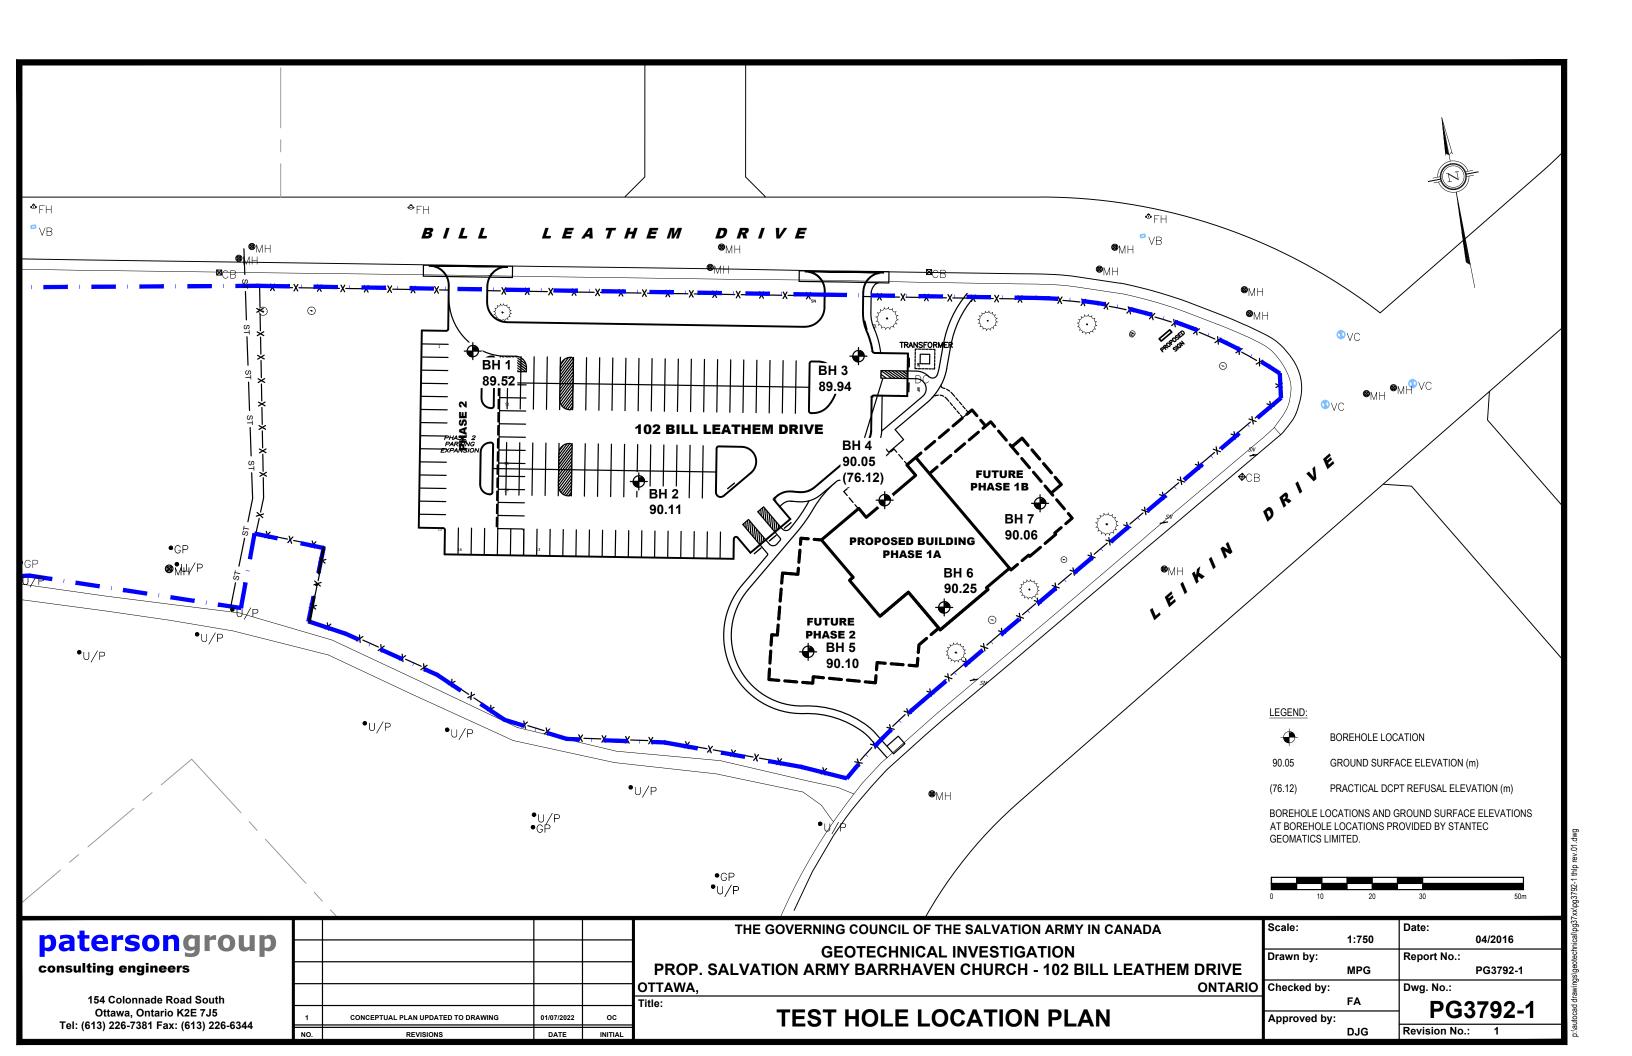
**DRAWING PG3792-1 - TEST HOLE LOCATION PLAN**

The location and ground surface elevations of the boreholes, and the TBM locations are presented on Drawing PG3792-1 - Test Hole Location Plan in Appendix 2.

The field program for the geotechnical investigation was carried out on March 23, 2016. At that time, seven (7) boreholes were advanced to a maximum depth of 13.9 m. The test hole locations were distributed across the subject site in a manner to provide general coverage of the proposed development. The borehole locations were selected and located in the field by Paterson. The borehole locations are shown on Drawing PG3792-1 - Test Hole Location Plan included in Appendix 2.
