# CHAMPLAIN OIL COMPANY SERVICE STATION

## A CULTURAL HERITAGE IMPACT STATEMENT 70 RICHMOND ROAD OTTAWA, ONTARIO

SUBMITTED TO: TRINITY DEVELOPMENT GROUP INC.

PREPARED BY: JOHN STEWART COMMONWEALTH HISTORIC RESOURCE MANAGEMENT

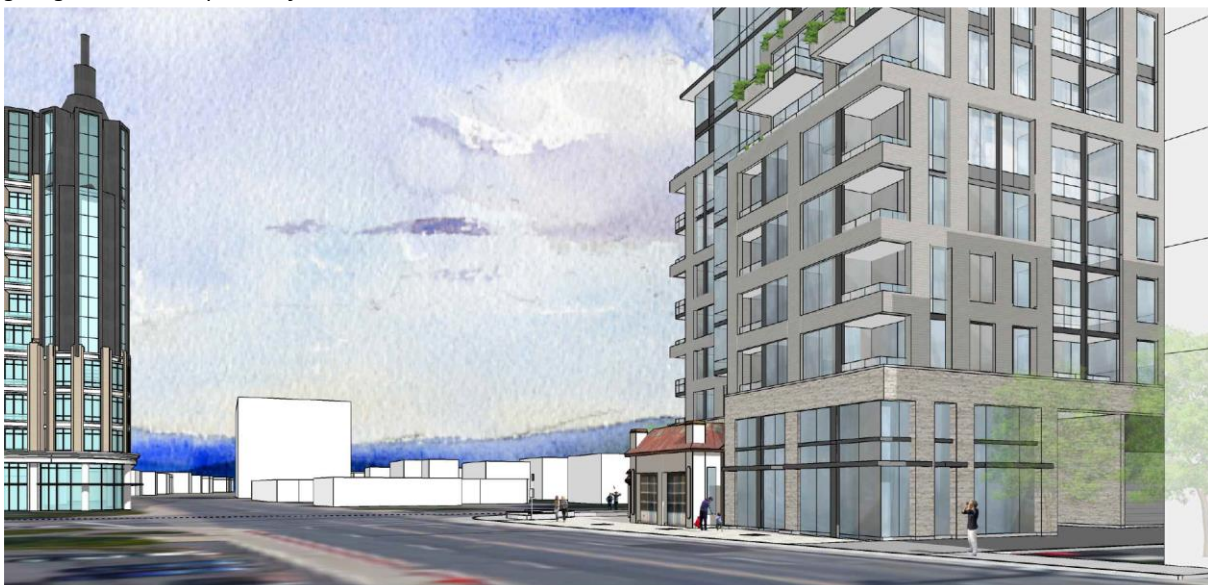
Figure 26: A view of the public realm along Richmond Road illustrating the transition between the main entrance and the Service Bays, which sits proud by 2.25 m. Source: Hobin Architecture 2022

The challenge is to make the new 9-storey development physically and visually compatible with the 1-storey Service Station. Because of the differences in scale, it is considered key to its visual compatibility that the materiality, and colour of the base of the midrise act as a backdrop to the Service Station without overwhelming it. The City questioned the approach being taken<sup>4</sup> and stated that the current proposal does not meet the direction set out in guideline 11. The email is included in Appendix B. The revised proposal allows the Service Station to project 2.25 metres in front of the midrise.

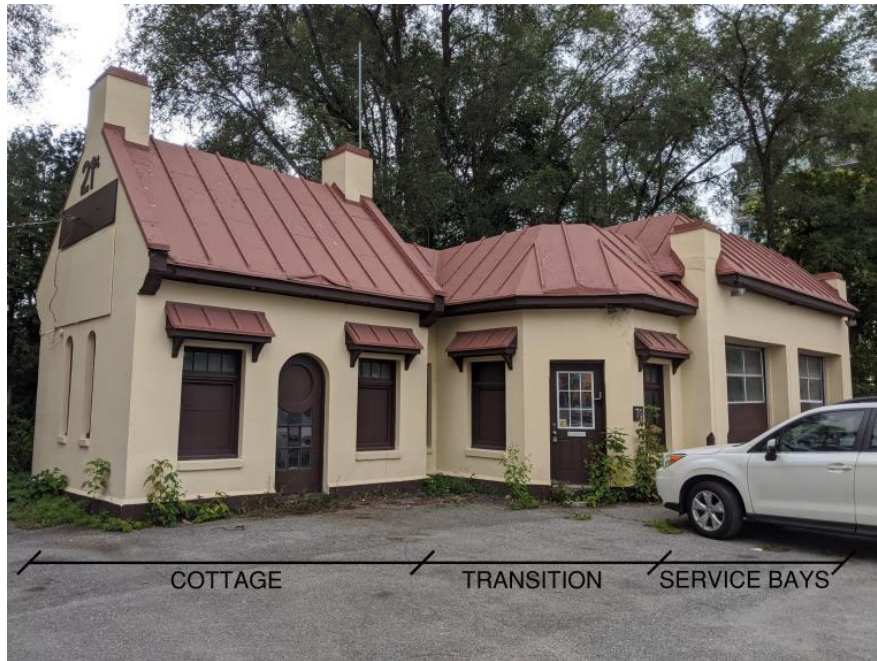
Figure 28: View of building referencing the house-form commercial section, the adjoining office area, and the two-bay service section.

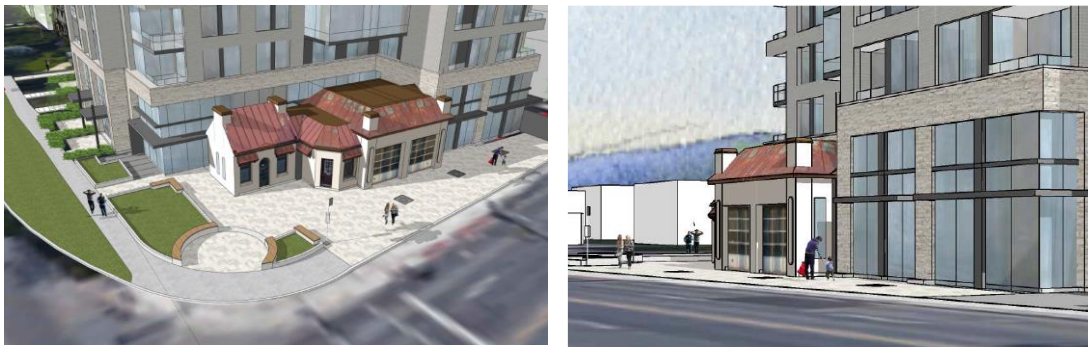
*Figure 30: Views looking west and east. In the bird's eye view looking east, the side façade is set back exposing the first window. The view looking west gives the Service Station a prominent expression and distinct transition from the mid-rise. Source: Hobin Architecture 2022.*

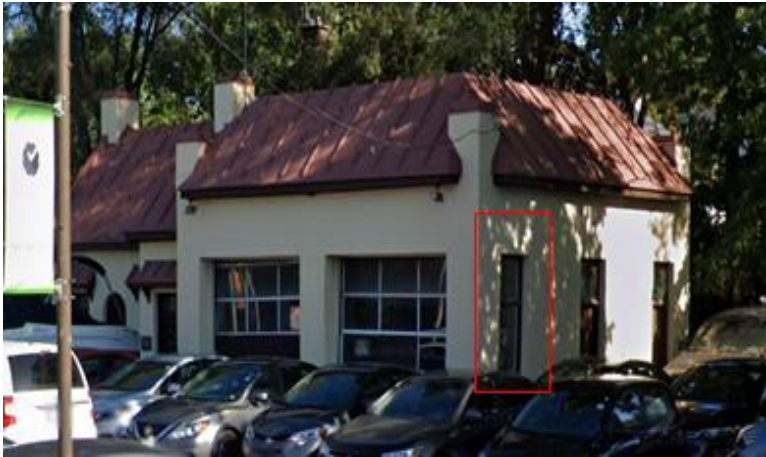
Figure 31: View showing the side elevation of the Service Station with three windows. The proposed midrise building has been set back and allows one of the side windows to be interpreted. Source: City of Ottawa.

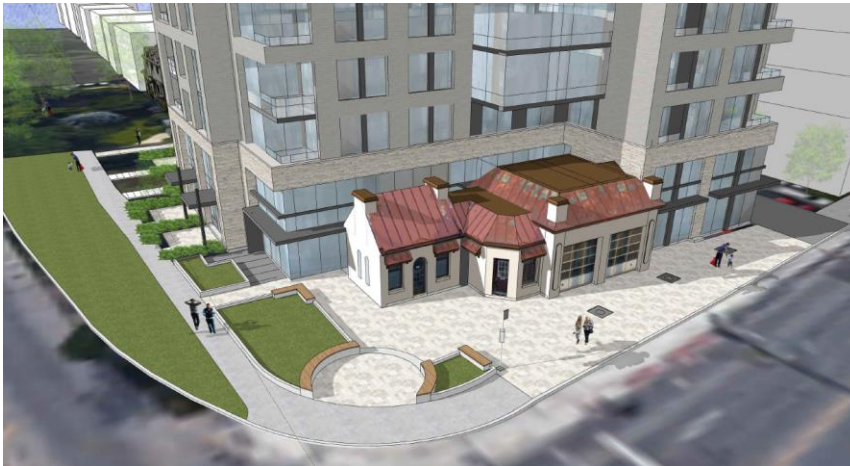
**Comment:** The bird's eye view illustrates that the Service Station will be in full sun in the mornings and afternoons. With the tower blocking the sun for part of the day. The heritage building's original location was in the same east-west orientation with a grove of trees to the south that blocked the sun and creating a similar environment.
