Date: April 19, 2022

No. 211-14010-00

Subject: **Site Plan Control Application for New Clubhouse Construction, Ottawa South United Soccer Association – Tree Information Report**

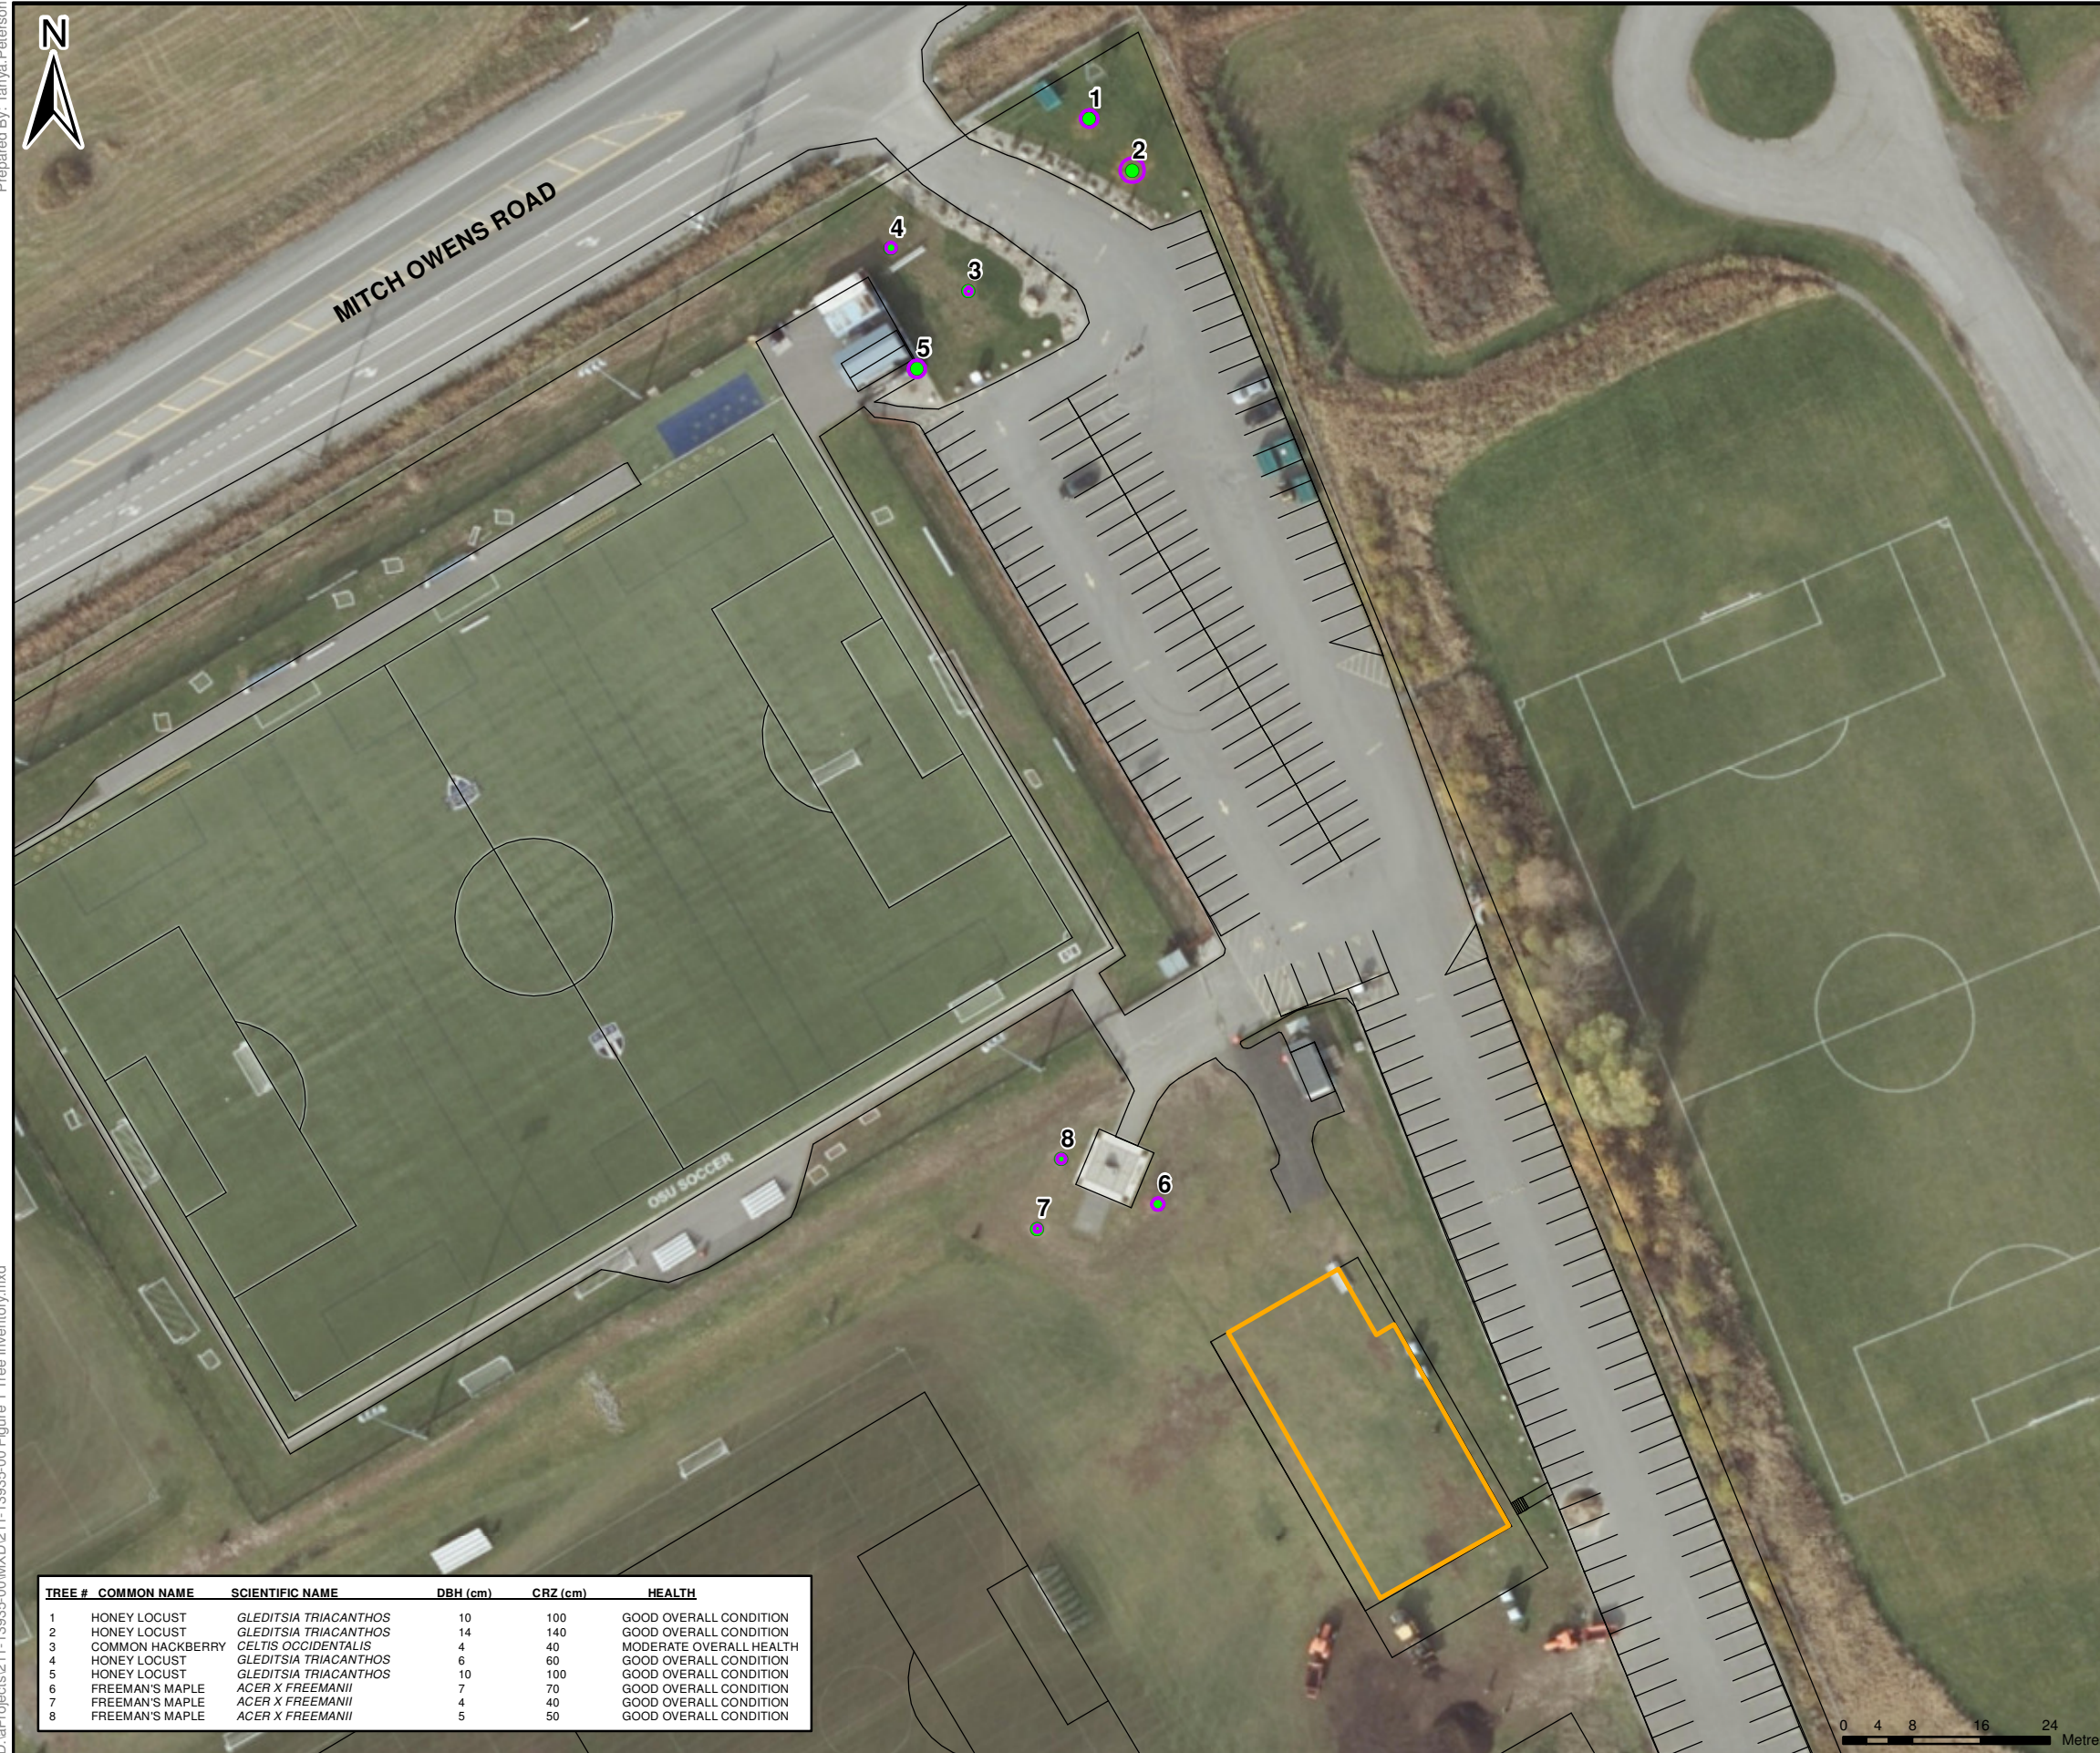
| | DATE: APRIL 2022 | FIGURE: 1 |

A plan showing the tree locations, including locations of City Trees with their Critical Root Zones (CRZ) in relation to the proposed site plan / development footprint is shown in **Figure 1**. As discussed, the trees are all municipally owned and are to be retained. The retained trees will be subject to protection and mitigation measures as outlined below.

The location of the tree protection fencing will occur around the CRZs of Trees 006, 007, 008 and follow the City of Ottawa's Tree Protection Specification (**Attachment A**). It is anticipated that Trees 001 to 005 will not be impacted by the proposed works.

- Prior to any work activity, tree protection fencing must be installed around the outer edge of the CRZ on those trees identified to be retained (Trees 006 to 008), as shown on **Figure 1**. The fencing shall remain in place until the work is complete.
- The tree protection fencing shall be at least 1.2 metres (m) in height and installed in such a way that the fence cannot be altered. Such as the use of orange plastic web snow fencing on a T-bar frame. The T-bar spacing is to be 1.8 m on-centre (O.C).
- Additional measures, as detailed on the City of Ottawa's Tree Protection Specification (**Attachment A**) must also be implemented.

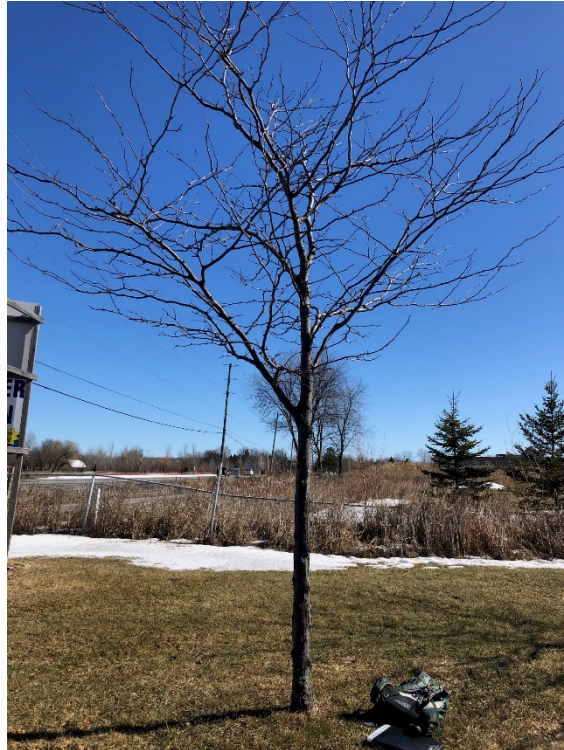
| Tree # | Common Name | Scientific Name | Size (cm) (DBH) | Ownership | Condition of Tree | Reason for Removal | Arborist Recommendation |
|---|---|---|---|---|---|---|---|
| 001 | Honey Locust | <i>Gleditsia triacanthos</i> | 10 | City Tree | Structural Integrity = Good Vigour = Good, 0% deadwood at time of assessment | N/A | Tree to be retained and CRZ to be protected where possible and follow the City's Tree Protection Specification. |

Photo 1: Tree 001: Honey Locust, Municipal tree, facing east, northeast end of property. March 22, 2022.

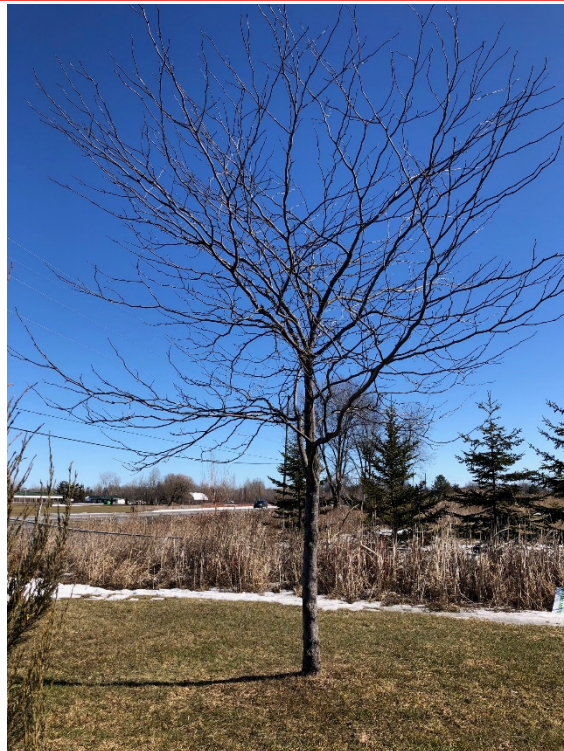
| Tree # | Common Name | Scientific Name | Size (cm) (DBH) | Ownership | Condition of Tree | Reason for Removal | Arborist Recommendation |
|---|---|---|---|---|---|---|---|
| 002 | Honey Locust | <i>Gleditsia triacanthos</i> | 14 | City Tree | Structural Integrity = Good Vigour = Good, 0% deadwood at time of assessment | N/A | Tree to be retained and CRZ to be protected where possible and follow the City's Tree Protection Specification. |

Photo 2: Tree 002: Honey Locust, Municipal tree, facing east, northeast end of property. March 22, 2022

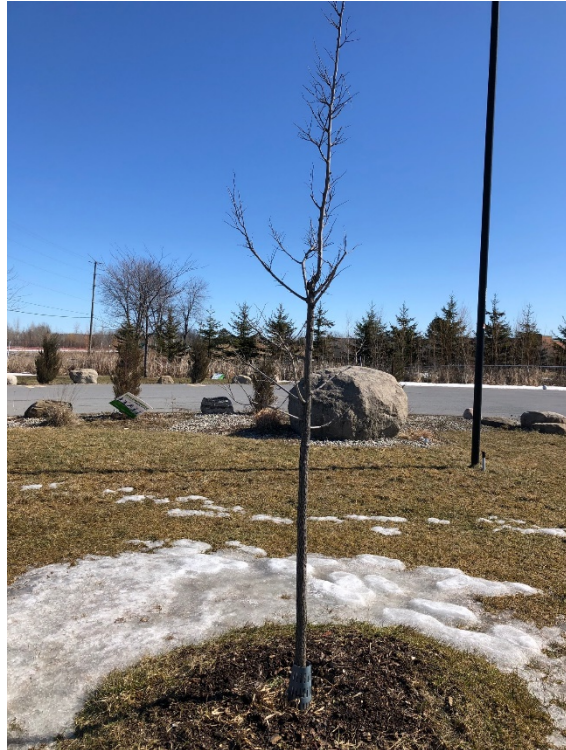
| Tree # | Common Name | Scientific Name | Size (cm) (DBH) | Ownership | Condition of Tree | Reason for Removal | Arborist Recommendation |
|---|---|---|---|---|---|---|---|
| 003 | Common Hackberry | <i>Celtis occidentalis</i> | 4 | City Tree | Structural Integrity = Good Vigour = Good, 0% deadwood at time of assessment | N/A | Tree to be retained and CRZ to be protected where possible and follow the City's Tree Protection Specification. |

Photo 3: Tree 003: Common Hackberry, Municipal tree, facing east, northeast end of property. March 22, 2022

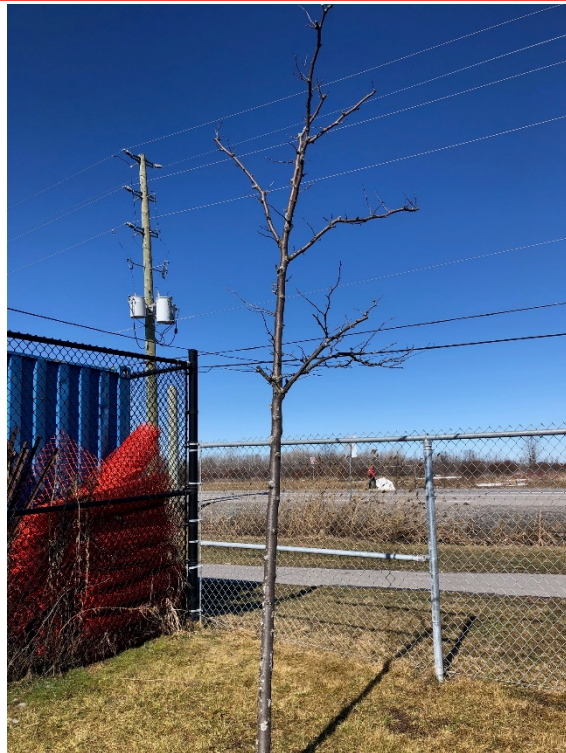
| Tree # | Common Name | Scientific Name | Size (cm) (DBH) | Ownership | Condition of Tree | Reason for Removal | Arborist Recommendation |
|---|---|---|---|---|---|---|---|
| 004 | Honey Locust | <i>Gleditsia triacanthos</i> | 6 | City Tree | Structural Integrity = Good Vigour = Good, 0% deadwood at time of assessment | N/A | Tree to be retained and CRZ to be protected where possible and follow the City's Tree Protection Specification. |

Photo 4: Tree 004: Honey Locust, Municipal tree, facing north, northeast side of property. March 22, 2022

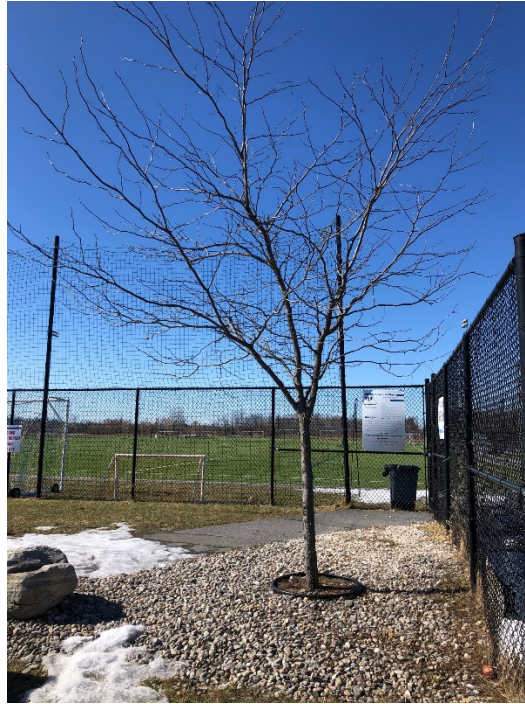
| Tree # | Common Name | Scientific Name | Size (cm) (DBH) | Ownership | Condition of Tree | Reason for Removal | Arborist Recommendation |
|---|---|---|---|---|---|---|---|
| 005 | Honey Locust | <i>Gleditsia triacanthos</i> | 10 | City Tree | Structural Integrity = Good Vigour = Good, 0% deadwood at time of assessment | N/A | Tree to be retained and CRZ to be protected where possible and follow the City's Tree Protection Specification. |

Photo 5: Tree 005: Honey Locust, Municipal tree, facing west, northeast side of property. March 22, 2022

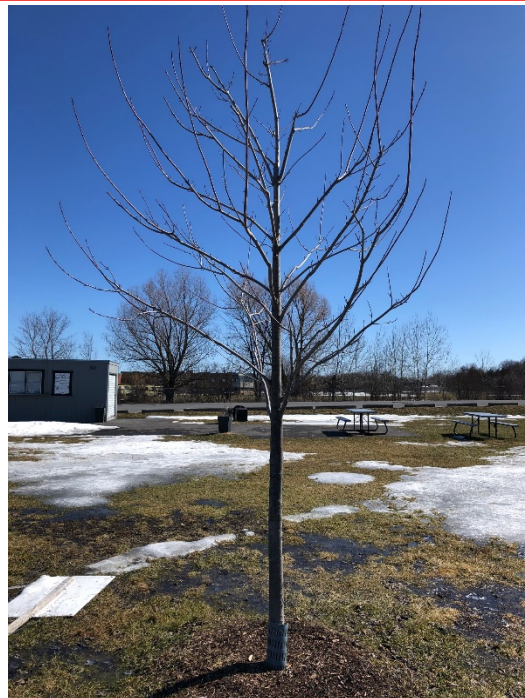
| Tree # | Common Name | Scientific Name | Size (cm) (DBH) | Ownership | Condition of Tree | Reason for Removal | Arborist Recommendation |
|---|---|---|---|---|---|---|---|
| 006 | Freeman's Maple | <i>Acer x freemanii</i> | 7 | City Tree | Structural Integrity = Good Vigour = Good, 0% deadwood at time of assessment | N/A | Tree to be retained and CRZ to be protected where possible and follow the City's Tree Protection Specification. |

Photo 6: Tree 006: Freeman's Maple, Municipal tree, facing east, east end of property. March 22, 2022

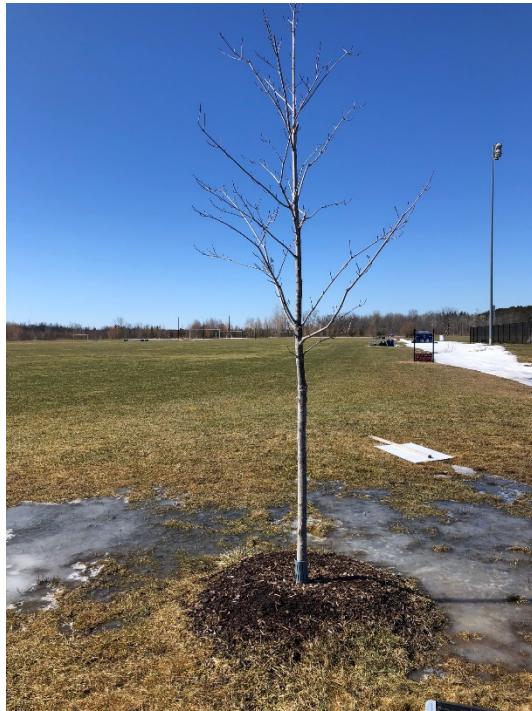
| Tree # | Common Name | Scientific Name | Size (cm) (DBH) | Ownership | Condition of Tree | Reason for Removal | Arborist Recommendation |
|---|---|---|---|---|---|---|---|
| 007 | Freeman's Maple | <i>Acer x freemanii</i> | 4 | City Tree | Structural Integrity = Good Vigour = Good, 0% deadwood at time of assessment | N/A | Tree to be retained and CRZ to be protected where possible and follow the City's Tree Protection Specification. |

Photo 7: Tree 007: Freeman's Maple, Municipal tree, facing west, east end of property. March 22, 2022

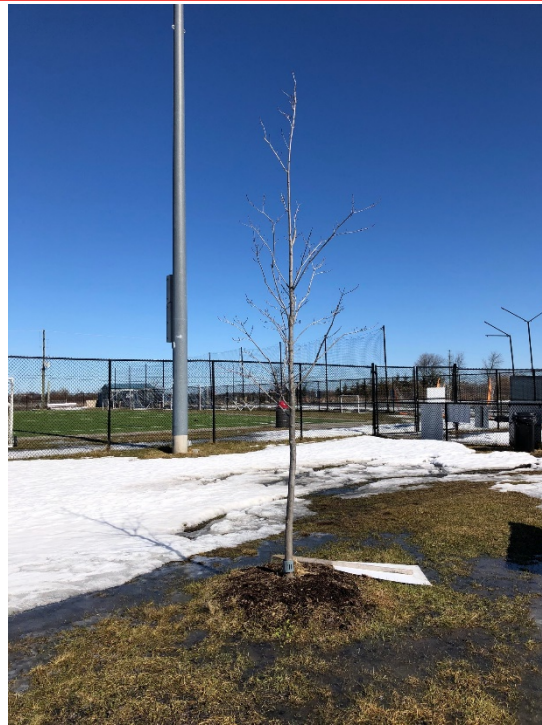
| Tree # | Common Name | Scientific Name | Size (cm) (DBH) | Ownership | Condition of Tree | Reason for Removal | Arborist Recommendation |
|---|---|---|---|---|---|---|---|
| 008 | Freeman's Maple | <i>Acer x freemanii</i> | 5 | City Tree | Structural Integrity = Good Vigour = Good, 0% deadwood at time of assessment | N/A | Tree to be retained and CRZ to be protected where possible and follow the City's Tree Protection Specification. |

Photo 8: Tree 008: Freeman's Maple, Municipal tree, facing northeast, east end of property. March 22, 2022
