REPORT

Geotechnical Investigation
Barrett Lands - Phase 3 East
Proposed Residential Development
Findlay Creek

Golder Associates Ltd.

August 22, 2022

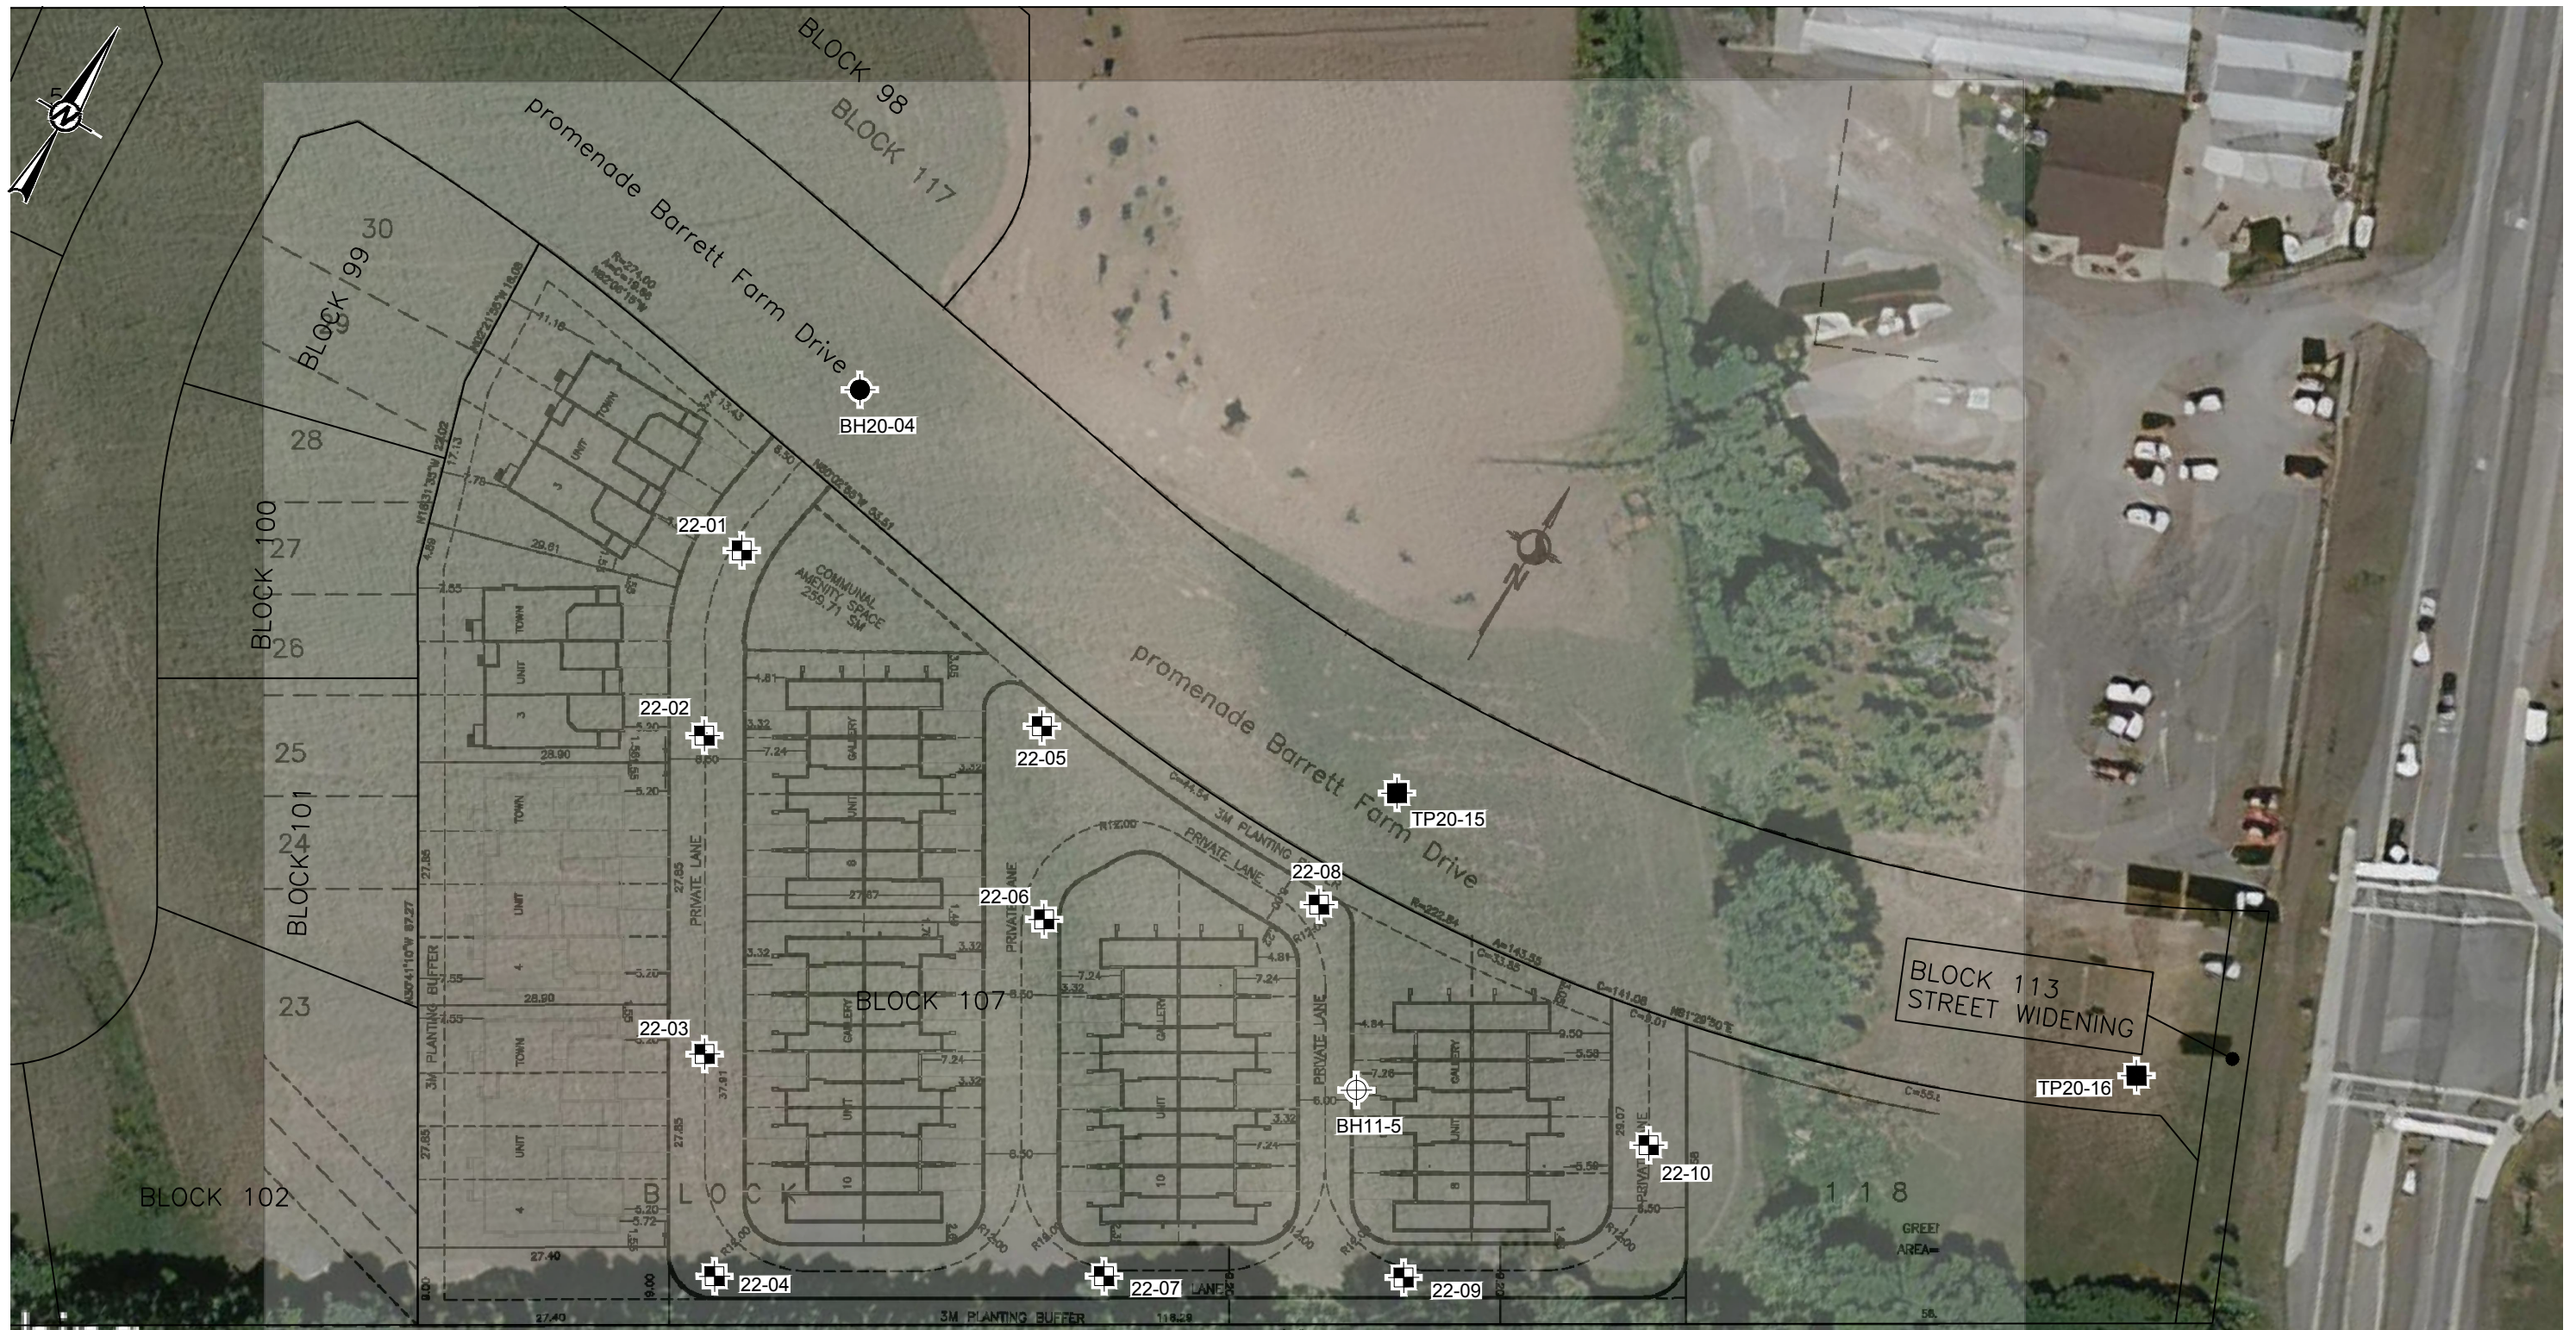
Figure 1 – Site Plan

- LEGEND**
- SURVEYED TESTPIT LOCATION, CURRENT INVESTIGATION
 - APPROXIMATE TESTHOLE LOCATION, PREVIOUS INVESTIGATION (GOLDER ASSOCIATES REPORT No. 20442530)
 - APPROXIMATE BOREHOLE LOCATION, PREVIOUS INVESTIGATION (GOLDER ASSOCIATES REPORT No. 20442530)
 - APPROXIMATE TESTHOLE LOCATION, PREVIOUS INVESTIGATION (GOLDER ASSOCIATES REPORT No. 1111210198)

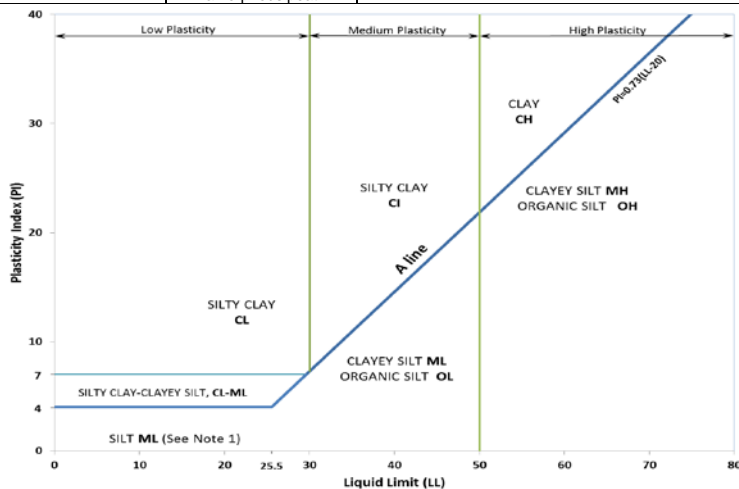
Note 1 – Fine grained materials with PI and LL that plot in this area are named (ML) SILT with slight plasticity. Fine-grained materials which are non-plastic (i.e. a PL cannot be measured) are named SILT.
Note 2 – For soils with <5% organic content, include the descriptor “trace organics” for soils with between 5% and 30% organic content include the prefix “organic” before the Primary name.

Dual Symbol — A dual symbol is two symbols separated by a hyphen, for example, GP-GM, SW-SC and CL-ML. For non-cohesive soils, the dual symbols must be used when the soil has between 5% and 12% fines (i.e. to identify transitional material between “clean” and “dirty” sand or gravel. For cohesive soils, the dual symbol must be used when the liquid limit and plasticity index values plot in the CL-ML area of the plasticity chart (see Plasticity Chart at left).
