**Phase Two Environmental Site Assessment
393 McArthur Avenue
Proposed Residential Development
Ottawa, Ontario**

June 2, 2022
Project: 64819.22 - V02

**Re: Phase Two Environmental Site Assessment
393 McArthur Avenue
Ottawa, ON**

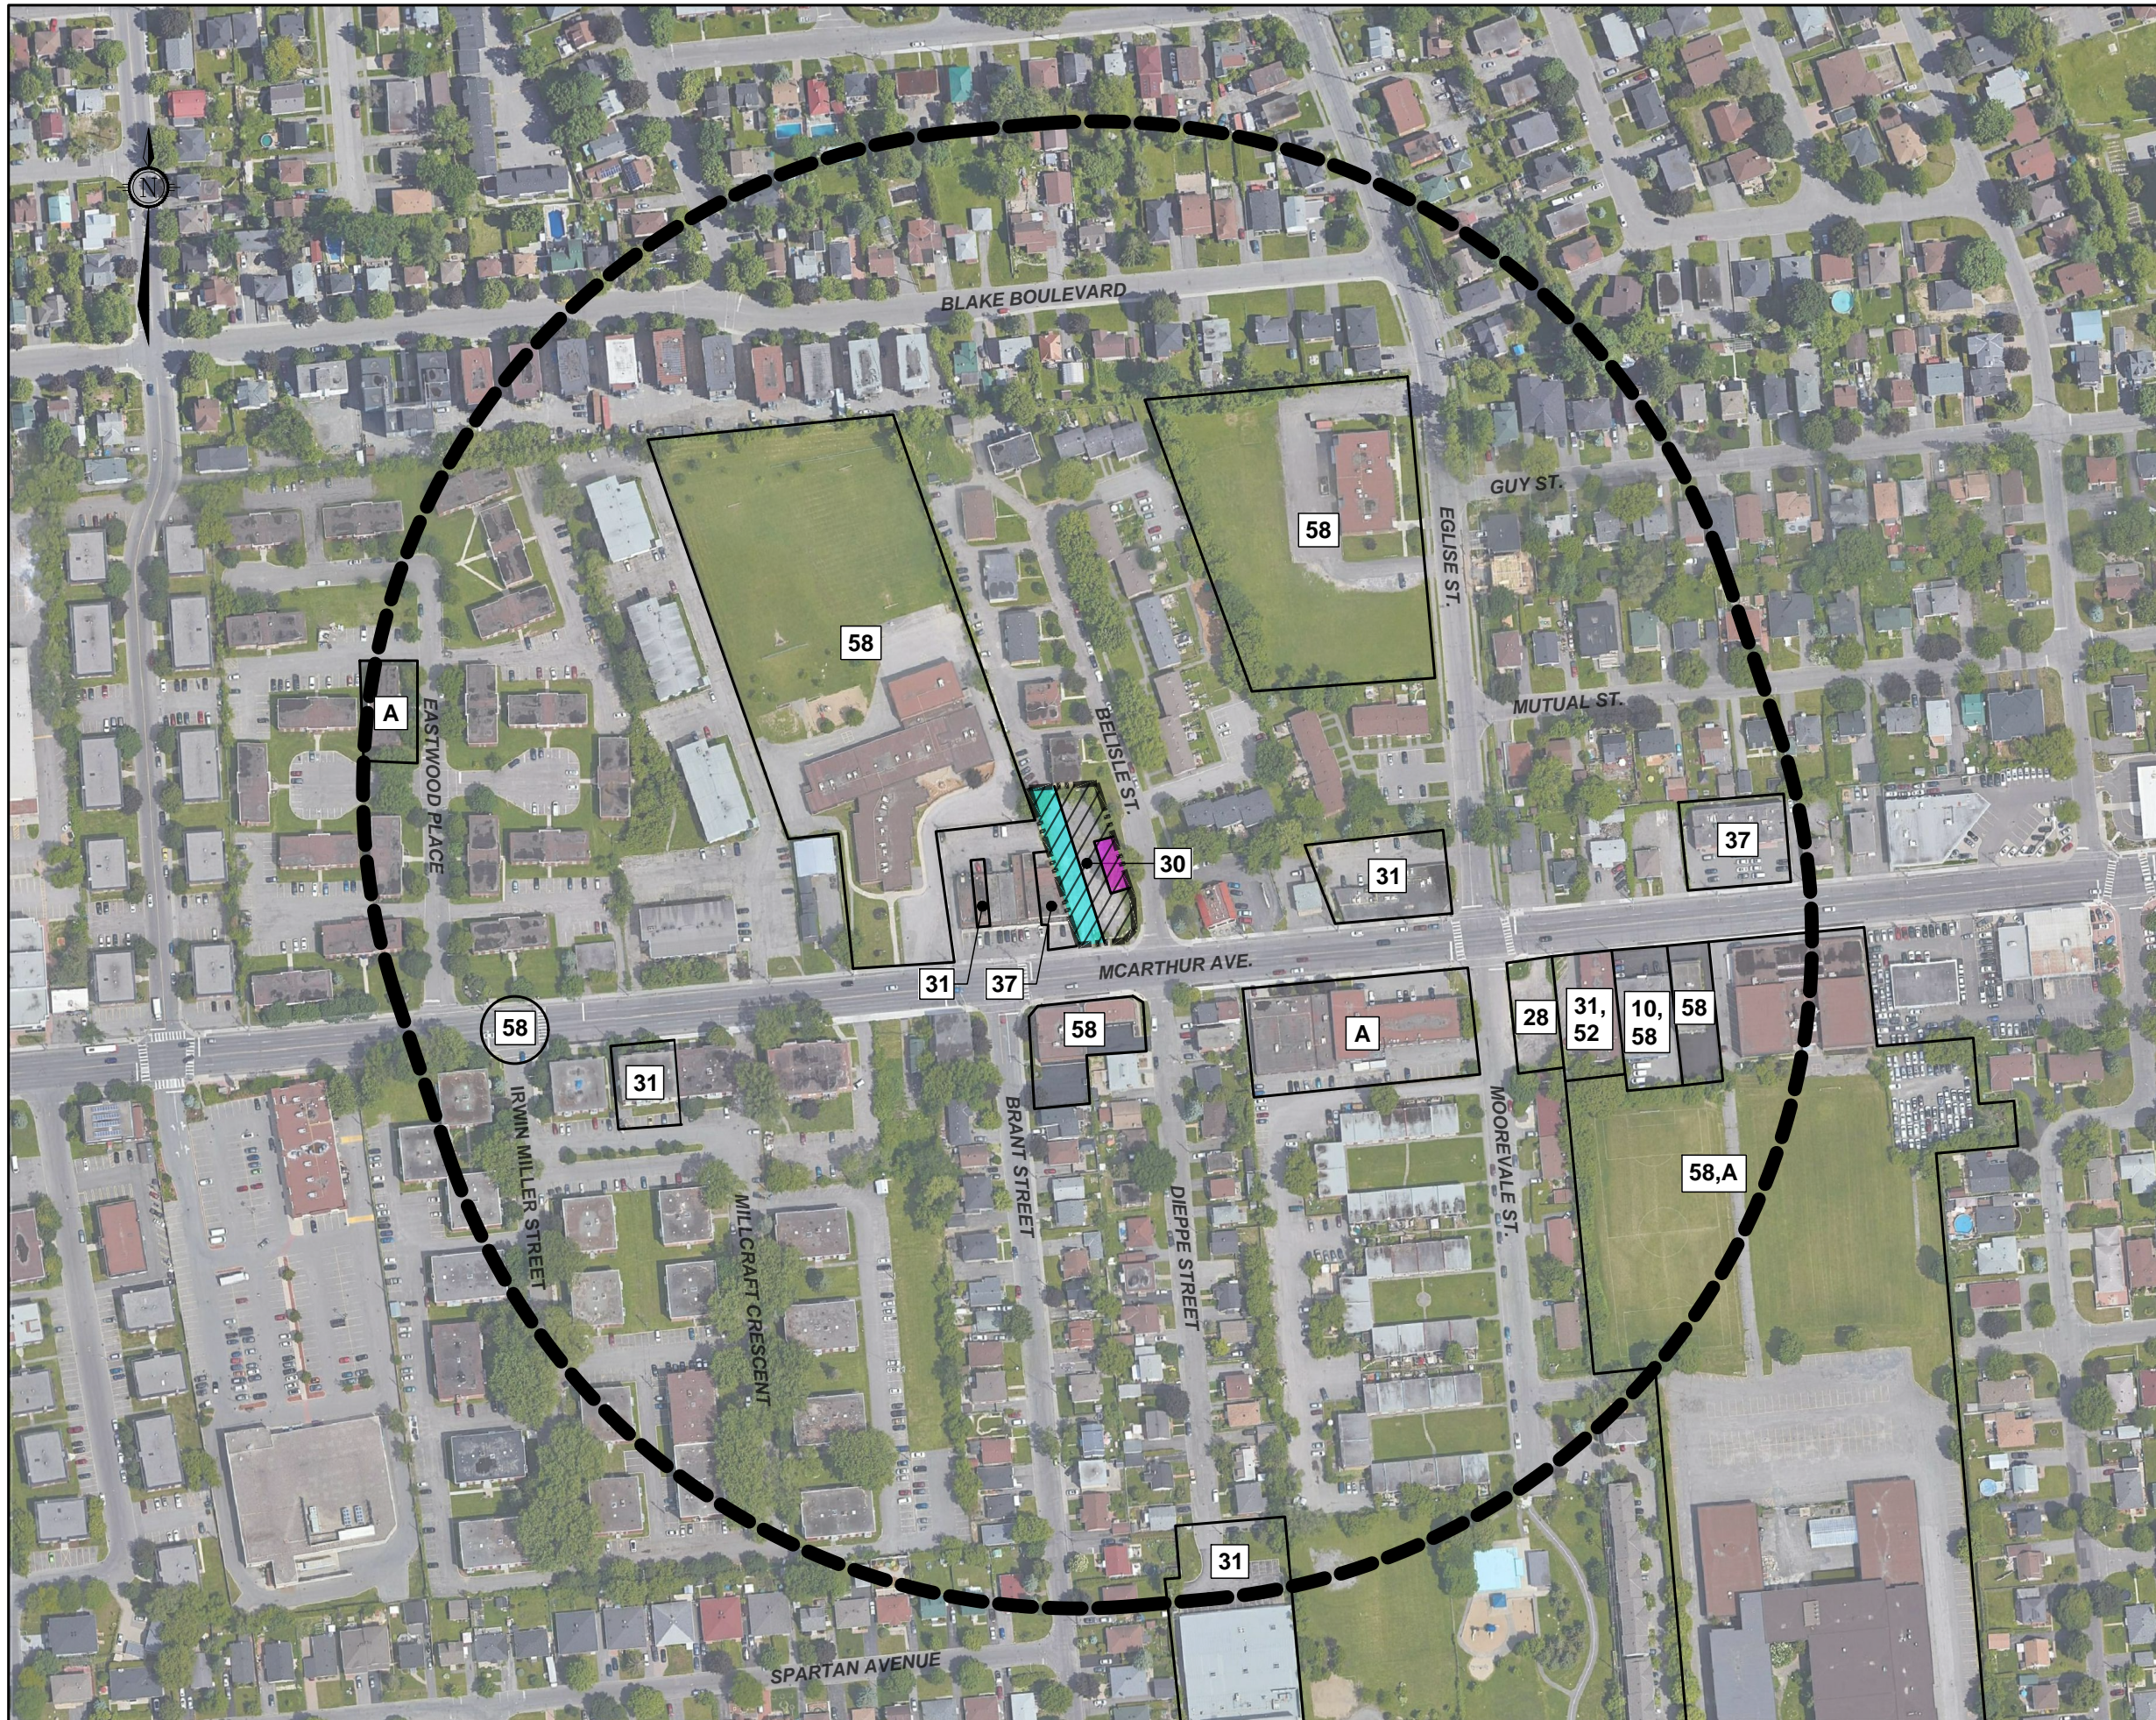
Date **JUNE 2020** Rev. **2** **FIGURE 9.3**

- SUBJECT SITE
- 250 METRE BUFFER SHOWING EXTENT OF STUDY AREA

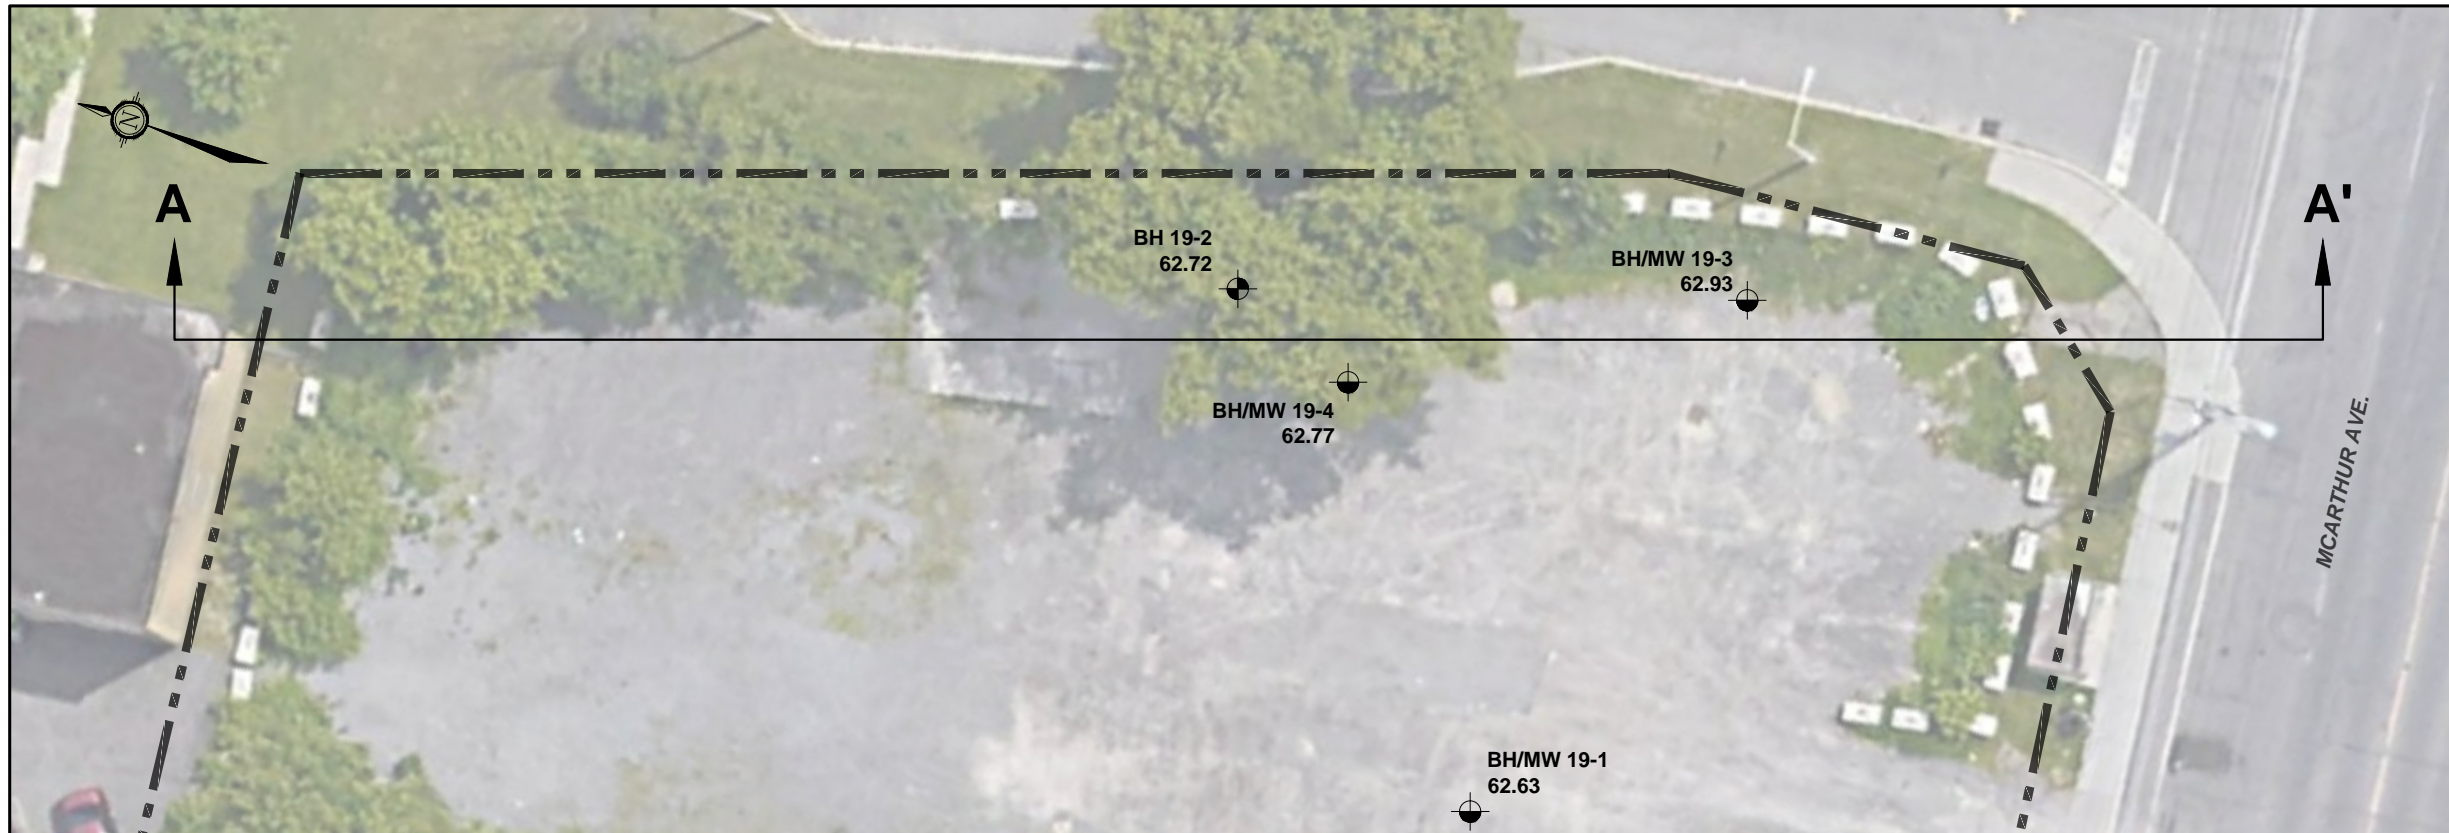
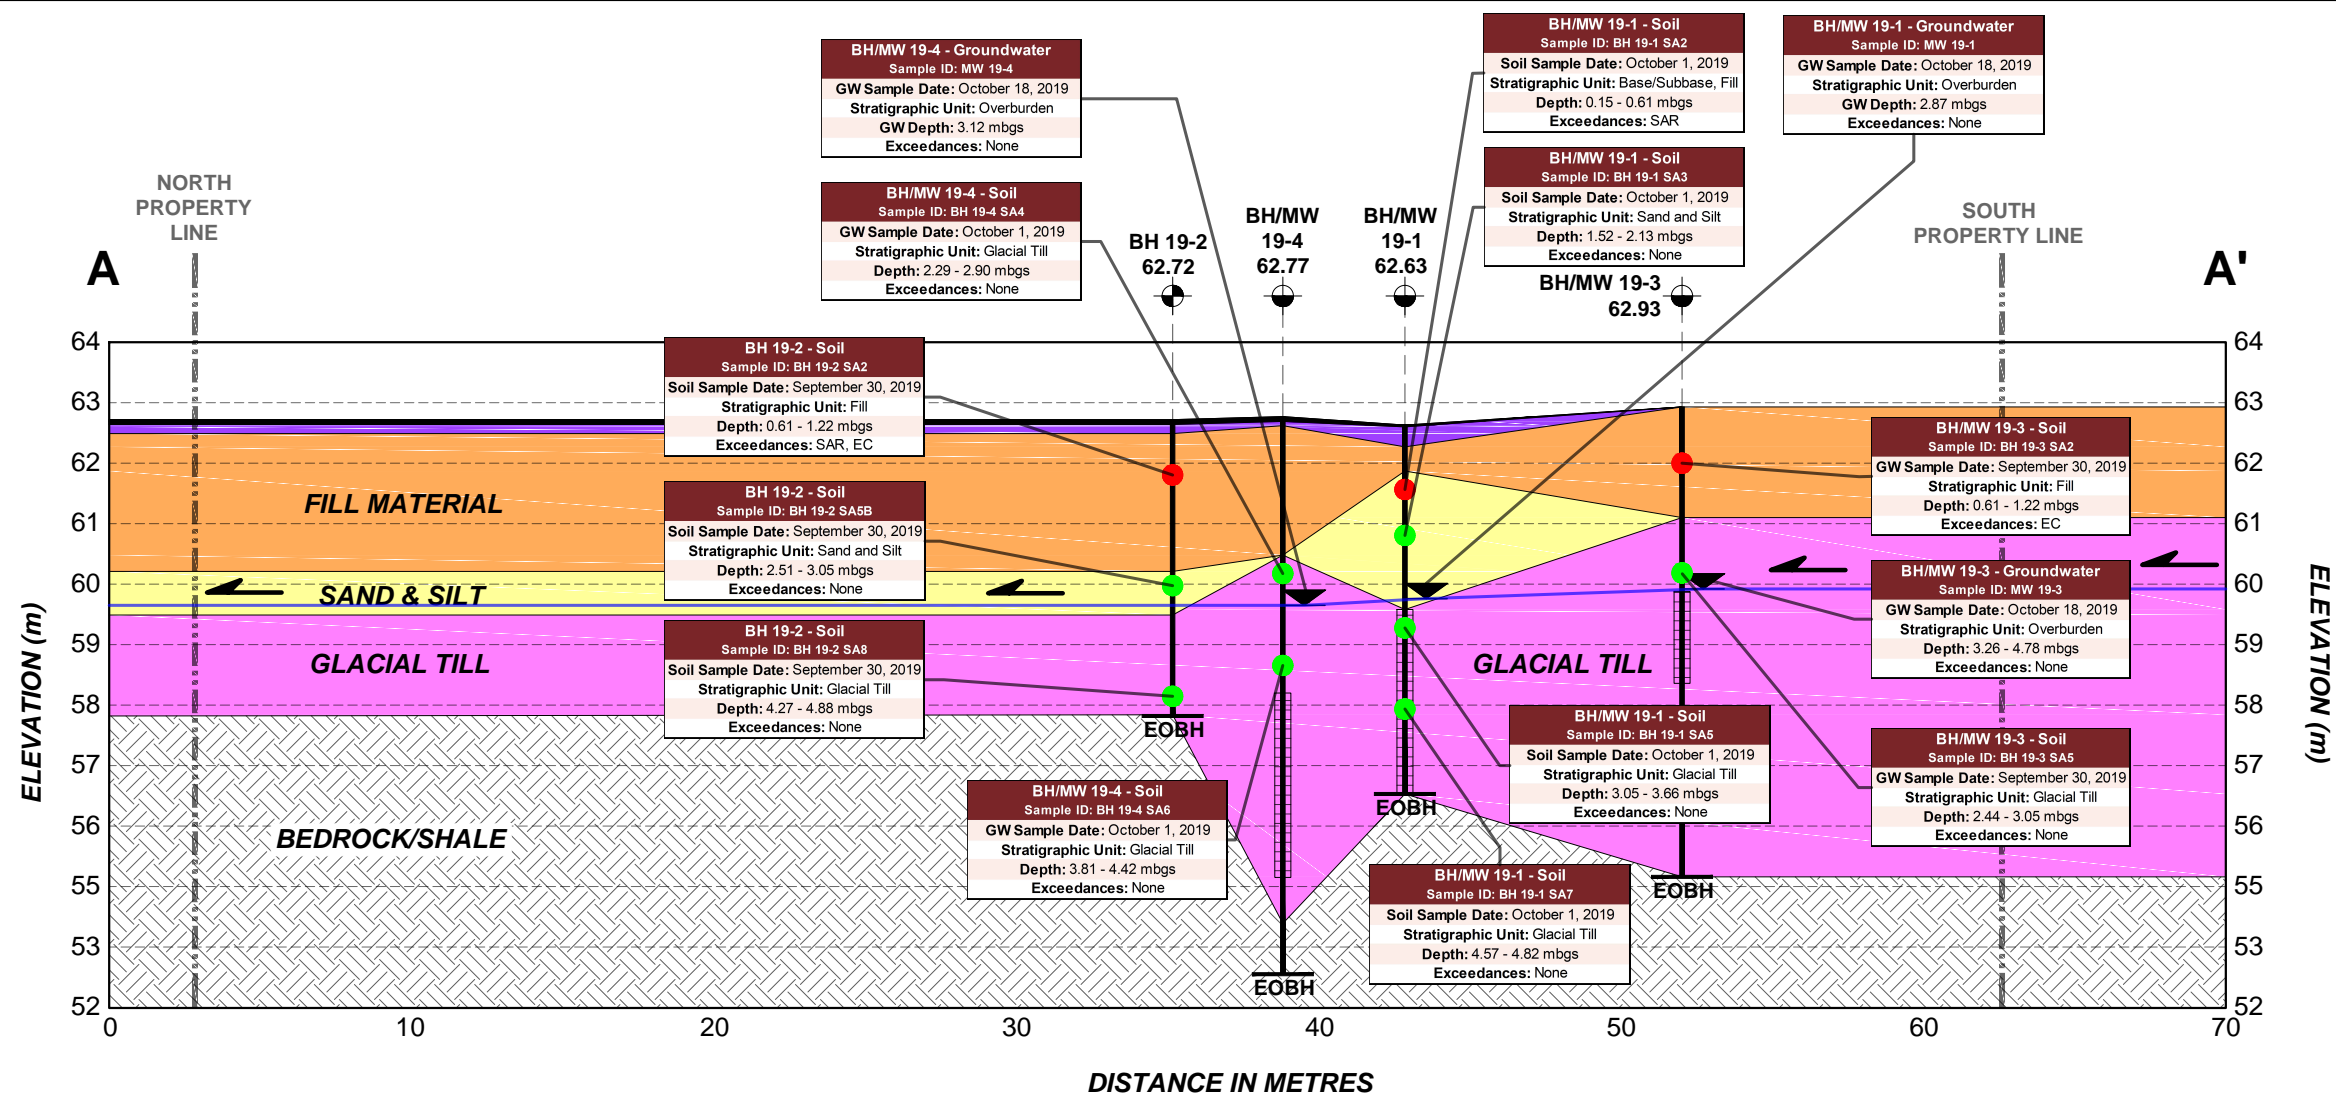
Drawing		CROSS SECTION A-A' SOIL QUALITY EXCEEDANCES	
Client		NOVATECH	
Project	64819.22	PHASE TWO ESA/RECORD OF SITE CONDITION 393 MCARTHUR AVENUE OTTAWA, ONTARIO	
Drwn by	P.C.	Chkd by	N.S.
Date	JUNE 2020	Rev.	2
			FIGURE 9.6

Based on the findings of the Phase One and Phase Two ESA reports, the applicable Site Condition Standards for the future use of the site is Table 3 Generic Site Condition Standards for use in a Non-Potable Ground Water Condition, Course Textured Soils (MOE, 2011a). Environmental conditions at the subject site, as part of the Phase Two CSM are illustrated in plan view on Figure 9.4 and in cross sections A-A' and B-B', Figures 9.6 and 9.7, respectively.

The results of the Phase Two ESA indicate the presence of soil contamination at the property at concentrations exceeding MECP Table 3 SCS. The area of soil contamination was along the east boundary of the main rental facility along Belisle Street. However, as indicated above, based on the conditions in which the contamination was incurred, and which conditions are likely to continue, EC and SAR in soil samples on are not considered to be contaminants within the project limits.

It is interpreted that elevated SAR and EC within the fill materials in BH19-2 and BH19-3 originate from the subject property are due to substances that have been applied to surfaces for the safety of vehicular or pedestrian traffic under conditions of snow or ice or both. Accordingly, as indicated above according to Section 20 (2) of O.Reg 407/19, MECP SCS exceedances of SAR, and EC in are not considered to be contamination within the project limits. As such, no further work is recommended.
