**Geotechnical Investigation
Proposed Commercial Building
4 Campbell Reid Court
Ottawa, Ontario**

August 19, 2022
Project: 65103.01

File: 65103.01 – R01

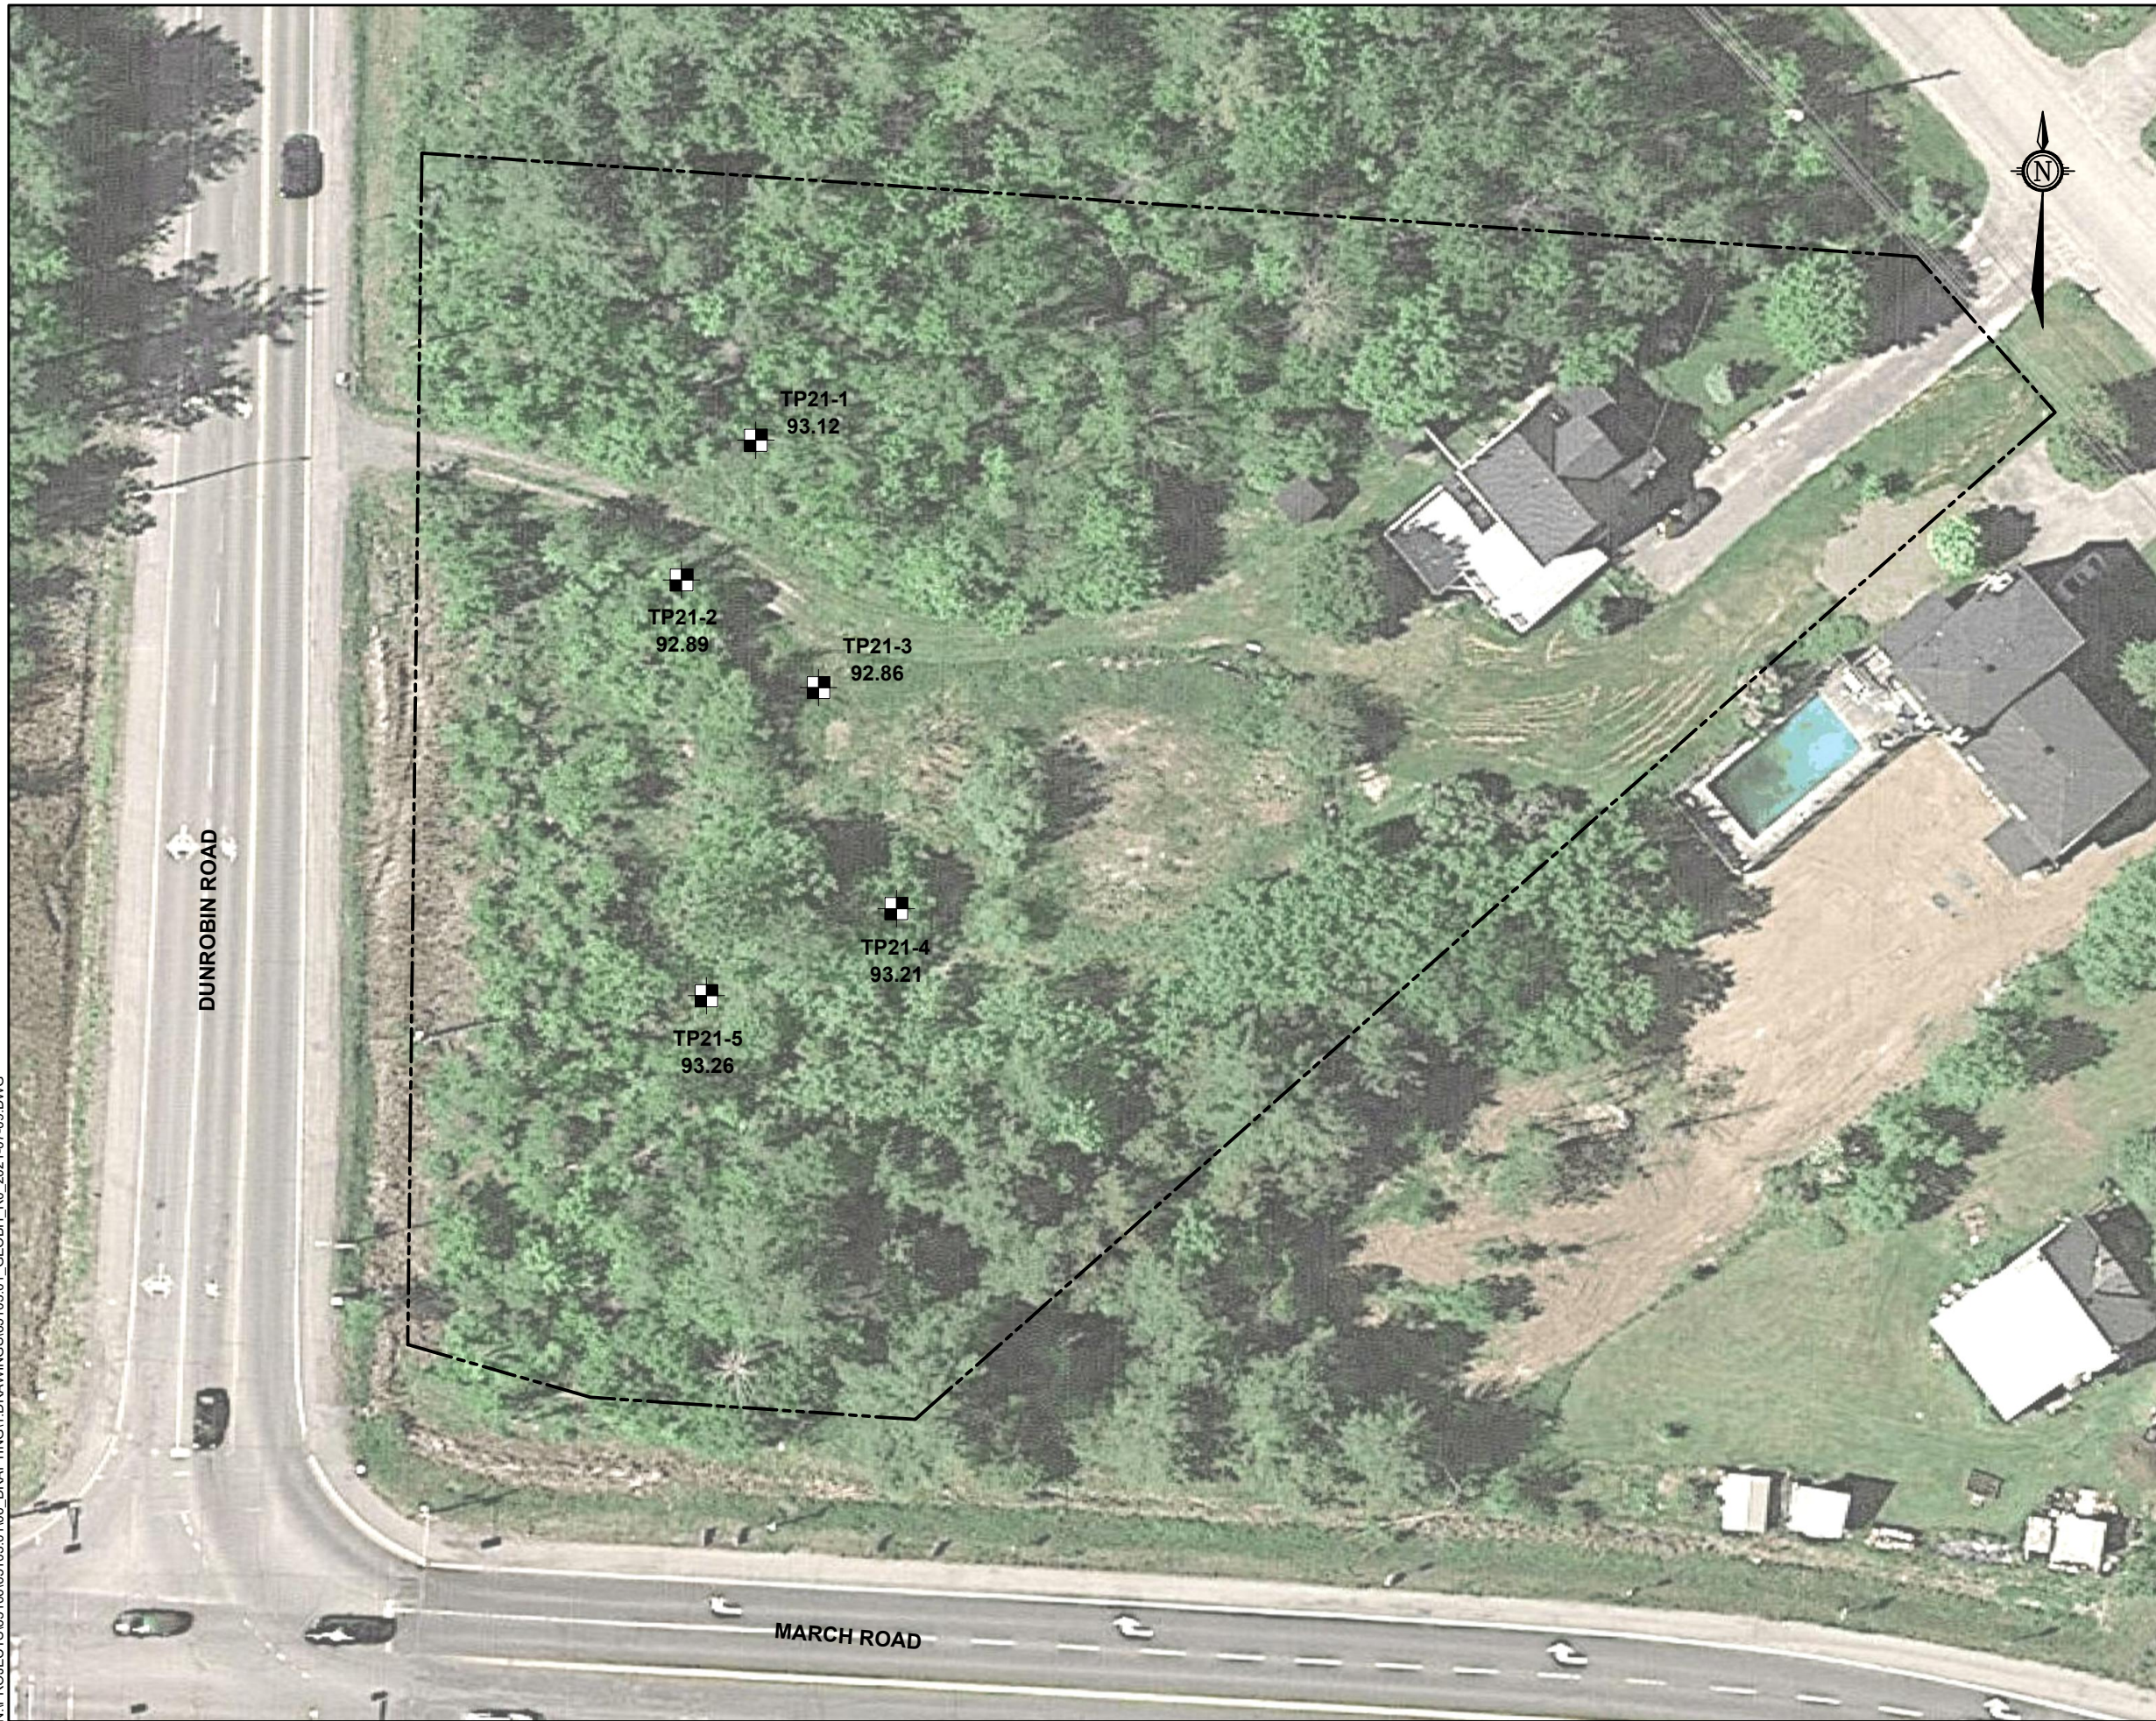
- TP # — TEST PIT ID
- XX.XX — GROUND SURFACE ELEVATION, IN METRES
GEODETC DATUM
- — TEST PIT LOCATION
(current investigation by GEMTEC)
- APPROXIMATE PROPERTY BOUNDARY

The results of the test pits are provided on the Record of Test Pit sheets in Appendix A. The approximate locations and ground surface elevations of the test pits are shown on the Test Pit Location Plan, Figure 1. The laboratory testing results are provided on the Soil Grading and Plasticity charts in Appendix B. The results of the chemical analysis of soil sample relating to corrosion of buried concrete and steel are provided in Appendix C.

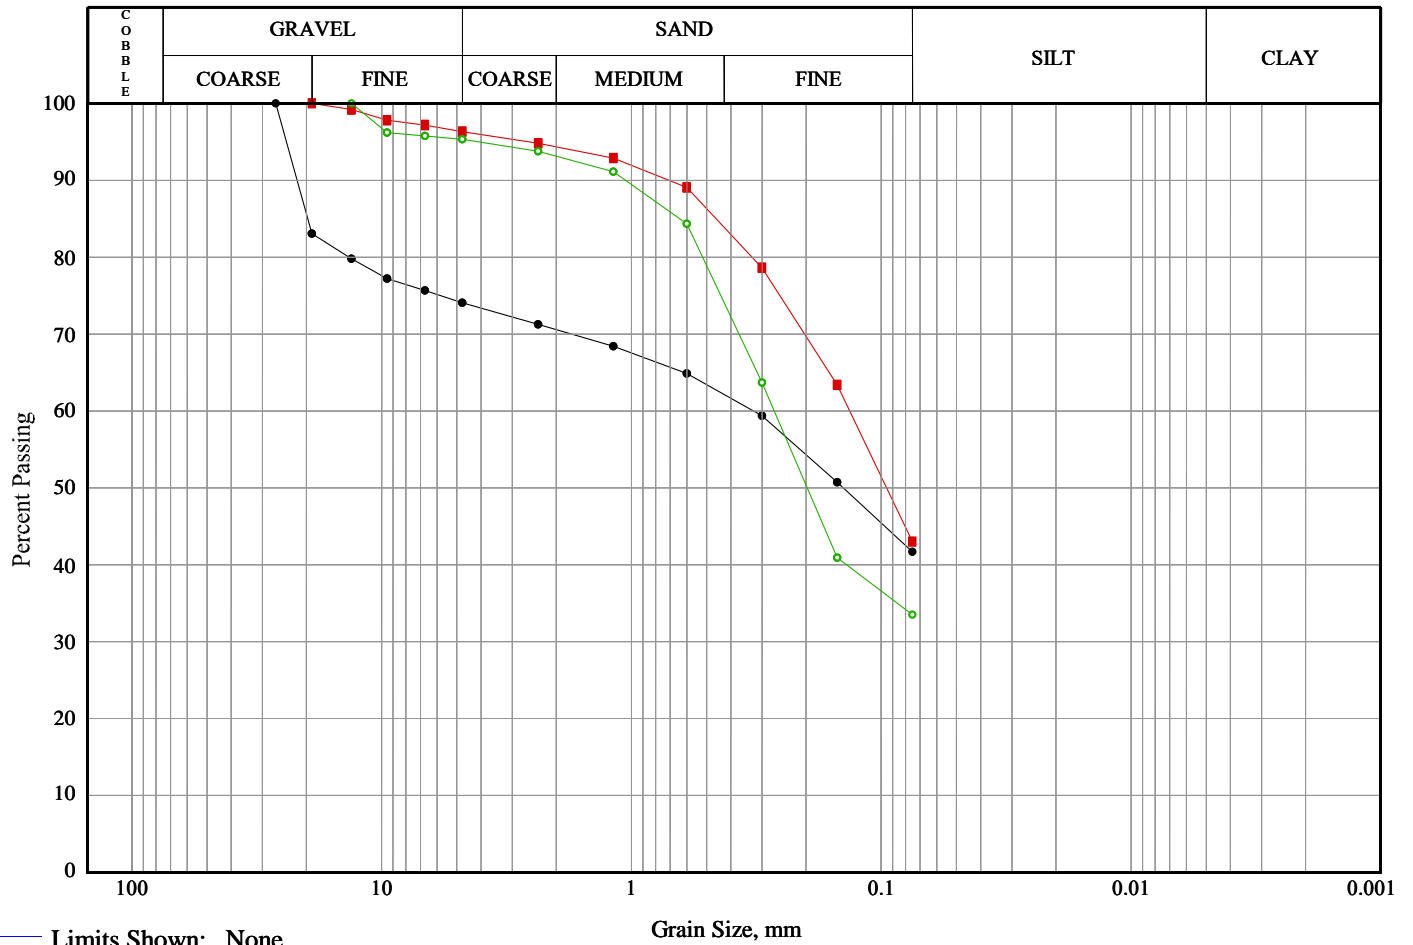
Laboratory Testing Results
Soils Grading Chart

Line Symbol	Sample	Borehole/ Test Pit	Sample Number	Depth	% Cob.+ Gravel	% Sand	% Silt	% Clay
—●—	Fill Material	21-1	GS1	0-0.9	25.9	32.4	41.7	
—■—	Glacial Till	21-1	GS3	1.1-1.3	3.7	53.3	43.0	
—○—	Glacial Till	21-5	GS3	1.2-1.3	4.7	61.8	33.5

The results of grain size distribution testing on a sample of the fill material from test pit 21-1 are provided on the Soils Grading Charts in Appendix B and summarized in Table 4.1.

The results of grain size distribution testing on samples of the glacial till from test pit 21-1 and 21-5 are provided on the Soil Grading Charts in Appendix B and summarized in Table 4.2.
