# Blocks 201, 202, 204 & 205B, Chaudière Island, Ottawa, Ontario

Hydrogeological Investigation

**Technical Report**

OTT-00250193-S0

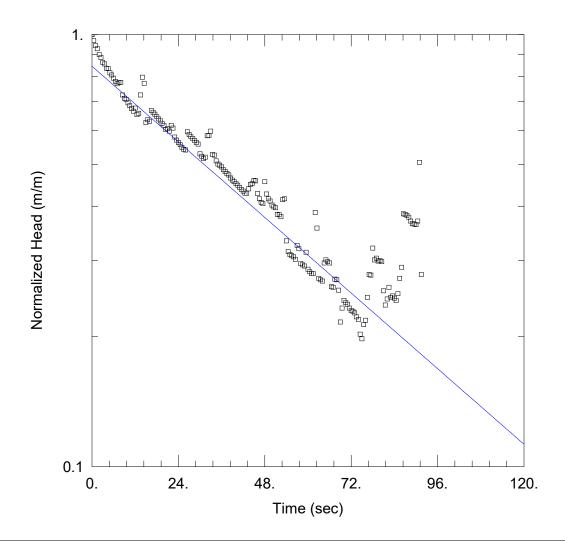
### MW 21-102 RISING HEAD SWRT

K = 7.884E-6 m/sec y0 = 0.8675 m

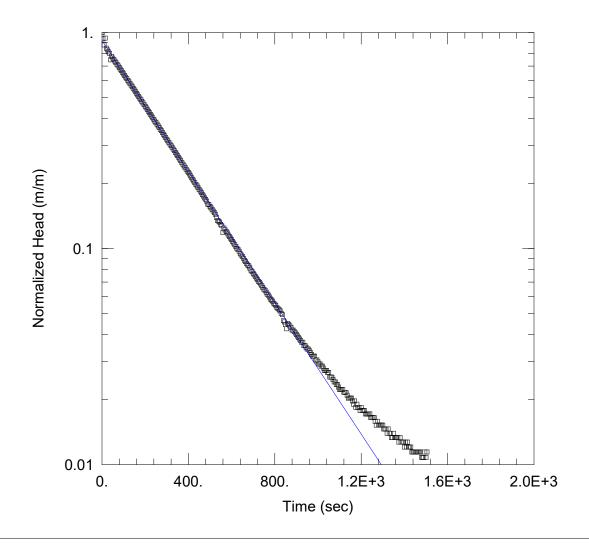
### MW 21-104 FALLING HEAD SWRT

K = 1.641E-6 m/sec y0 = 1.447 m

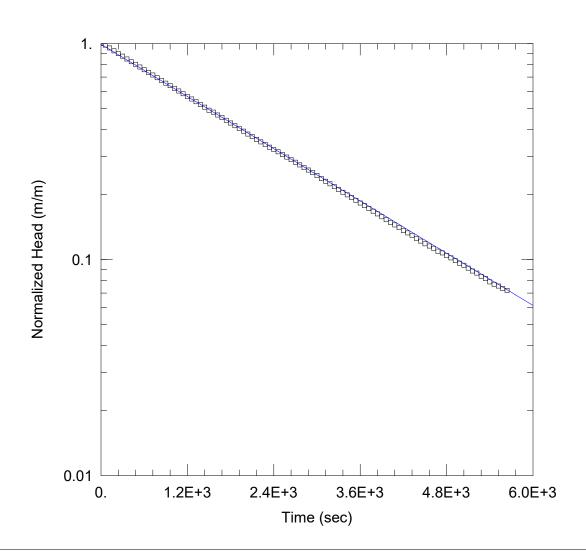
#### MW 21-110 FALLING HEAD SWRT

K = 1.833E-7 m/sec y0 = 1.435 m

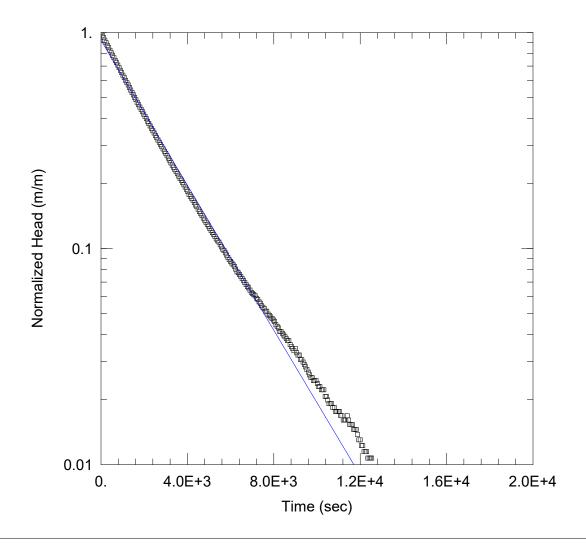
#### MW 21-110 RISING HEAD SWRT

K = 1.814E-7 m/sec y0 = 1.205 m

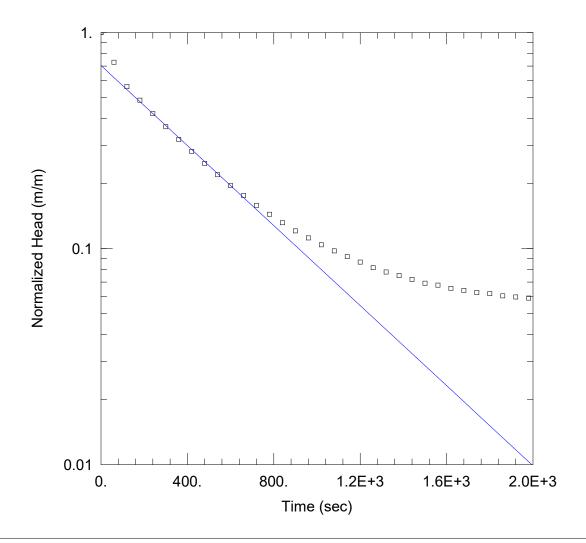
#### MW 21-112 FALLING HEAD SWRT

K = 1.001E-6 m/sec y0 = 0.967 m

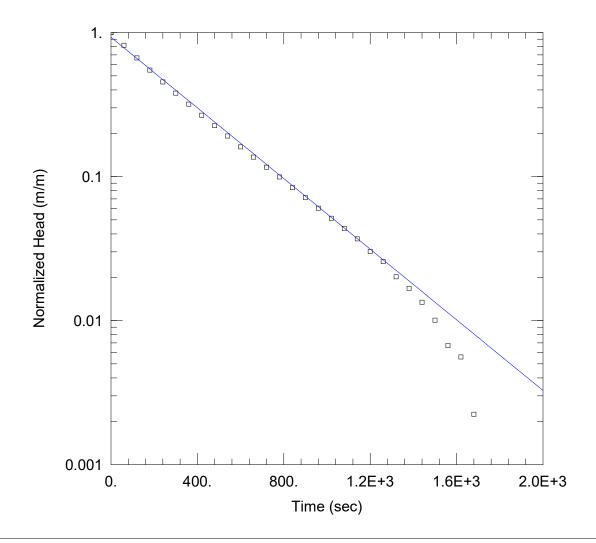
#### MW 21-112 RISING HEAD SWRT

K = 1.326E-6 m/sec y0 = 0.8305 m

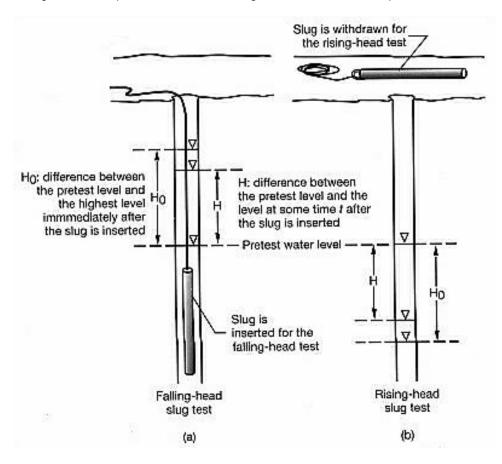
The figure below depicts a schematic of a slug and bail test and the respective water level changes.

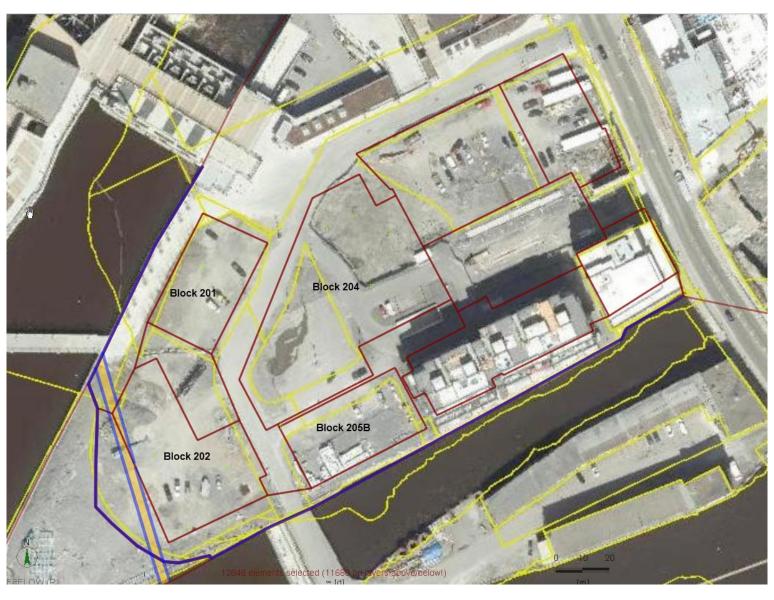
Figure G1. Proposed Construction Area with Blocks 201, 202, 204 and 205B on 2022 Aerial Photo

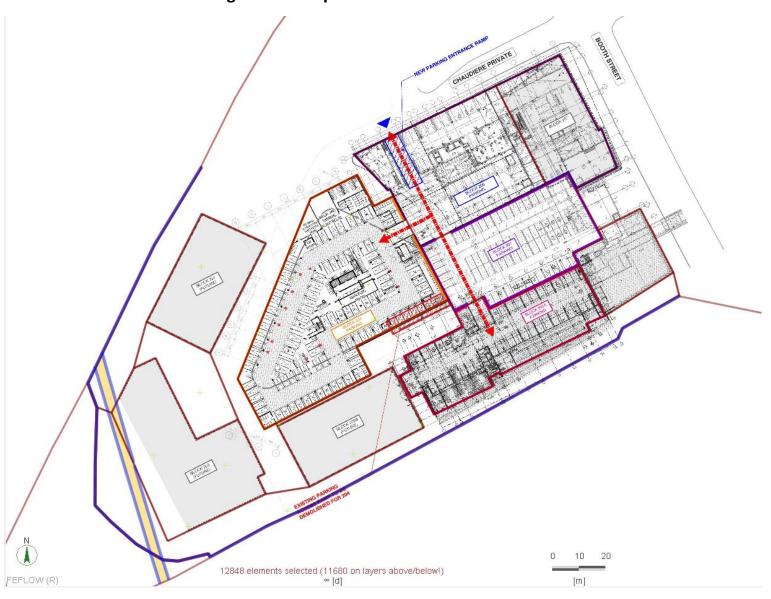
**Figure G2. Proposed Construction Block 204**

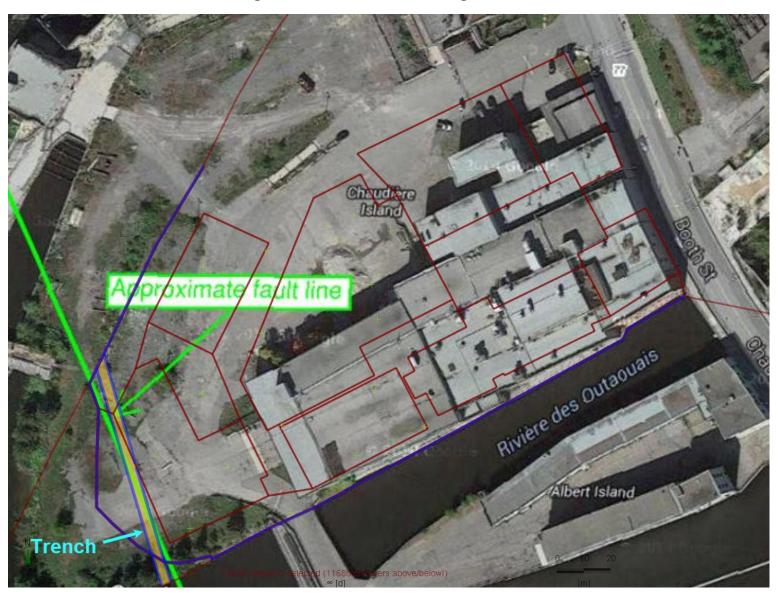
Figure G3. Trench and Geological Fault

The Site sits in a tectonic graben. Bedrock is broken into fault blocks, A fault striking NW-SE intersects the Site Chaudière Island. Karst and/or karstic features have not been identified on the island. The surficial and Paleozoic geology maps are provided in Figures 2A and 2B, respectively.

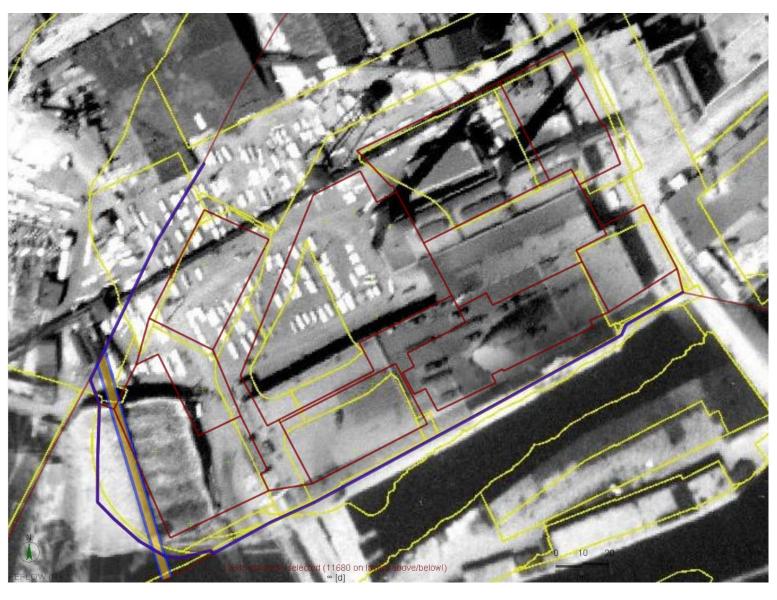
Figure G4. Trench Location on 1928 Aerial Photo

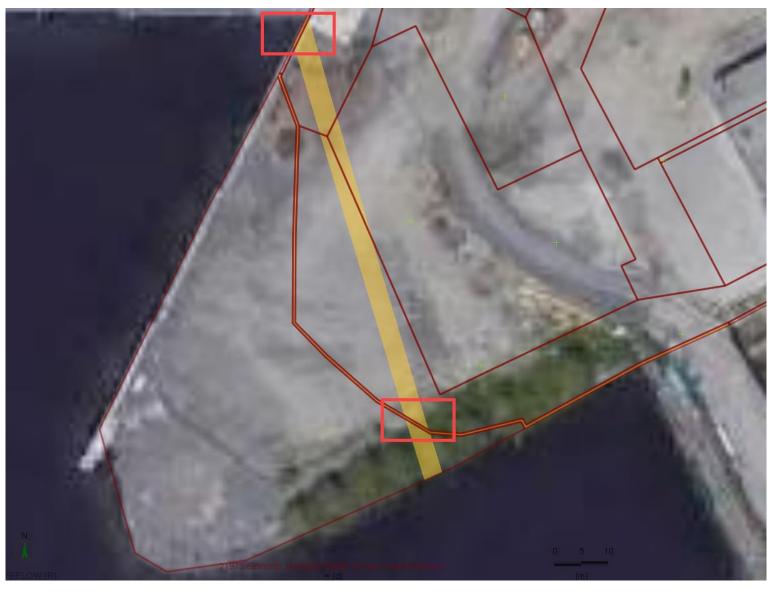
Figure G5. Expected Critical Locations where Trench Intersects Proposed Caisson Wall

If groundwater cut-off systems (caisson walls or equivalent) are installed, these should be designed for maximum hydrostatic pressure for shallow and deep water levels, without dewatering on the outer side of the groundwater cut-off systems. Soldier pile and lagging and groundwater cut-off systems should be designed to account for shallow groundwater conditions and take into consideration that dewatering systems may not provide fully dewatered conditions of the lithological unit (s).

If groundwater cut-off systems (caisson walls, sheet piles or equivalent) are used for decreasing long-term dewatering rates, these should be designed as permanent structures to cutoff groundwater inflow in the long-term. All perforations should be sealed permanently (ex: tiebacks, breaches, and cold joints) with no leakages and inspected. Fillers should extend into low

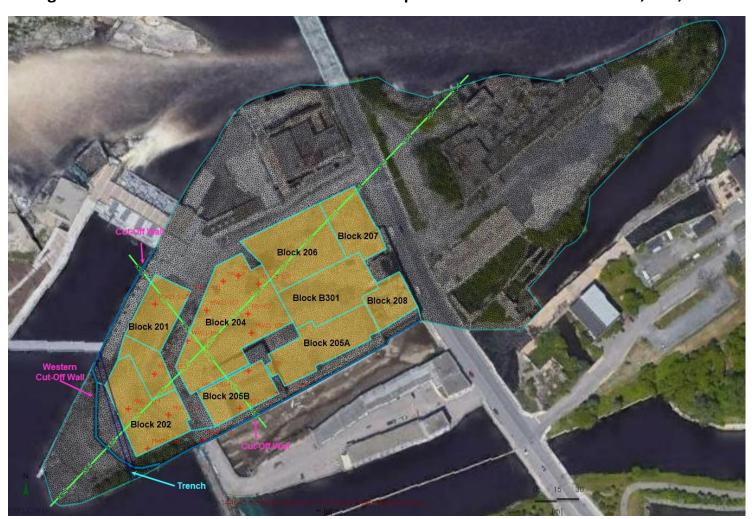
Figure G6. Plan View of Model Domain with Proposed Construction Blocks 201, 202, 204 and 205B

To estimate flow rates into the proposed excavation areas during the construction phase (short-term), as well as to the future sub-drains for the post-construction phase (long-term), three-dimensional (3D) groundwater flow models based on the Richard's Equation were created with FEFLOW, Version 7.5. FEFLOW is a software founded on the finite element method (FEM). It is owned and developed by the Danish Hydrology Institute (DHI). Modeling results are presented in Appendix G in section view.

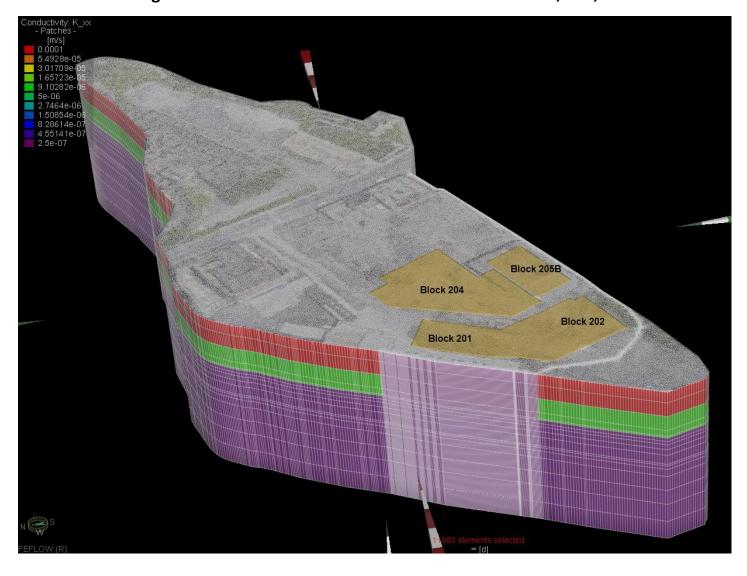
Figure G7. 3-D View of Model Domain with Blocks 201, 202, 204 and 205B
