TECHNICAL MEMORANDUM**DATE** September 8, 2022**Project No.** 21493887**TO** City of Ottawa
Public Works Department**FROM** Caitlin Cooke**EMAIL** ccooke@golder.com**RESAMPLING RESULTS, WELL PW11-1, AND UPDATED TERRAIN ANALYSIS
HYDRO ONE ORLEANS OC, PHASE 2
3440 FRANK KENNY ROAD, OTTAWA, ONTARIO**

Golder Associates Ltd., 2012. Hydrogeology, Terrain Analysis and Impact Assessment Study, 3406-3450 Frank Kenney Road. Report No. 11-1122-0129(3000), February 2012.

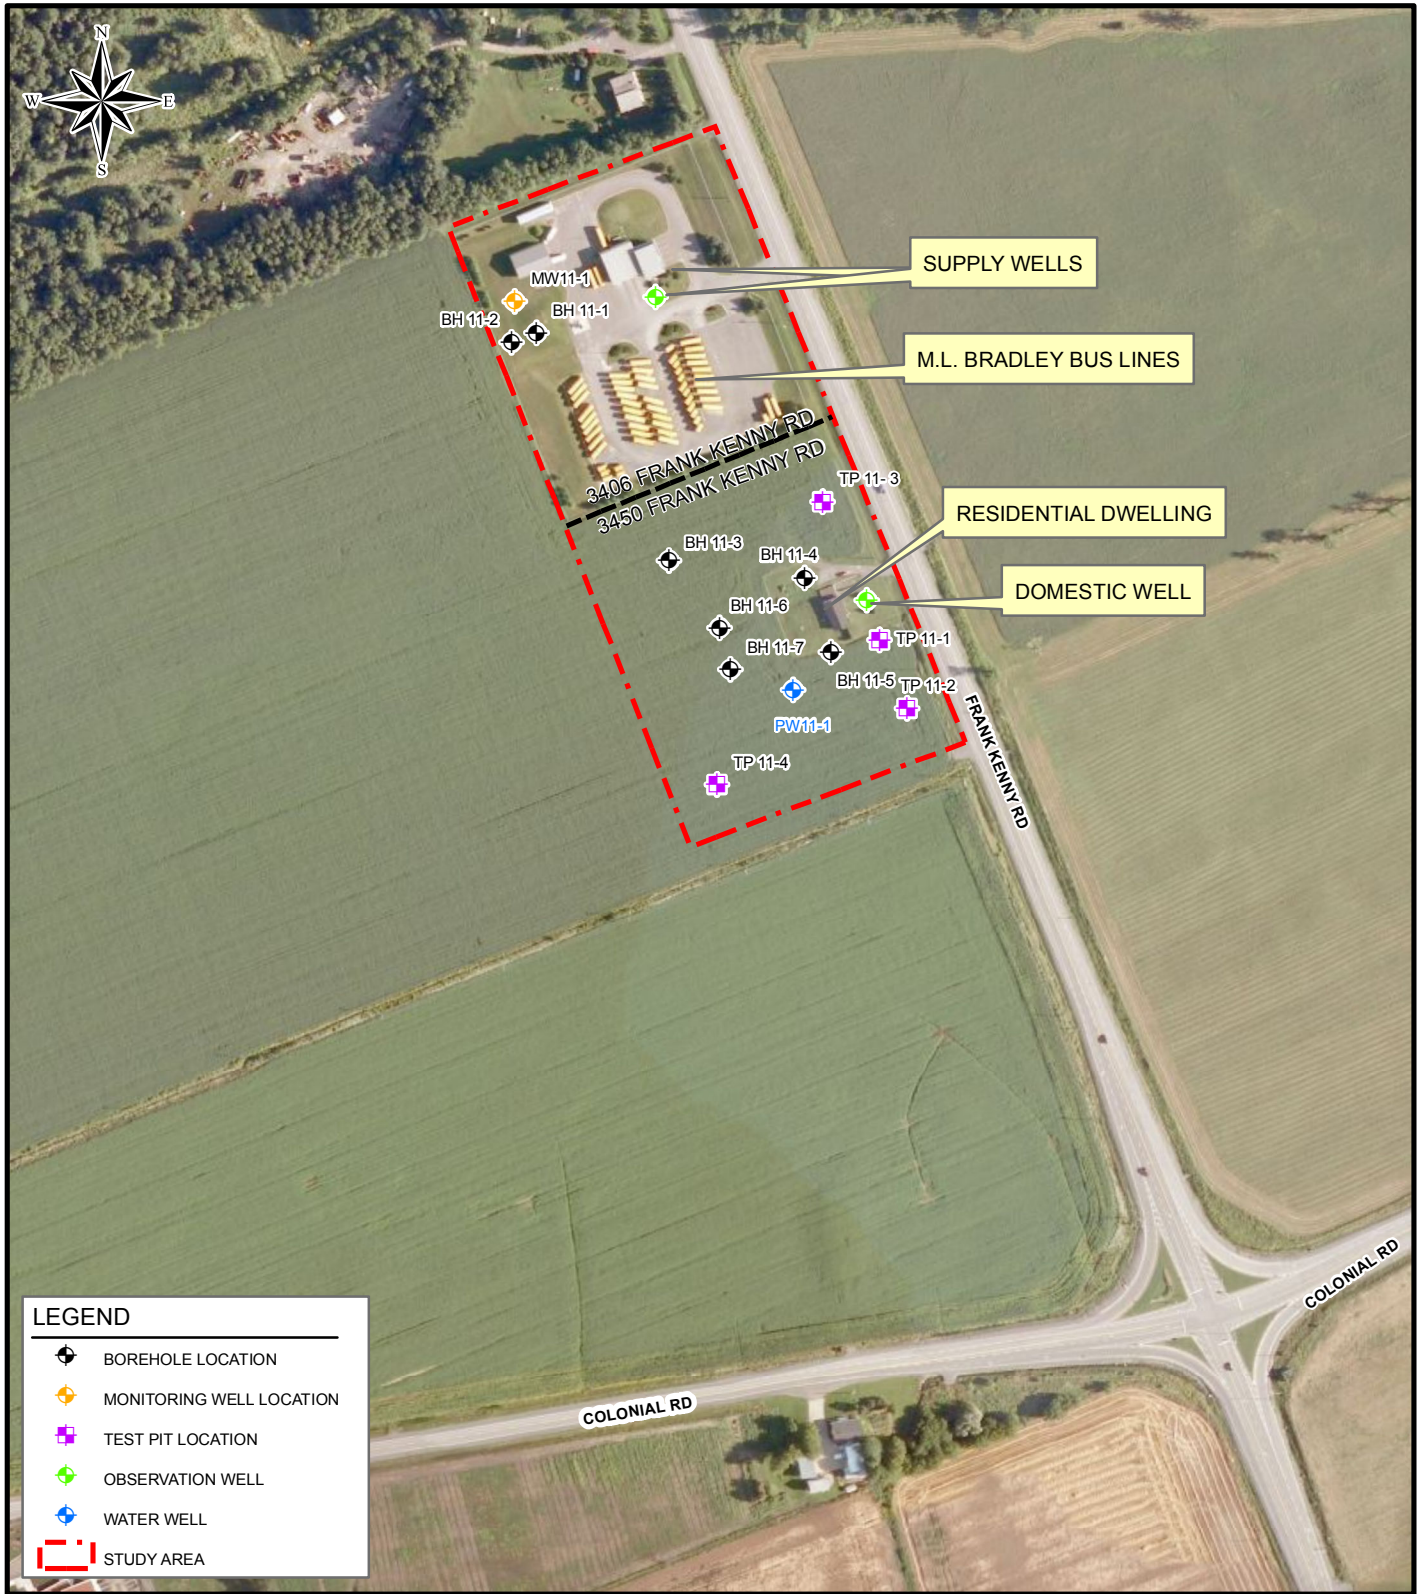
<p>Golder Associates Ottawa, Ontario</p>	DATE	Nov. 2011	<p>SITE PLAN</p>		
	DESIGN	CAMC			
	GIS	BJ			
PROJECT No.	11-1122-0129	CHECK	CAMC	<p>FIGURE 2</p>	
SCALE	AS SHOWN	REV.	0		PROJECT

Test pits TP11-1, TP11-2, TP11-3 and TP11-4 and boreholes BH11-4 and BH11-5 were advanced in the area of the proposed on-site sewage disposal system. Details of the subsurface conditions at each location are presented on the Record of Test Pits in Appendix B. The locations of the test pits are shown on Figure 2.

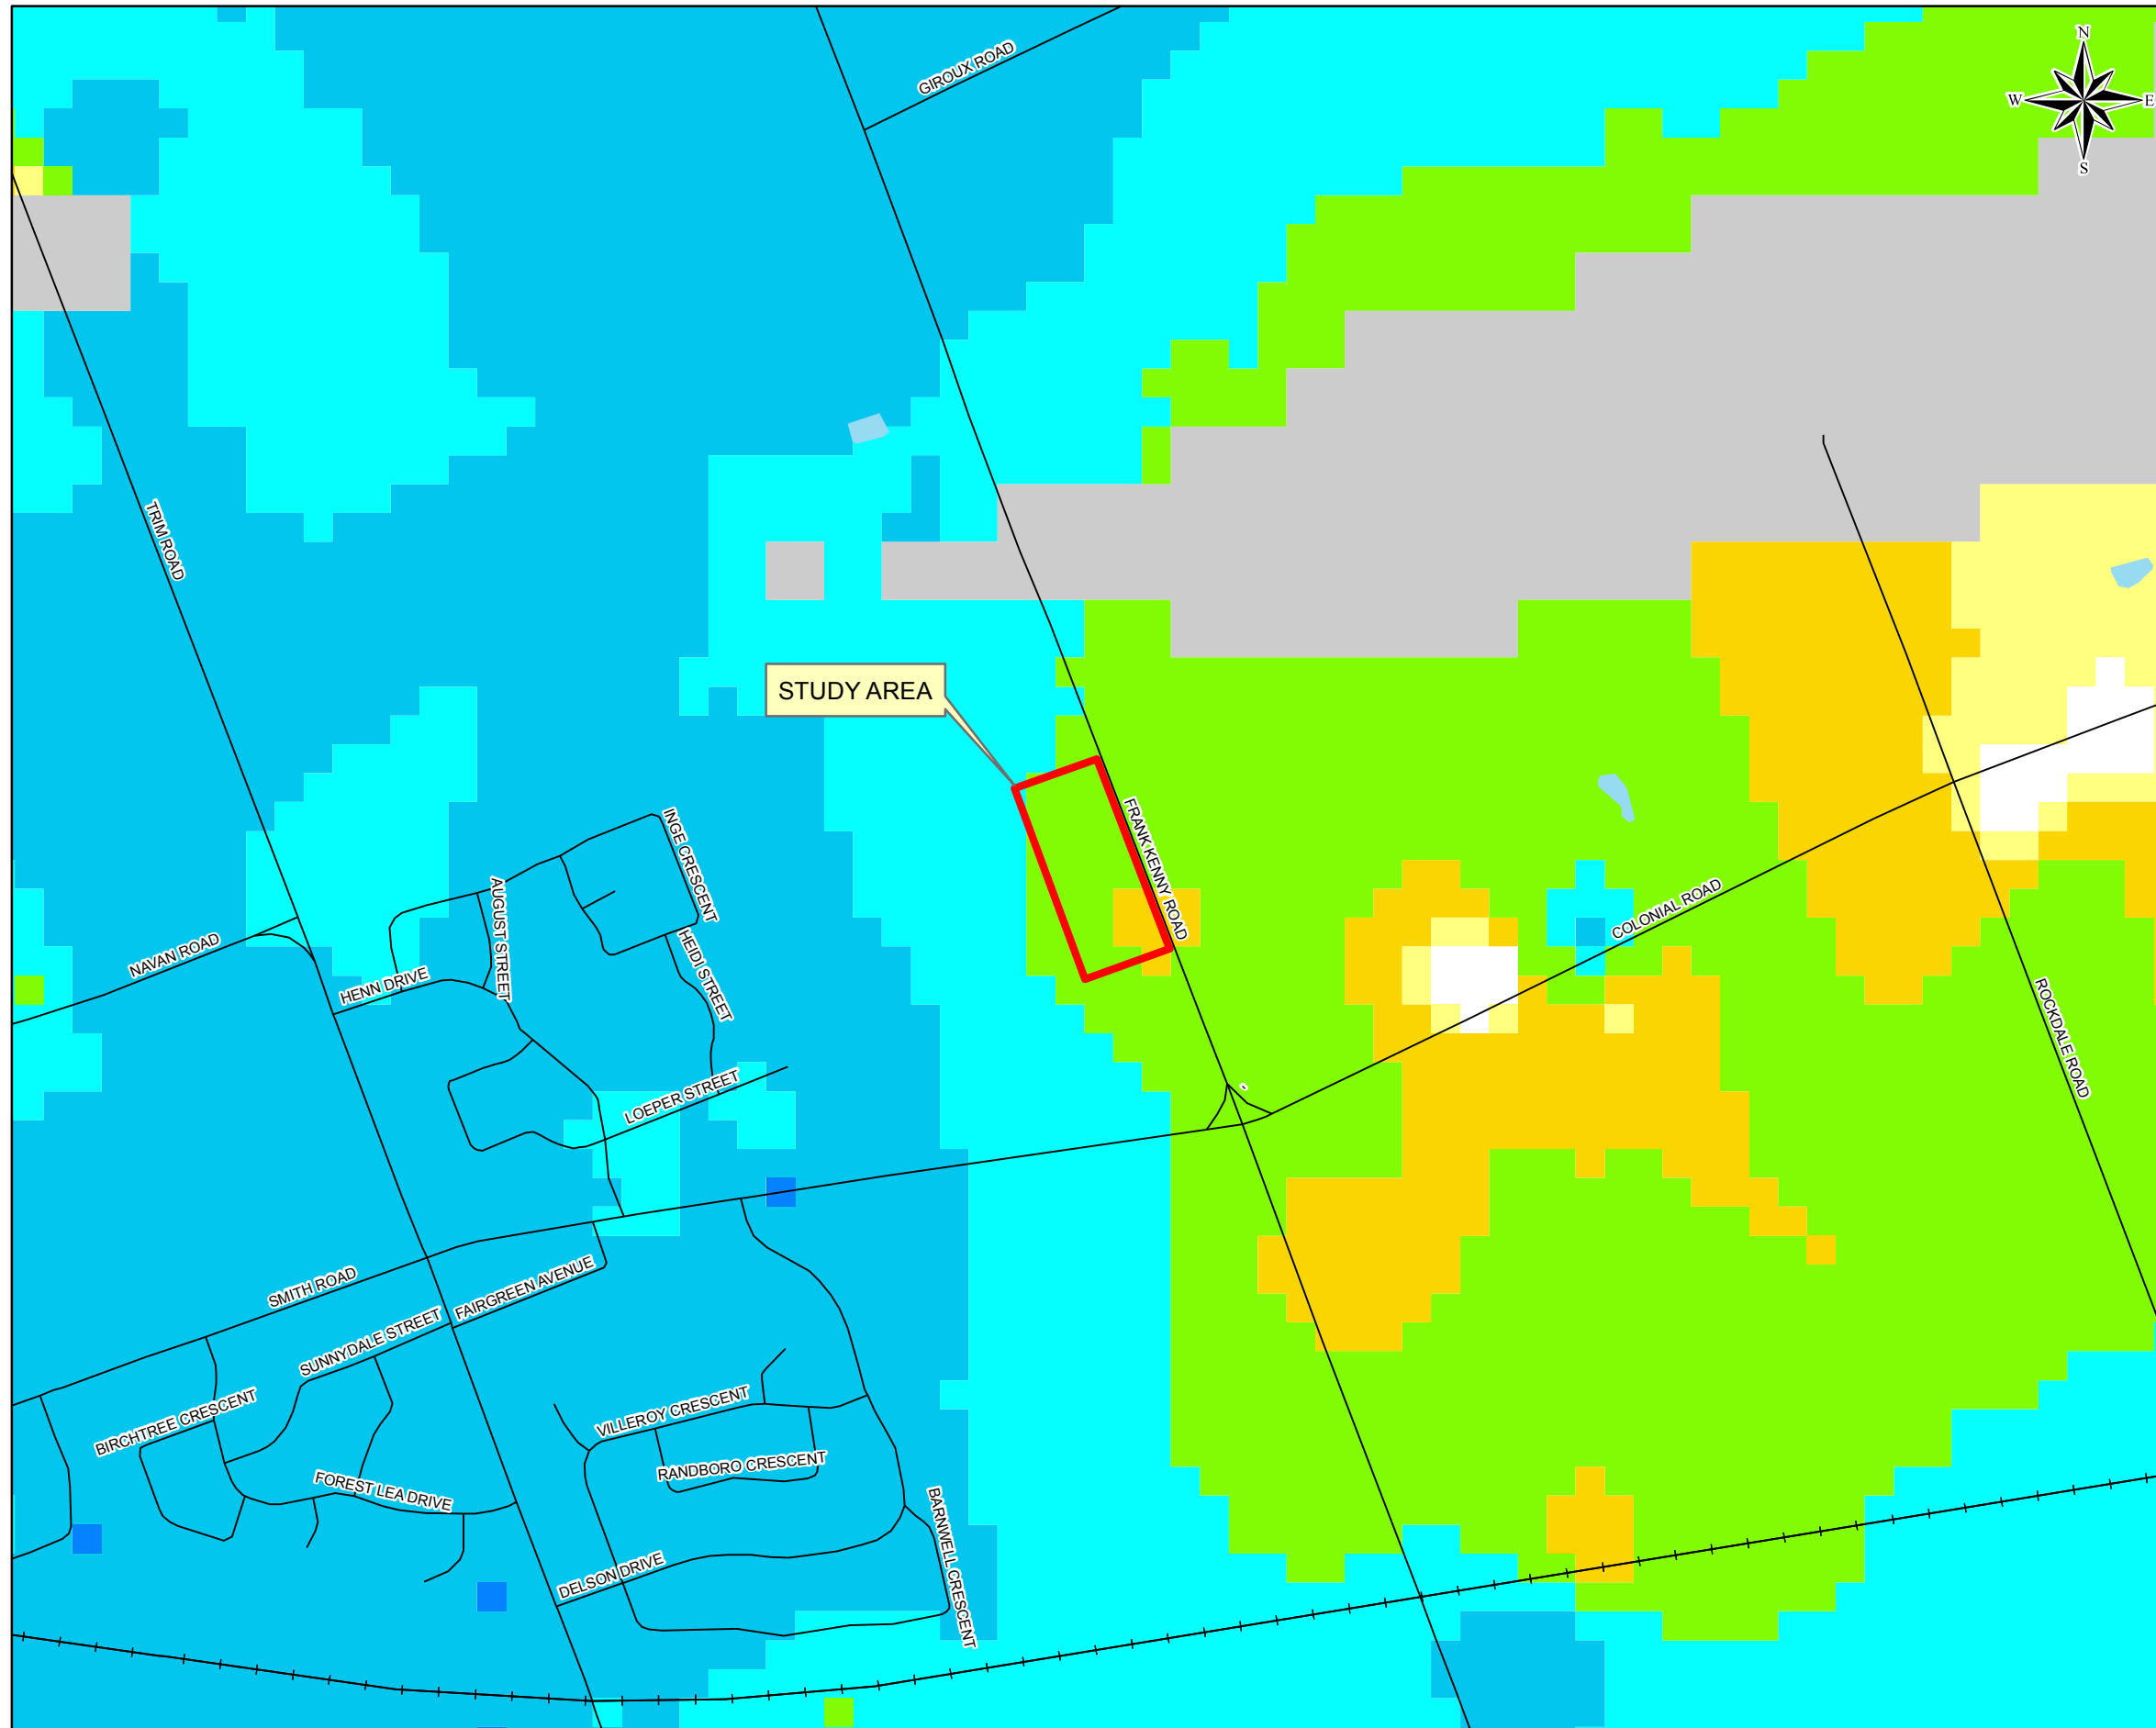
PROJECT			
TERRAIN ANALYSIS AND HYDROGEOLOGICAL STUDY 3406-3450 FRANK KENNY ROAD, OTTAWA, ONTARIO			
TITLE			
TREND IN DEPTH TO BEDROCK			
	PROJECT No. 11-1122-0129	SCALE AS SHOWN	REV. 0.0
DESIGN	CAMC	Nov. 2011	FIGURE 4
GIS	BJ	Nov. 2011	
CHECK	CAMC	Nov. 2011	
REVIEW	SRW	Nov. 2011

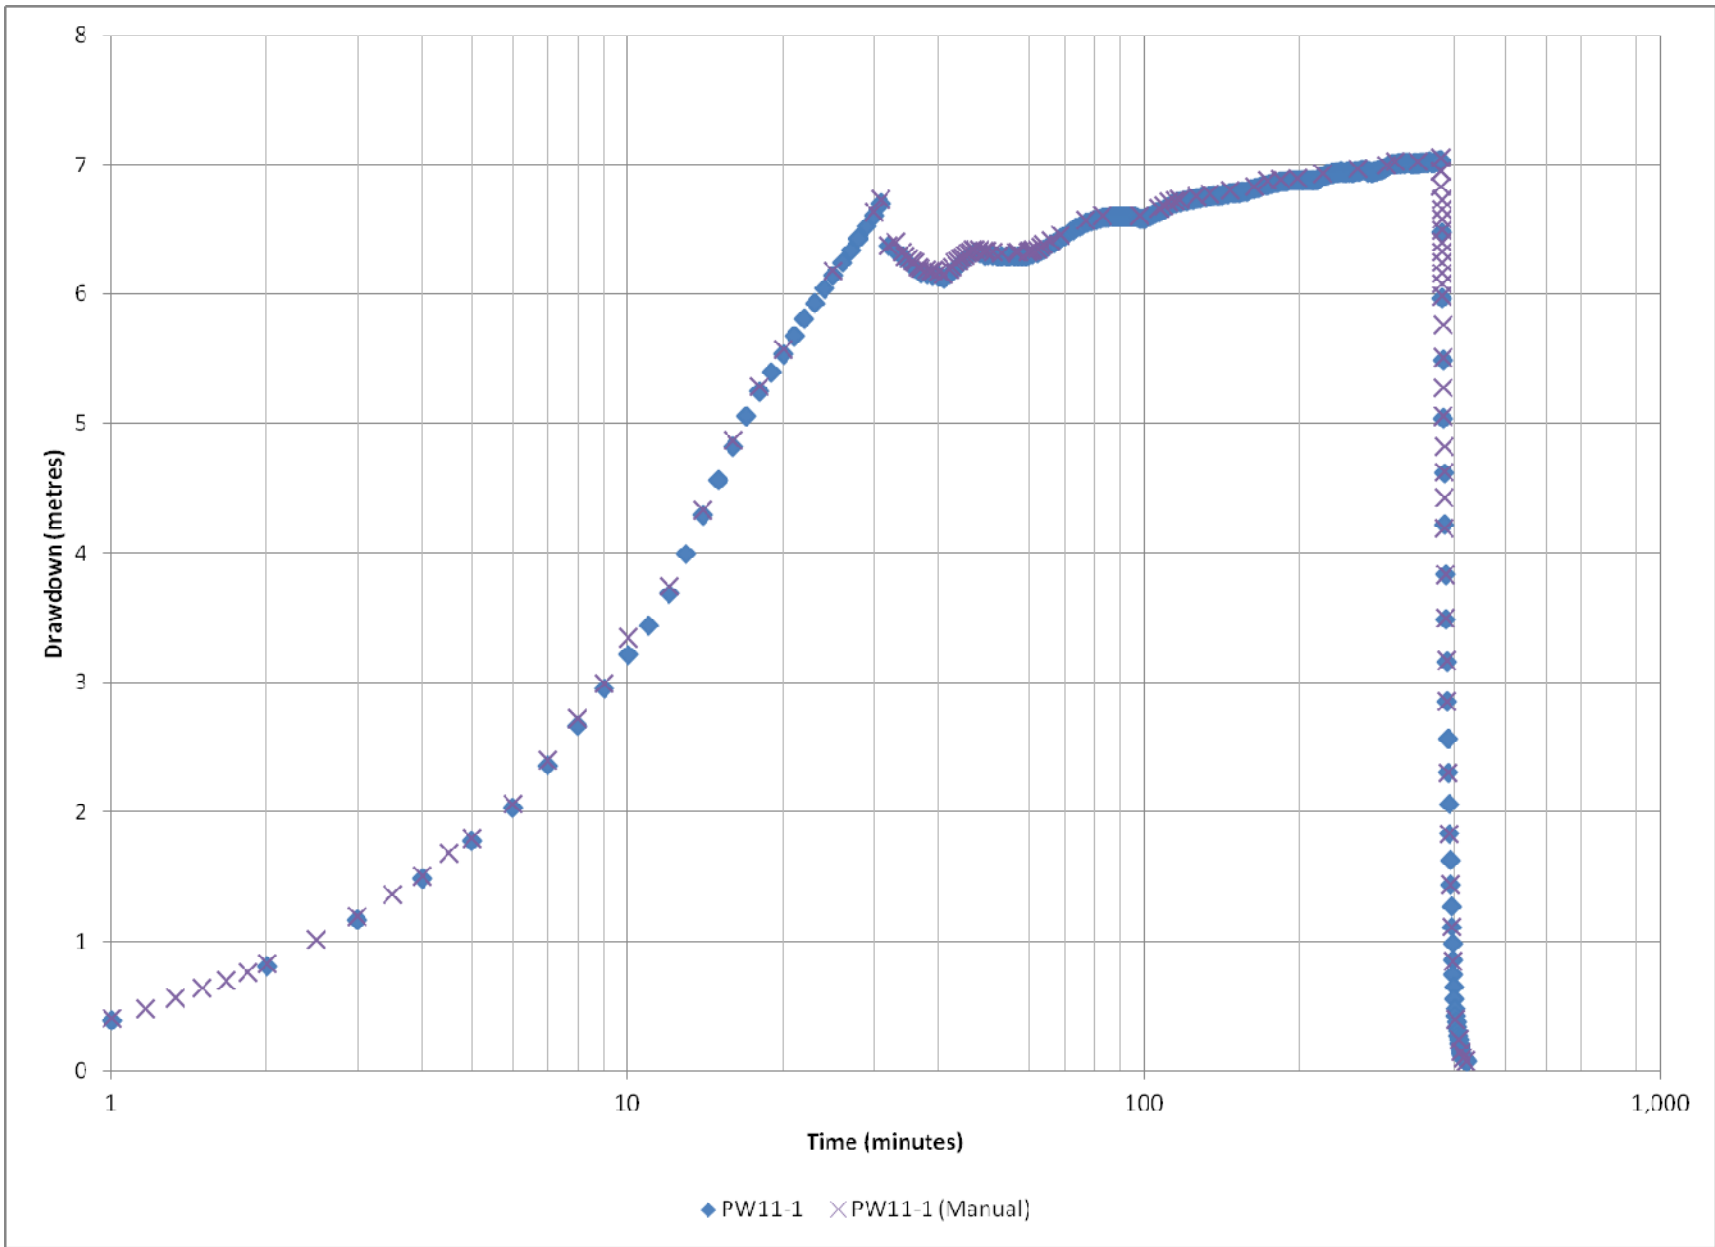
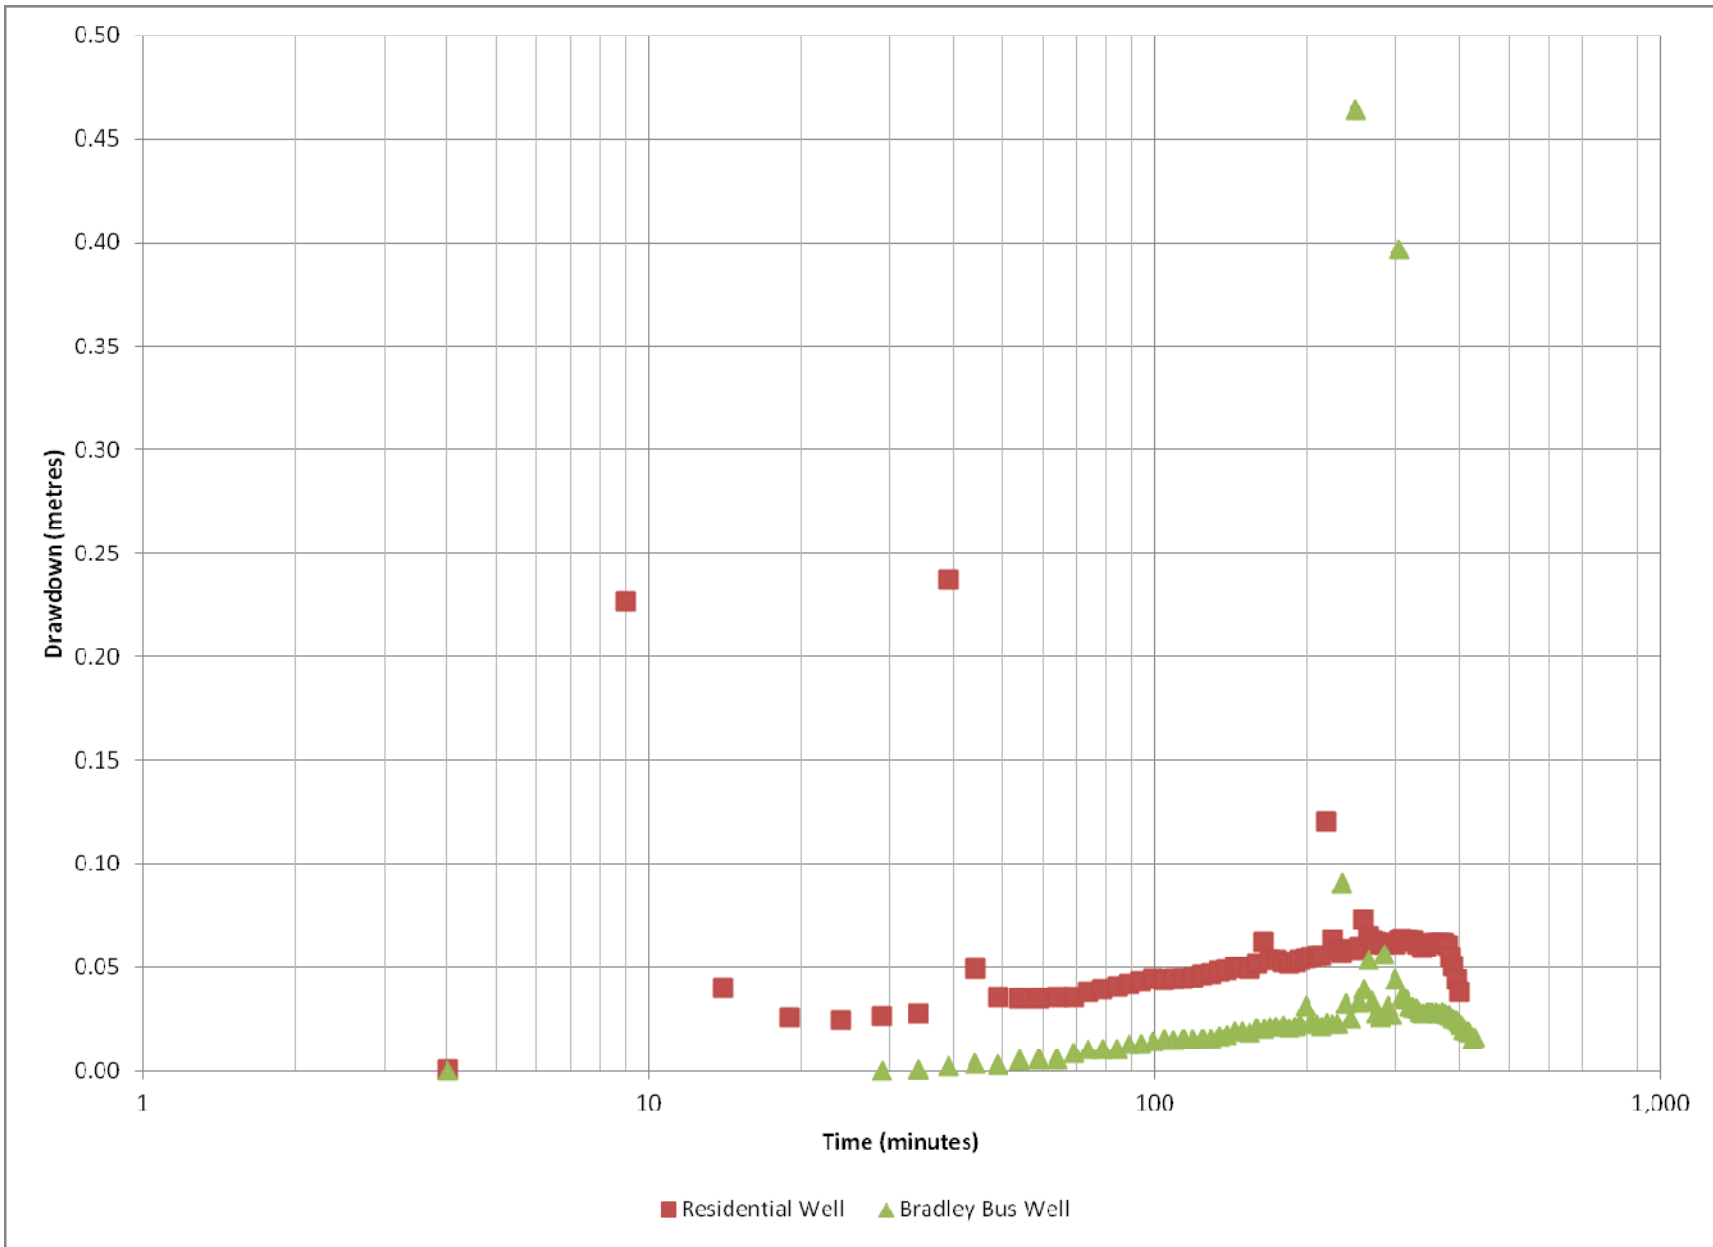
GROUNDWATER LEVEL DRAWDOWN
 BRADLEY BUS WELL AND RESIDENTIAL WELL

The drawdown observed at PW11-1 during the November 2011 pumping test is illustrated on Figure 6, and the drawdown observed at the observation wells is illustrated on Figure 7. The two observation wells were in use during the pumping test on PW11-1 and the abrupt changes in the amount of drawdown measured in these wells were attributed to coincidental pumping from these wells during the pumping test. The general downward trend in measured water levels in the observation wells were assumed to represent the response from pumping PW11-1.

The water level recovery in PW11-1 achieved 95% recovery approximately 26 minutes following the cessation of pumping. The drawdown in the observation wells was small relative to the precision of the pressure transducer loggers and the manual water level tape, and relative to the drawdown caused by coincidental water usage at these wells during the pumping test. As a result, it was difficult to calculate the percent recovery at these wells following the cessation of the pumping test. The residual drawdown measured at the residential well 23 minutes after the end of pumping was 0.04 metres, and at the Bradley Bus well 53 minutes after the end of pumping was 0.02 metres.

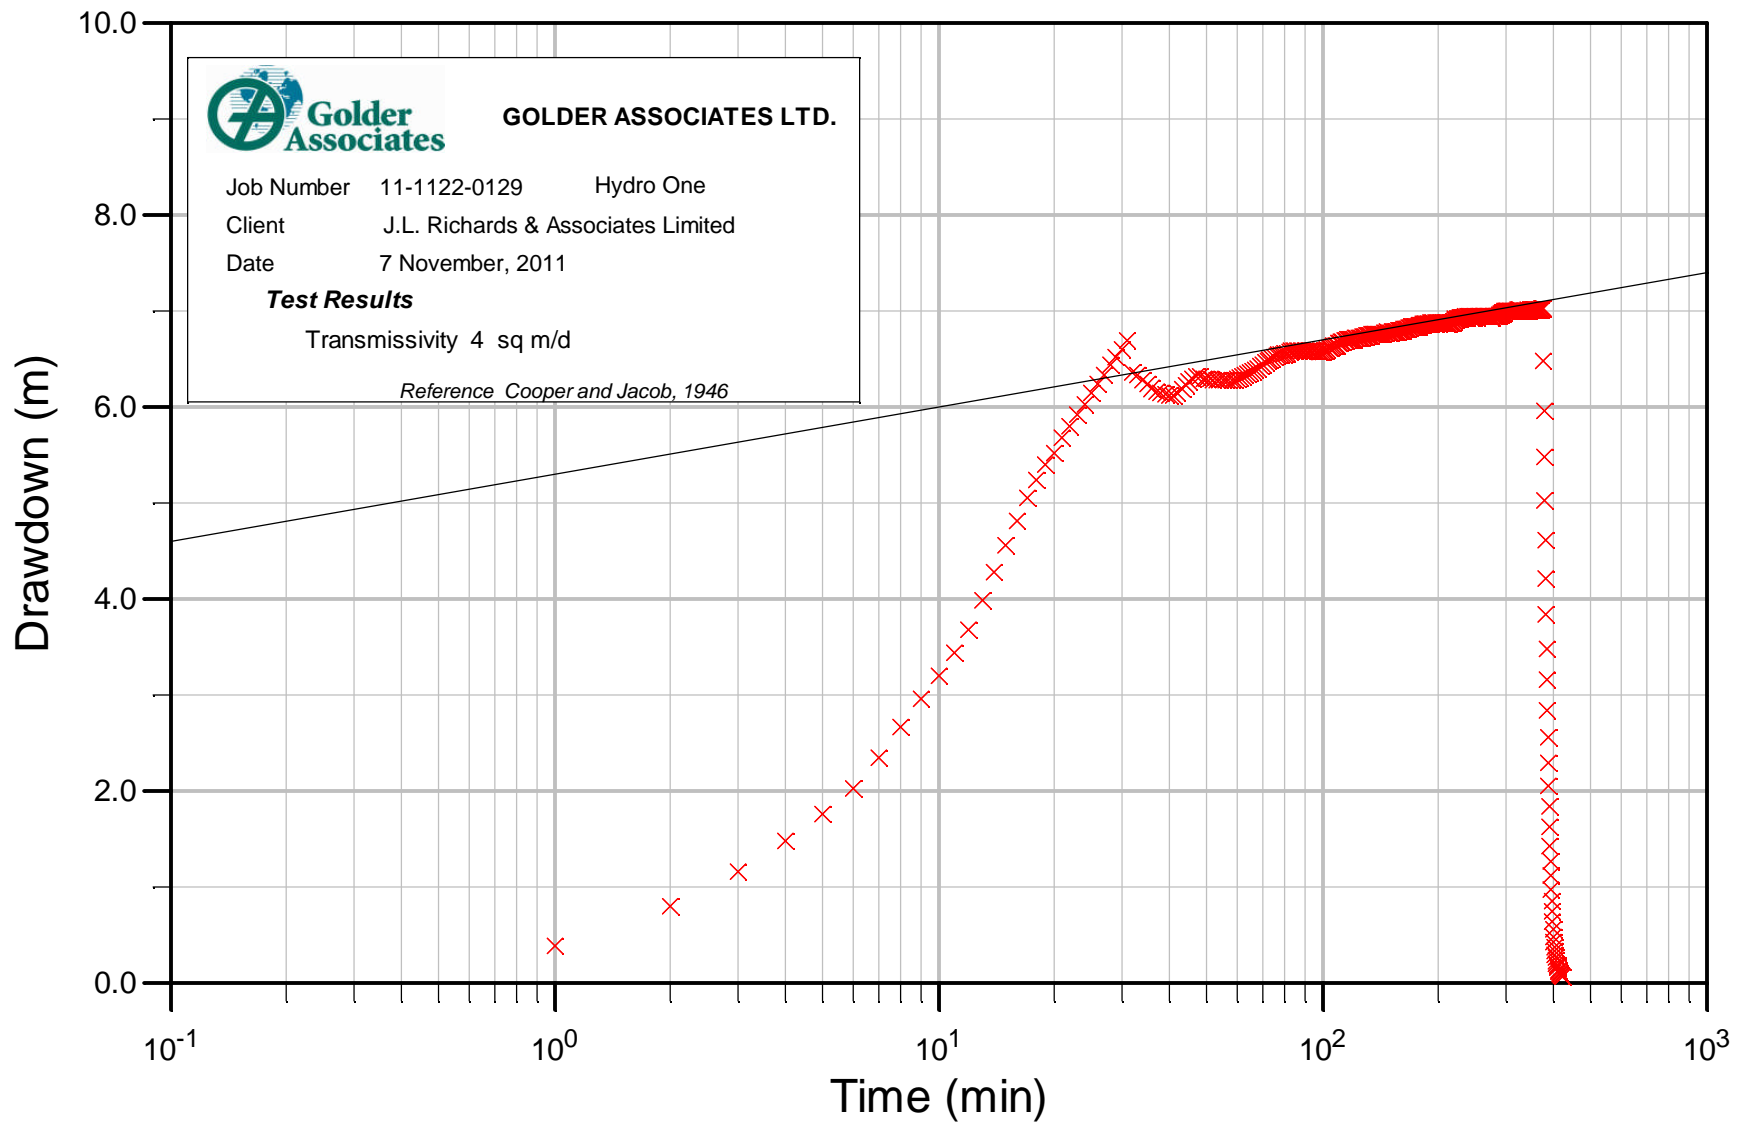
PW11-1 Cooper and Jacob

A pumping test of approximately 360 minutes in duration was conducted on PW11-1 from approximately 9:30 am until 4 pm on November 7, 2011. The well was pumped at a rate of approximately 15.1 L/min (4 US GPM) for the first 32 minutes of the test, after which the rate was reduced to approximately 9.5 L/min (2.5 US GPM) due to the large amount of drawdown observed in the pumping well. At the 40-minute mark, the rate was increased to 10.2 L/min (2.7 US GPM) and at 66 minutes, increased again to 11.3 L/min (3 US GPM) for the remainder of the test. The pumping rates used in the test are summarized in the following table.
