## Geotechnical Investigation

Geotechnical Investigation  
Proposed Riverside South Catholic Elementary School  
Brian Good Avenue and Solarium Avenue,  
Ottawa, Ontario

OTT-22012013-A0

September 21, 2022

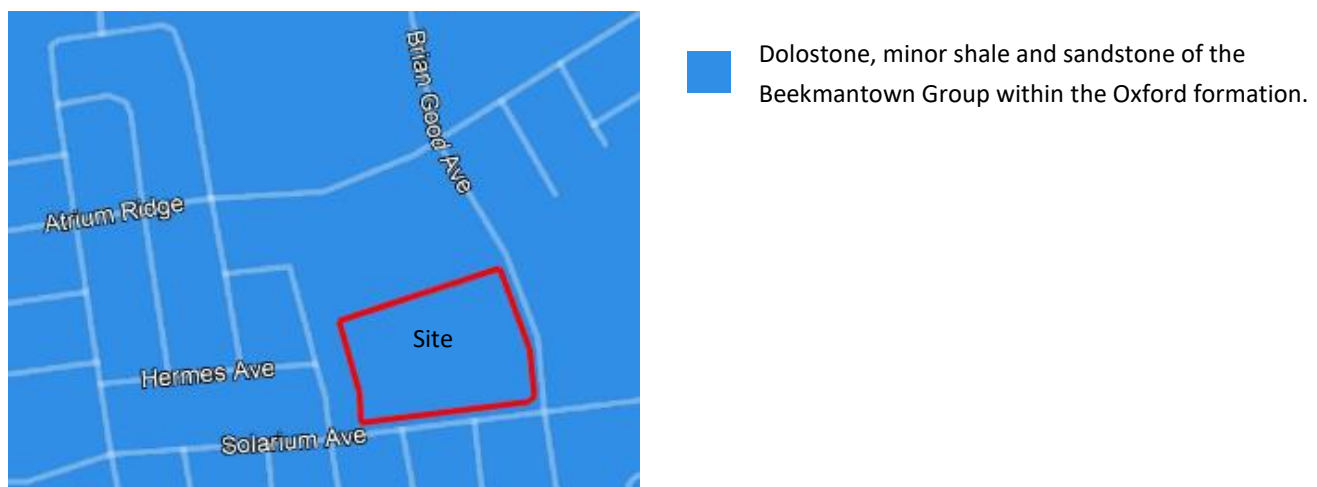
Image 2 – Bedrock Geology

The bedrock geology map (Map 1508A – Generalized Bedrock Geology, Ottawa-Hull, Ontario and Quebec, Geological Survey of Canada, printed by the Surveys and Mapping Branch, 1979) indicates the site is underlain by sandstone, dolostone or minor shale of the Beekmantown Group within the Oxford formation. The bedrock geology is show in Image 2 below.

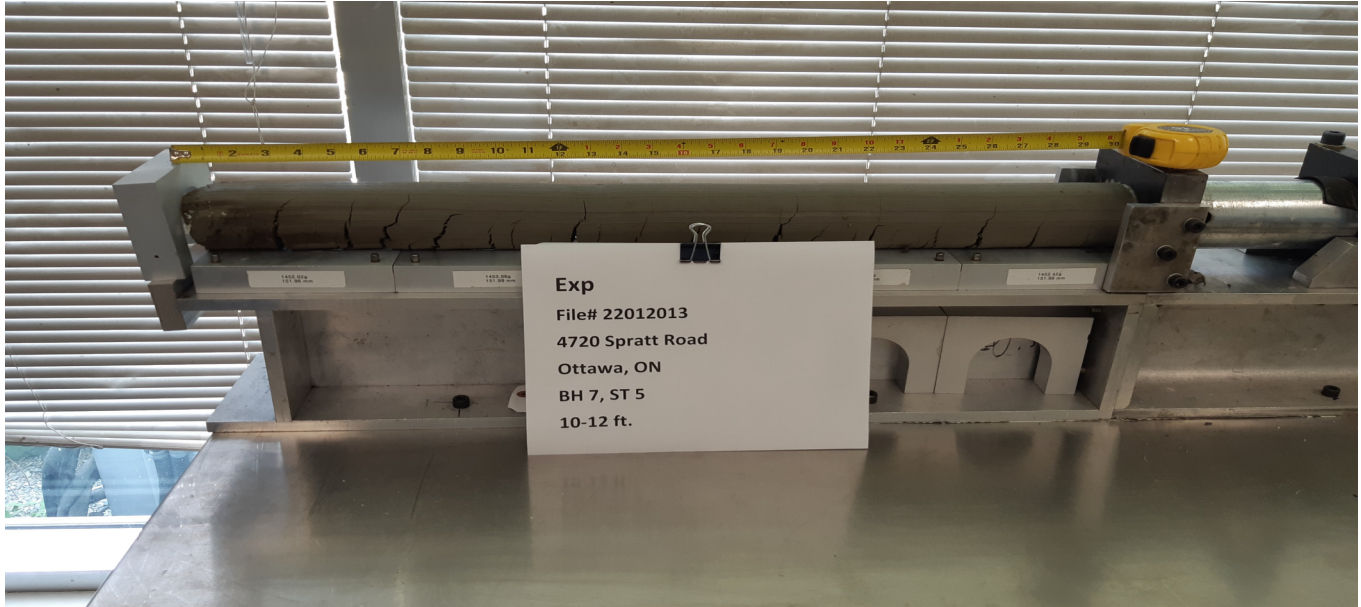
1

Borehole: BH7 ST5

Depth: 10 – 12 ft
