**HYDROGEOLOGICAL
STUDY
PROPOSED COACH HOUSE
3674 YORK'S CORNERS ROAD
OSGOODE WARD
CITY OF OTTAWA, ONTARIO**

220471

RE: HYDROGEOLOGICAL AND TERRAIN STUDY
PROPOSED COACH HOUSE
3674 YORK'S CORNERS ROAD
OSGOODE WARD
CITY OF OTTAWA, ONTARIO

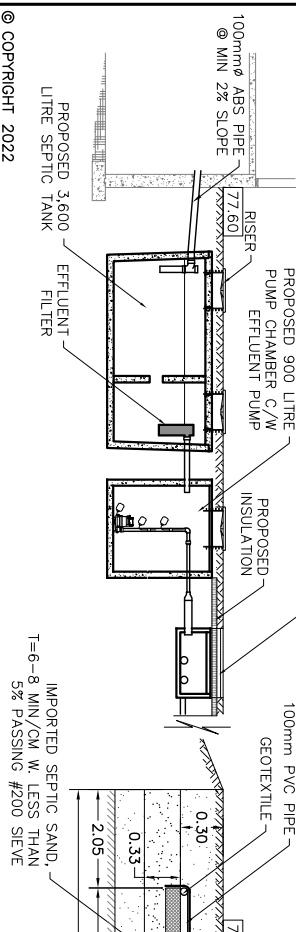
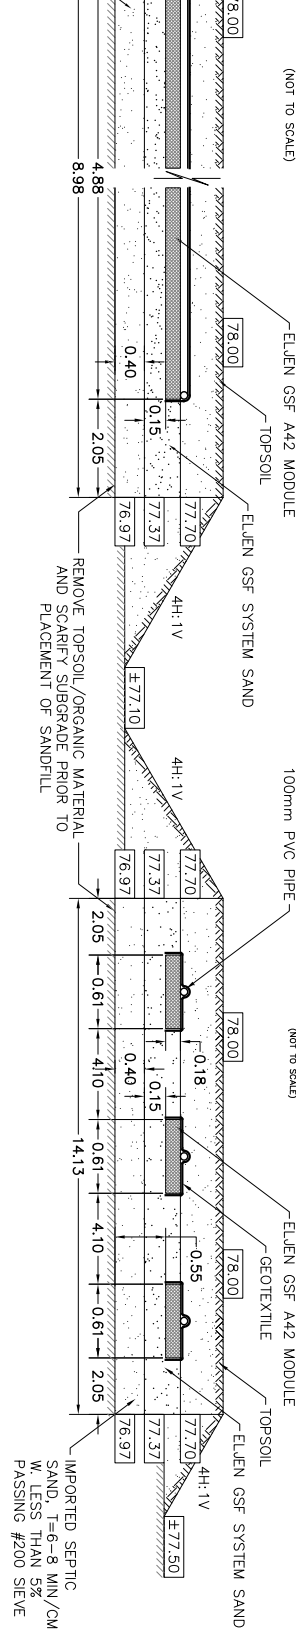
DRAWING NUMBER: 220471-SD

SEWAGE DESIGN PLAN

- * REMOVE ORGANIC MATERIAL AND SCARIFY SUBGRADE PRIOR TO PLACEMENT OF SEPTIC SAND
- * INSTALL ELJEN SYSTEM AS PER MANUFACTURER SPECIFICATIONS AND INSTALLATION MANUAL
- * PUMPING SYSTEM TO BE EQUIPPED WITH AUDIO AND VISUAL ALARMS
- * PUMPS TO BE HARDWIRED, NO PLUGS

SECTION A-A (NOT TO SCALE)

SECTION B-B (NOT TO SCALE)

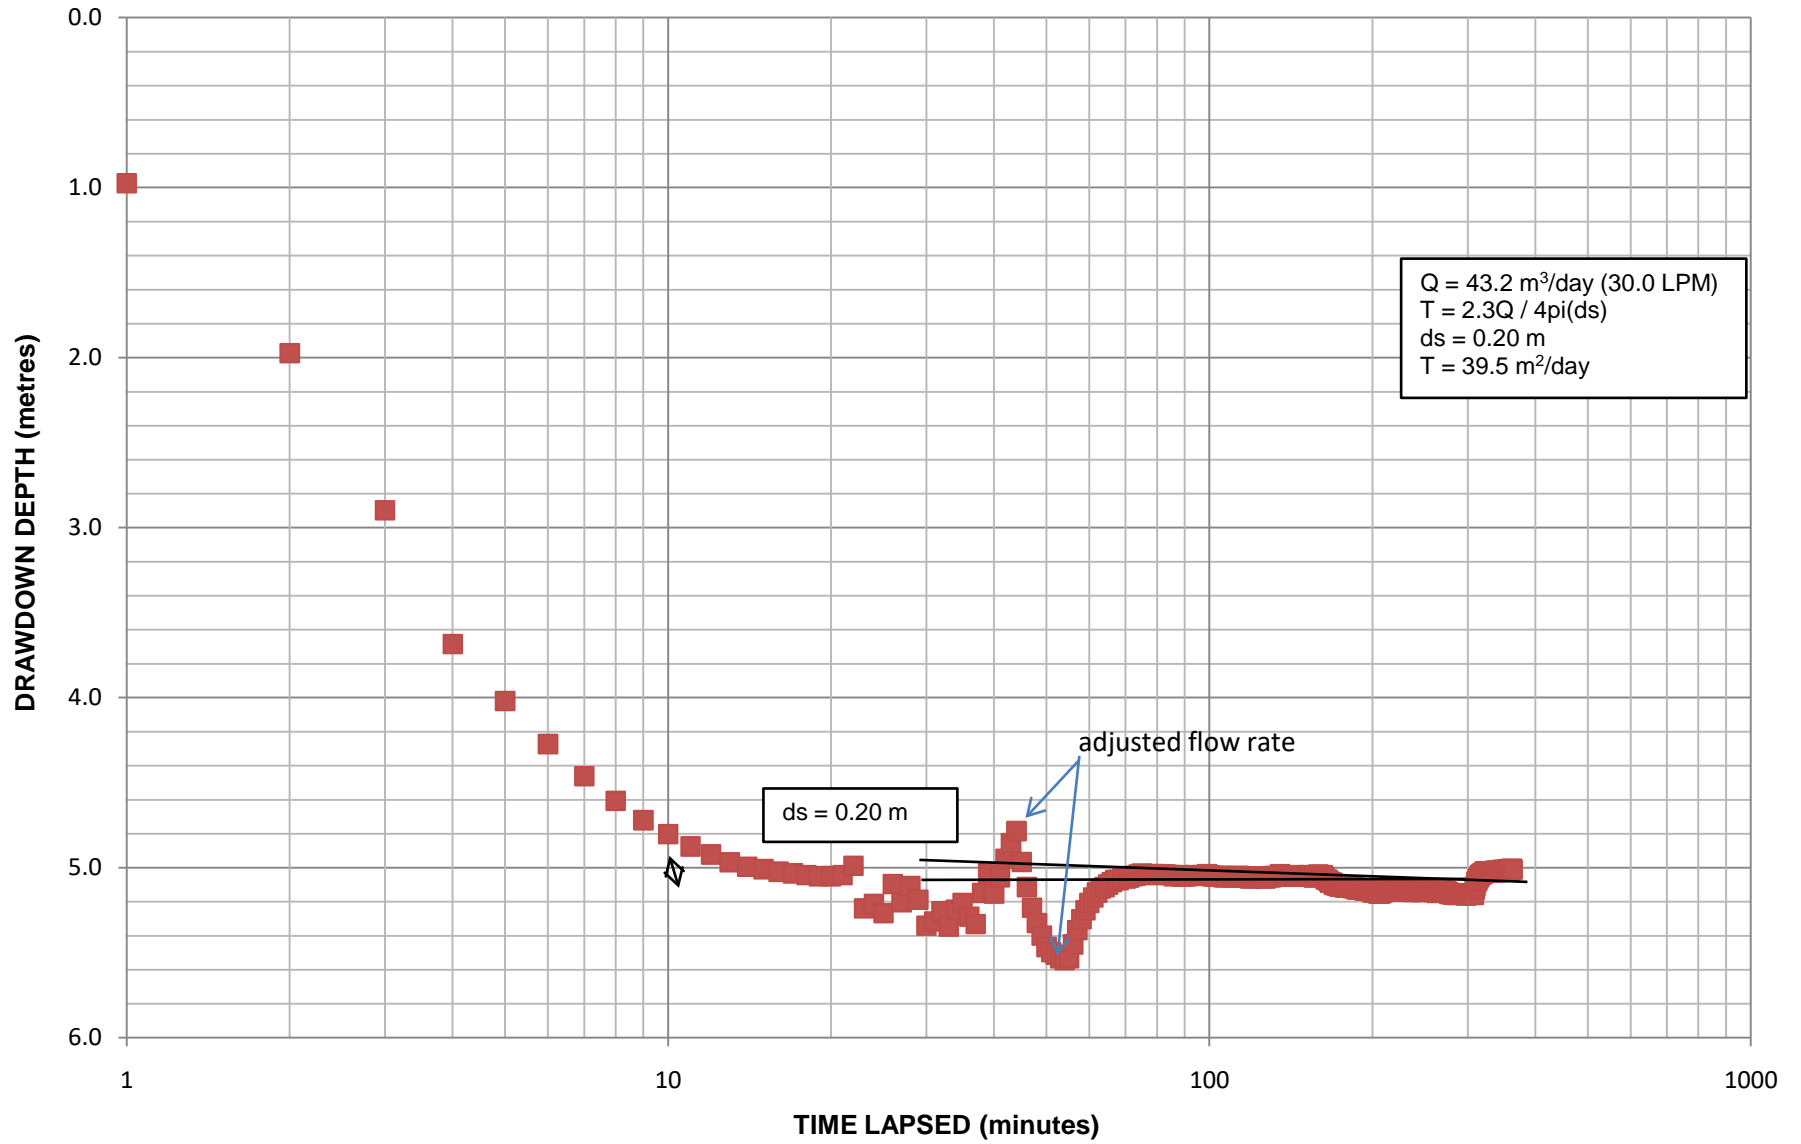
TW1-WELL DRAWDOWN VS. TIME-KOLLAARD FILE 220471

The well was pumped for about 360 minutes at a pumping rate of about 30.0 litres per minute. Over the course of the pumping test, the water level in the well dropped some 4.85 metres. At the end of pumping, 93% recovery of the total drawdown in the static water level created during pumping was measured after about 50 minutes. The subsequent day, a final water level reading was obtained

DRAWDOWN DATA TW1

The pumping test drawdown and recovery data and plots for TW1 are provided as Attachment C. The drawdown and recovery data provided were measured with reference to the top of the well casing at the test well location.

The pumping test data for the test well was analyzed using the method of Cooper and Jacob (1946). Although the assumptions on which these equations are based are not strictly met, this method provides a reasonable estimate of the aquifer transmissivity.

Based on the pumping test drawdown and recovery data, the transmissivity of the aquifer is estimated to be between about 39.5 and 22.6 m²/day, respectively.

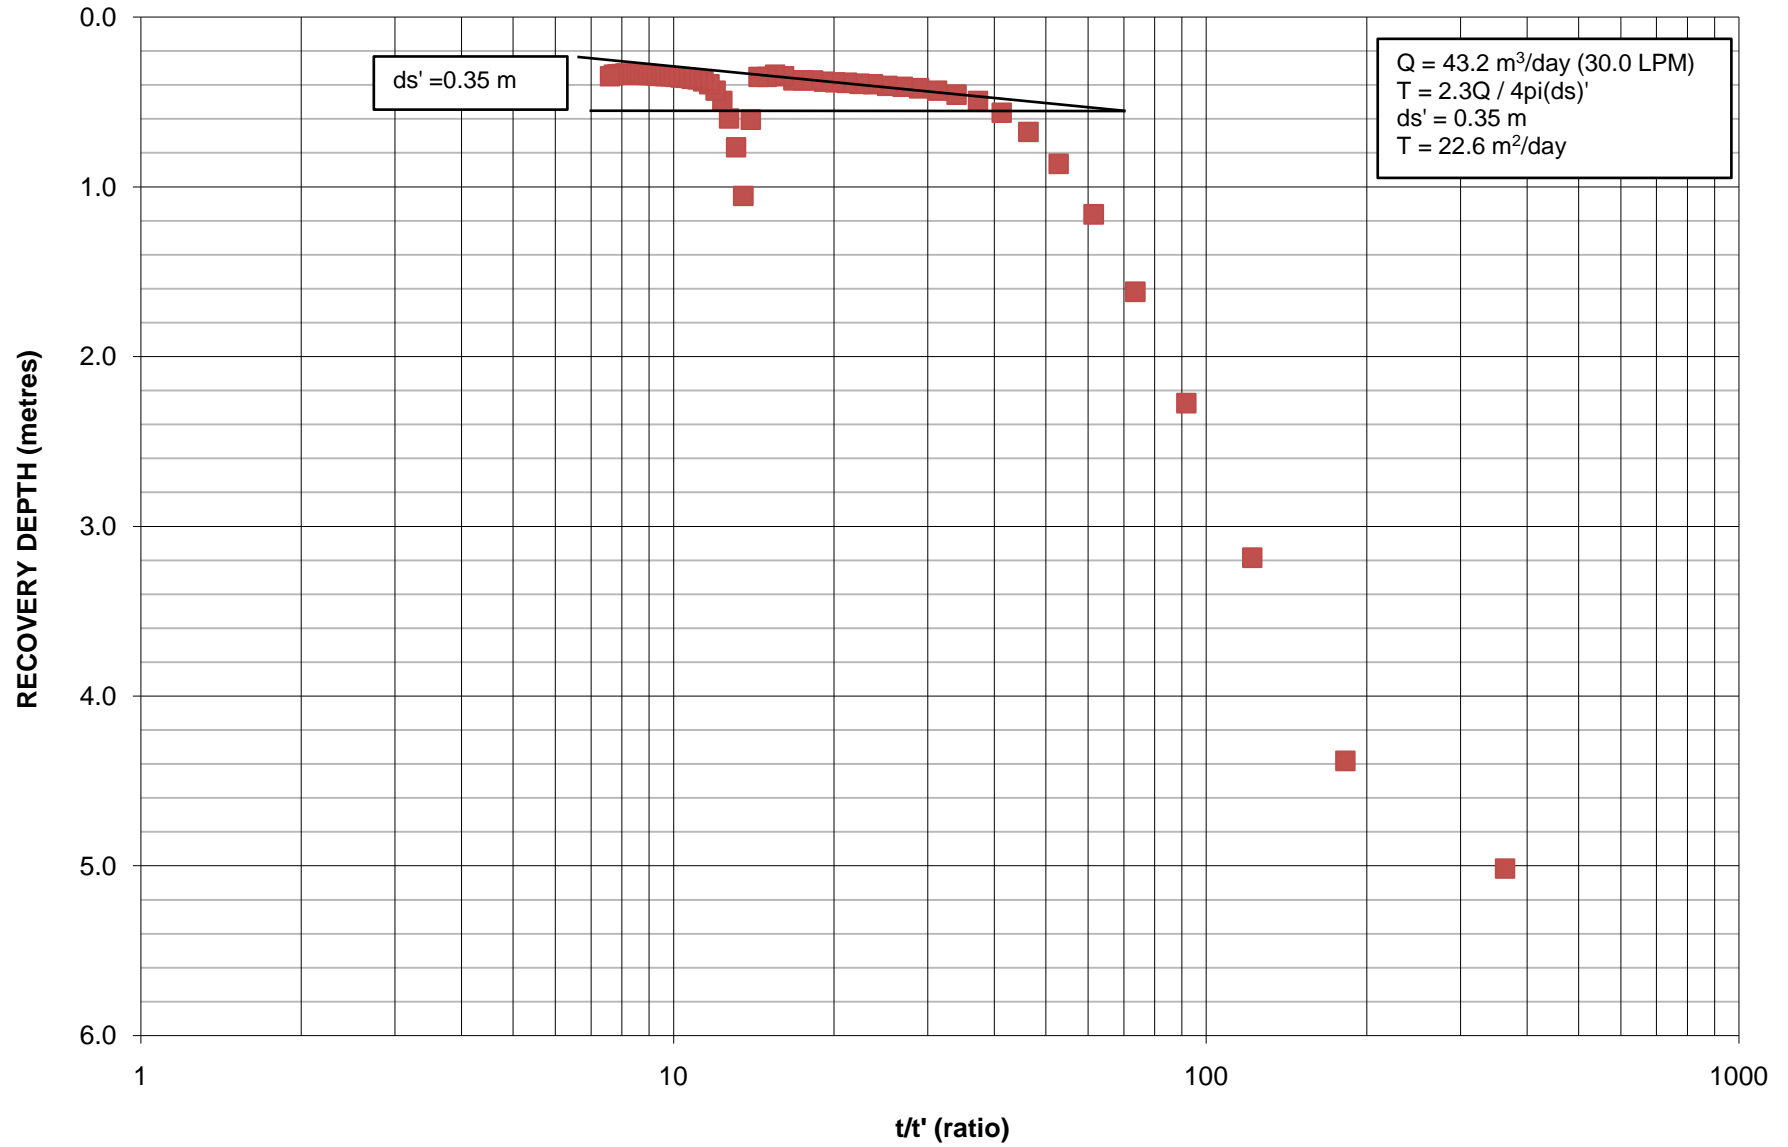
TW1- WELL RECOVERY VS. TIME - KOLLAARD FILE 220471

manually after some 26 hours and 45 minutes. At that time, the water level recovery was some 96%.

RECOVERY DATA TW-1
