# Preliminary Geotechnical Investigation

Children's Hospital of Eastern Ontario Campus  
401 & 407 Smyth Road  
Ottawa, Ontario

Infrastructure Ontario

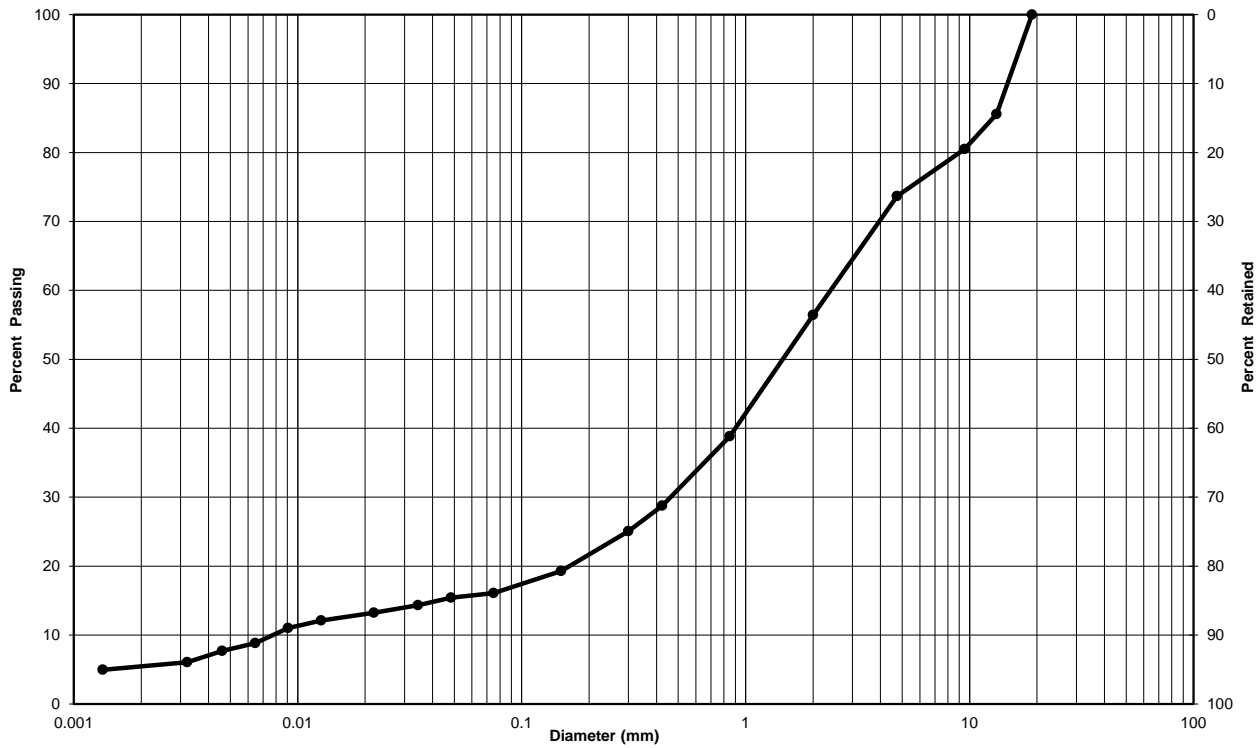
Soil Description	Gravel (%)	Sand (%)	Clay & Silt (%)
Silty Sand with Gravel, Trace Clay	26	58	16

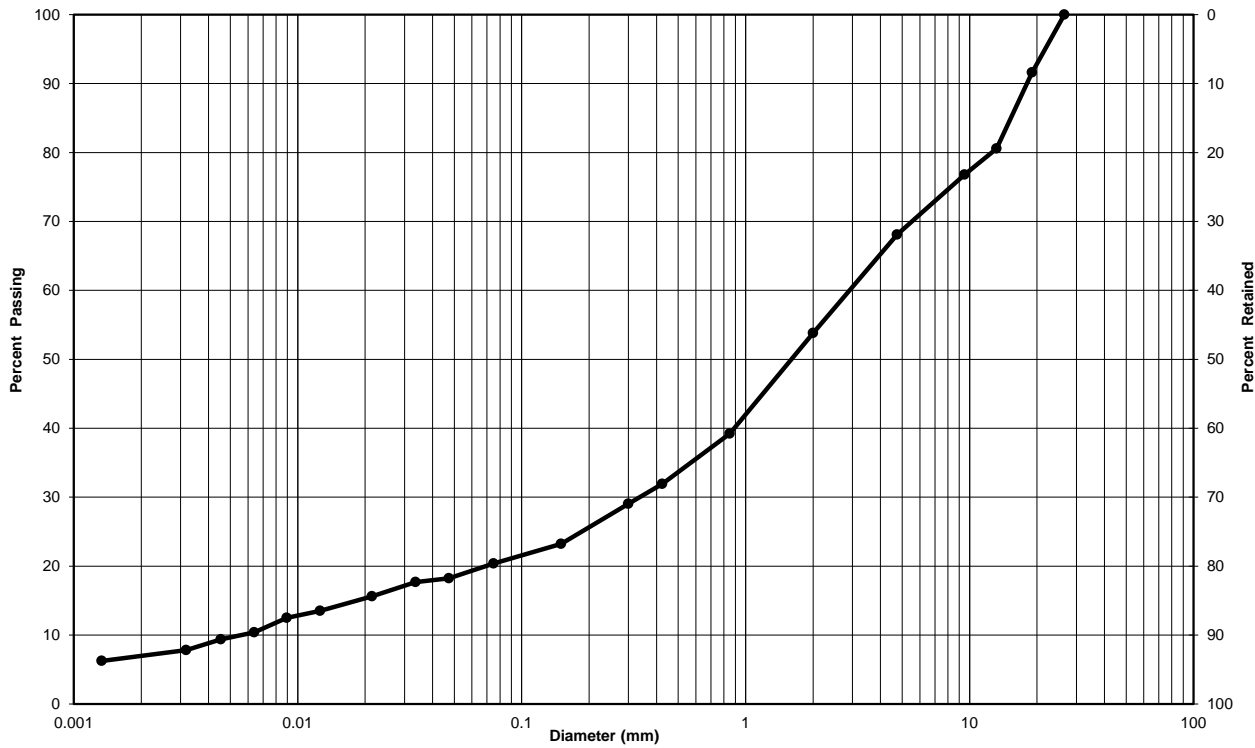
Soil Description	Gravel (%)	Sand (%)	Clay & Silt (%)
Silty Sand with Gravel, Trace Clay	32	48	20

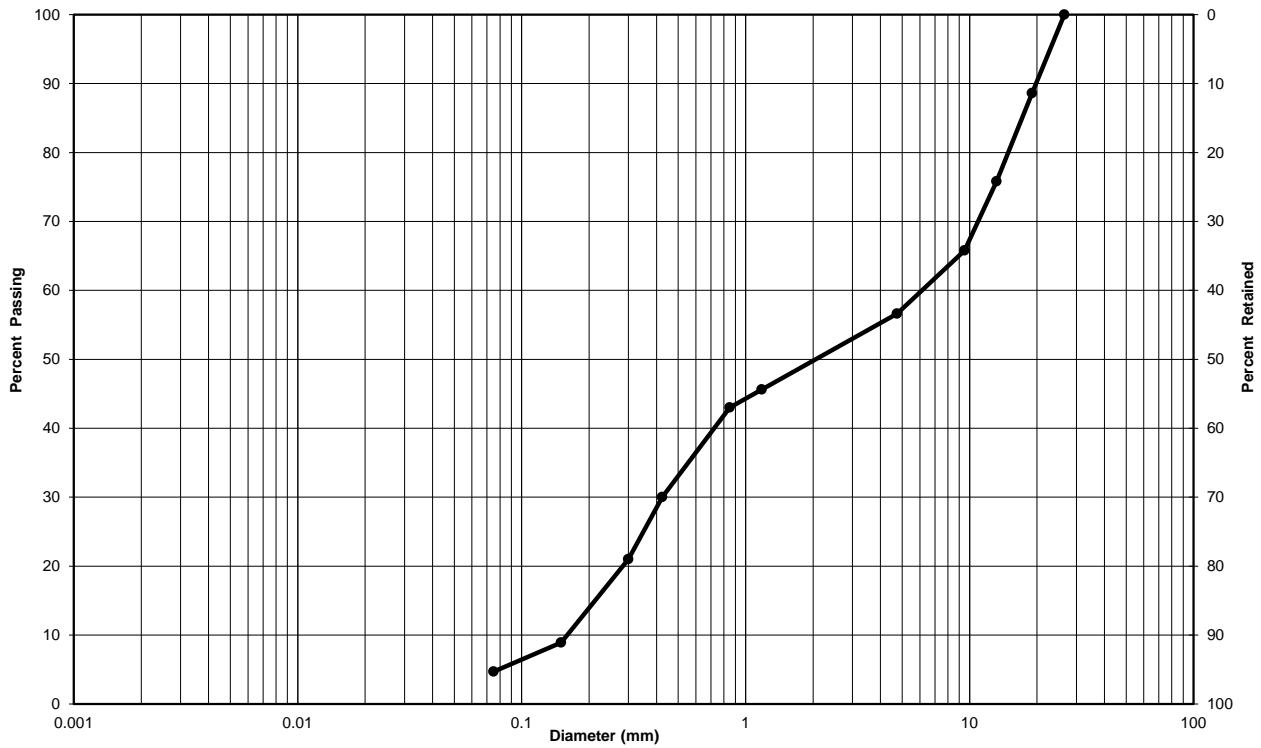
Soil Description	Gravel (%)	Sand (%)	Clay & Silt (%)
Sand with Gravel and Silt	43	52	5

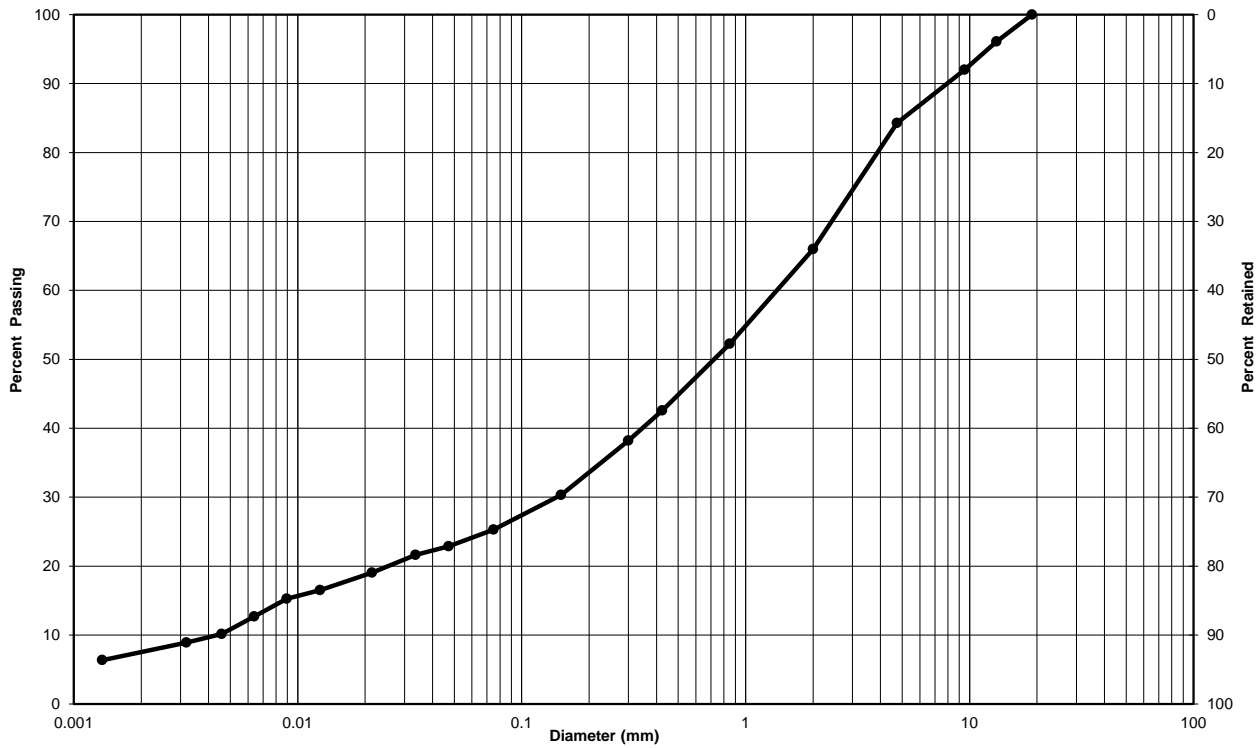
Soil Description	Gravel (%)	Sand (%)	Clay & Silt (%)
Silty Sand with Gravel, Trace Clay	16	59	25

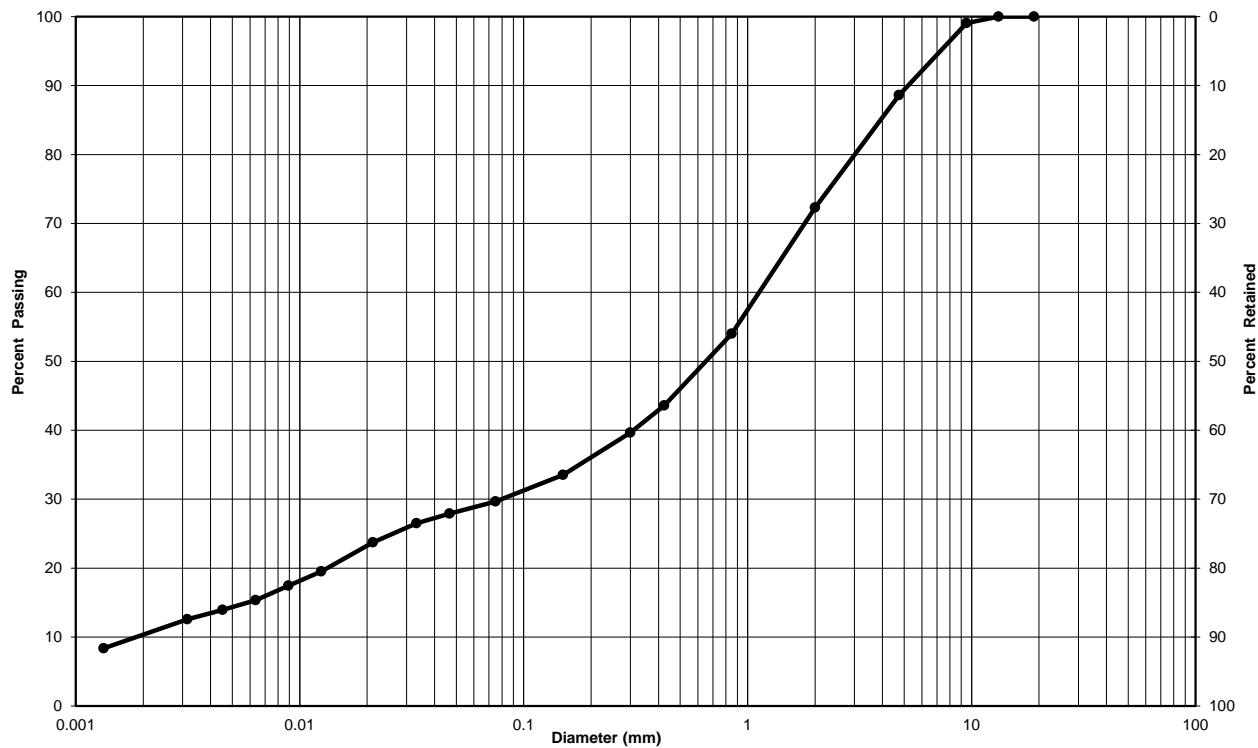
Soil Description	Gravel (%)	Sand (%)	Clay & Silt (%)
Silty Sand, Some Gravel, Trace Clay	11	59	30

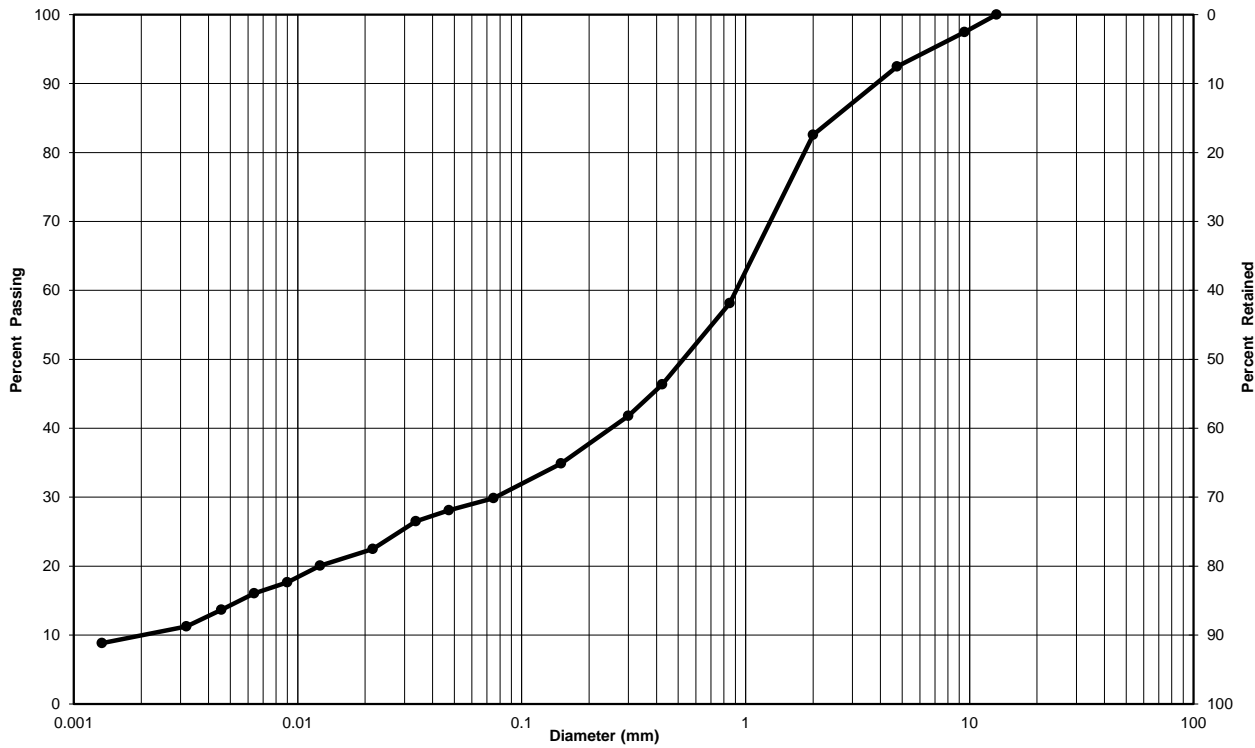
Soil Description	Gravel (%)	Sand (%)	Clay & Silt (%)
Silty Sand, Trace Gravel, Trace Clay	8	62	30

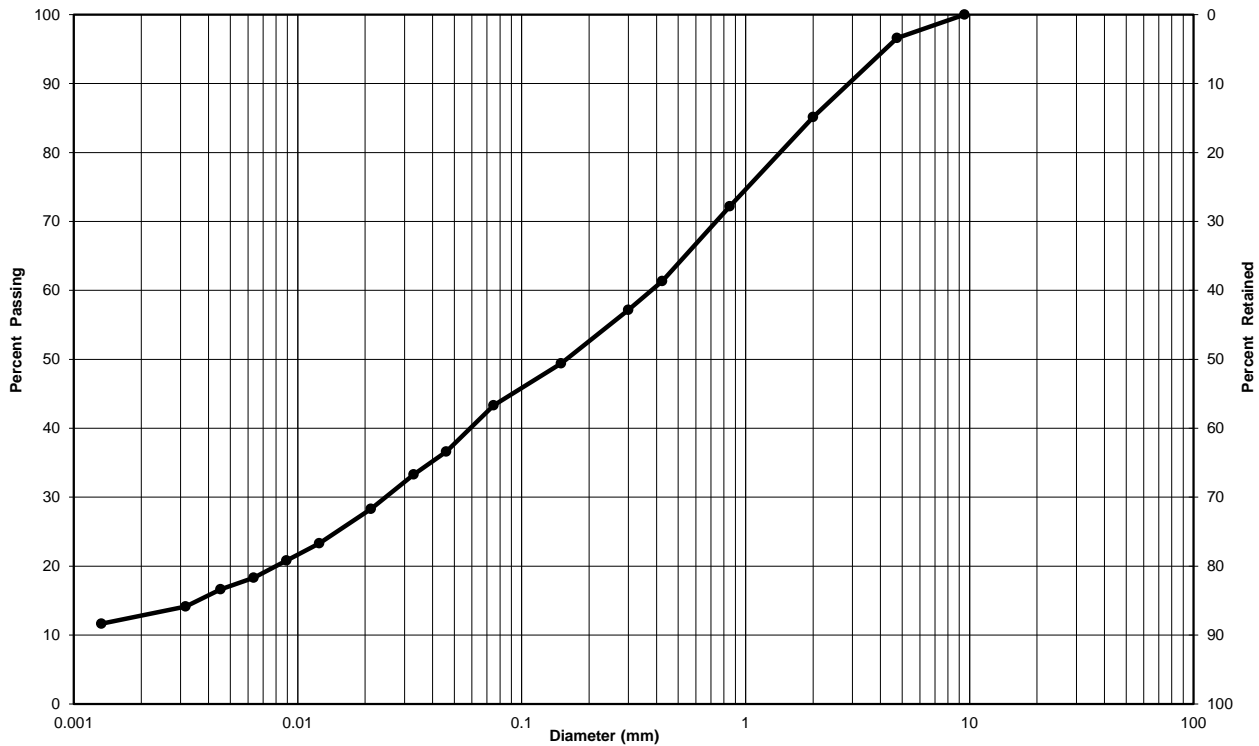
Borehole No.: MW7 Sample No.: SS2  
 Depth: 0.8m - 1.4m Enclosure: \_\_\_\_\_

Soil Description	Gravel (%)	Sand (%)	Clay & Silt (%)
Silty Sand, Some Clay , Trace Gravel	3	54	43

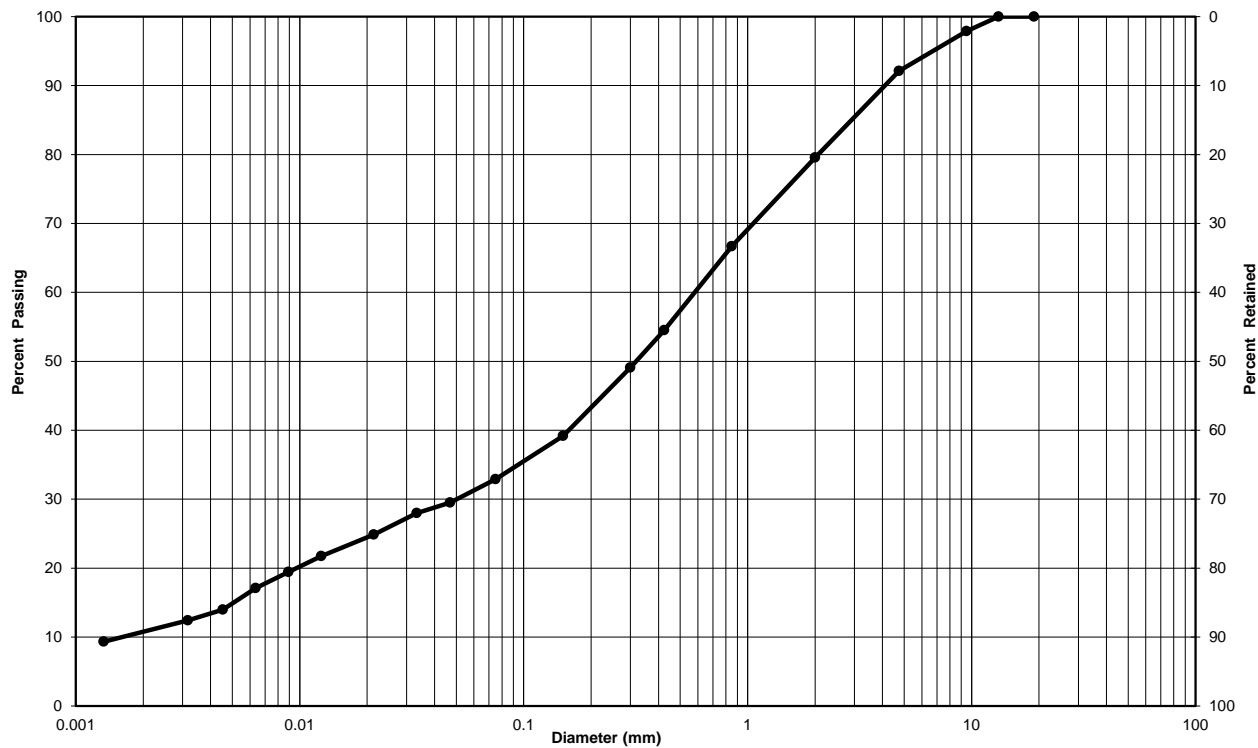
Soil Description	Gravel (%)	Sand (%)	Clay & Silt (%)
Silty Sand, Some Clay , Trace Gravel	8	59	33

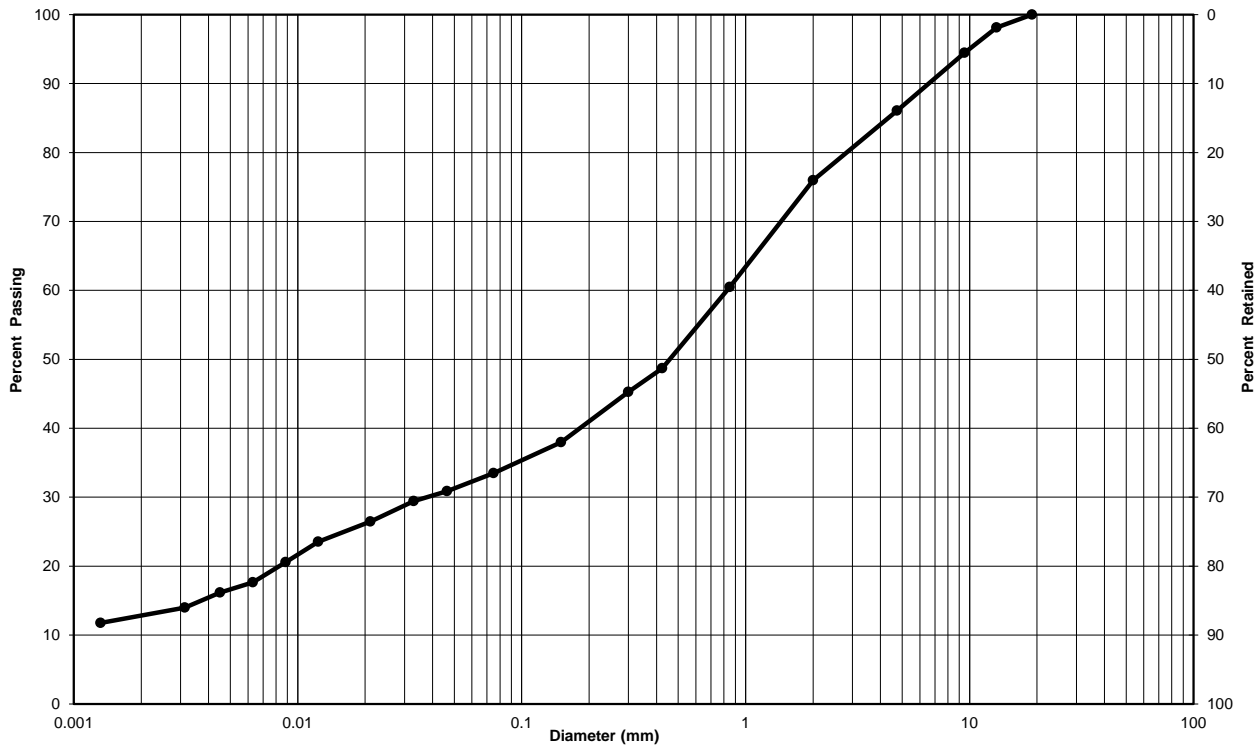
Soil Description	Gravel (%)	Sand (%)	Clay & Silt (%)
Silty Sand, Some Gravel, Some Clay	14	53	33

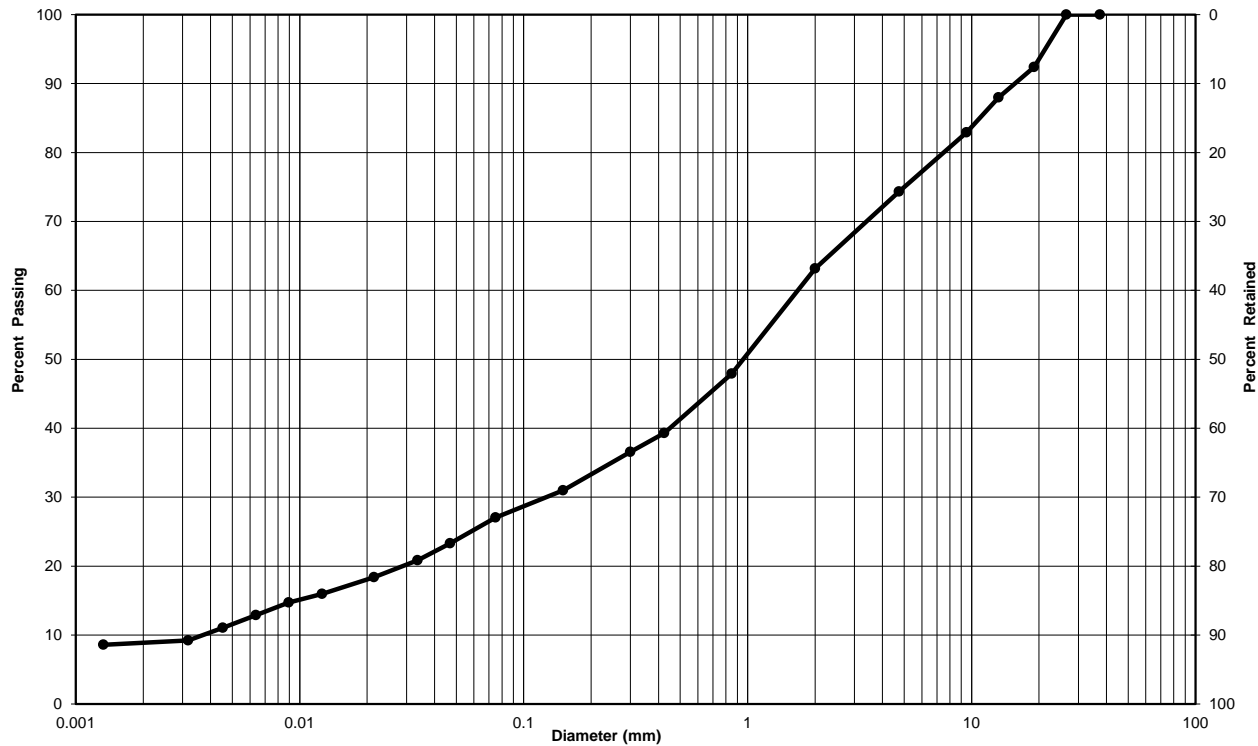
Soil Description	Gravel (%)	Sand (%)	Clay & Silt (%)
Silty Sand with Gravel, Trace Clay	26	47	27

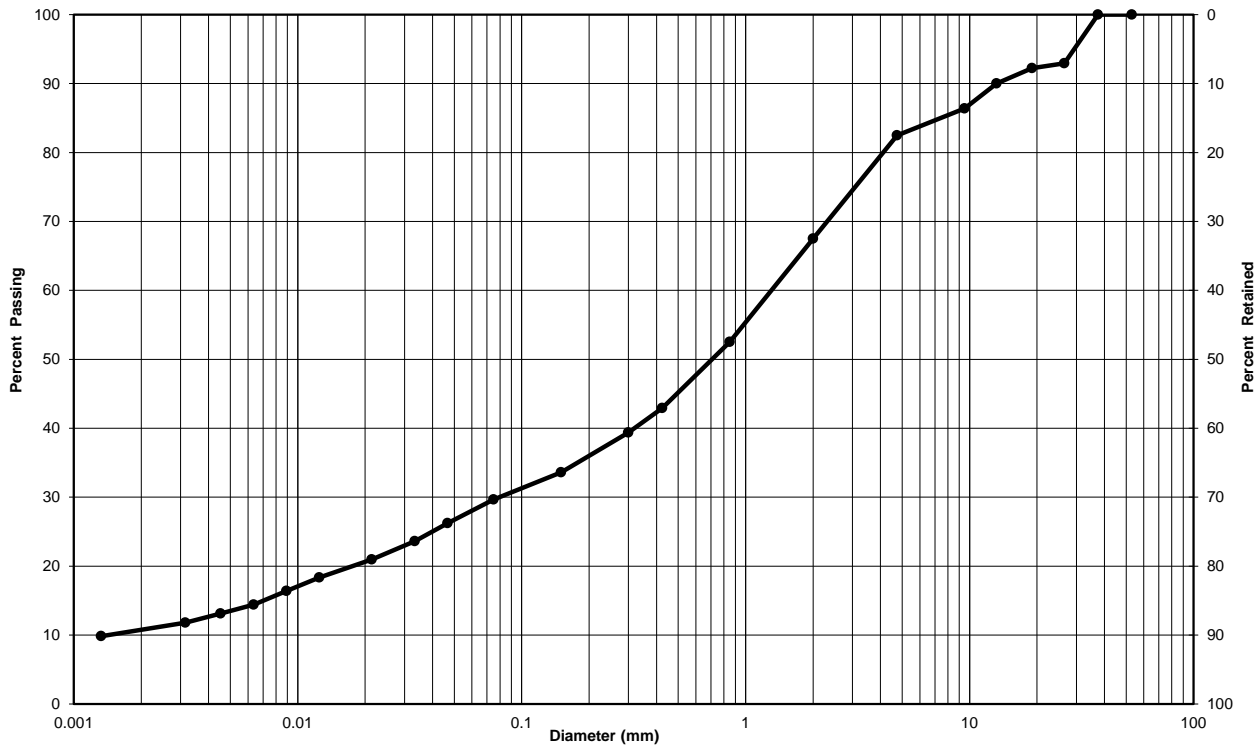
Soil Description	Gravel (%)	Sand (%)	Clay & Silt (%)
Silty Sand with Gravel, Some Clay	18	52	30

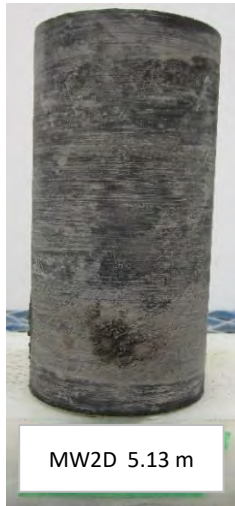
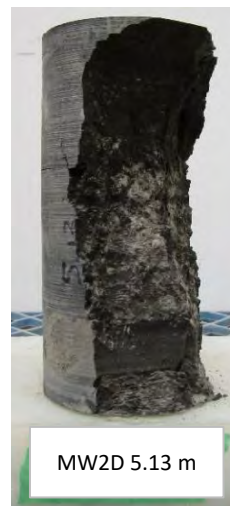
Maximum Applied Load, kN	110.3
Compressive Strength, MPa	35.9

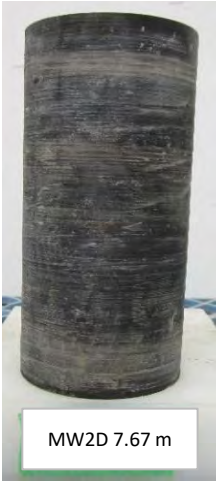
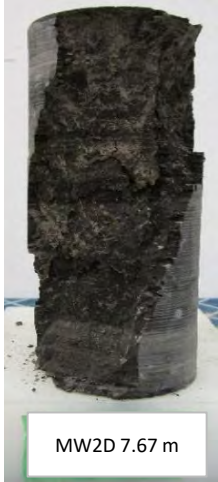
Maximum Applied Load, kN	96.2
Compressive Strength, MPa	31.4

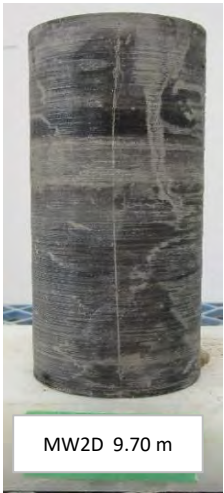
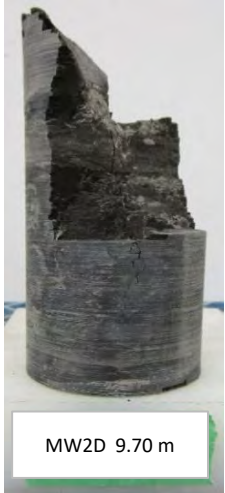
Maximum Applied Load, kN	75.0
Compressive Strength, MPa	24.4

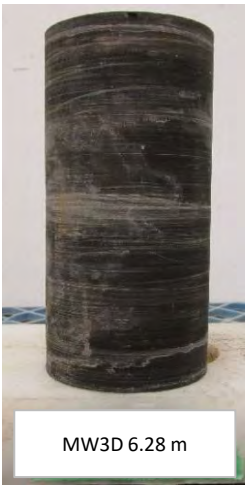
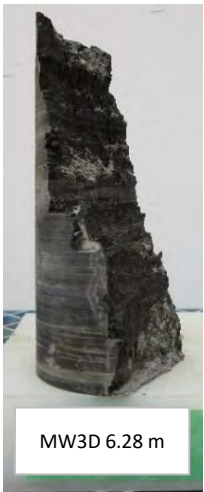
Maximum Applied Load, kN	87.2
Compressive Strength, MPa	28.4

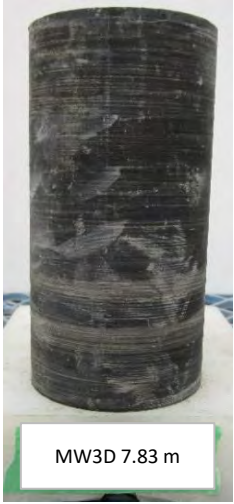
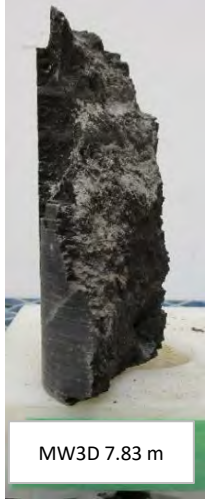
Maximum Applied Load, kN	103.2
Compressive Strength, MPa	33.5

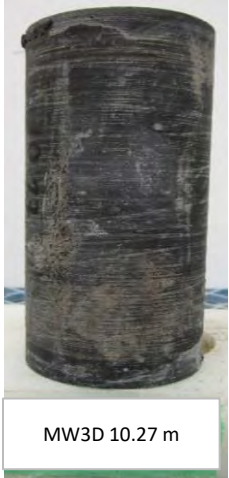
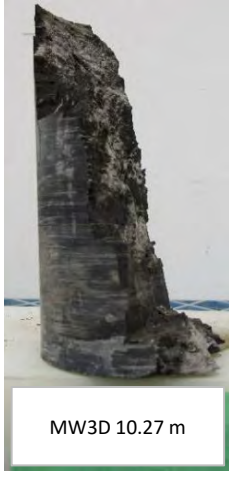
Maximum Applied Load, kN	109.0
Compressive Strength, MPa	35.4

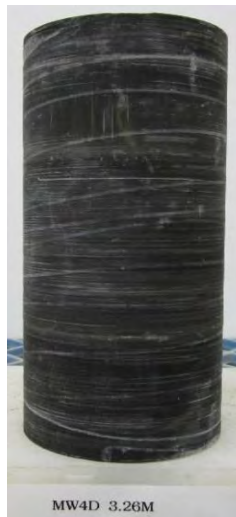
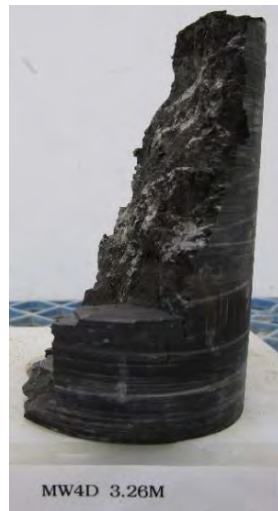
Maximum Applied Load, kN	128.0
Compressive Strength, MPa	41.8

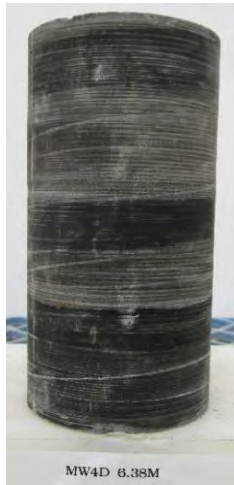
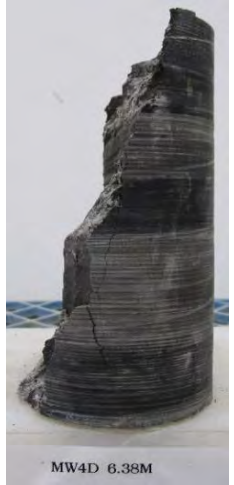
Maximum Applied Load, kN	87.5
Compressive Strength, MPa	28.5

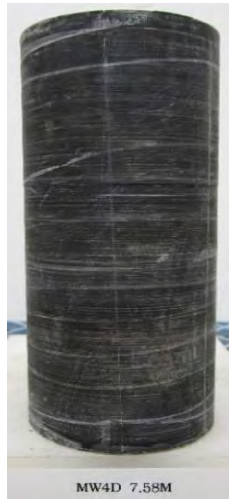
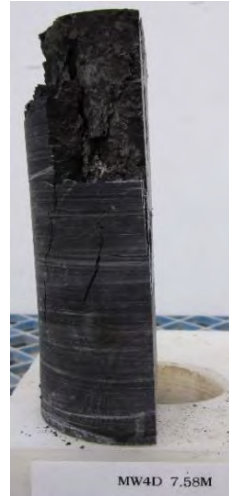
Maximum Applied Load, kN	93.5
Compressive Strength, MPa	30.5

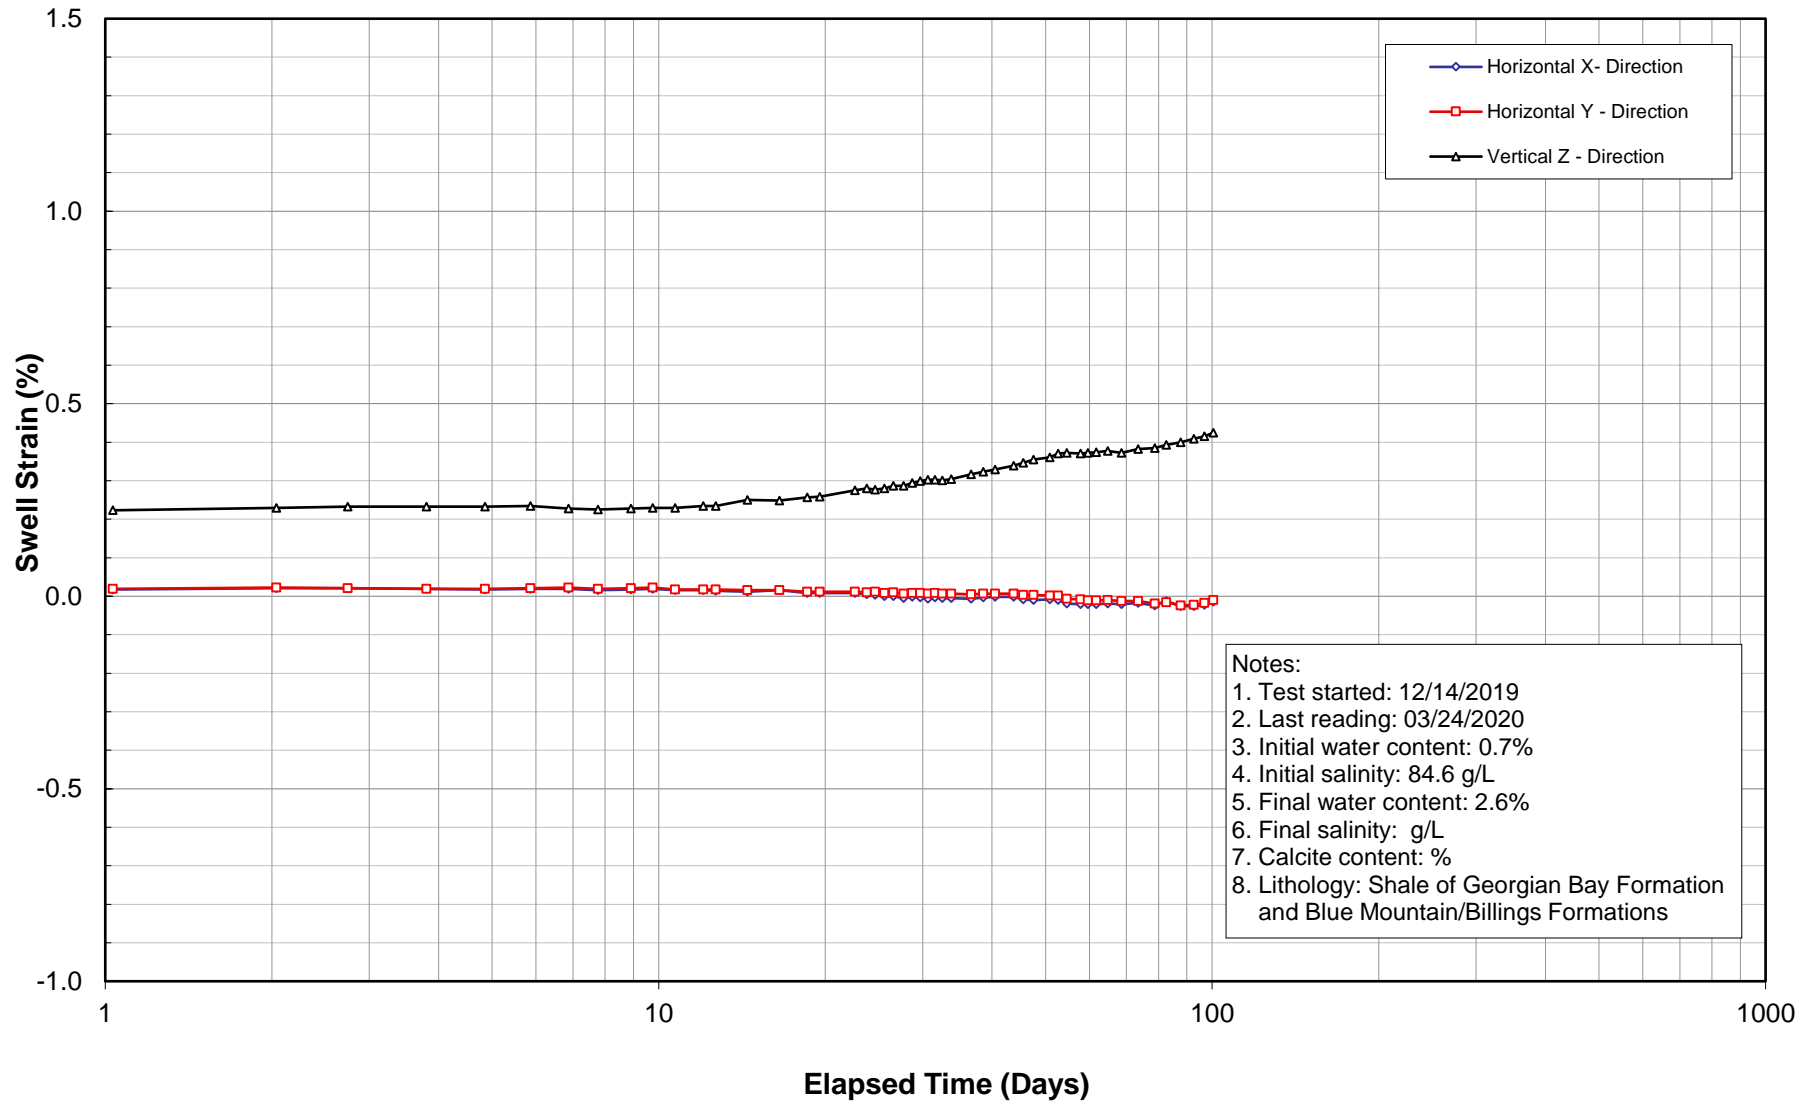
Free Swell Test  
Children's Hospital of Eastern Ontario Campus -  
Preliminary Geotechnical Investigation, Ottawa  
**FST-MW2D-1**  
**BH: MW2D; Depth: 4.38m - 4.44m**

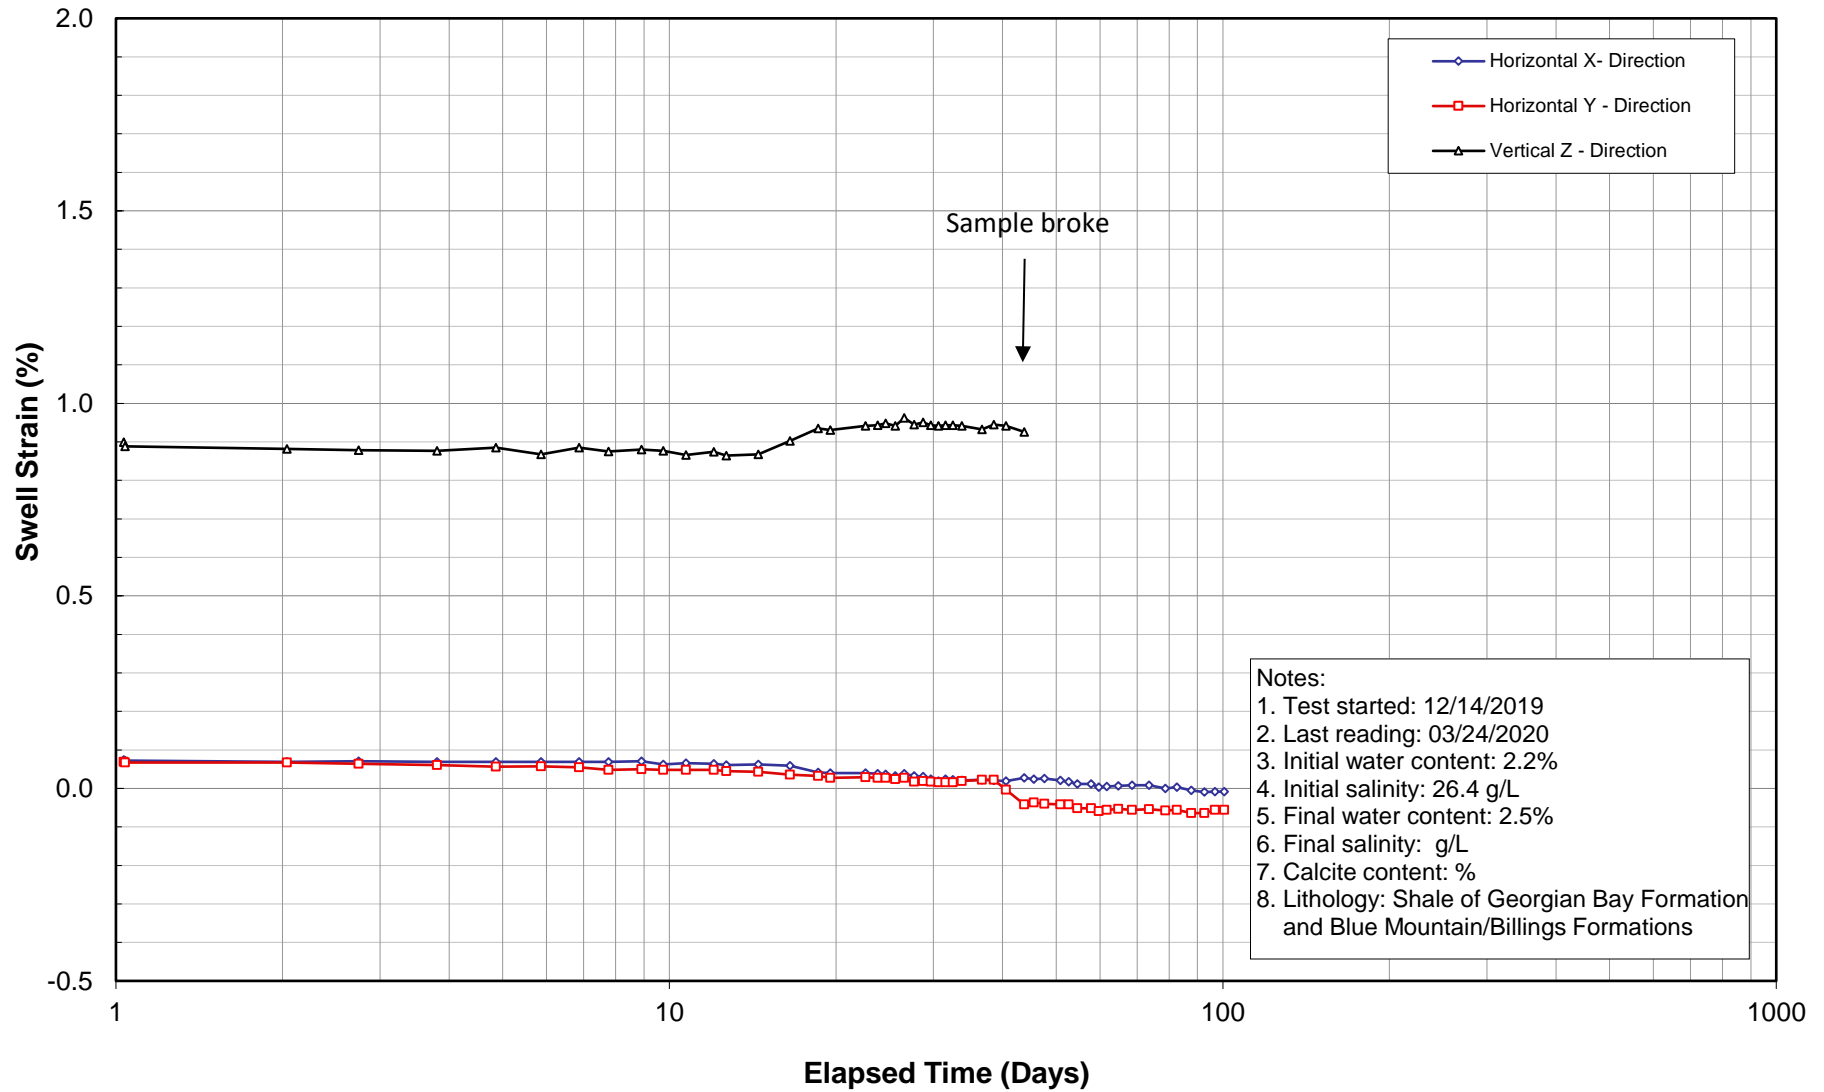
**Free Swell Test**  
 Children's Hospital of Eastern Ontario Campus -  
 Preliminary Geotechnical Investigation, Ottawa  
**FST-MW3D-1**  
**BH: MW3D; Depth: 4.85m - 4.91m**

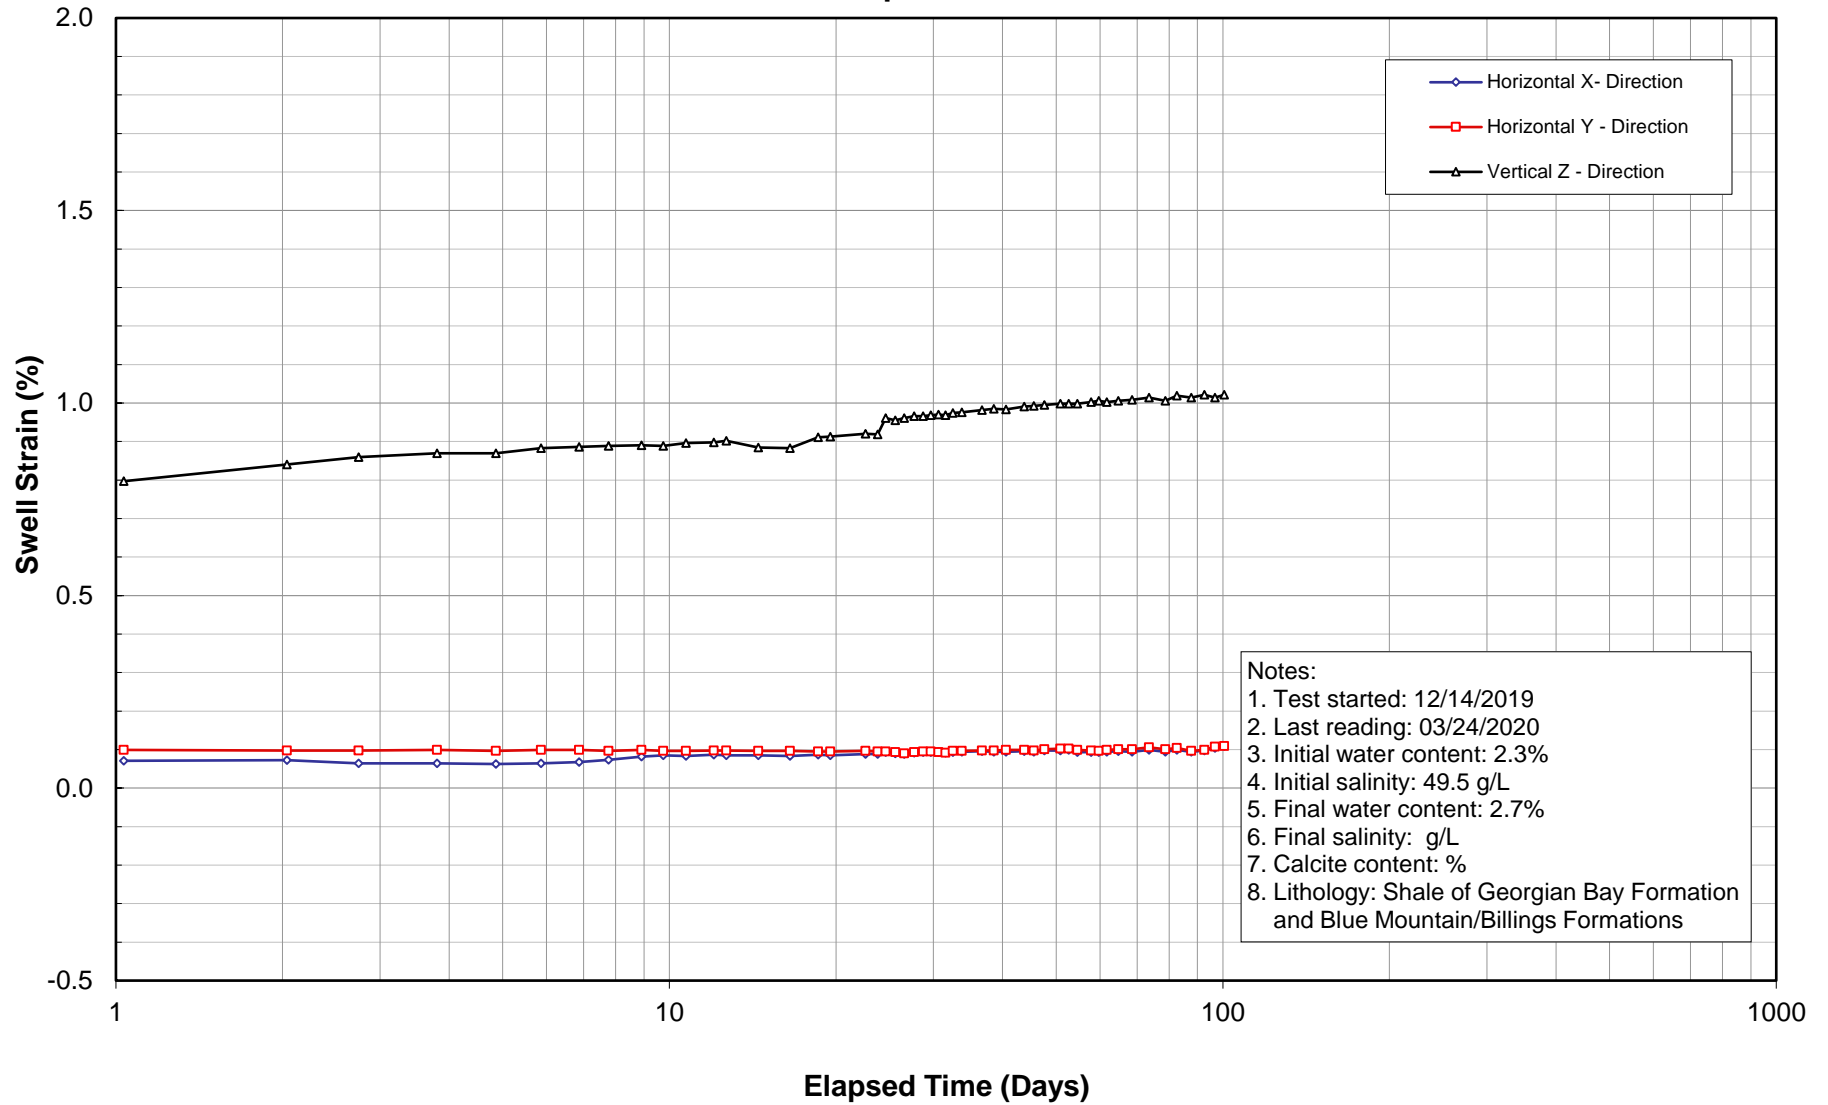
Free Swell Test  
Children's Hospital of Eastern Ontario Campus -  
Preliminary Geotechnical Investigation, Ottawa  
**FST-MW4D-1**  
**BH: MW4D; Depth: 4.51m - 4.60m**

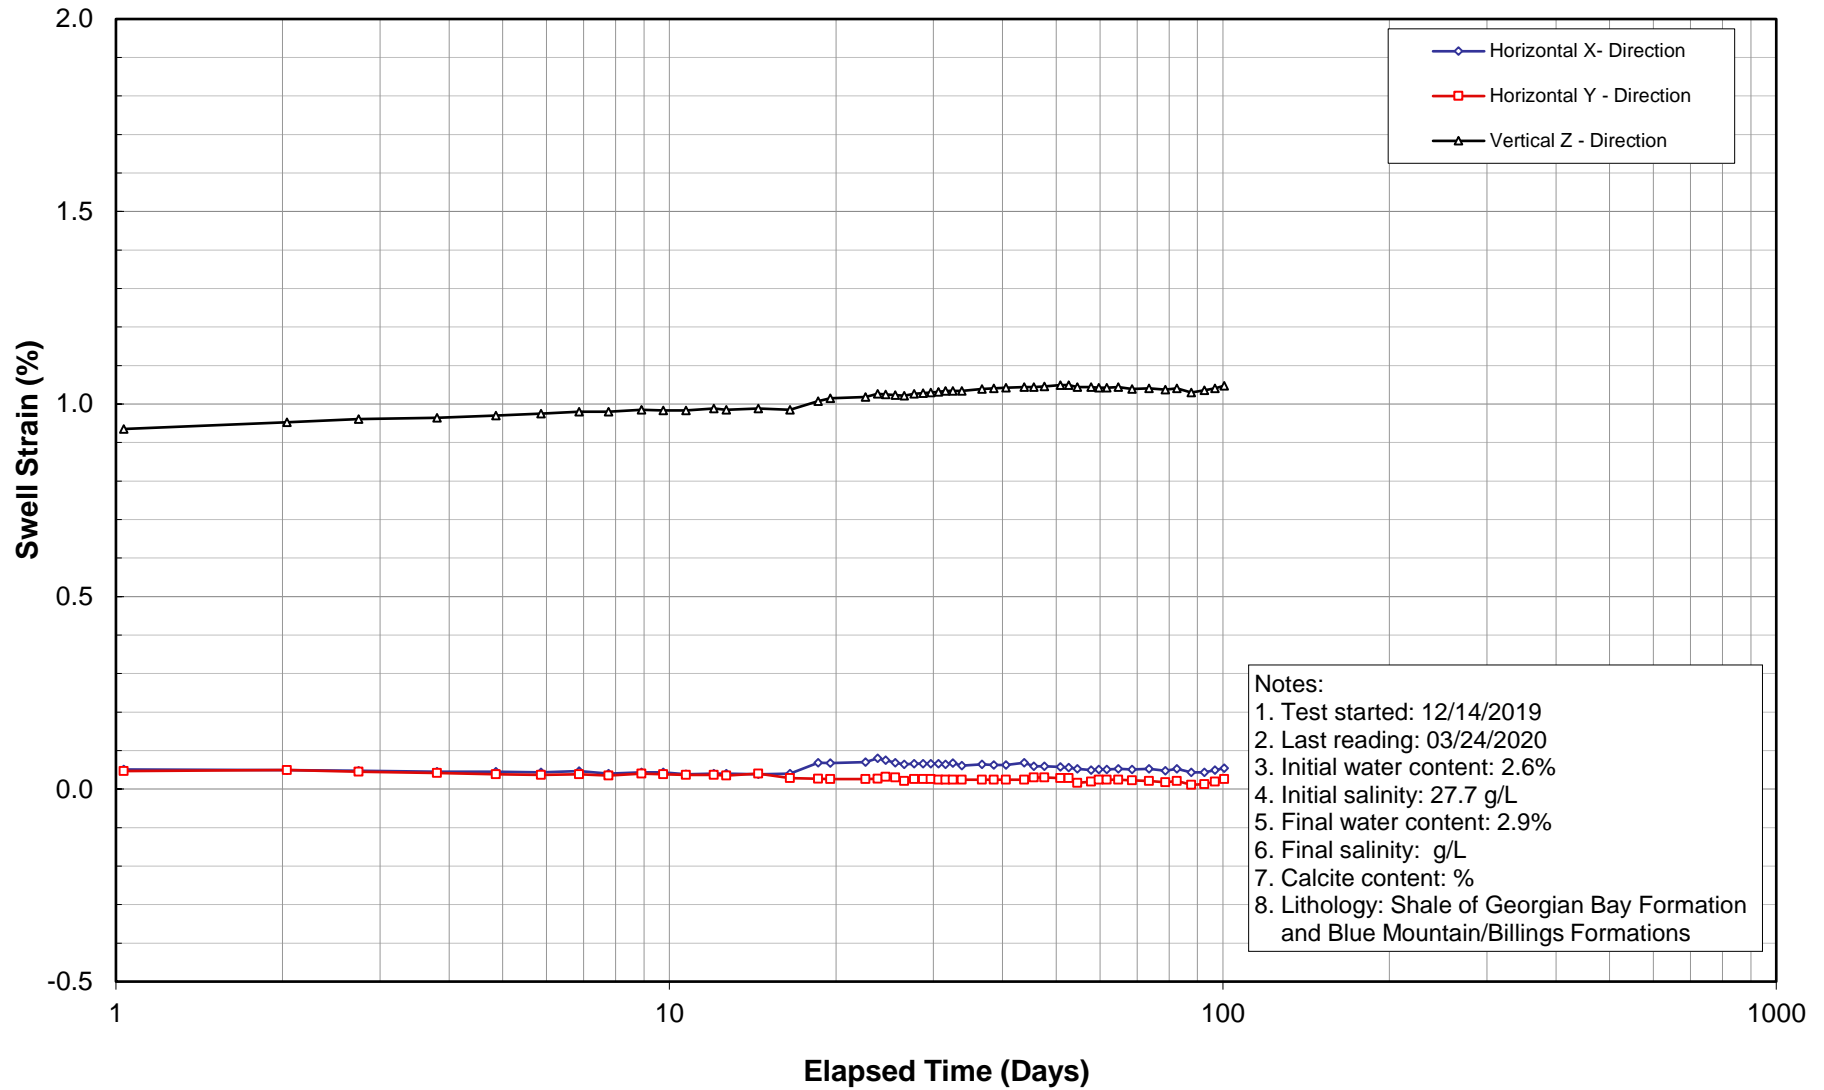
Free Swell Test  
Children's Hospital of Eastern Ontario Campus -  
Preliminary Geotechnical Investigation, Ottawa  
**FST-MW4D-2**  
**BH: MW4D; Depth: 4.84m - 4.90m**

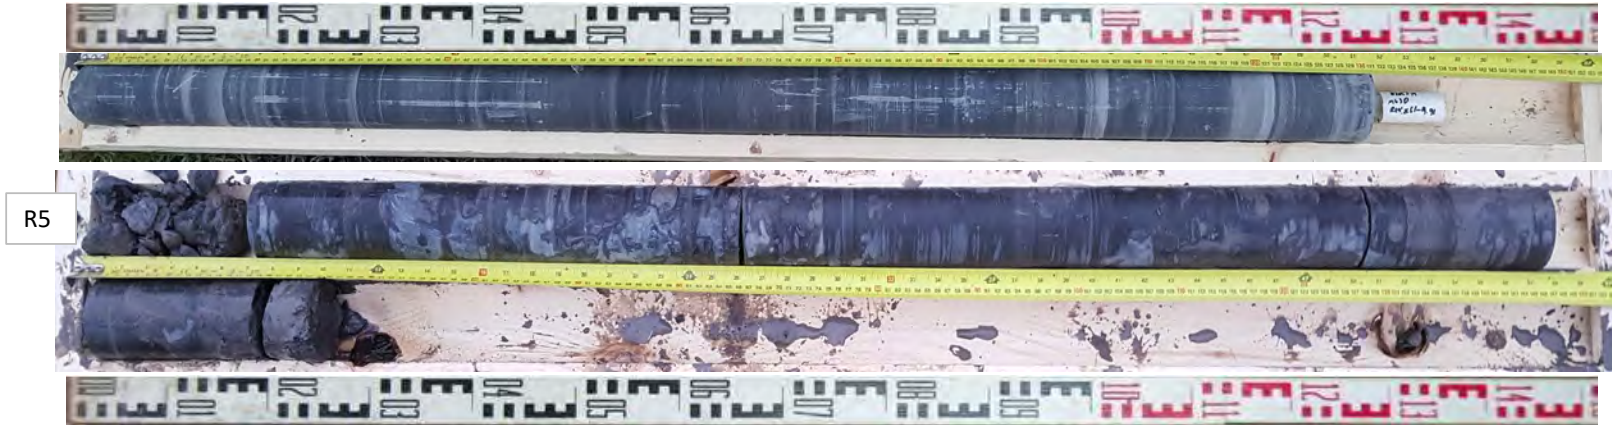
# Rock Core Photo Log MW3

R4 (RUN 4): 8.62 m - 9.91 m  
 R5 (RUN 5): 9.91 m - 11.43 m

Bedrock was encountered in all boreholes at a depth of 0.9 to 3.8 mBGS. The shale bedrock was cored in three boreholes (MW2, MW3, and MW4) to verify the presence of bedrock and assess the bedrock quality. The boreholes within the completely weathered zones were advanced by auguring and SPT sampling for variable thicknesses, but generally less than 2 m before reaching auger refusal. From the recovered rock cores, the bedrock was visually identified as the Georgian Bay Formation. The shale was generally observed to be dark grey in color, thinly laminated, completely weathered at its surface and became gradually fresh with depth. This formation consists generally of a dark grey weak to moderately strong shale interbedded with light grey color strong to very strong limestone and siltstone layer.

The Total Core Recovery (TCR) achieved with the HQ size core bit ranged from approximately 80 to 100% and the Solid Core Recovery (SCR) ranged from 59 to 100 %. The Rock Quality Designation (RQD) ranged from 0 to 100% with the lower values of RQD observed near the surface of the rock and percentages generally increased with depth. The RQD values are a general indicator of rock mass quality; however, in horizontally laminated sedimentary rock formation such as the Georgian Bay Formation, the RQD values may likely underestimate the quality of the rock.
