# Preliminary Geotechnical Investigation

Children's Hospital of Eastern Ontario Campus  
401 & 407 Smyth Road  
Ottawa, Ontario

Infrastructure Ontario

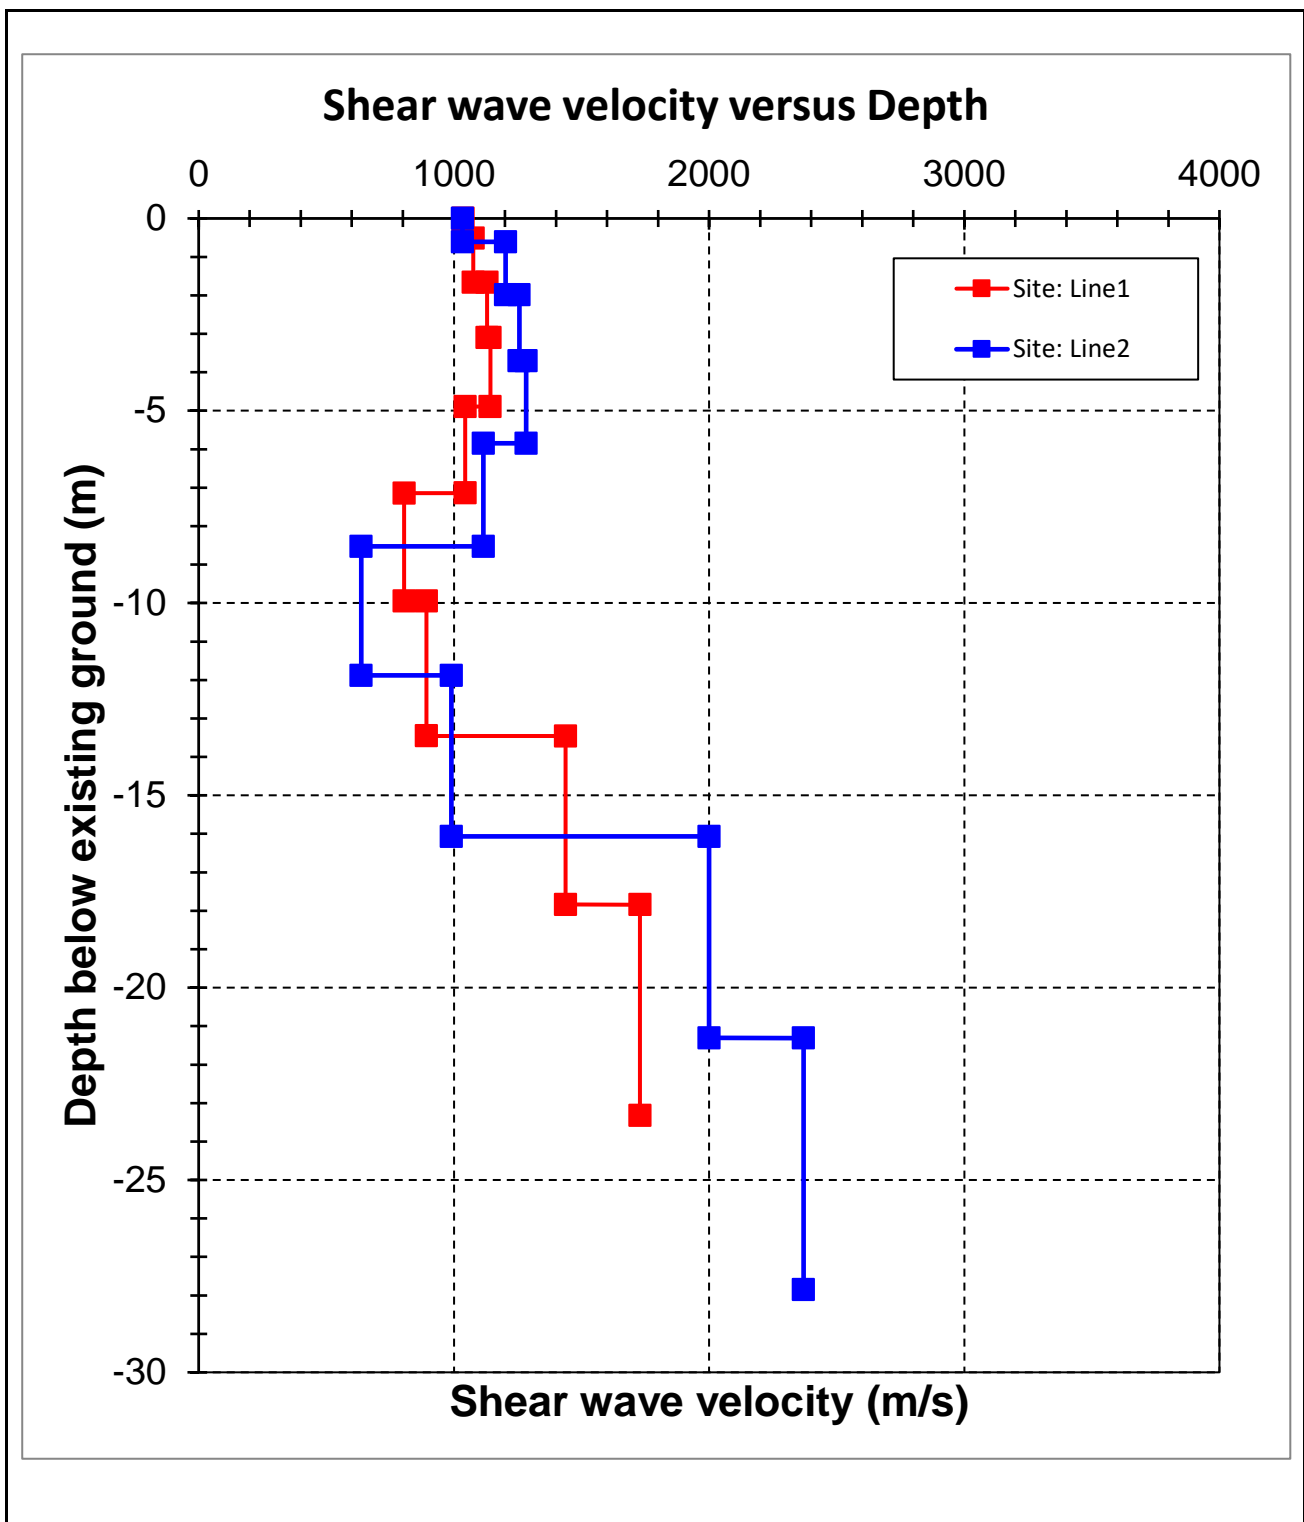
Infrastructure Ontario  
 Proposed 1Door4Care Development  
 Part of Childrens Hospital of Eastern Ontario Campus  
 401 and 407 Smyth Road, Ottawa Ontario  
**SHEAR WAVE VELOCITY VS DEPTH**

- 1 - The Seismic Site class is recommended in accordance to Table 4.1.8.4.A of the National Building code of Canada 2010 and based on the lowest measured average shear wave velocity measured along the investigated lines.
- 2 -  $VS_{30}$  is calculated based on the average shear wave velocity below the proposed founding elevation.
- 3 - Site Classes A and B are only applicable if footings are founded on bedrock or there is no more than 3.0 m of soil between founding elevation and bedrock.
- 4 - The recommended site class is only applicable if site conditions for Site Class F (liquefiable soil/soft soil layers more than 3.0 m thick) are not applicable.

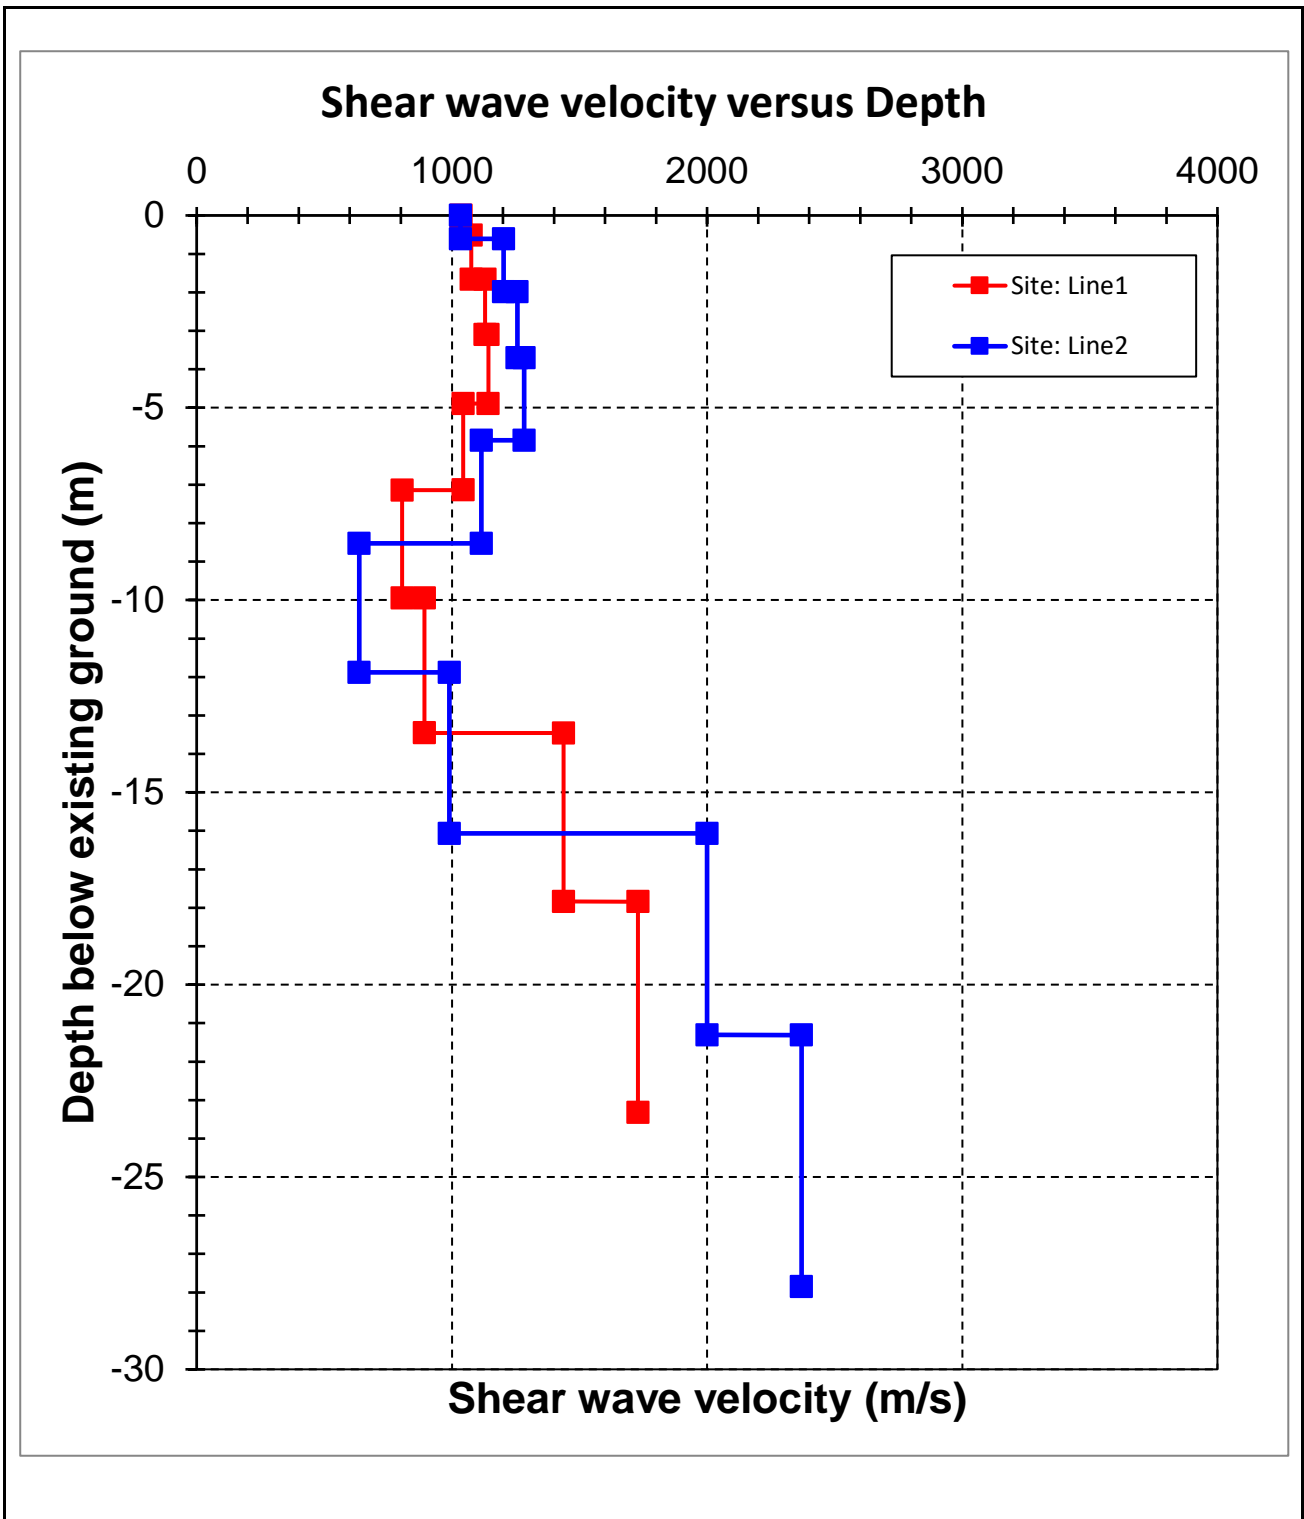
Infrastructure Ontario  
 Proposed 1Door4Care Development  
 Part of Childrens Hospital of Eastern Ontario Campus  
 401 and 407 Smyth Road, Ottawa Ontario  
**SHEAR WAVE VELOCITY VS DEPTH**

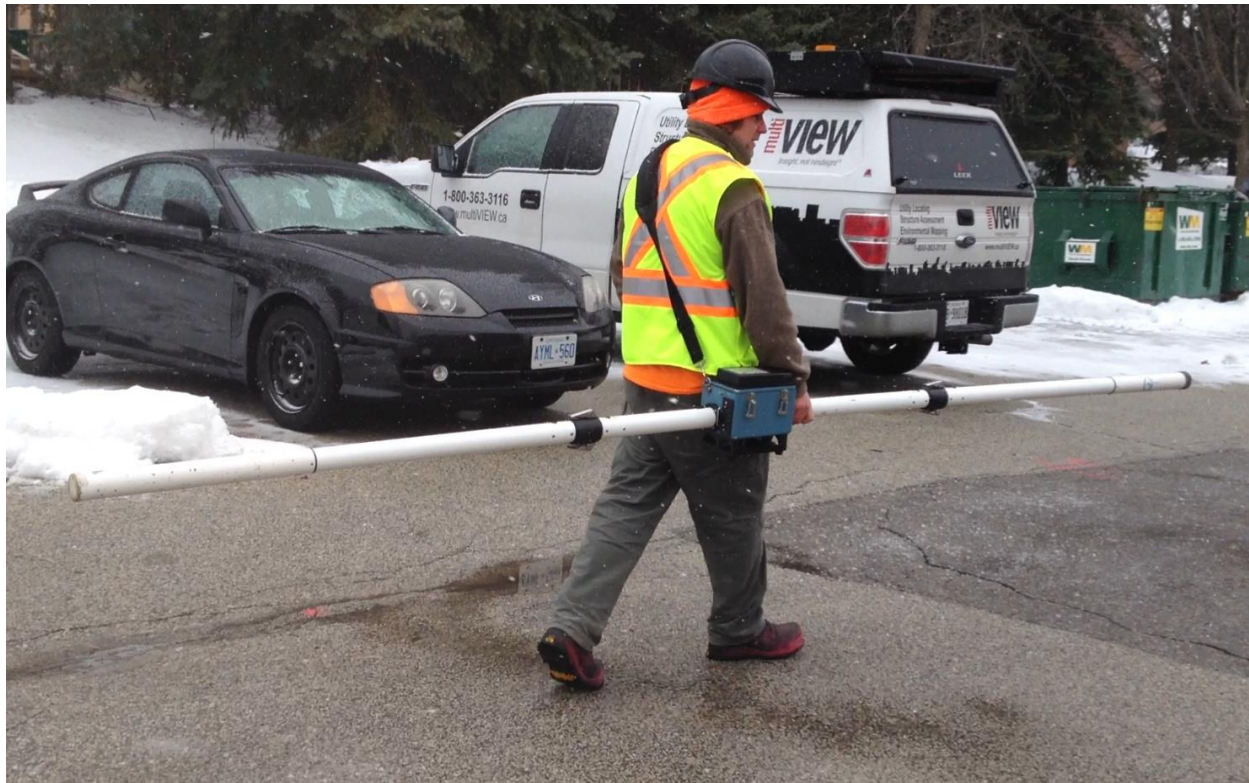
Figure 3-2: Typical FDEM Acquisition System Setup

The measurement units of the system are “milli-Siemens per metre” (mS/m) for the Quadrature component and “parts per thousand” (ppt) for the In-phase component of the measured electromagnetic field. The electromagnetic data were acquired at approximate station spacing of 2 metres along lines spaced at 2 metres apart, excluding obstructed areas. GPS data were collected synchronously with the FDEM data using a receiver externally mounted on the EM31 logging system. Following the field survey, the GPS data were integrated with the FDEM data.

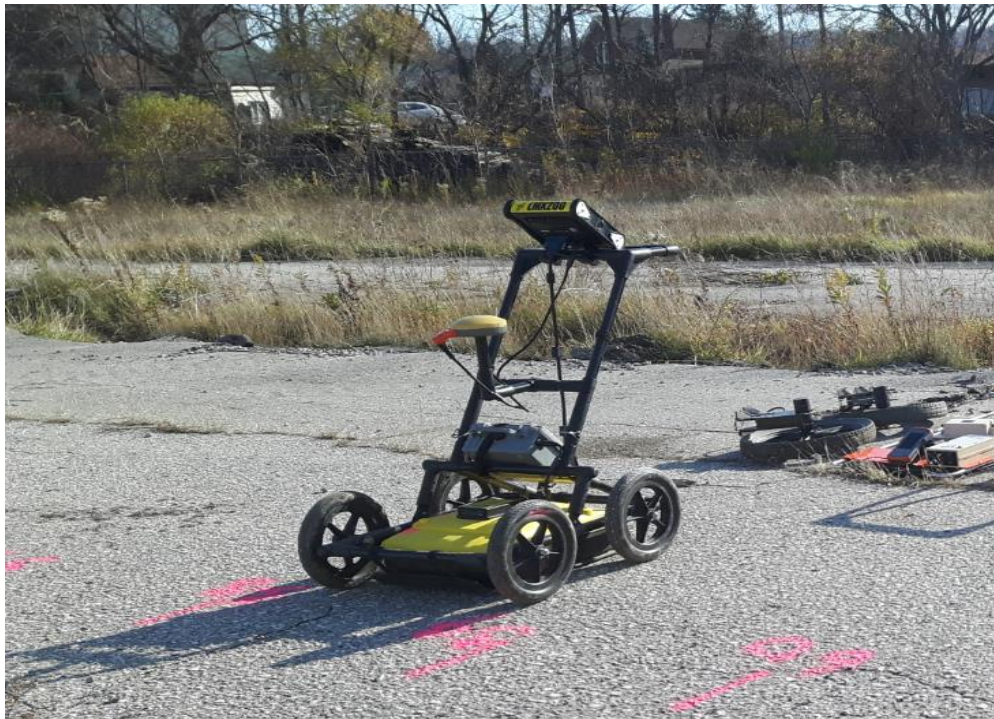
Figure 3: Typical GPR Acquisition System Setup

The ground penetrating radar electromagnetic signal transmitted into the subsurface and reflected by the structures, geological features and buried objects are recorded by Ground Penetrating Radar (GPR) instrumentation permitting real-time interpretation of subsurface features to a depth.
