**Geotechnical Investigation  
Proposed Commercial Development  
2885 Carp Road  
Ottawa, Ontario**

January 30, 2023  
Project: 101688.002

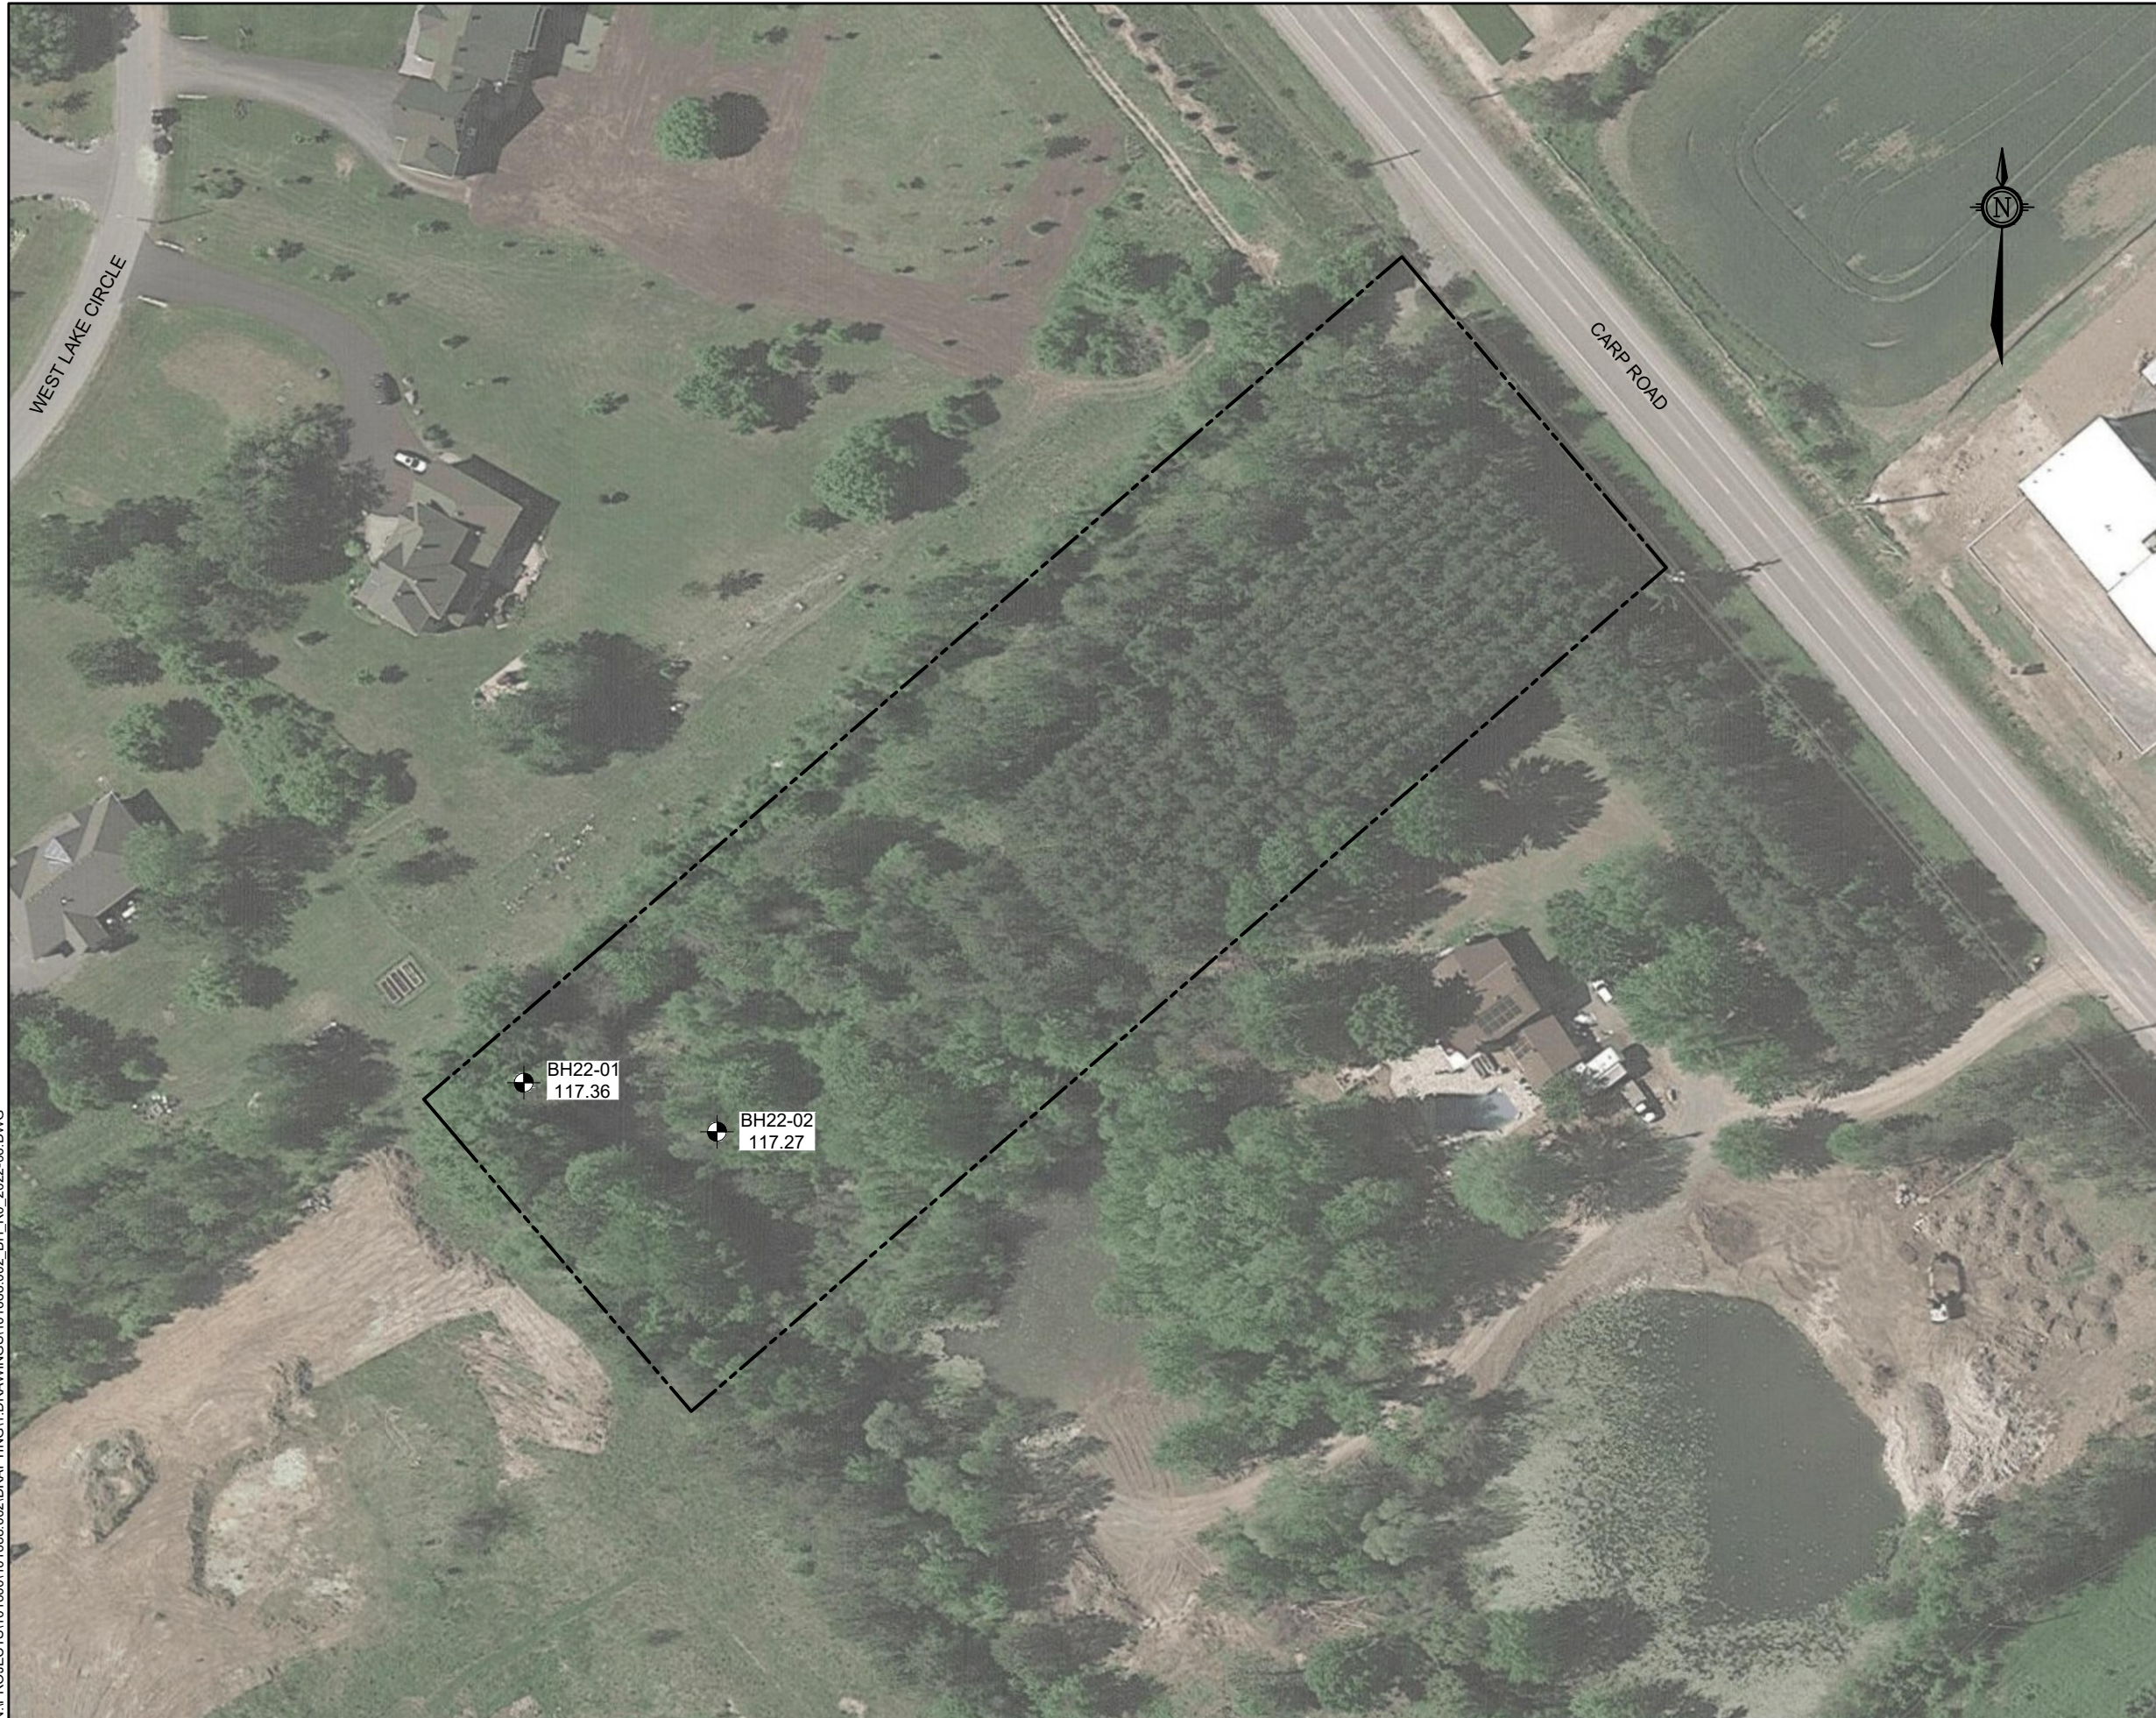
Figure 1 – Site Plan

The fieldwork for the geotechnical investigation was carried out on May 18, 2022. On that day, two boreholes (numbered 22-01 and 22-02) were advanced at the approximate locations shown on the Site Plan, Figure 1.

Descriptions of the subsurface conditions logged in the boreholes are provided on the Record of Borehole Sheets in Appendix A. The results of the laboratory classification testing are provided on the Record of Borehole sheets and in Appendix B. The results of chemical testing completed on one soil sample are provided in Appendix C. The results of the slope stability analysis are provided in Appendix D. The approximate locations of the boreholes are shown on the Site Plan, Figure 1.

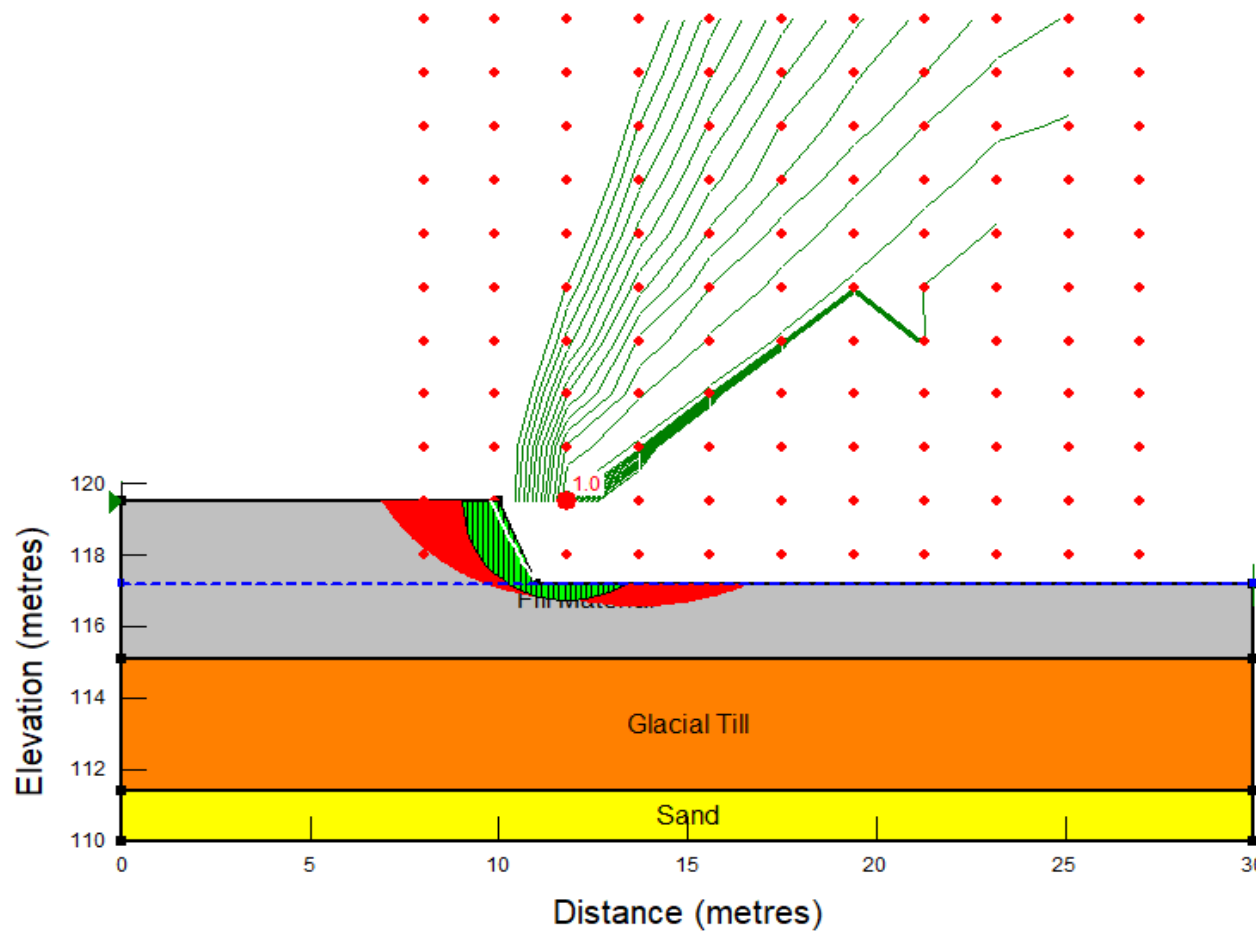
**Figure D4**

Name: Fill Material  
 Model: Mohr-Coulomb  
 Unit Weight: 18 kN/m<sup>3</sup>  
 Cohesion: 0 kPa  
 Phi: 32 °  
 Piezometric Line: 1

Name: Glacial Till  
 Model: Mohr-Coulomb  
 Unit Weight: 22 kN/m<sup>3</sup>  
 Cohesion: 0 kPa  
 Phi: 38 °  
 Piezometric Line: 1

The slope stability analysis indicated that the existing slope, has a factor of safety against overall rotational failure of less than 1.0.
