AVENYN CAPITAL PARTNERS LP II

ENVIRONMENTAL SITE ASSESSMENT

1591 - 1611 Michael Street, Ottawa, Ontario

January 18, 2023

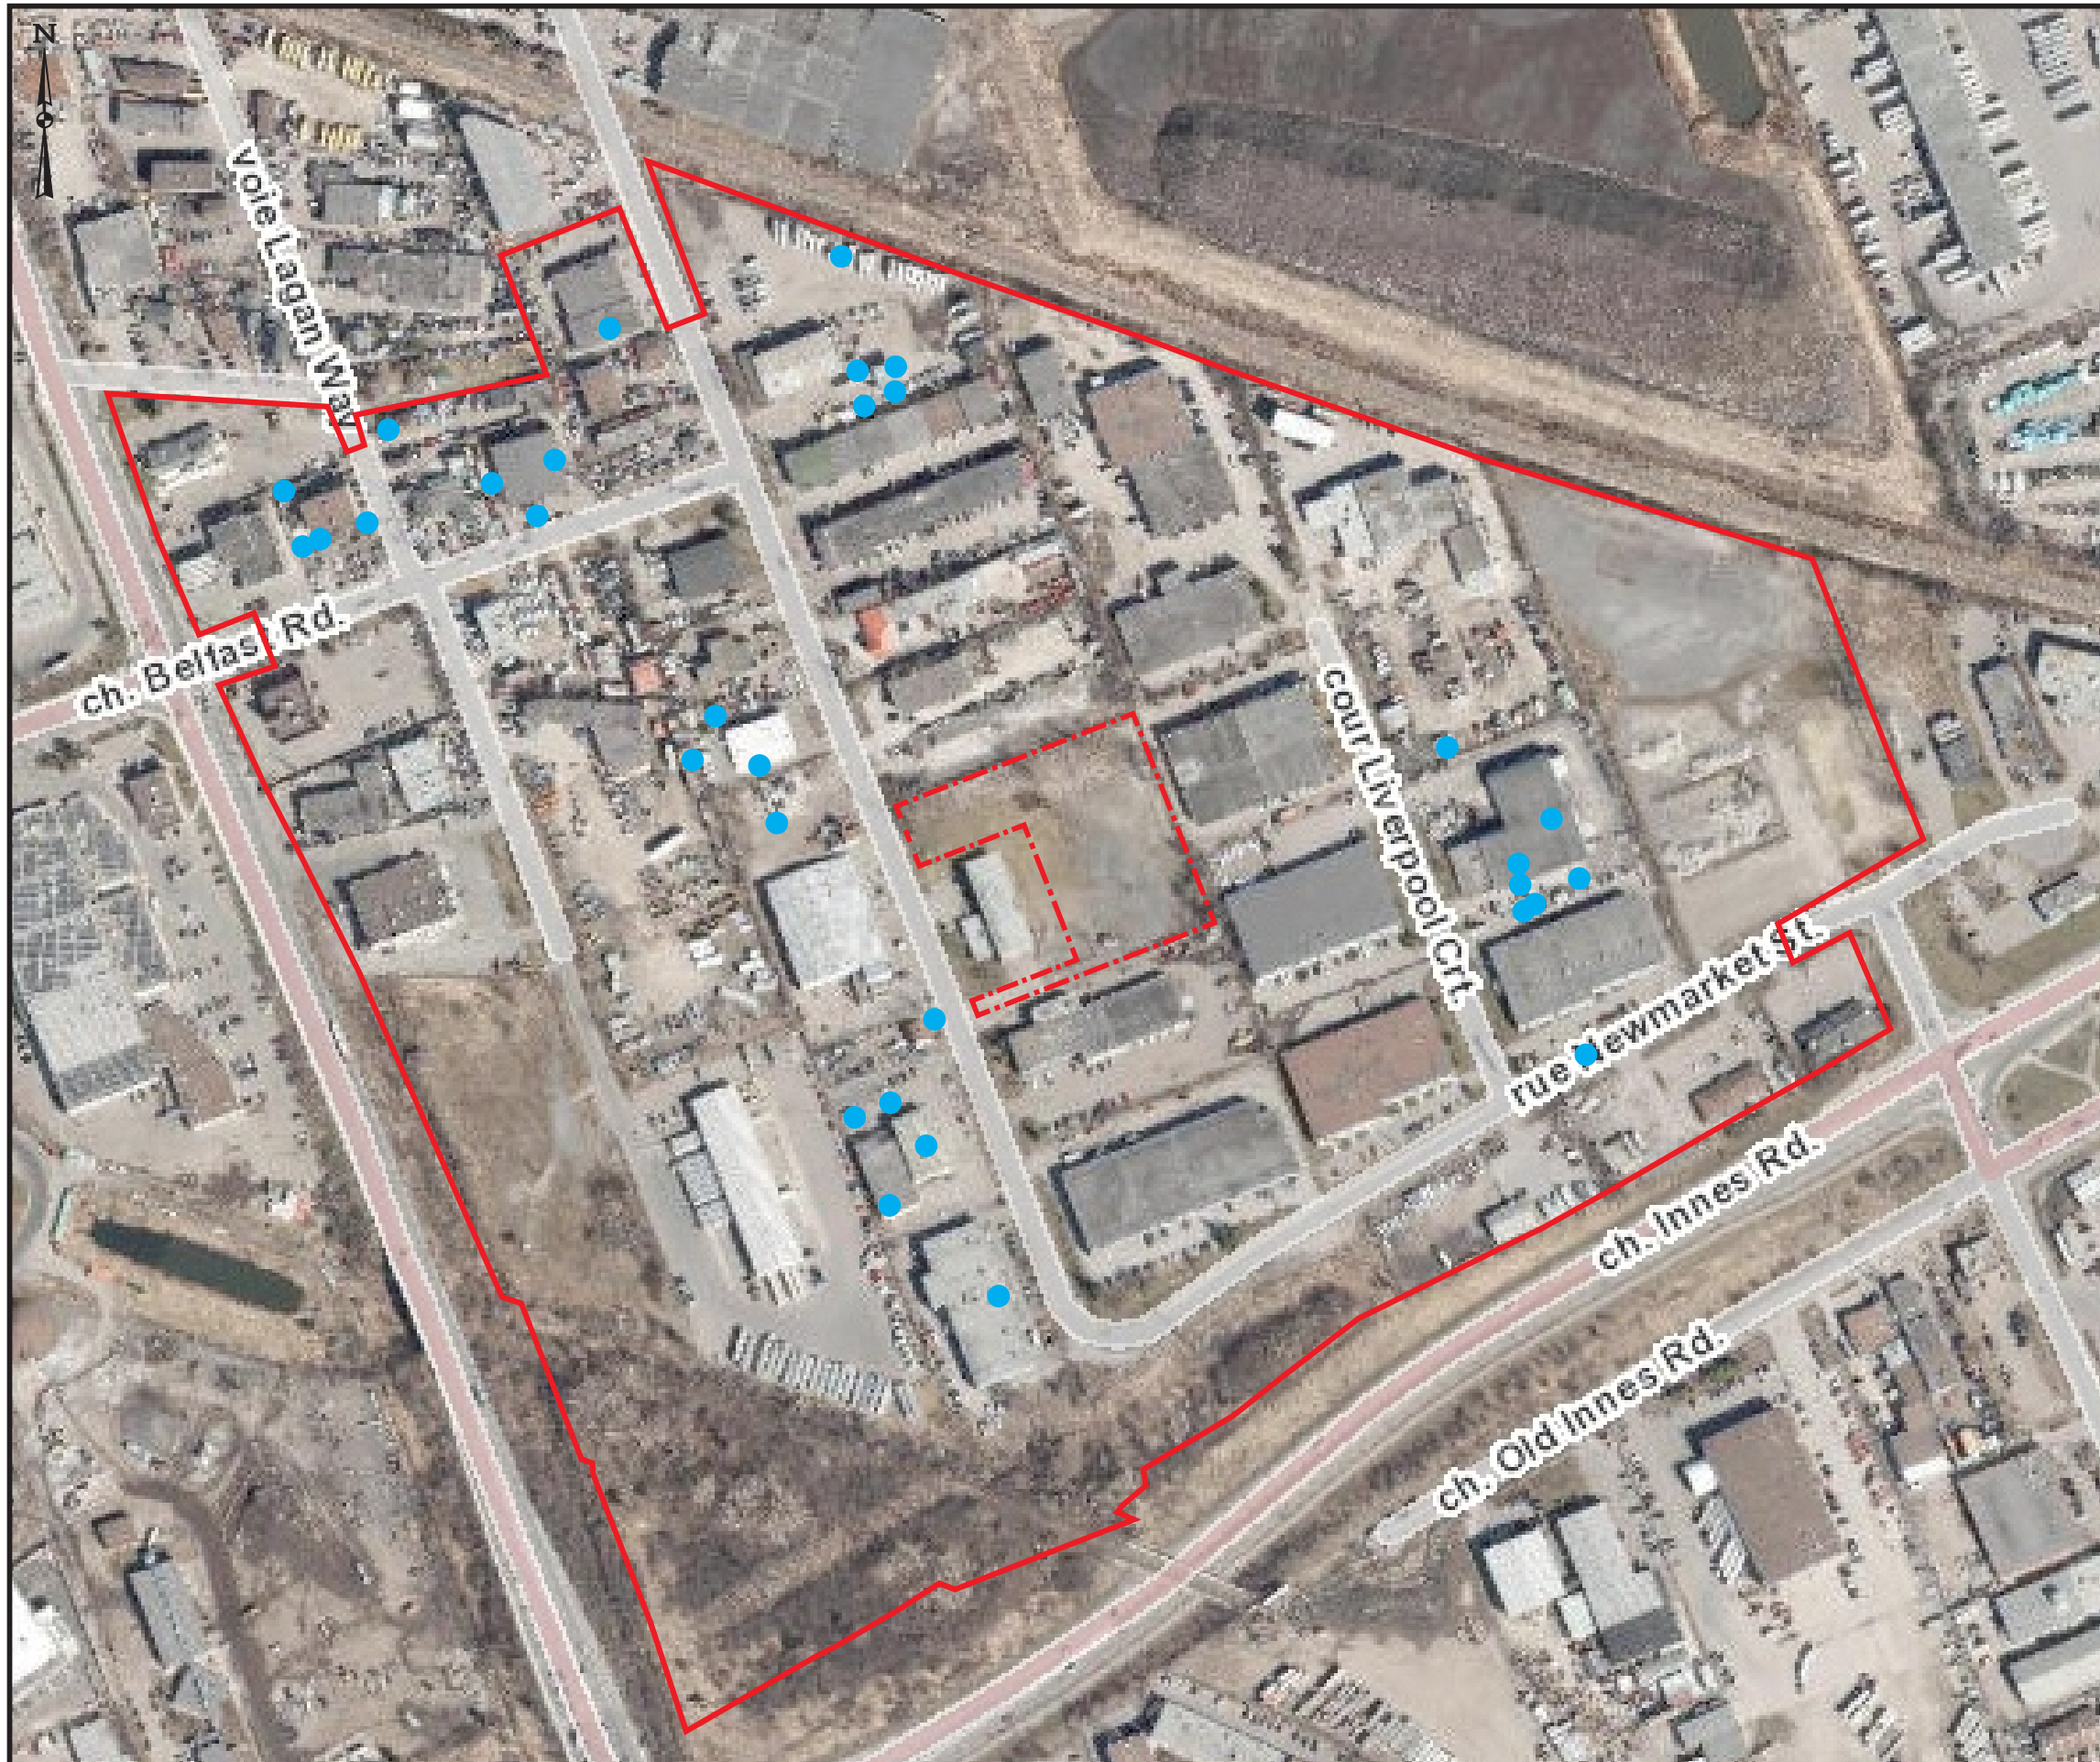
DRAWN BY: SW	PROJECT NO: CO892.01	CHECKED BY: XX
REVISION: 00	DATE: OCTOBER 2022	FIGURE: 2

TITLE:
GENERAL SITE LAYOUT

The extent of the Phase One property was provided by the Client and includes 2 adjoining registered parcels. Information regarding the location and identification of the Phase One property and those authorizing this study is provided in Table 1, below. The location of the Site and the general Site layout are shown in Figure 1 and Figure 2, respectively.

The Site location is shown in Figure 1 and the Site layout is shown in Figure 2. Selected photographs of the Site and Phase One study area are provided in Appendix X.

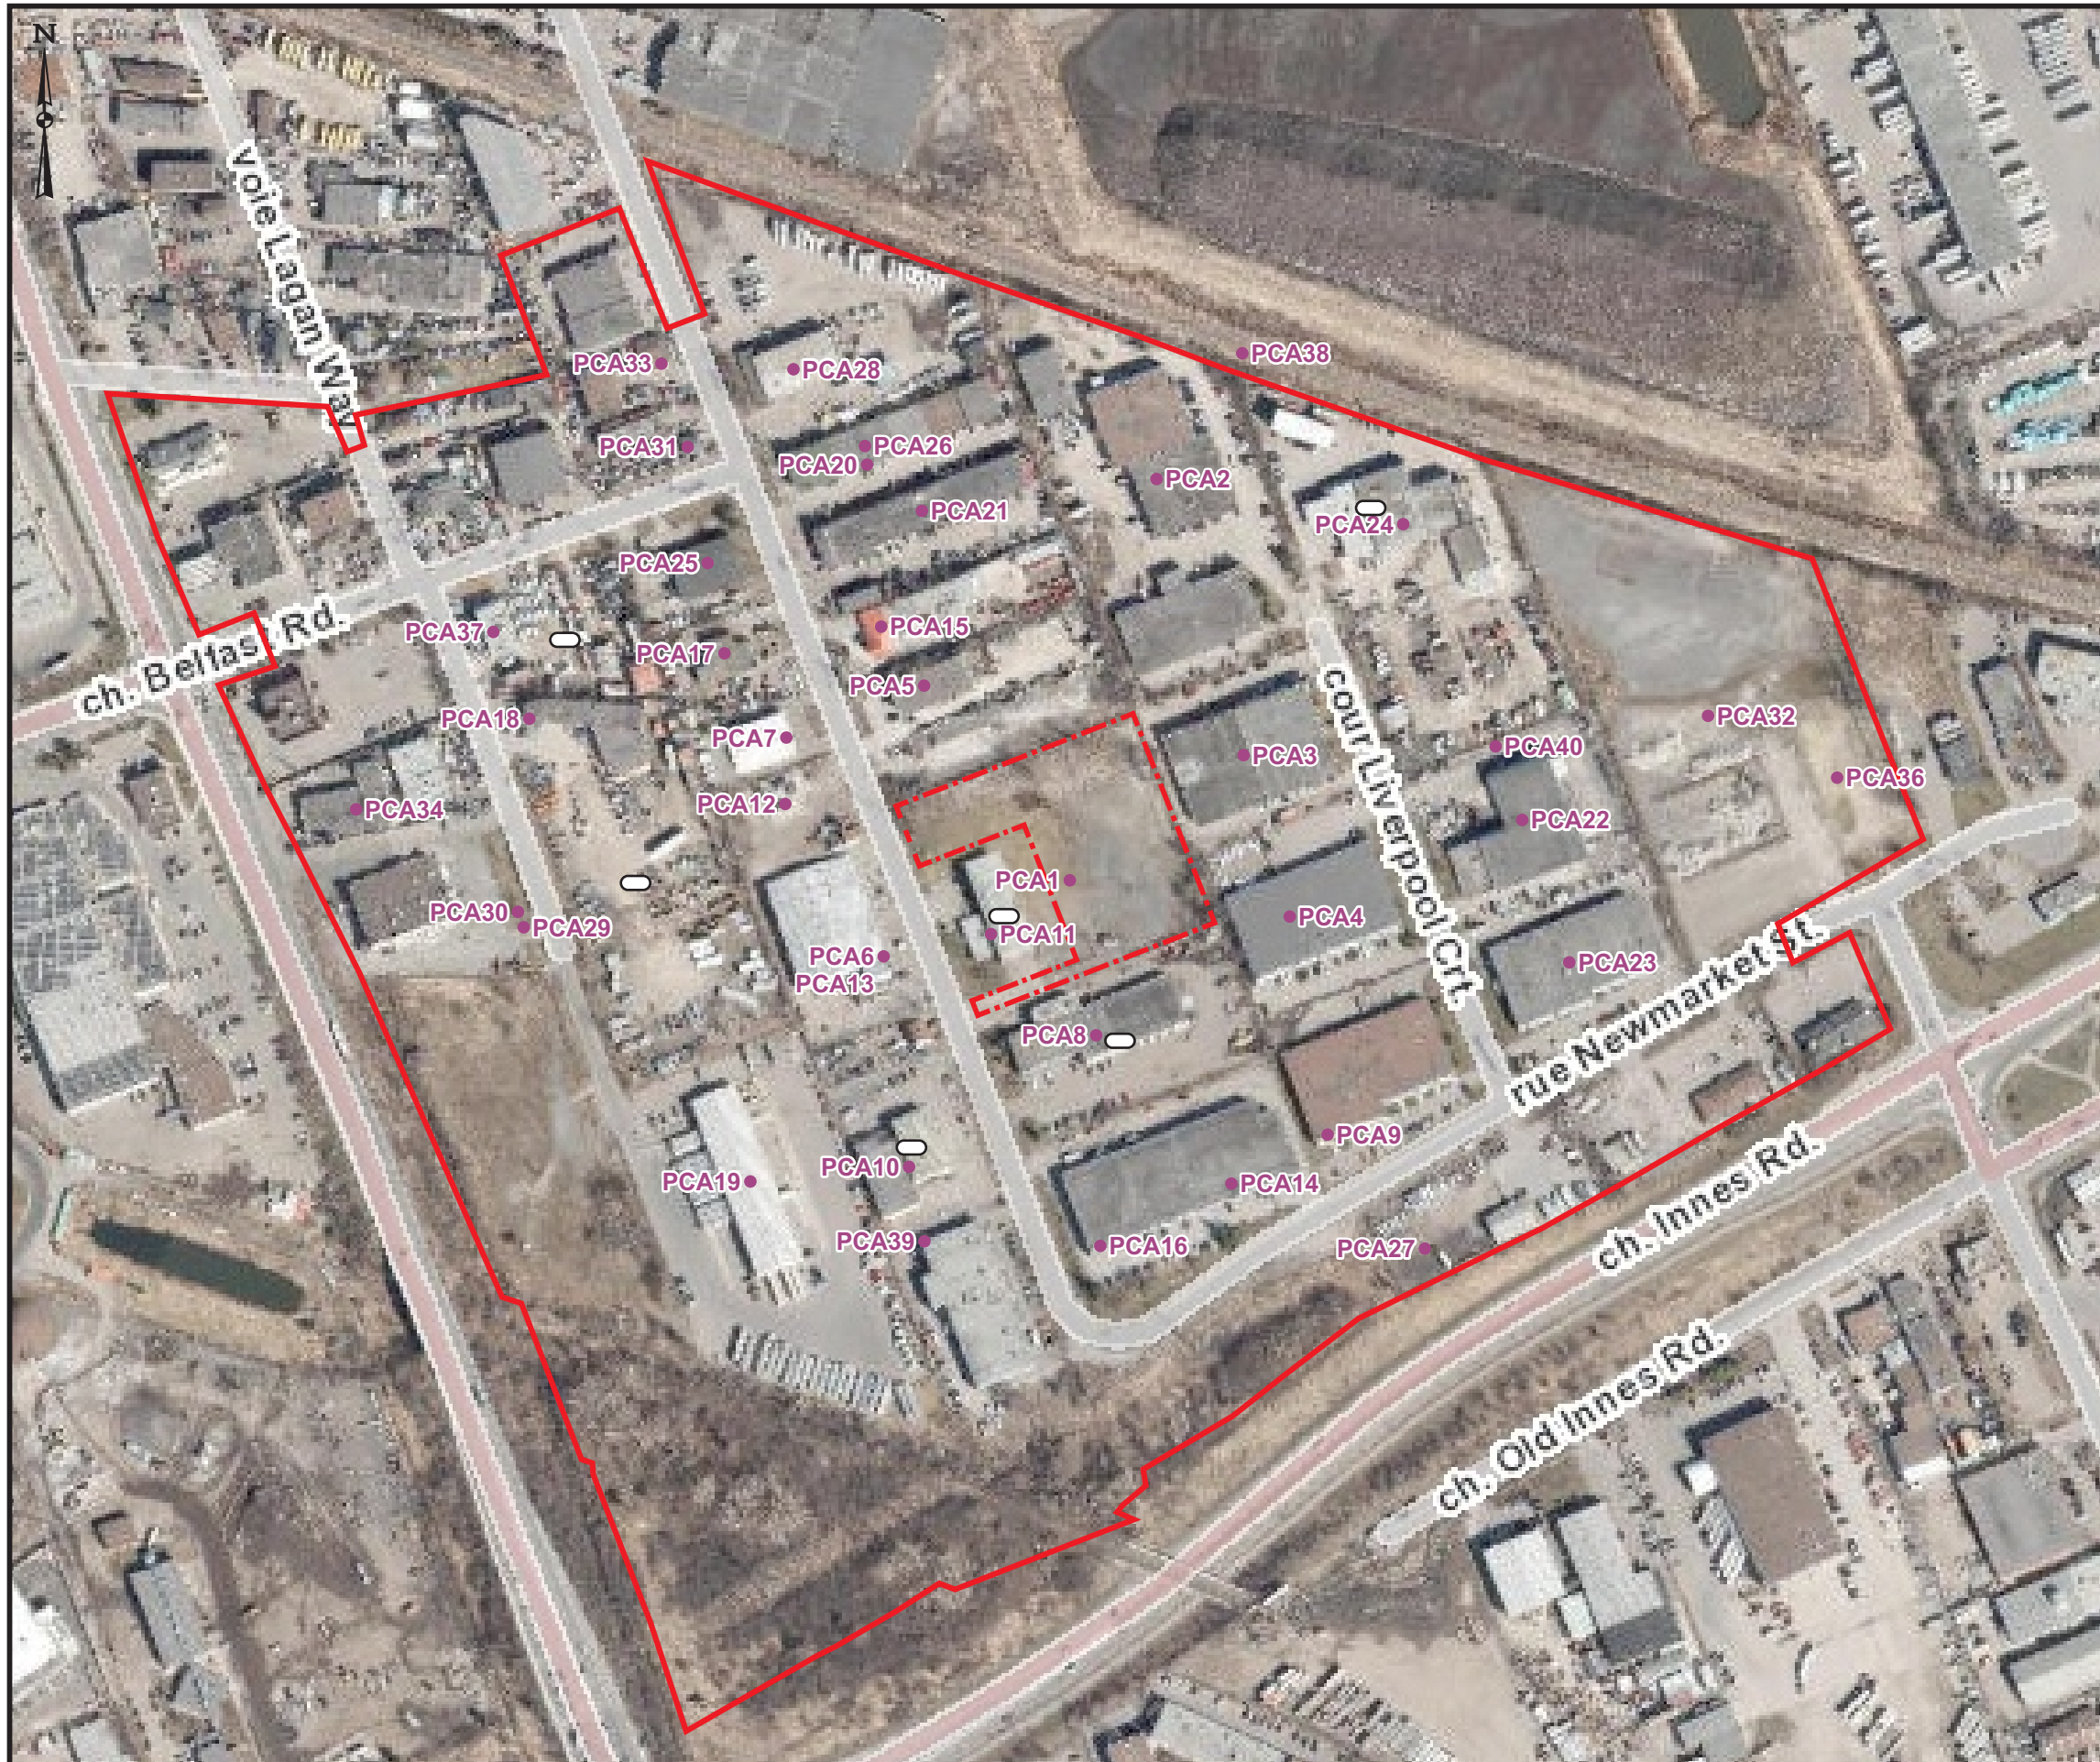
DRAWN BY: SW	PROJECT NO.: CO892.01	CHECKED BY: XX
REVISION: 00	DATE: OCTOBER 2022	FIGURE: 3

- SITE BOUNDARY
- PHASE ONE STUDY AREA
- WATER WELL LOCATION

TITLE:
PHASE ONE STUDY AREA

The Phase One study area is shown in Figure 3.

Water well record locations are provided in Figure 3. The WWIS report and supply well records are provided in Appendix IX.

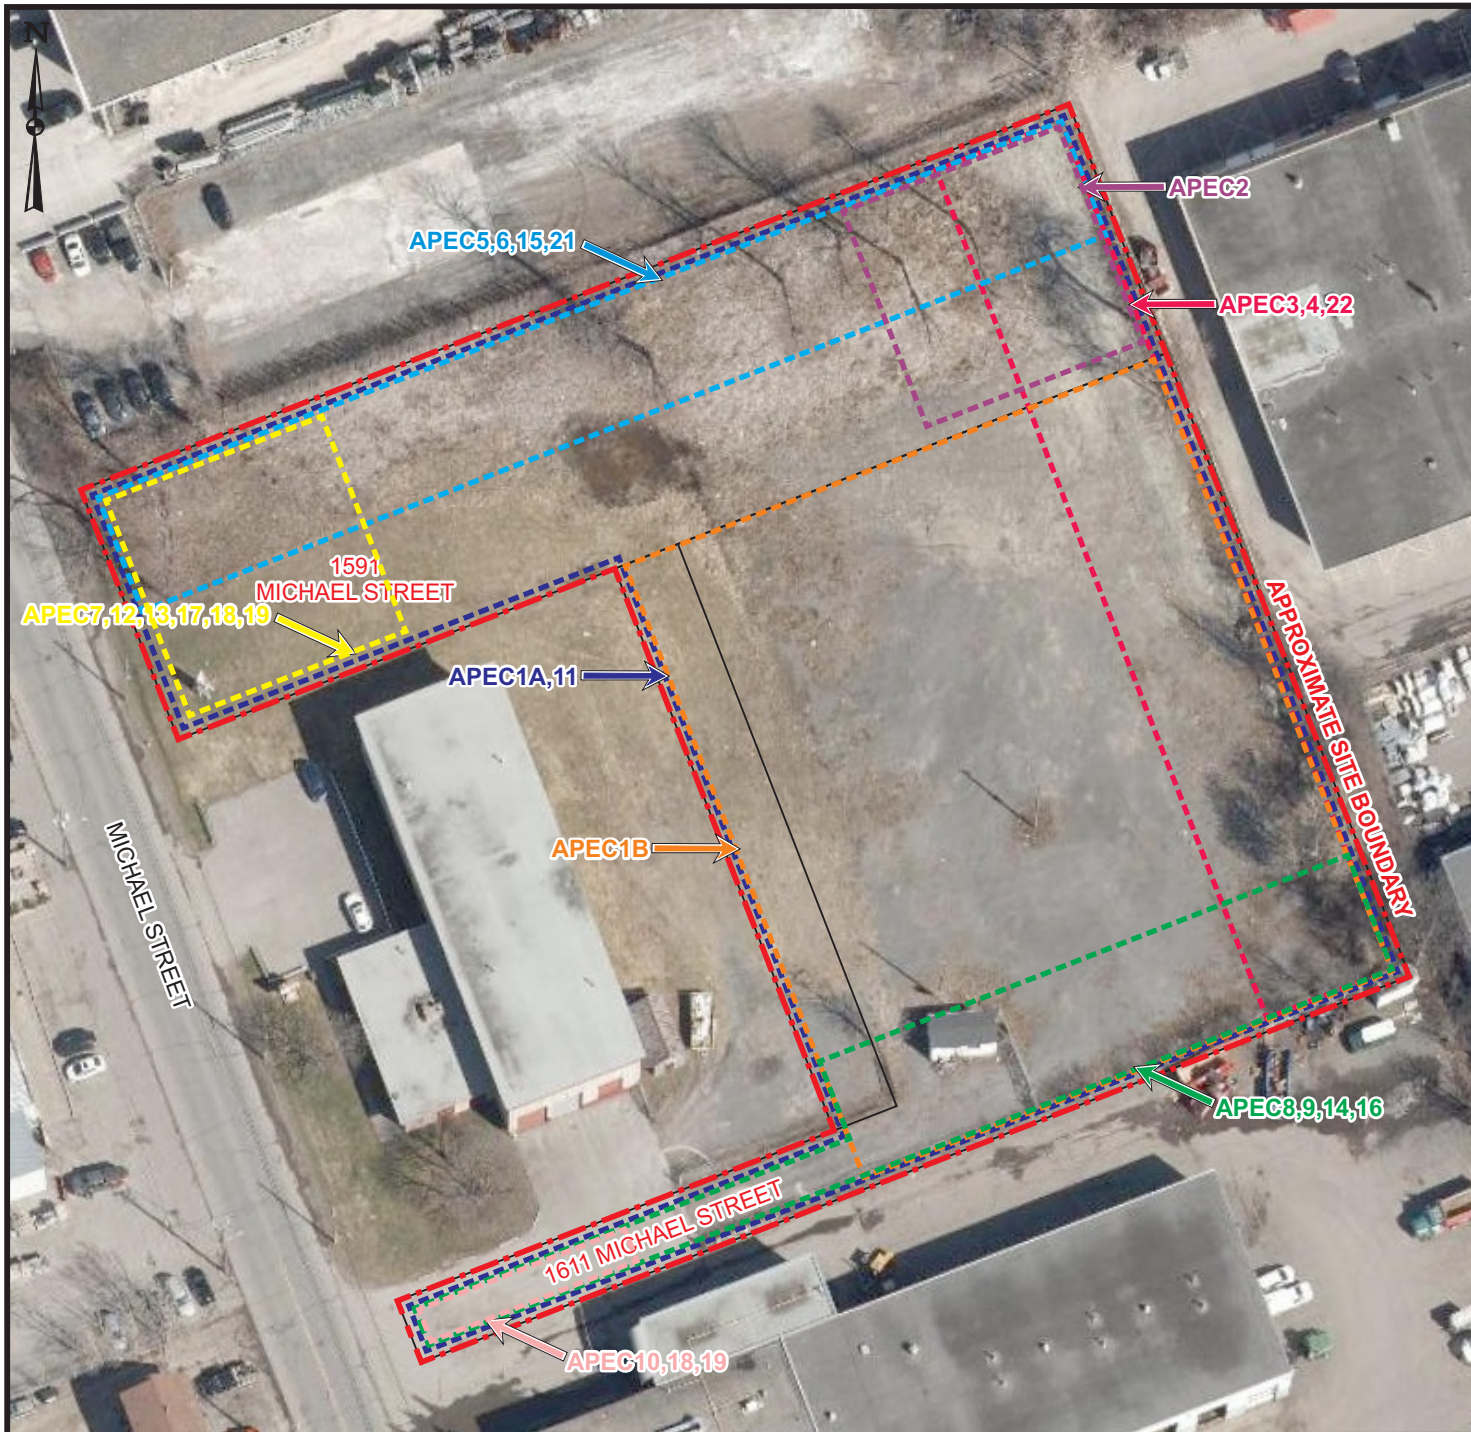
DRAWN BY: SW	PROJECT NO.: CO892.01	CHECKED BY: XX
REVISION: 00	DATE: DECEMBER 2022	FIGURE: 4

- SITE BOUNDARY
- PHASE ONE STUDY AREA
- POTENTIALLY CONTAMINATING ACTIVITIES (PCA)
- TANK LOCATION

TITLE:
**CONCEPTUAL SITE MODEL AND
 POTENTIALLY CONTAMINATING ACTIVITIES**

The City of Ottawa provided a copy of the HLUI record for the vicinity of the Site. A copy of the HLUI search results is provided in Appendix VI, and current and/or historical tank locations identified in the HLUI report are shown on Figure 4. Other pertinent results of the HLUI report are provided below:

A PCA as defined in O. Reg. 153/04 is a use or activity set out in Column A of Table 2 of Schedule D that is occurring or has occurred in the Phase One study area. Other activities not specifically listed in Table 2 of Schedule D, may also be considered as PCAs based on the judgement/discretion of the qualified person. The PCAs which are occurring or have previously occurred on properties within the Phase One study area, including the Site are listed below, and are shown in Figure 4.

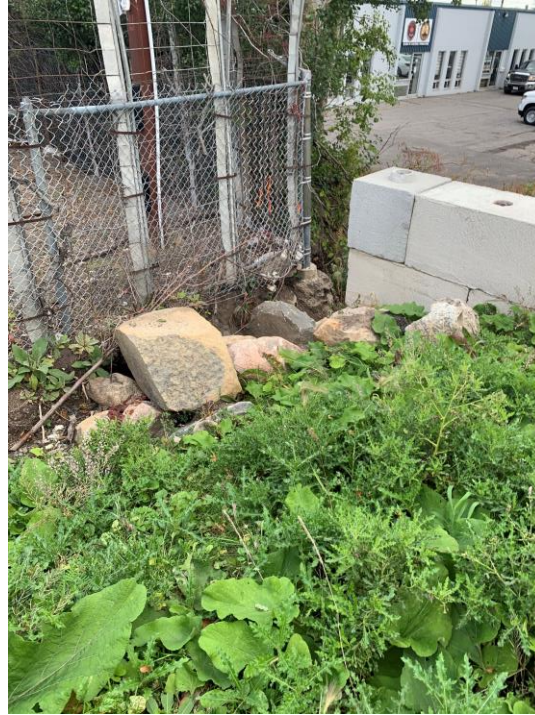
Photo No: 2

A retaining wall was observed along the eastern property boundary.

Apparent fill material and evidence of excavation was observed along the eastern property boundary, where a concrete block retaining wall was present. An area of lower elevation was observed in the north-central portion of the Site, evidenced by softer, wet soils.

The presence of a retaining wall at the eastern boundary of the Site and the observed debris piles were indicative of the presence of fill of unknown quality and quantity.

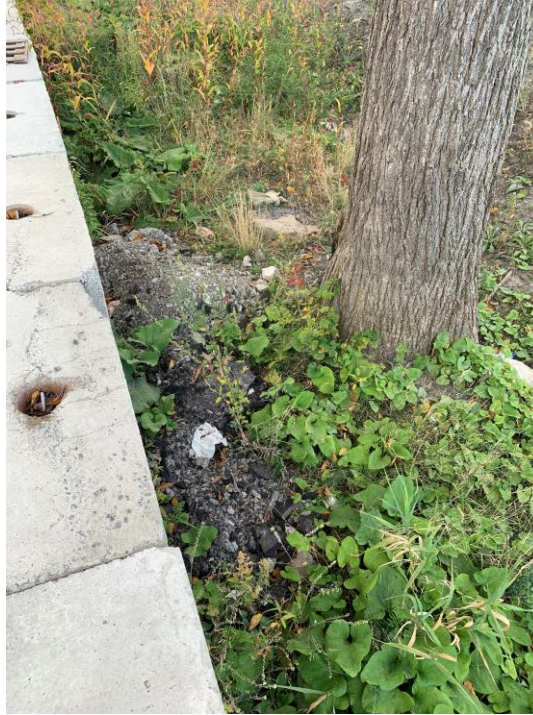
**Photo No:** 4**Date:** 29-SEP-22**Viewing Direction:**
Southeast**Description:**

Disturbed soil and debris piles were observed at the southeast property limit.

Debris and Fill Material: Debris piles were observed along the eastern portion of the property. A retaining wall, holding fill material on-Site, was observed towards the eastern extent of the Site.

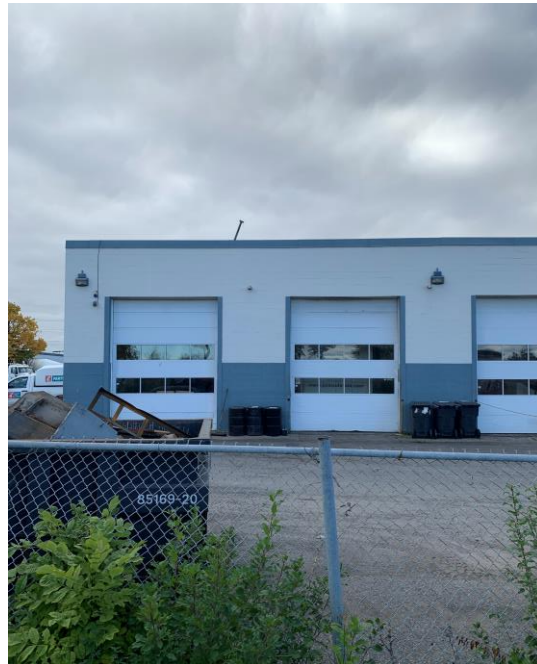
**Photo No:** 6**Date:** 29-SEP-22**Viewing Direction:**
Southwest**Description:**

A half-storey modular building with a shingle roof and wood frame was observed along the southwestern property limit at 1611 Michael Street.

One half-storey wood-framed modular building was observed on-Site. The building had a shingle roof and vinyl siding. The interior of the building was not inspected.
