# Geotechnical Investigation – Proposed Residential Development

3900 Innes Road, Ottawa, Ontario

January 31, 2023

Pinchin File: 304017.001

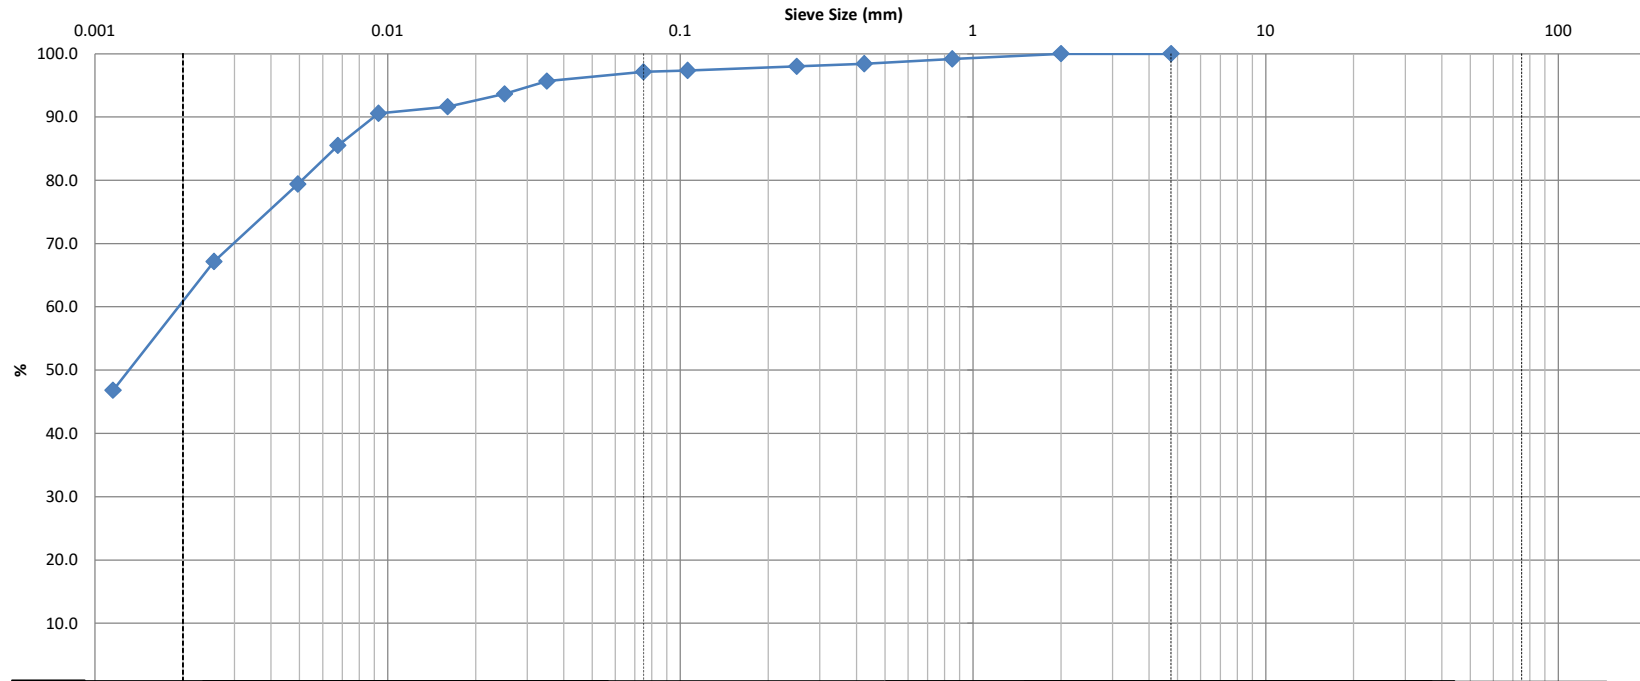
CLIENT:	Pinchin	DEPTH:	5'-0" to 7'-0"	FILE NO:	PM4184
CONTRACT NO.:		BH OR TP No.:	BH-101	LAB NO:	41674
PROJECT:	304017.001			DATE RECEIVED:	10-Jan-23
DATE SAMPLED:	4-Jan-23			DATE TESTED:	12-Jan-23
SAMPLED BY:	Client			DATE REPORTED:	19-Jan-23
				TESTED BY:	DK/CS

Identification	Soil Classification					MC(%)	LL	PL	PI	Cc	Cu
	D100	D60	D30	D10	Gravel (%)	Sand (%)	Silt (%)	Clay (%)			
					0.0	2.9	36.6	60.5

results of four particle size distribution analyses performed samples of the material indicate that the samples contain 1% sand, 31 to 38% silt and 62 to 69% clay. Two additional particle size distribution analyses were performed on samples of the silty clay taken from the supplemental field investigation. The results revealed similar conditions with the samples containing 1 to 3% sand, 32 to 37% silt and 61 to 66% clay. Atterberg Limit testing indicates the material in both field investigations has a liquid limit of between 69 and 84%, a plastic limit of between 31 and 40%, and a plasticity index of between 38 and 44%. The moisture content of the samples tested ranged between 48 to 87%, indicating the material tested was wetter than plastic limit (WTPL) at the time of sampling.

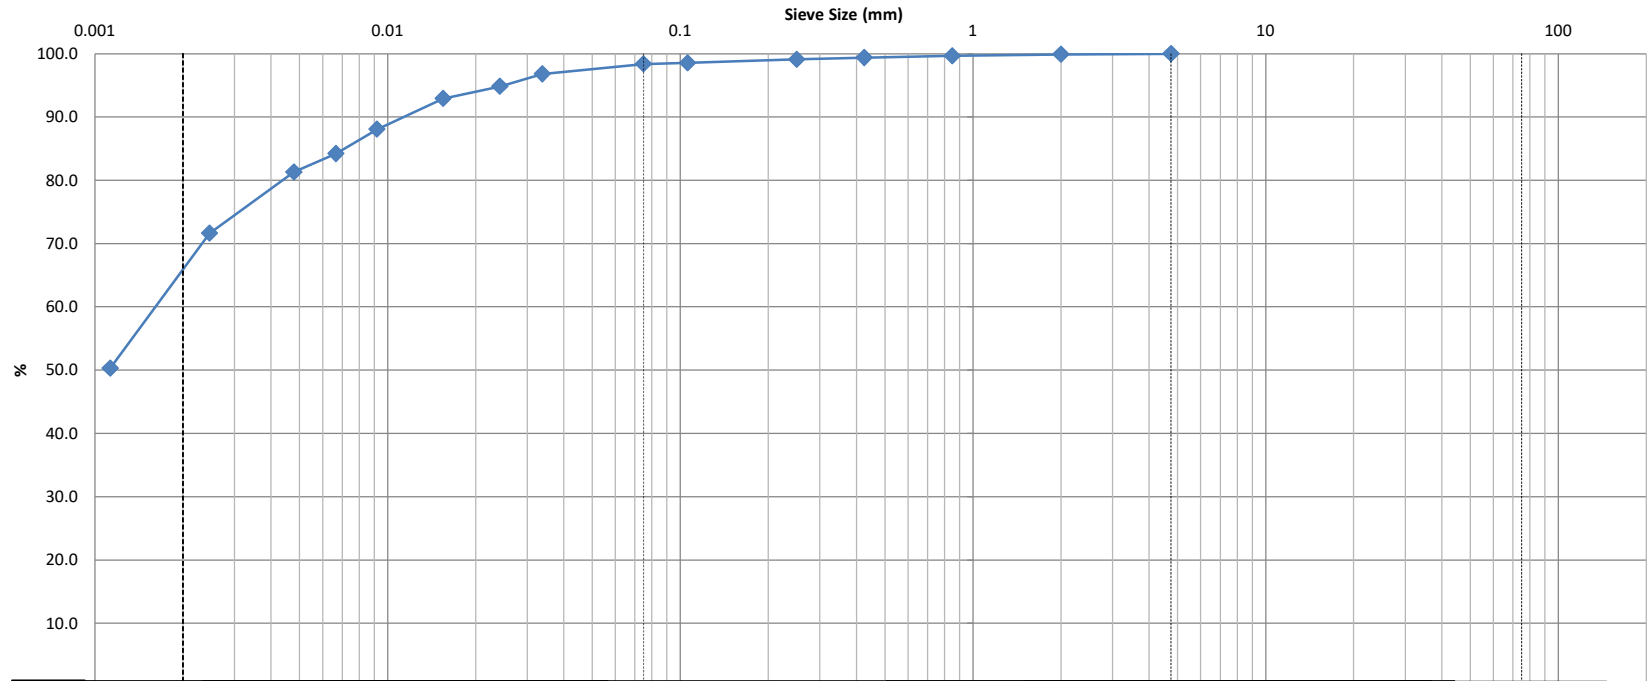
CLIENT:	Pinchin	DEPTH:	15'-0" to 17'-0"	FILE NO:	PM4184
CONTRACT NO.:		BH OR TP No.:	BH-102	LAB NO:	41675
PROJECT:	304017.001			DATE RECEIVED:	10-Jan-23
				DATE TESTED:	12-Jan-23
DATE SAMPLED:	4-Jan-23			DATE REPORTED:	19-Jan-23
SAMPLED BY:	Client			TESTED BY:	DK/CS

Identification	Soil Classification					MC(%)	LL	PL	PI	Cc	Cu
	D100	D60	D30	D10	Gravel (%)	Sand (%)	Silt (%)	Clay (%)			
					0.0	1.6	32.4	66.0

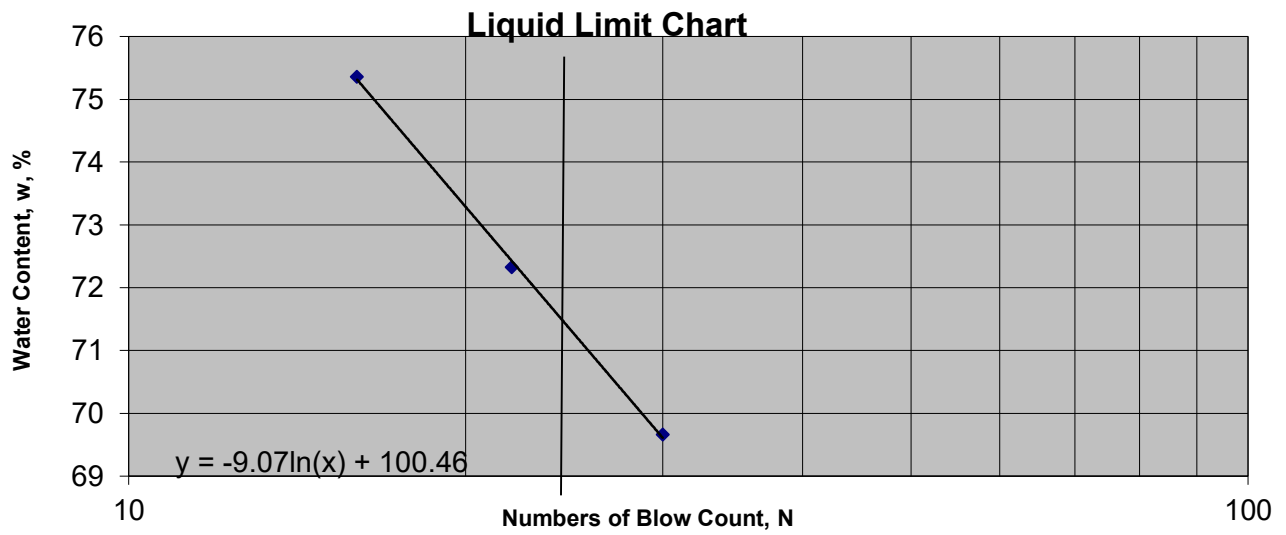
CAN NO.	9	18
WT. OF CAN	19.35	20.01
WT. OF SOIL & CAN	27.09	28.12
WT. OF DRY SOIL & CAN	25.11	26.04
WT. OF MOISTURE	1.98	2.08
WT. OF DRY SOIL & CAN	5.76	6.03
WATER CONTENT, w, %	<b>34.38</b>	<b>34.49</b>

RESULTS	
LIQUID LIMIT	<b>72</b>
PLASTIC LIMIT	<b>34</b>
PLASTICITY INDEX	<b>38</b>

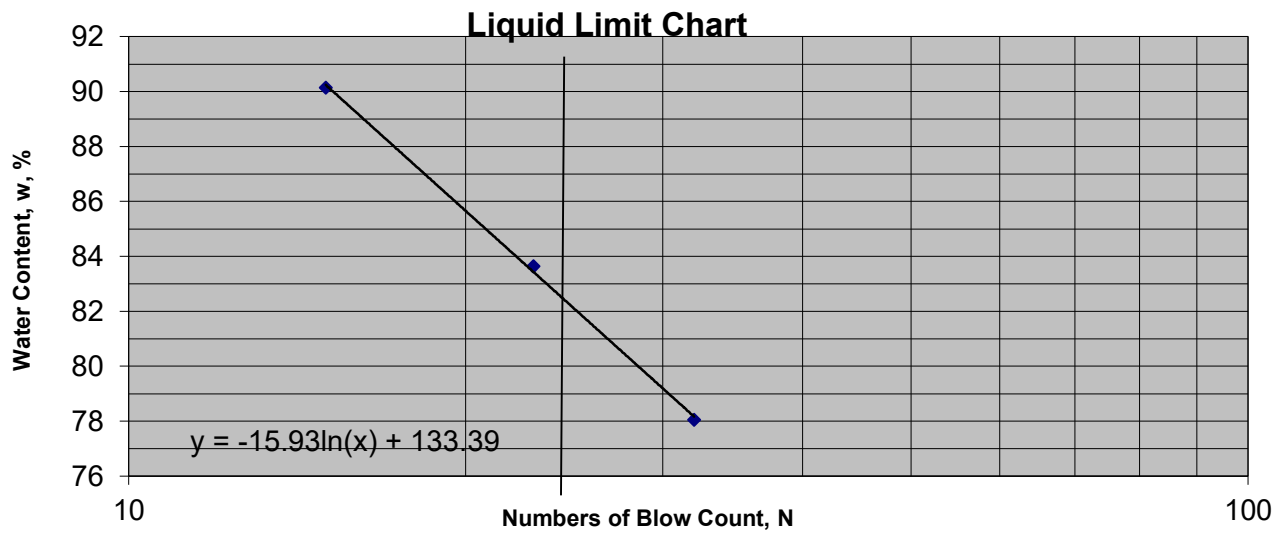
RESULTS	
LIQUID LIMIT	<b>84</b>
PLASTIC LIMIT	<b>40</b>
PLASTICITY INDEX	<b>44</b>

CAN NO.	3	12
WT. OF CAN	19.4	16.73
WT. OF SOIL & CAN	28.31	24.96
WT. OF DRY SOIL & CAN	25.74	22.61
WT. OF MOISTURE	2.57	2.35
WT. OF DRY SOIL & CAN	6.34	5.88
WATER CONTENT, w, %	<b>40.54</b>	<b>39.97</b>

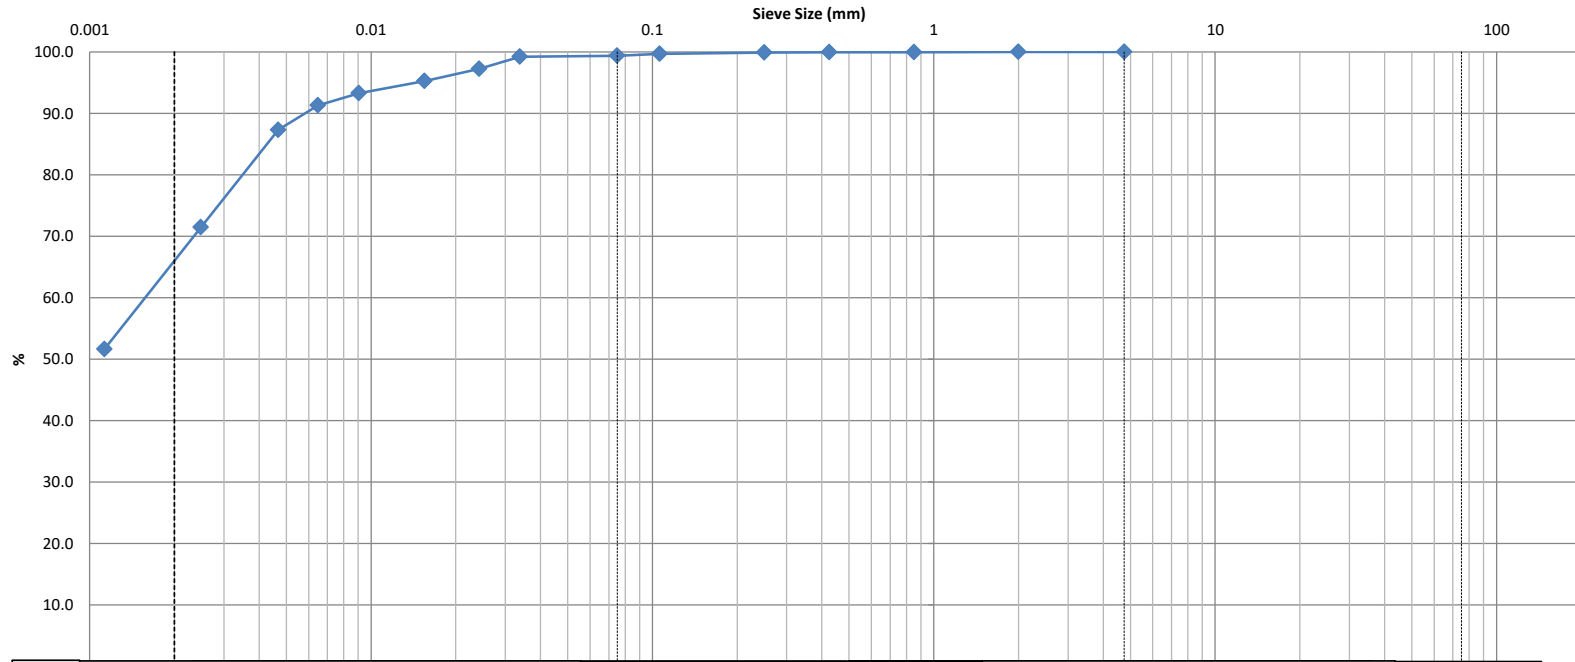
CLIENT:	Pinchin	DEPTH:	5'-7'	FILE NO:	PM4184
CONTRACT NO.:		BH OR TP No.:	BH7	LAB NO:	32743
PROJECT:	304017			DATE RECEIVED:	4-May-22
				DATE TESTED:	6-May-22
DATE SAMPLED:	4-May-22			DATE REPORTED:	11-May-22
SAMPLED BY:	Client			TESTED BY:	DK

Identification	Soil Classification					MC(%)	LL	PL	PI	Cc	Cu
	D100	D60	D30	D10	Gravel (%)	50.0					
					0.0	0.6		33.4		66.0

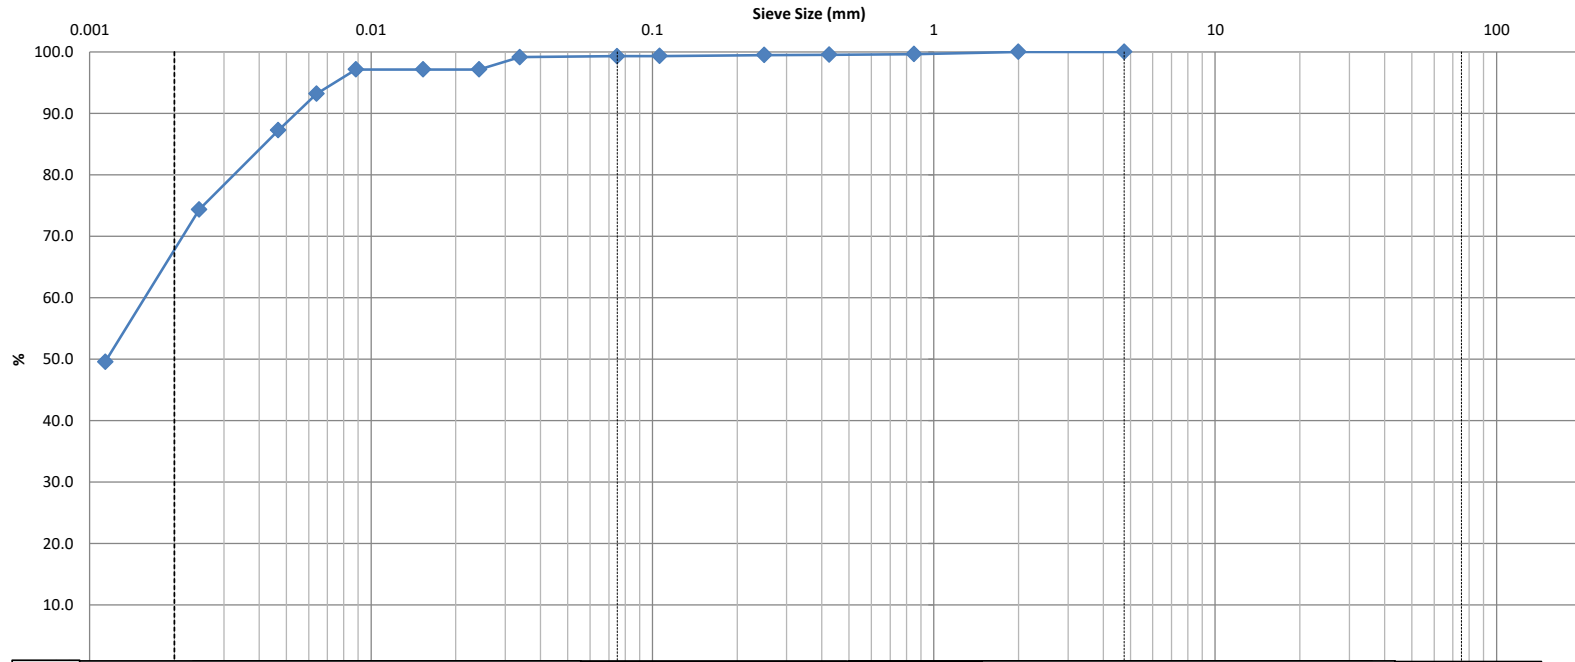
CLIENT:	Pinchin	DEPTH:	15' - 17'	FILE NO:	PM4184
CONTRACT NO.:		BH OR TP No.:	BH5	LAB NO:	32744
PROJECT:	304017			DATE RECEIVED:	4-May-22
				DATE TESTED:	6-May-22
DATE SAMPLED:	3-May-22			DATE REPORTED:	12-May-22
SAMPLED BY:	Client			TESTED BY:	DK

Identification	Soil Classification					MC(%)	LL	PL	PI	Cc	Cu
	D100	D60	D30	D10	Gravel (%)	87.0					
					0.0	0.7		30.8		68.5

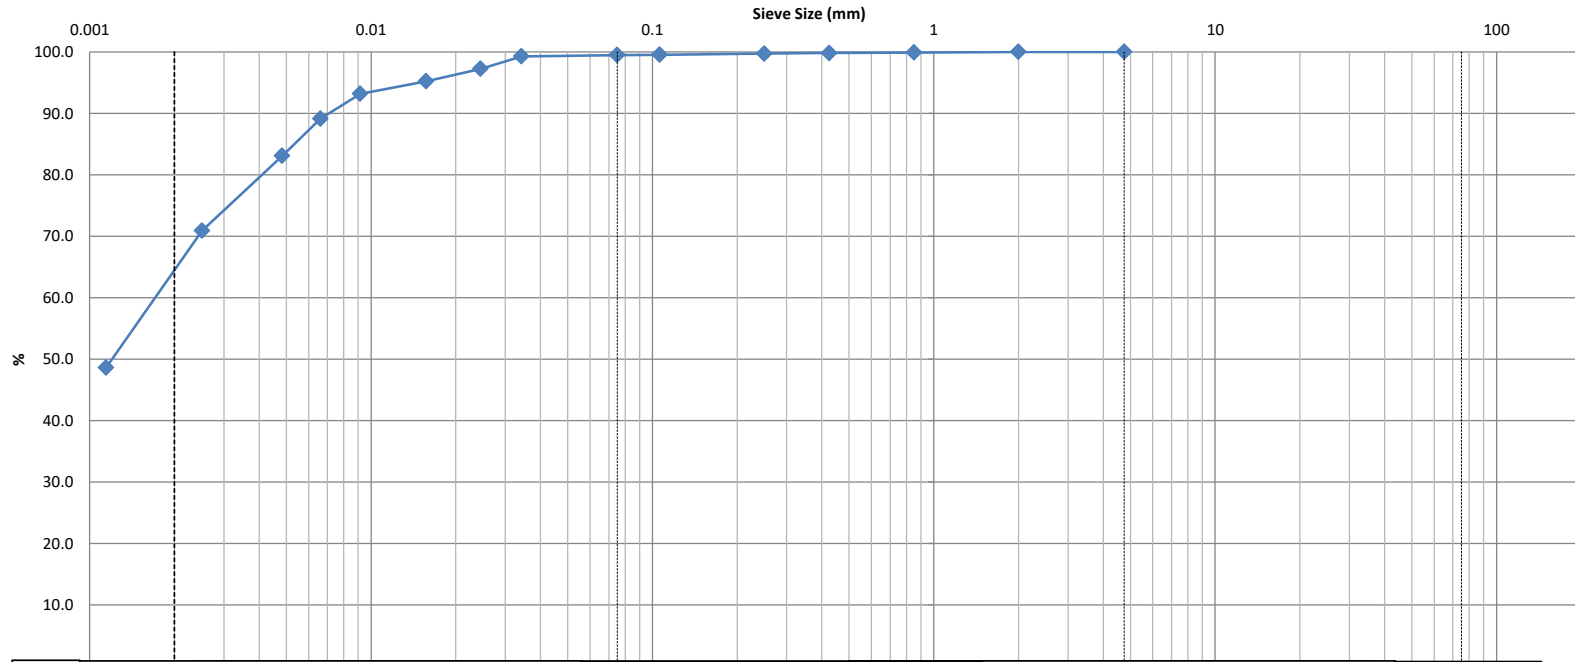
CLIENT:	Pinchin	DEPTH:	7.5' - 9.5'	FILE NO:	PM4184
CONTRACT NO.:		BH OR TP No.:	BH1	LAB NO:	32745
PROJECT:	304017			DATE RECEIVED:	4-May-22
				DATE TESTED:	6-May-22
DATE SAMPLED:	3-May-22			DATE REPORTED:	12-May-22
SAMPLED BY:	Client			TESTED BY:	DK

Identification	Soil Classification					MC(%)	LL	PL	PI	Cc	Cu
	D100	D60	D30	D10	Gravel (%)	65.1					
					0.0	0.5		35.5		64.0

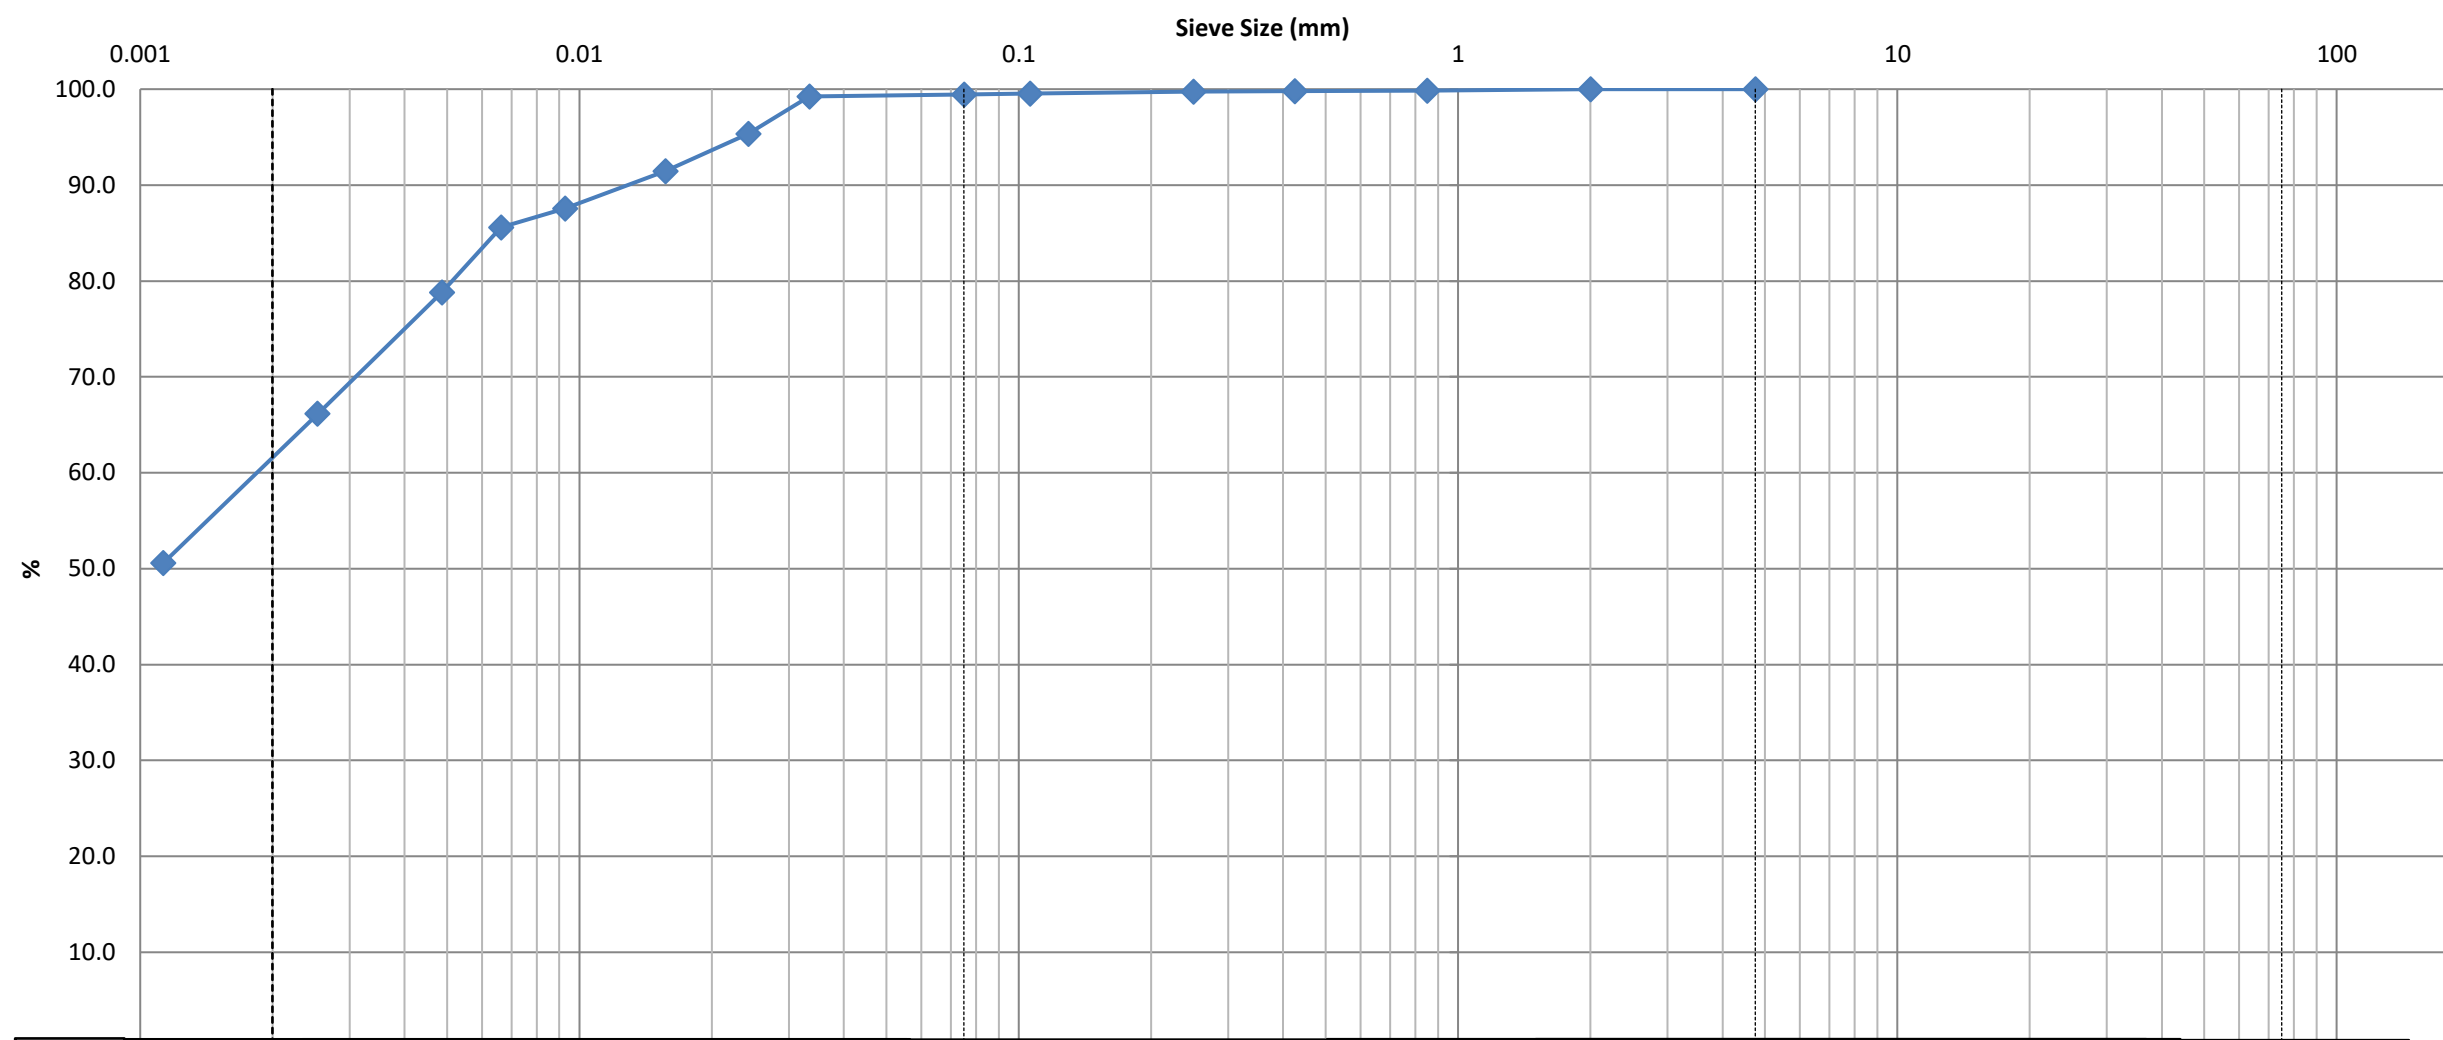
CLIENT:	Pinchin	DEPTH:	5.0'-7.0'	FILE NO:	PM4184
CONTRACT NO.:		BH OR TP No.:	BH11	LAB NO:	32741
PROJECT:	304017			DATE RECEIVED:	4-May-22
DATE SAMPLED:	2-May-22			DATE TESTED:	20-May-22
SAMPLED BY:	Client			DATE REPORTED:	27-May-22
				TESTED BY:	DK

Identification	Soil Classification					MC(%)	LL	PL	PI	Cc	Cu
	D100	D60	D30	D10	Gravel (%)	Sand (%)	Silt (%)	Clay (%)			
					0.0	0.6	37.9	61.5

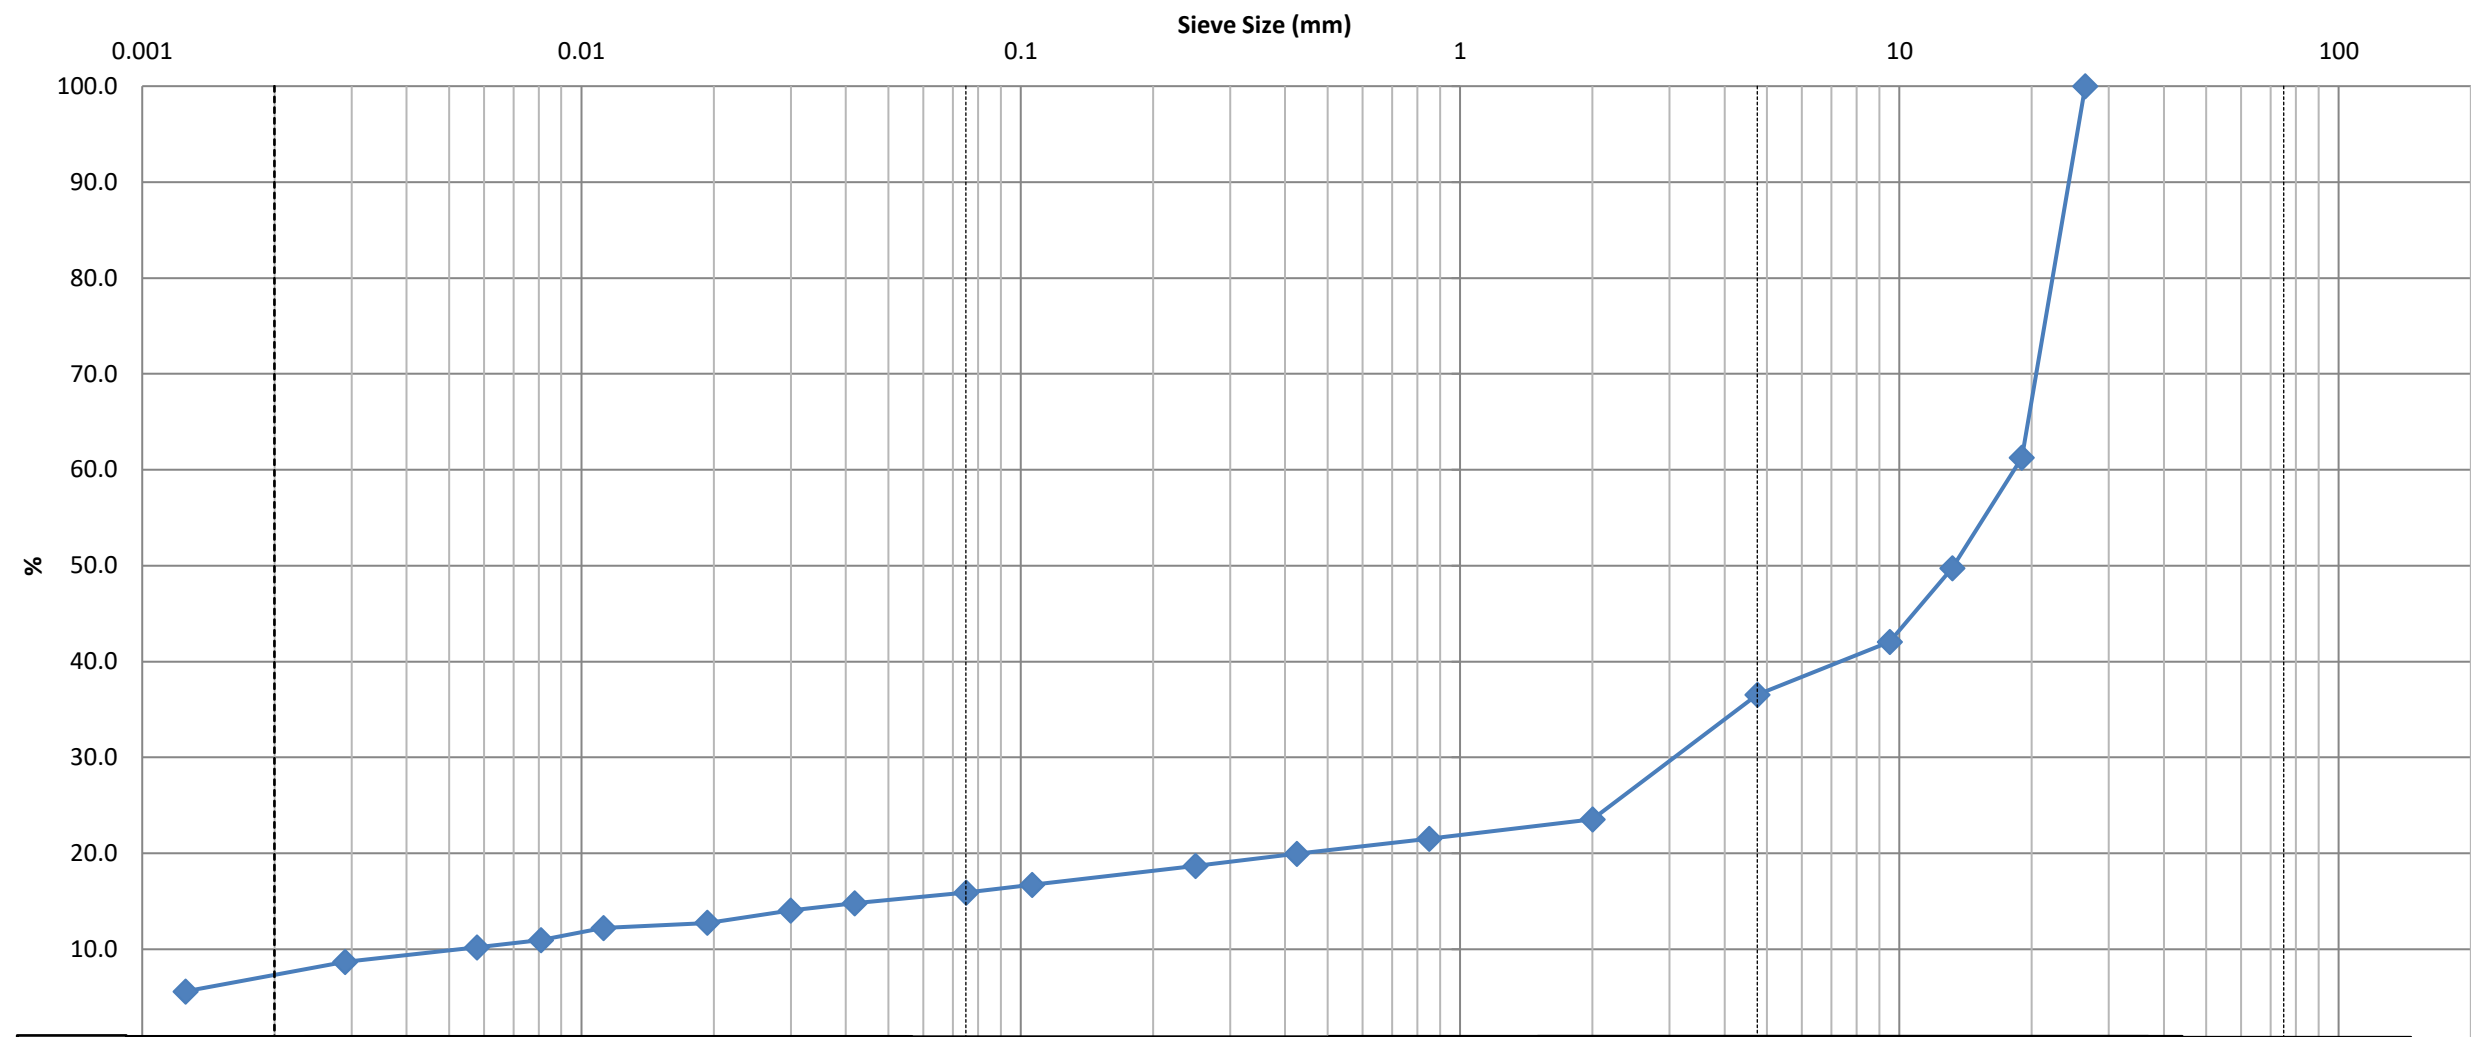
CLIENT:	Pinchin	DEPTH:	20.0'-22.0'	FILE NO:	PM4184
CONTRACT NO.:		BH OR TP No.:	BH2	LAB NO:	32742
PROJECT:	304017			DATE RECEIVED:	4-May-22
DATE SAMPLED:	2-May-22			DATE TESTED:	20-May-22
SAMPLED BY:	Client			DATE REPORTED:	27-May-22
				TESTED BY:	DK

Identification	Soil Classification					MC(%)	LL	PL	PI	Cc	Cu
	D100	D60	D30	D10	Gravel (%)	Sand (%)	Silt (%)	Clay (%)			
					63.4	20.6	8.4	7.5

Glacial till was encountered underlying the silty clay in Boreholes BH1, BH2, BH5, BH9, BH13 and BH101 at depths ranging from approximately 2.4 to 6.1 mbgs and extended to the top of bedrock at depths of up to 7.9 mbgs. The glacial till remained consistent in soil matrix and comprised sandy gravel containing trace silt and trace clay that was brown in colour. The material had a loose to compact relative density based on SPT 'N' values of 6 to 27 blows per 300 mm penetration of a split spoon sampler. The result of one particle size distribution analysis performed on a sample of the glacial till material indicates that the sample contains 63% gravel, 21% sand, 8% silt and 8% clay. The moisture content of the sample tested was 13.3% indicating the material was in a moist condition at the time of sampling.

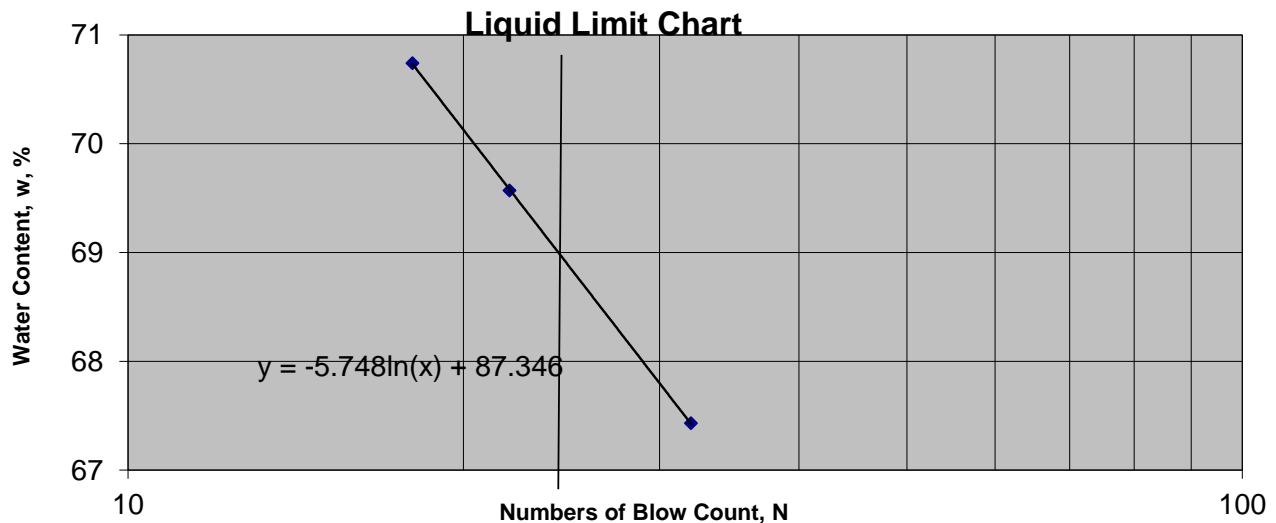
LIQUID LIMIT	<b>69</b>
PLASTIC LIMIT	<b>31</b>
PLASTICITY INDEX	<b>38</b>

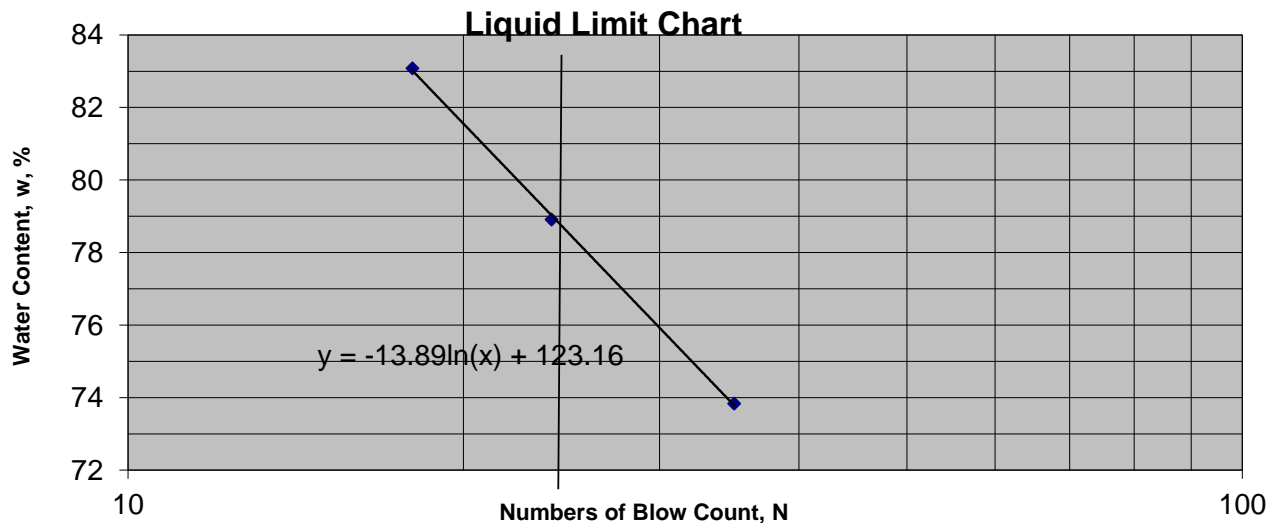
LIQUID LIMIT	<b>79</b>
PLASTIC LIMIT	<b>38</b>
PLASTICITY INDEX	<b>41</b>

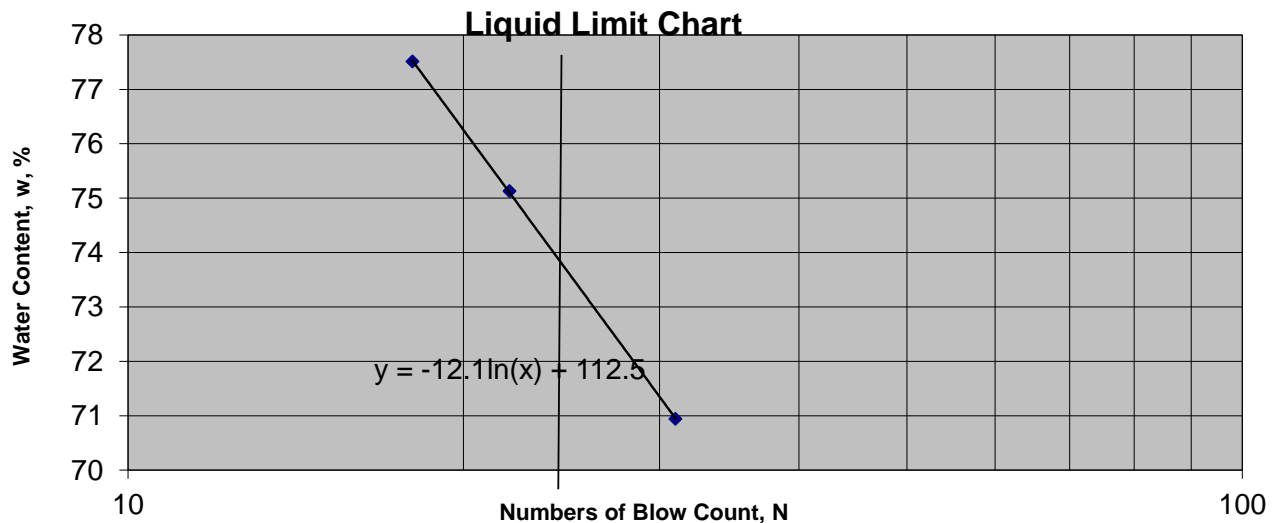
LIQUID LIMIT	<b>75</b>
PLASTIC LIMIT	<b>36</b>
PLASTICITY INDEX	<b>39</b>
