**Geotechnical Investigation
Block 175 on Plan 4M-1689
Shea Road and Cosanti Drive**

Ottawa, Ontario

GEMTEC Project: 102166.001-RPT01-Rev1

November 2, 2022

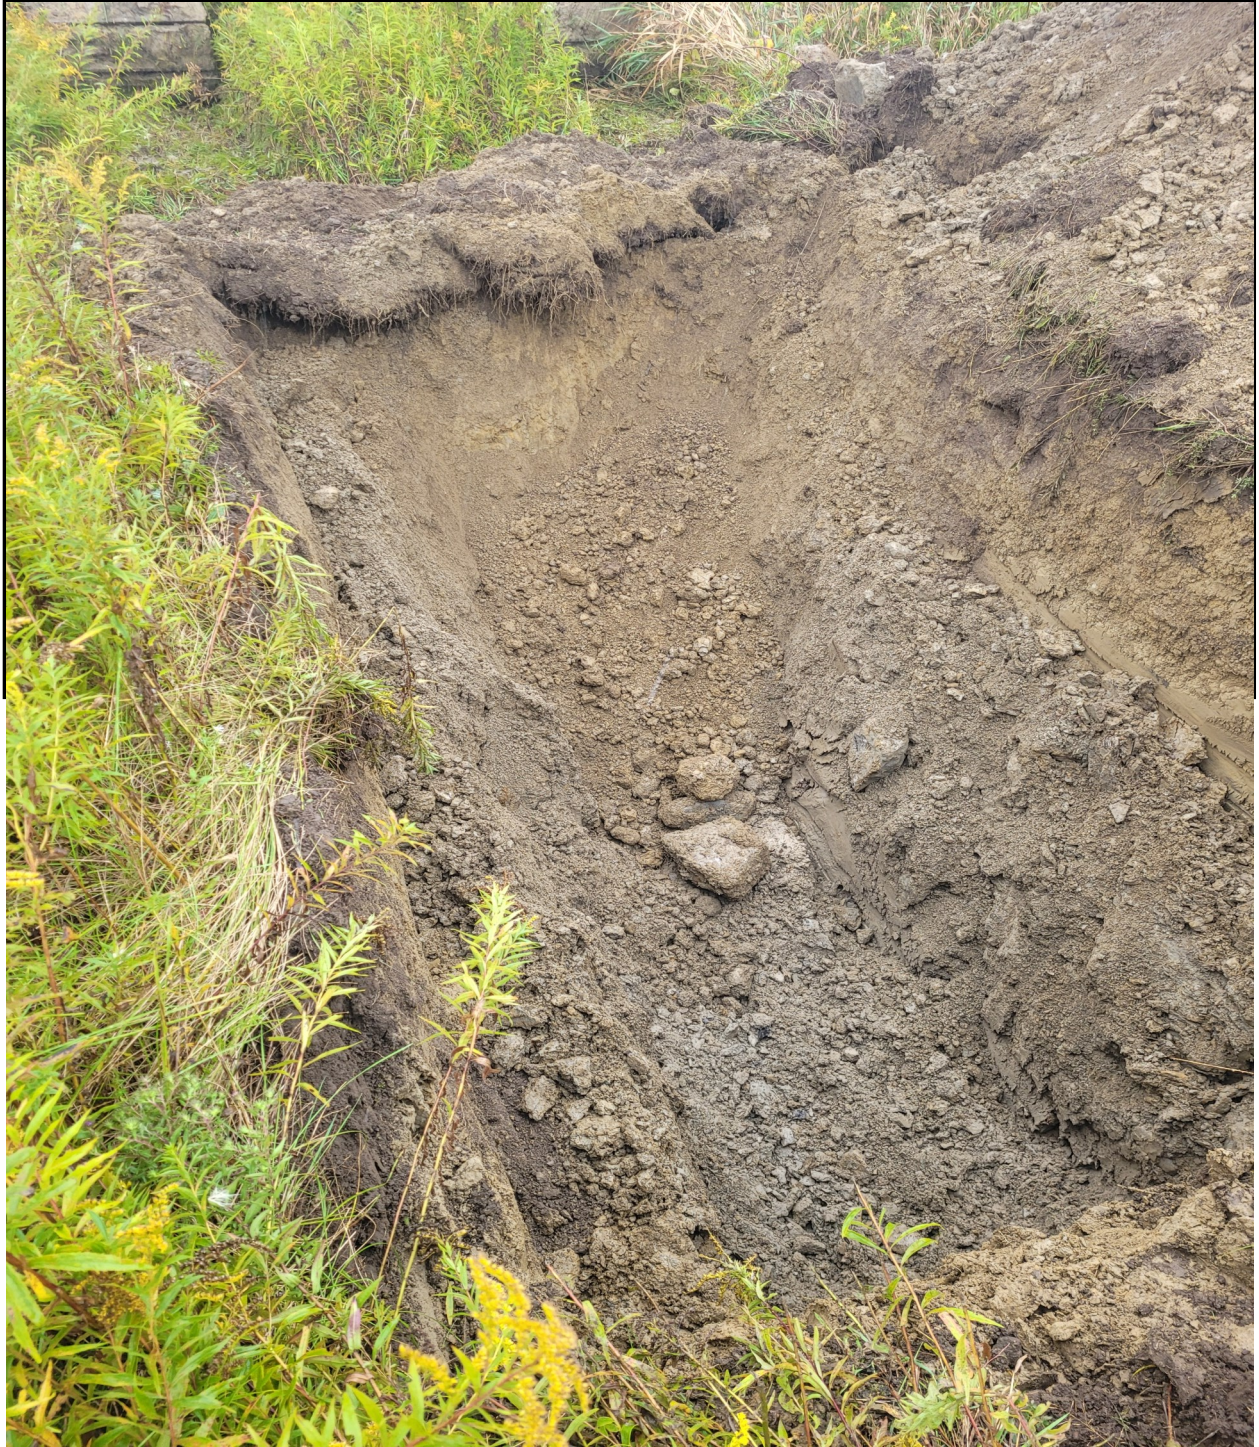
FIGURE D1

TP22-01

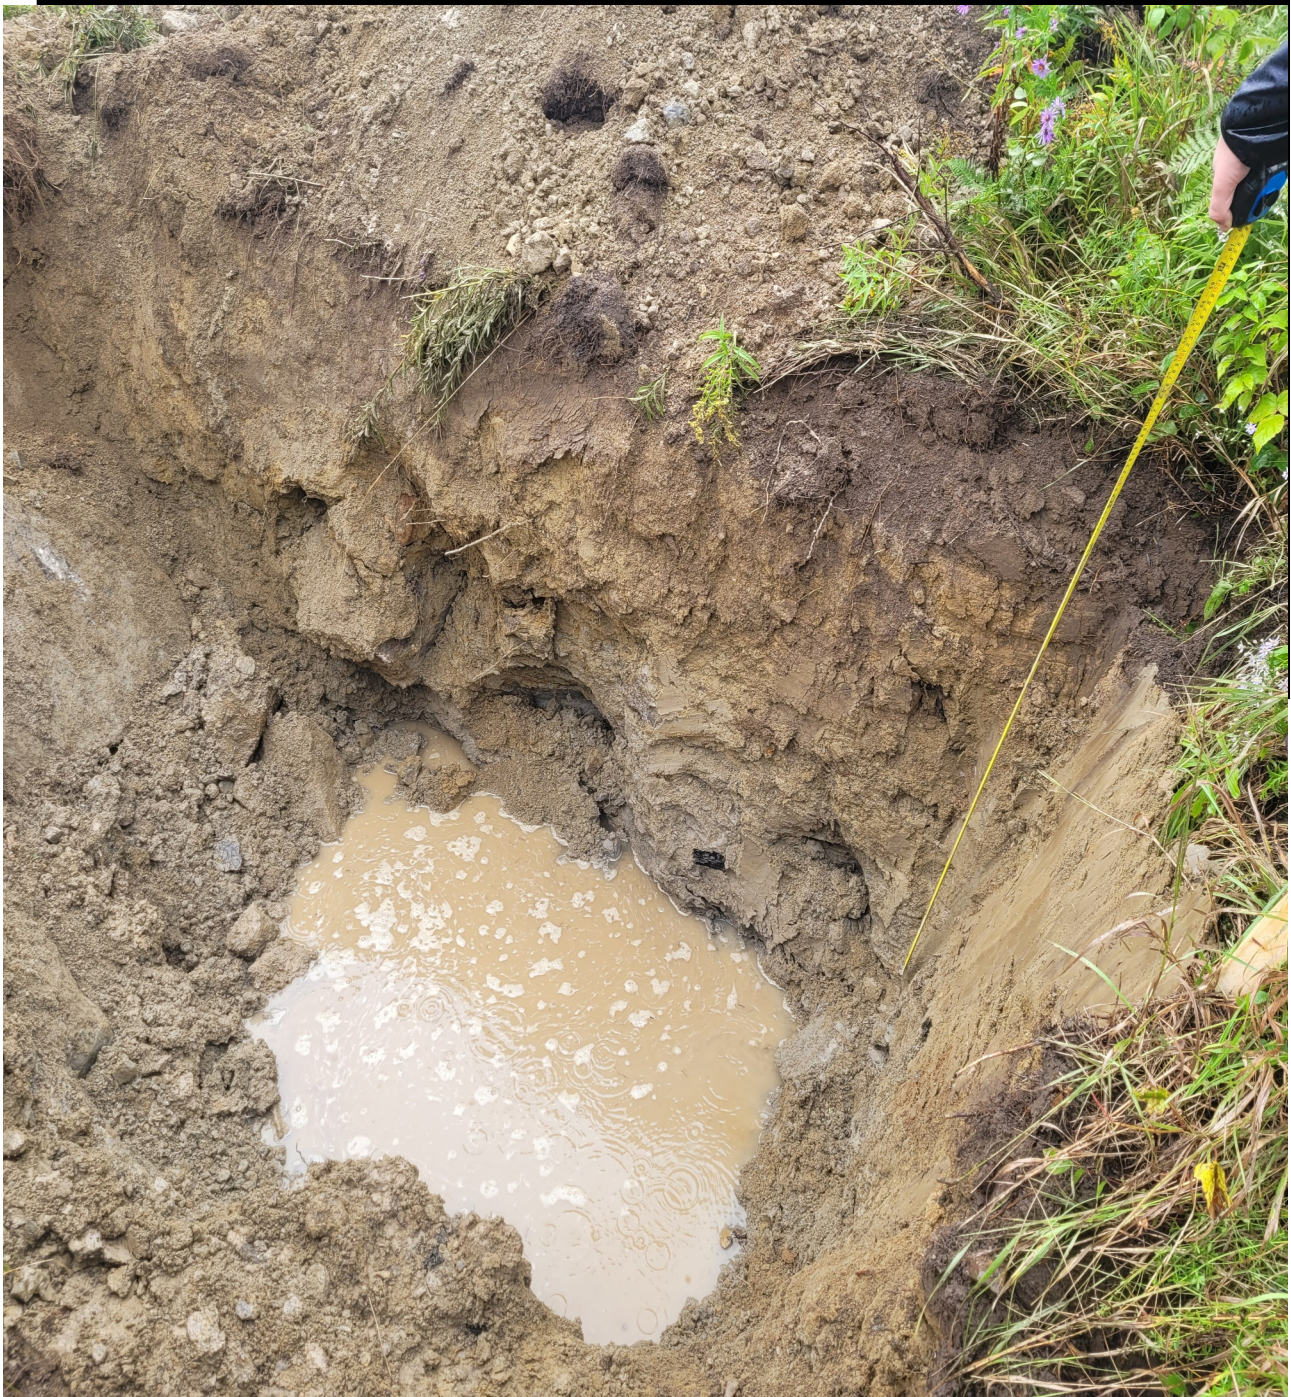
FIGURE D2

TP22-02

in TP-22-02, TP-22-03, TP-22-04, TP22-05, TP 22-08, leading to standing water ponding across the base of the test pit. No indications of seepage or groundwater inflow were noted in the other test pits. The depths and elevations at which groundwater seepage was observed are summarized in Table 5.3.

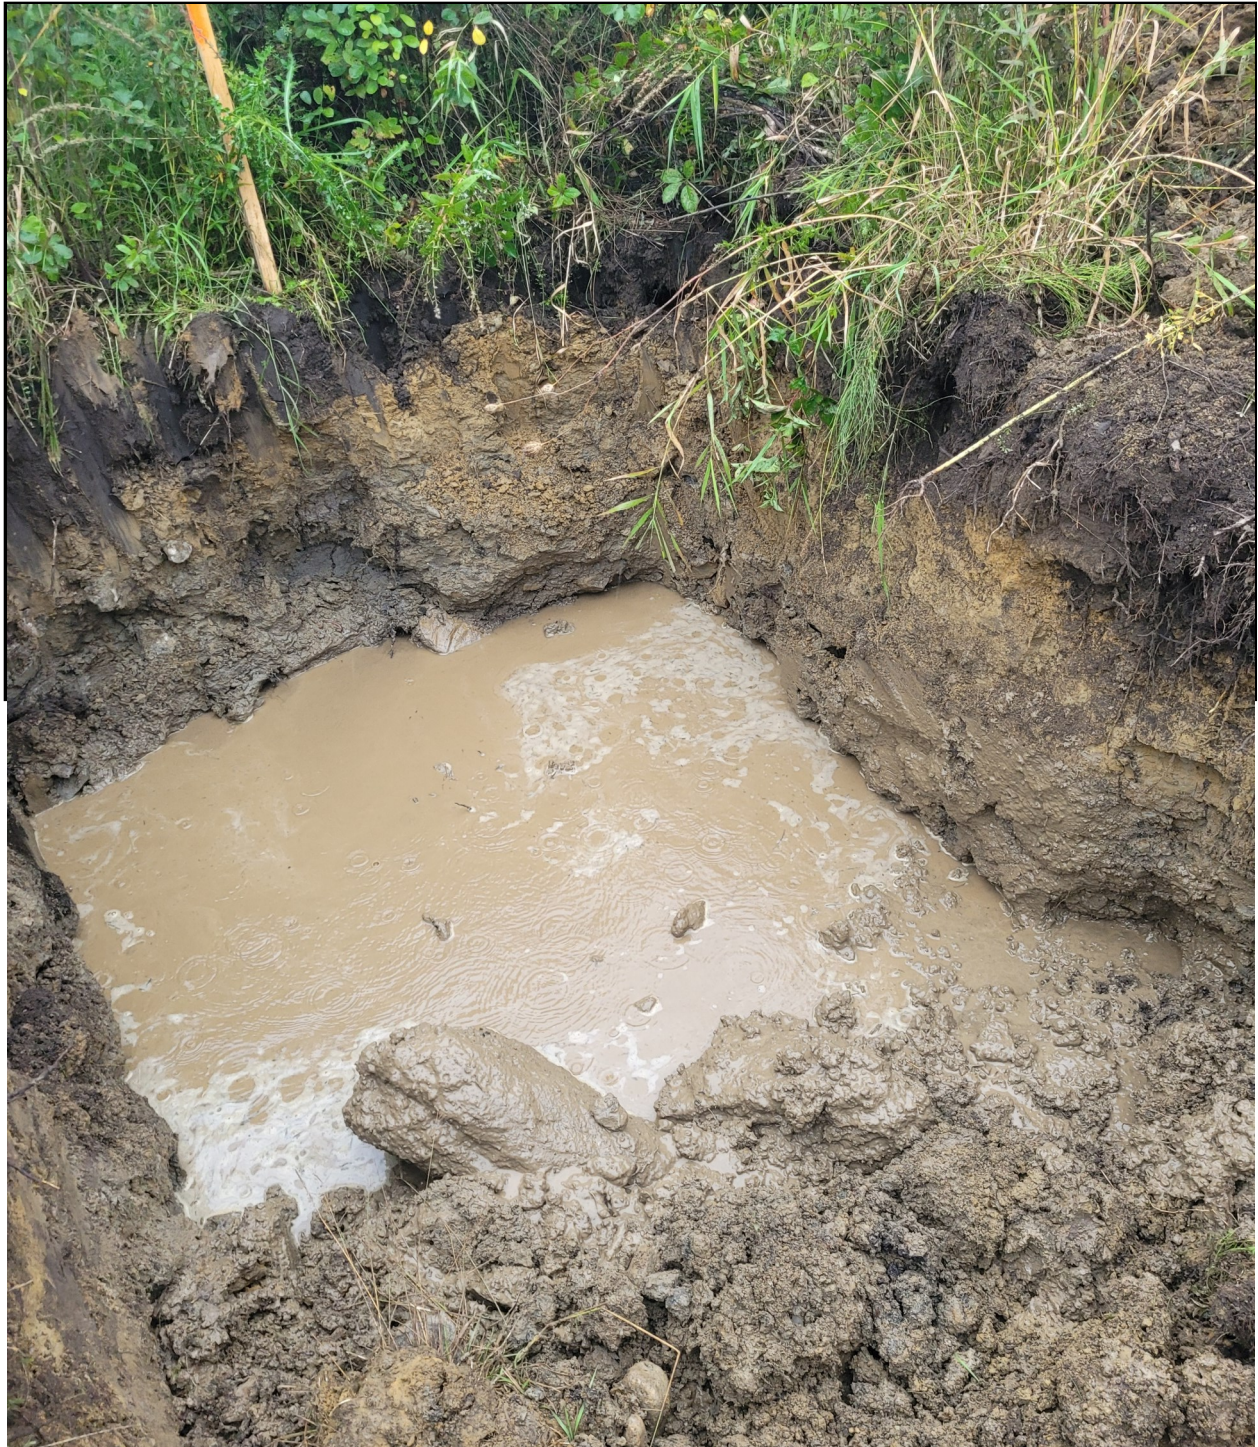
FIGURE D3

TP22-03

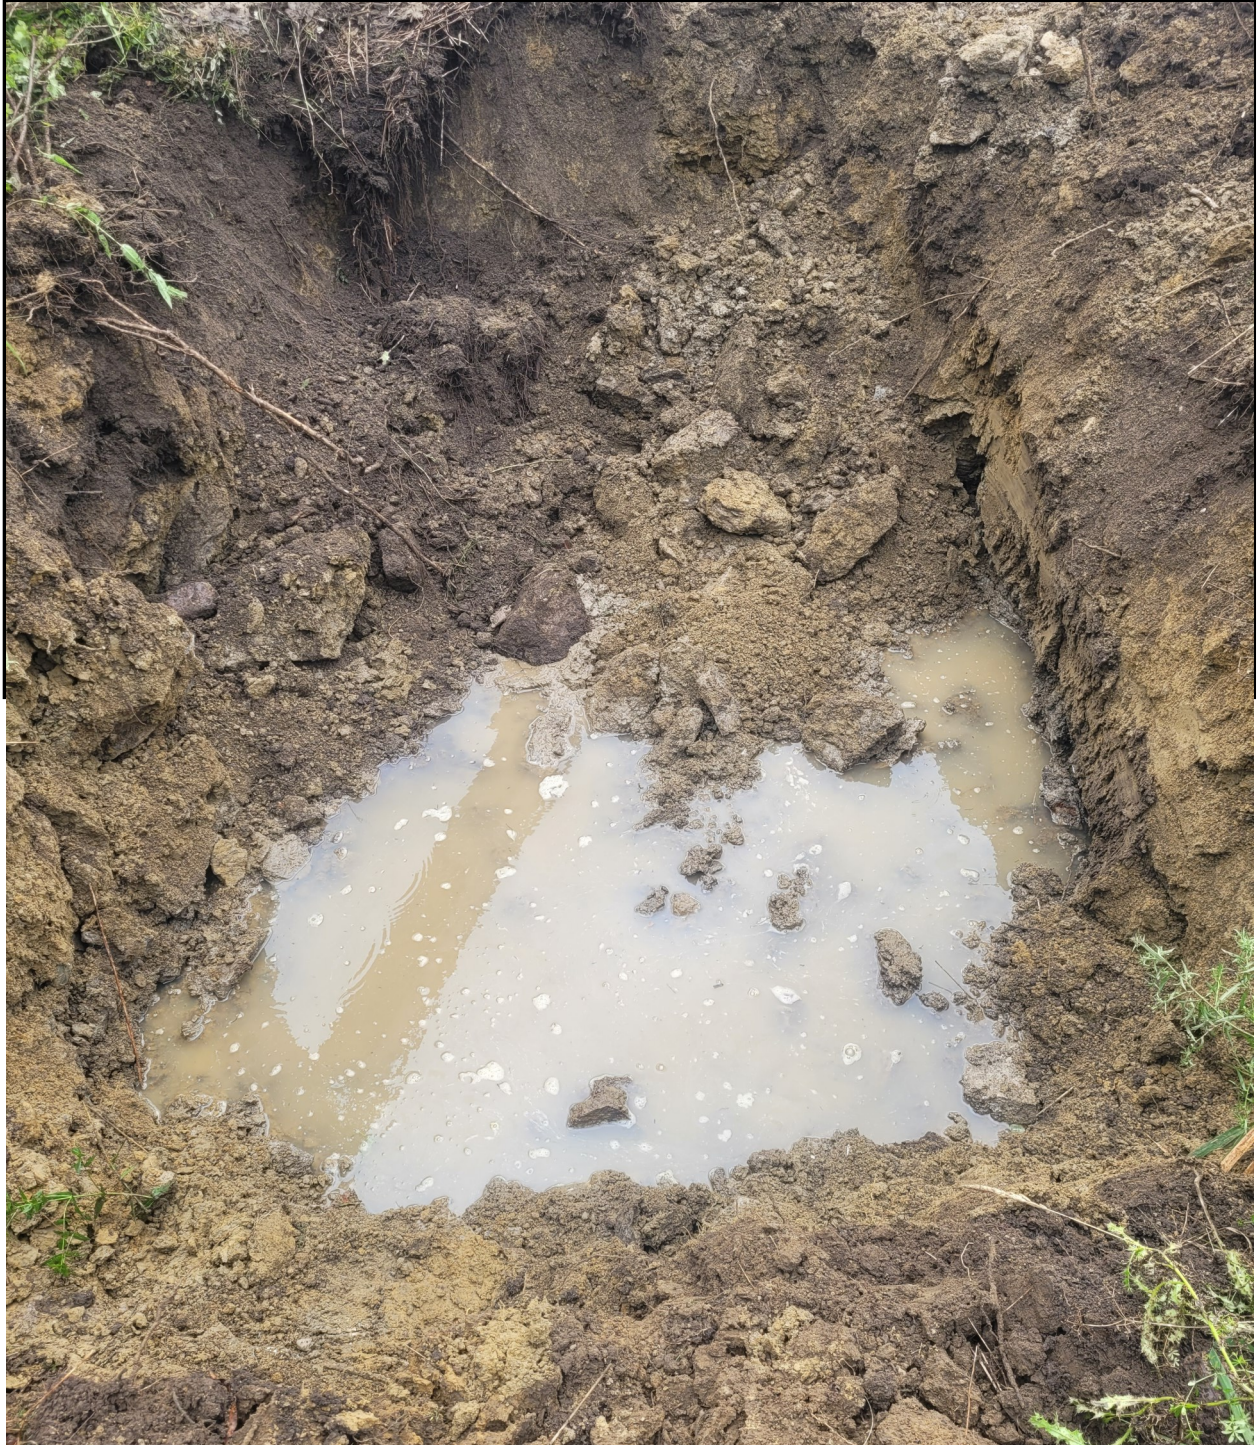
FIGURE D4

TP22-04

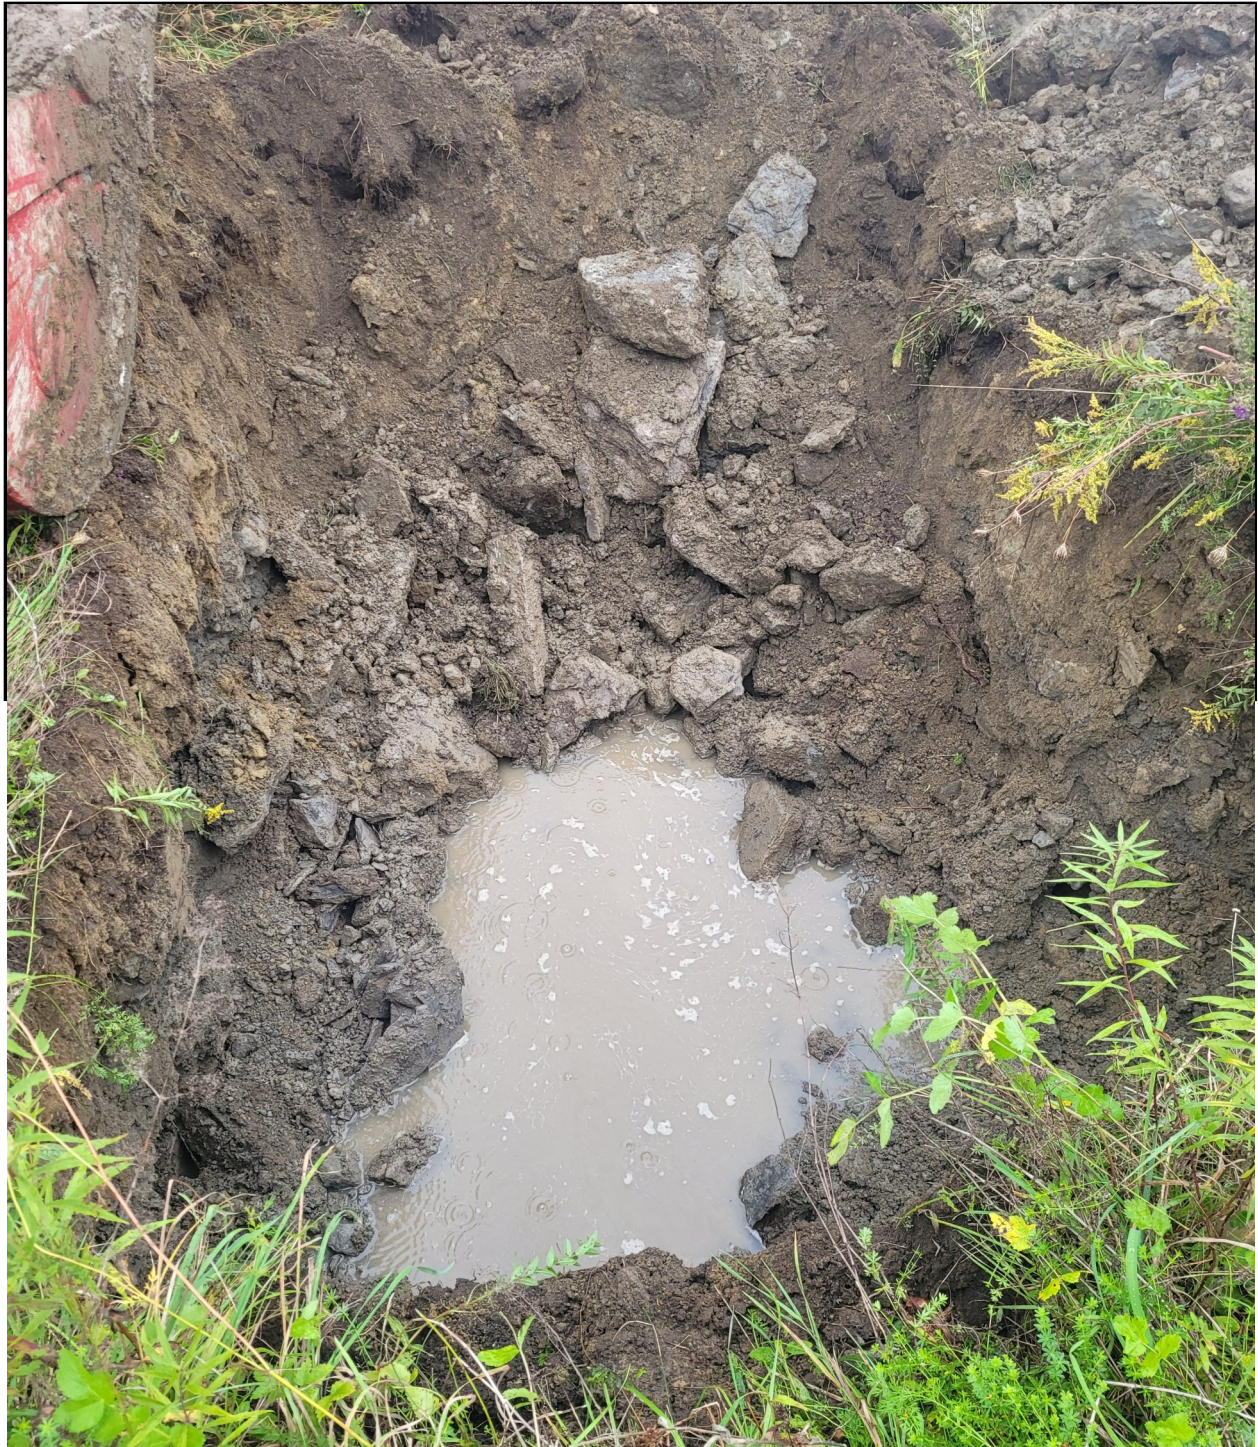
FIGURE D5

TP22-05

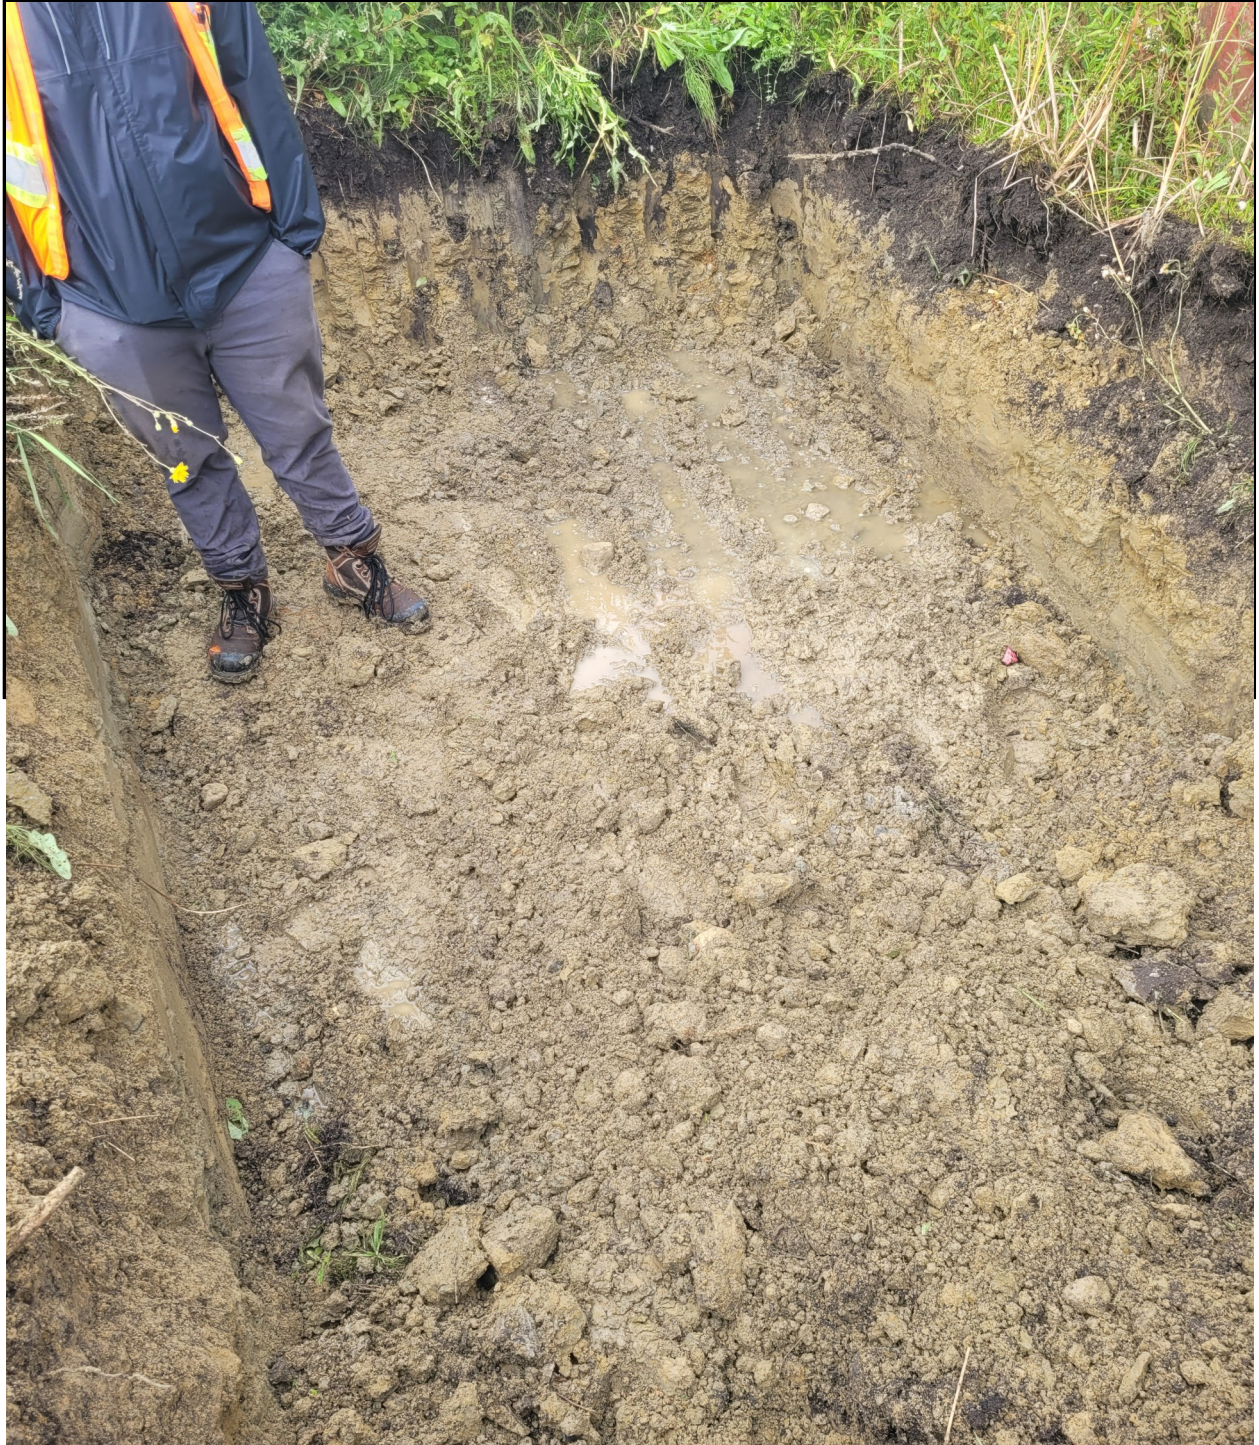
FIGURE D6

TP22-06

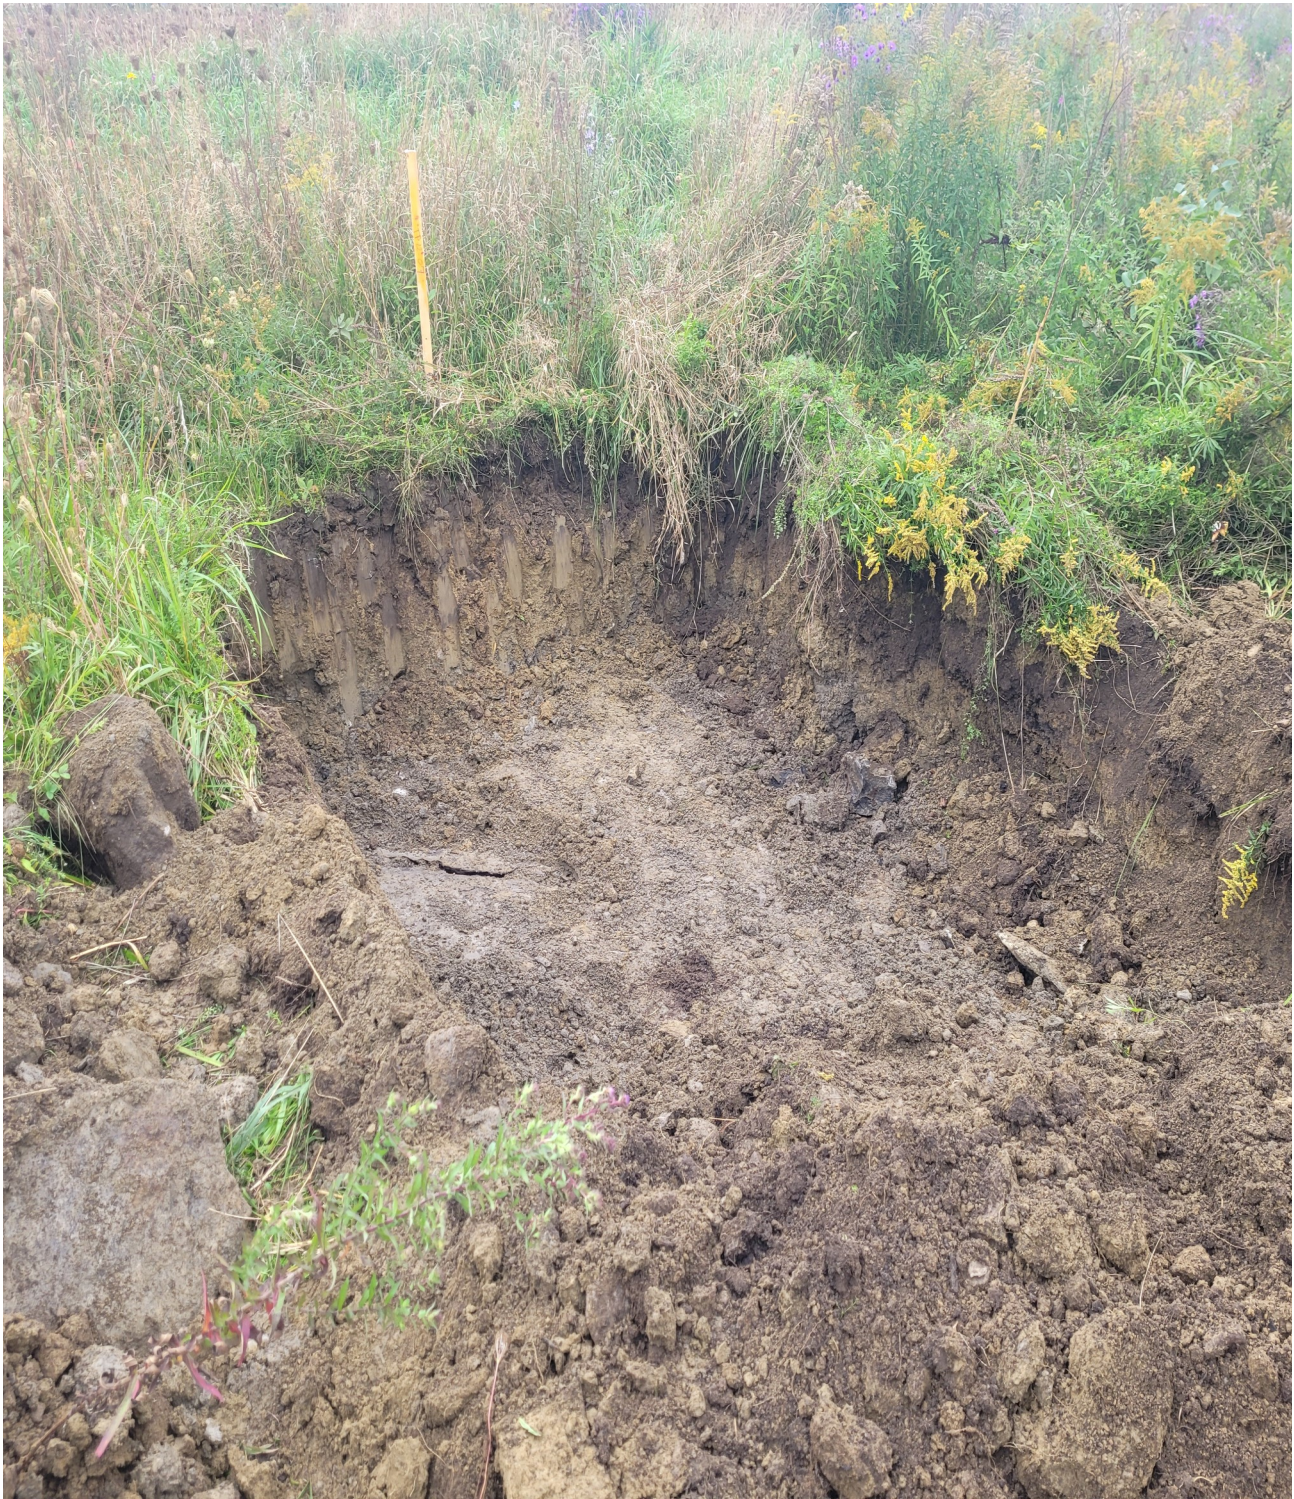
FIGURE D7

TP22-07

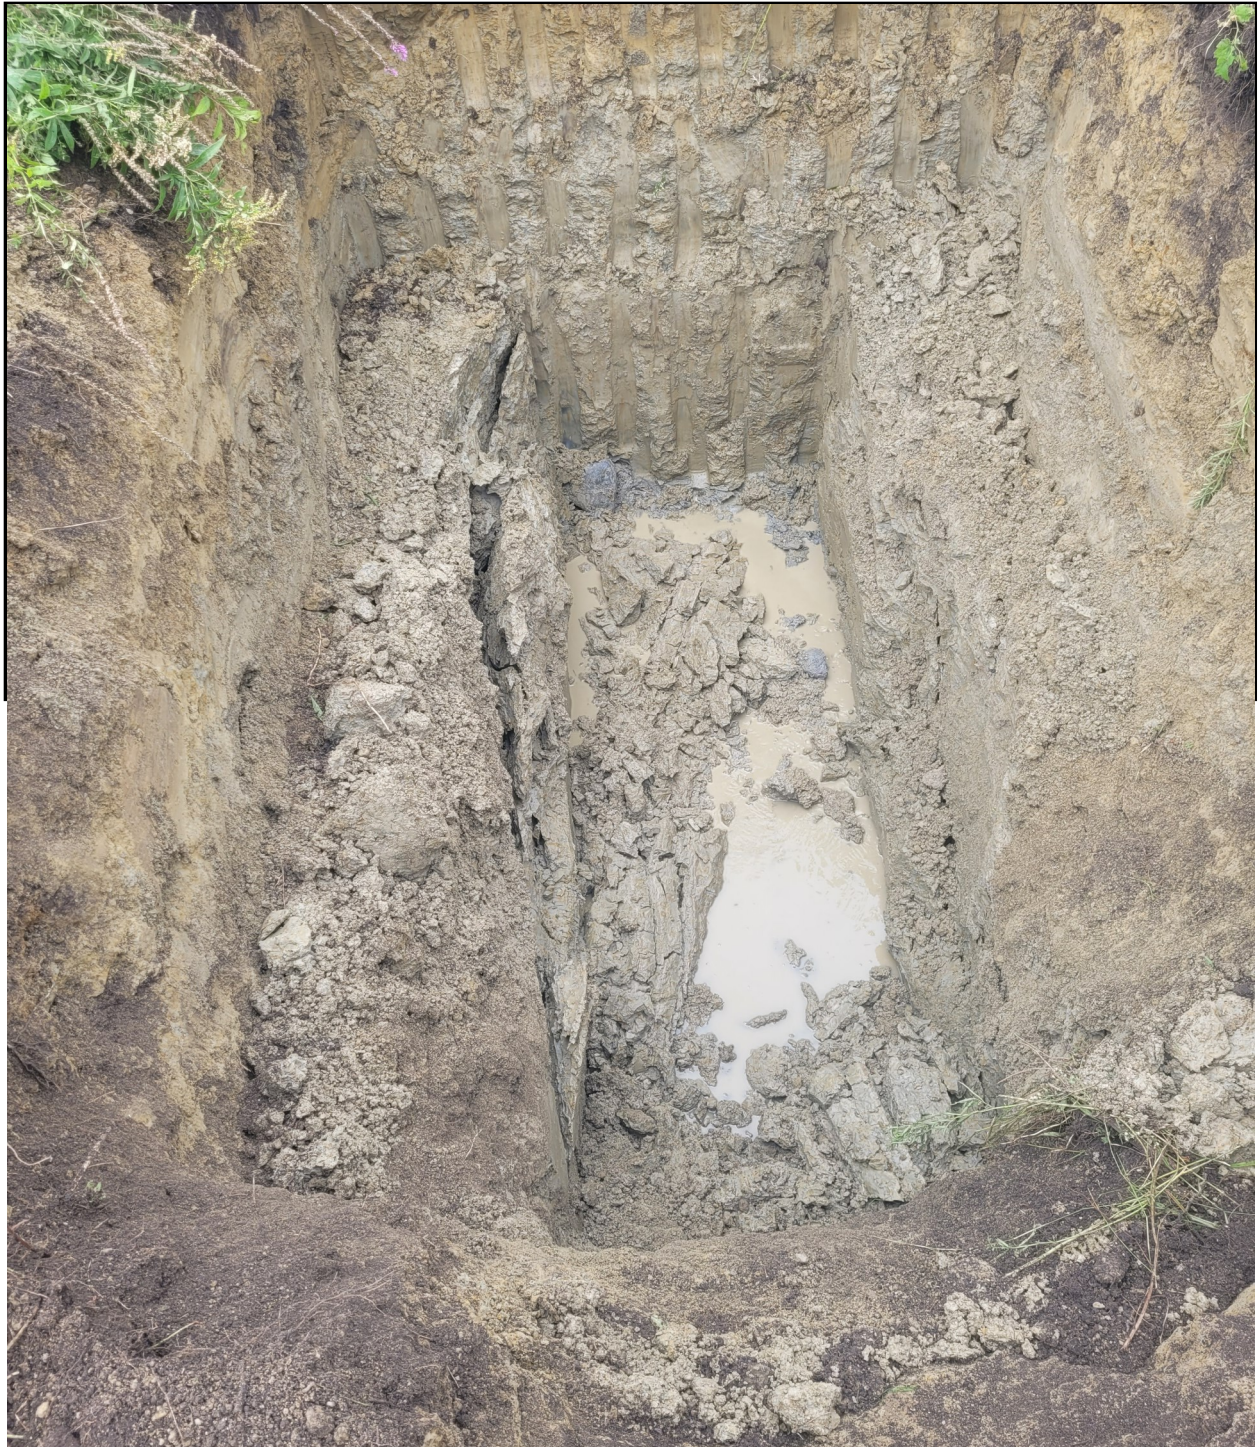
FIGURE D8

TP22-08

With the exception of test pit 22-08, no sloughing or collapse of the test pits sidewalls was observed over the relatively short period of time for which the excavations remained open, noting that these test pits were excavated to relatively shallow depth. The sidewalls of test pit 22-08 were unstable and collapsing below a depth of about 1.0 to 1.2 metres below ground surface.

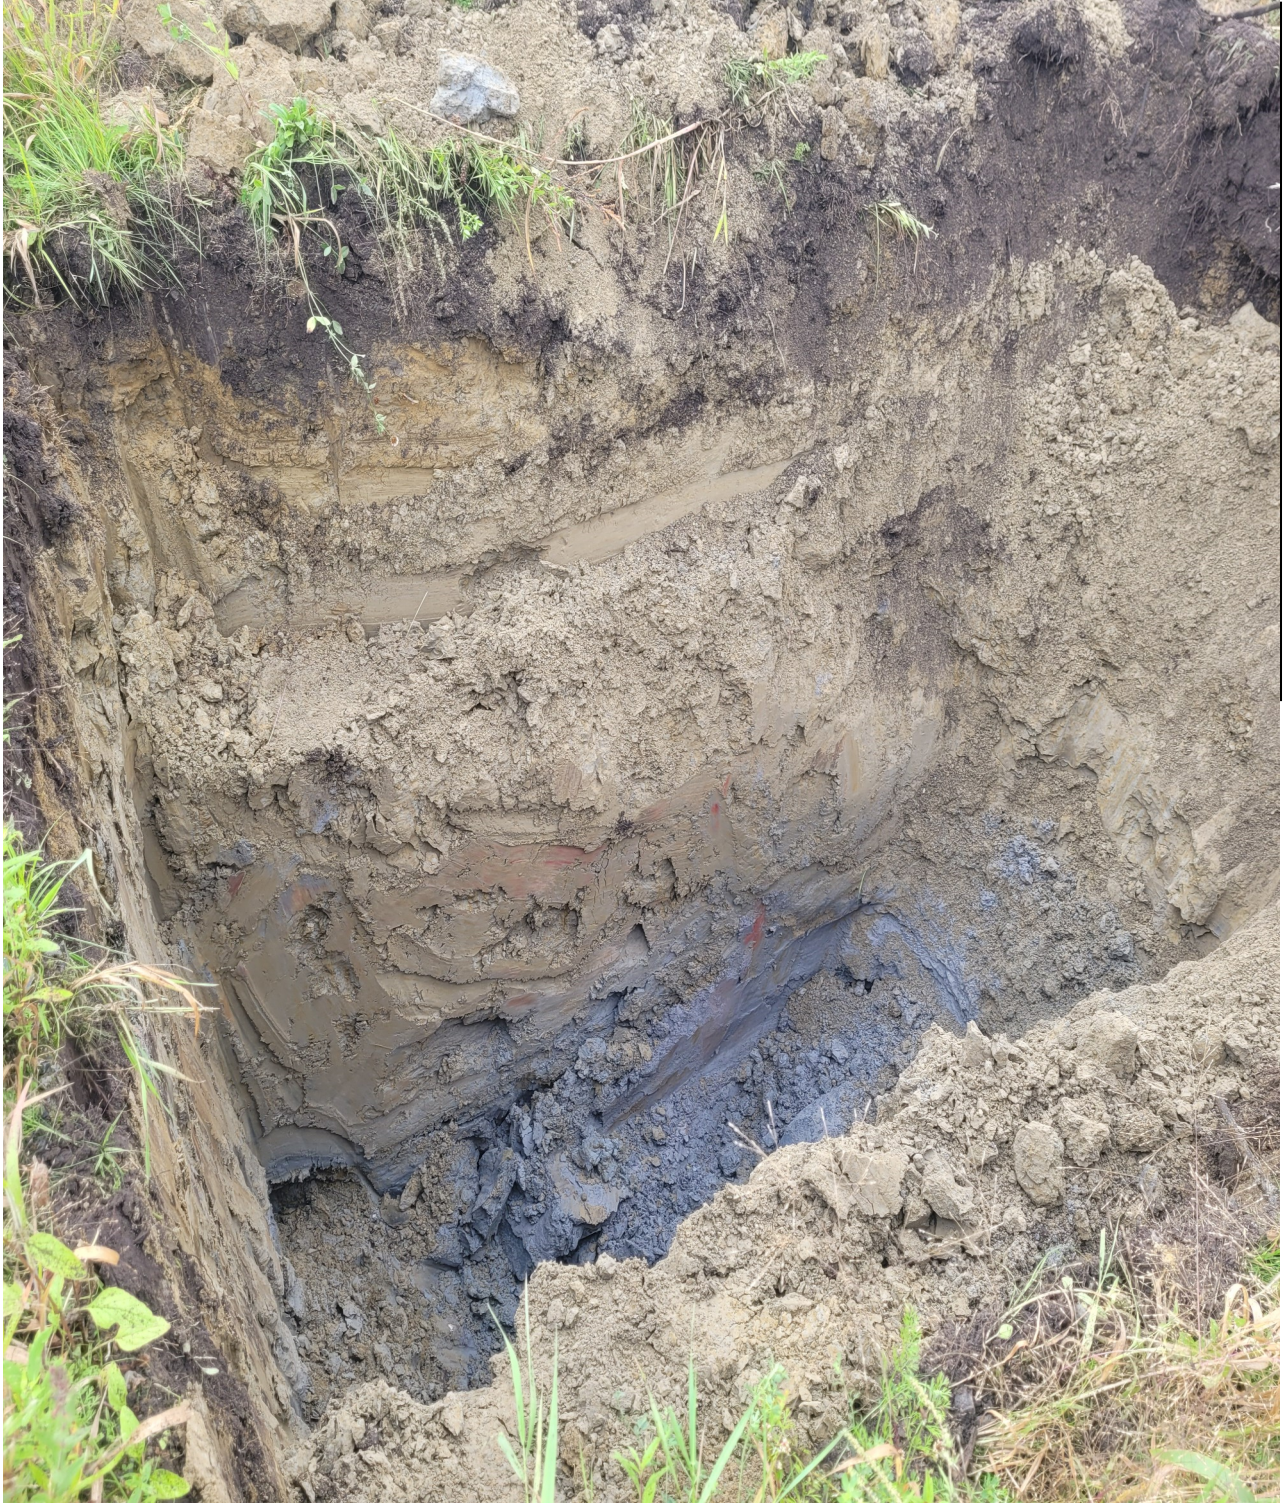
TP22-10
