Phase I - Environmental Site Assessment

352 Somerset Street West
Ottawa, Ontario

TKS Holdings

Report: PE4776-1R

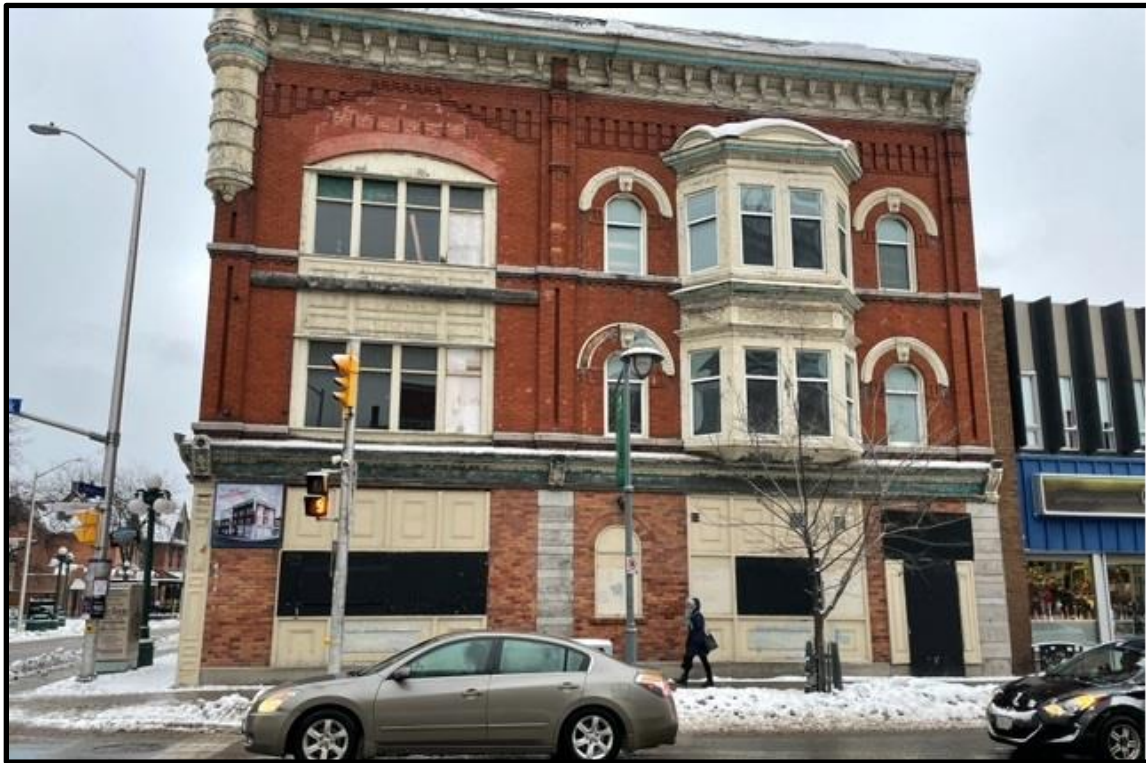
Photograph 1: West view of the Phase I Property, taken from Bank Street.

The Phase I Property is partially occupied by the abandoned building and gravel covered where the eastern portion of the building once existed. Four (4) large empty propane cylinders were noted on the exterior north side of the building next to the natural gas meter. No concerns were noted at the time of the site visit.
