FINAL REPORT

Geotechnical Investigation
Access Property Developments
864 Lady Ellen Place, Ottawa, ON

22524317_REV1

April 17, 2023

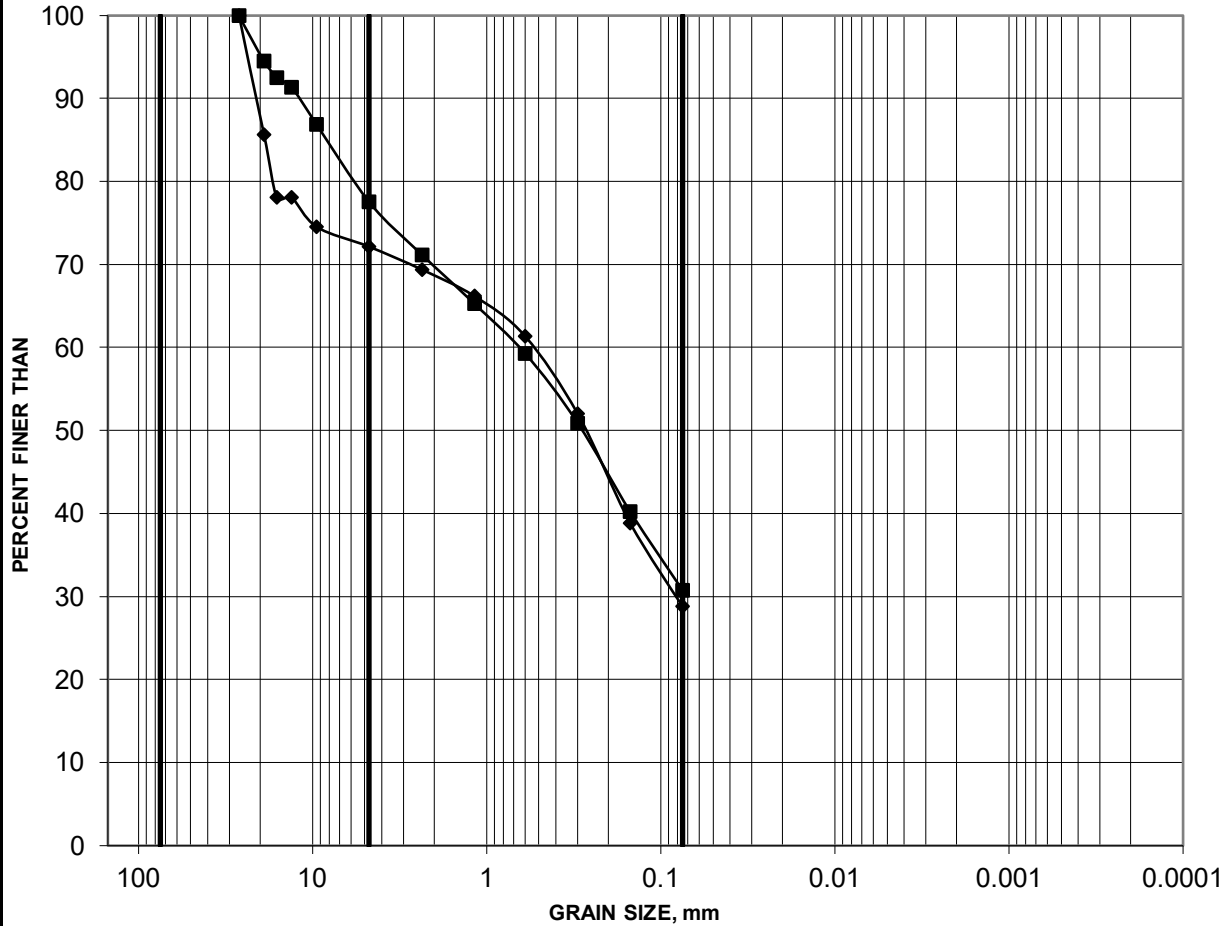
FIGURE C-1

FILL

Borehole	Sample	Depth (m)	Constituents (%)			
			Gravel	Sand	Silt	Clay
■ 22-01	1	0.15-0.76	22	47	31	
◆ 22-07	1B	0.00-0.61	28	43	29

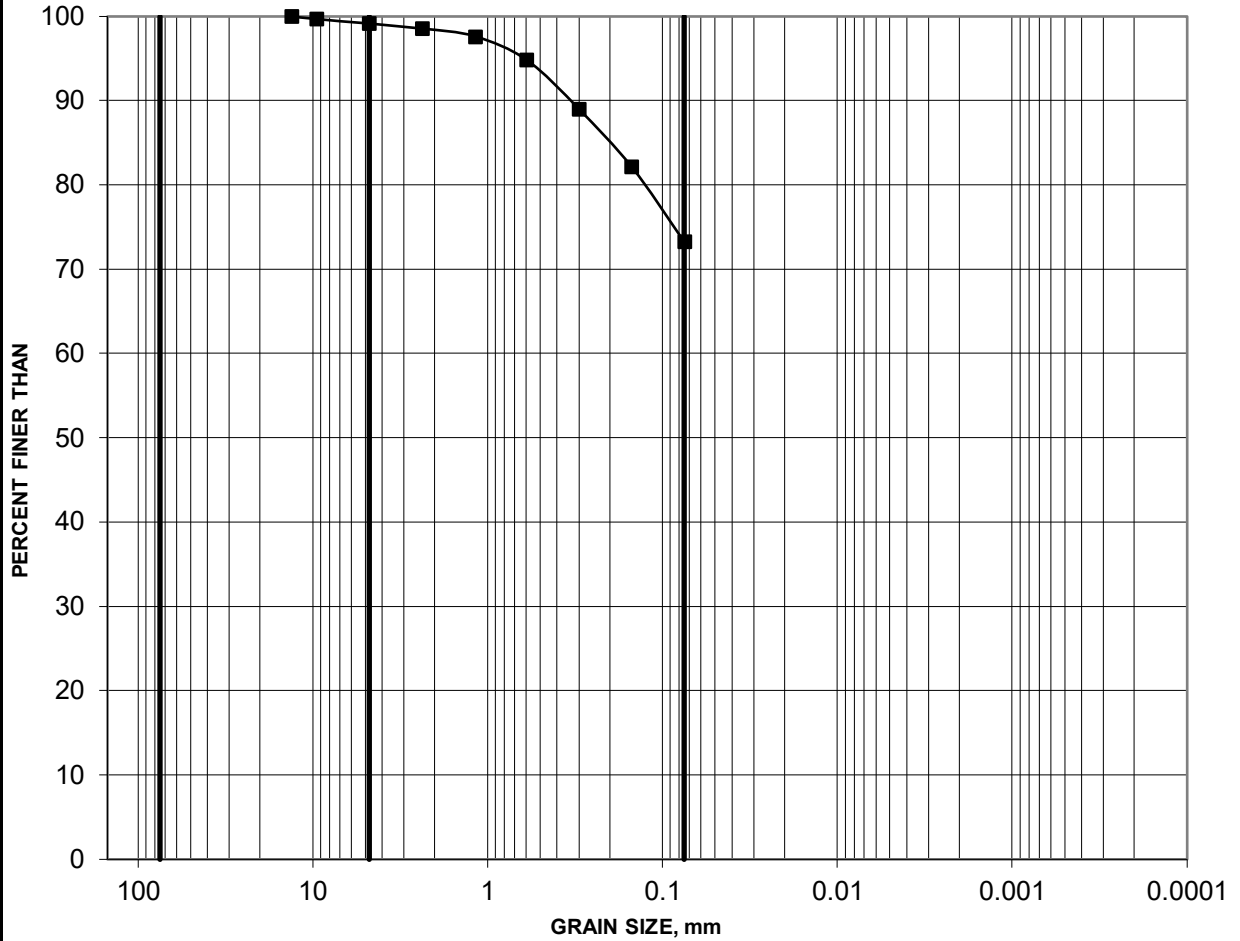
FIGURE C-2

SANDY SILT

Borehole	Sample	Depth (m)	Constituents (%)			
			Gravel	Sand	Silt	Clay
■ 22-02	2C	0.76-1.37	1	26	73

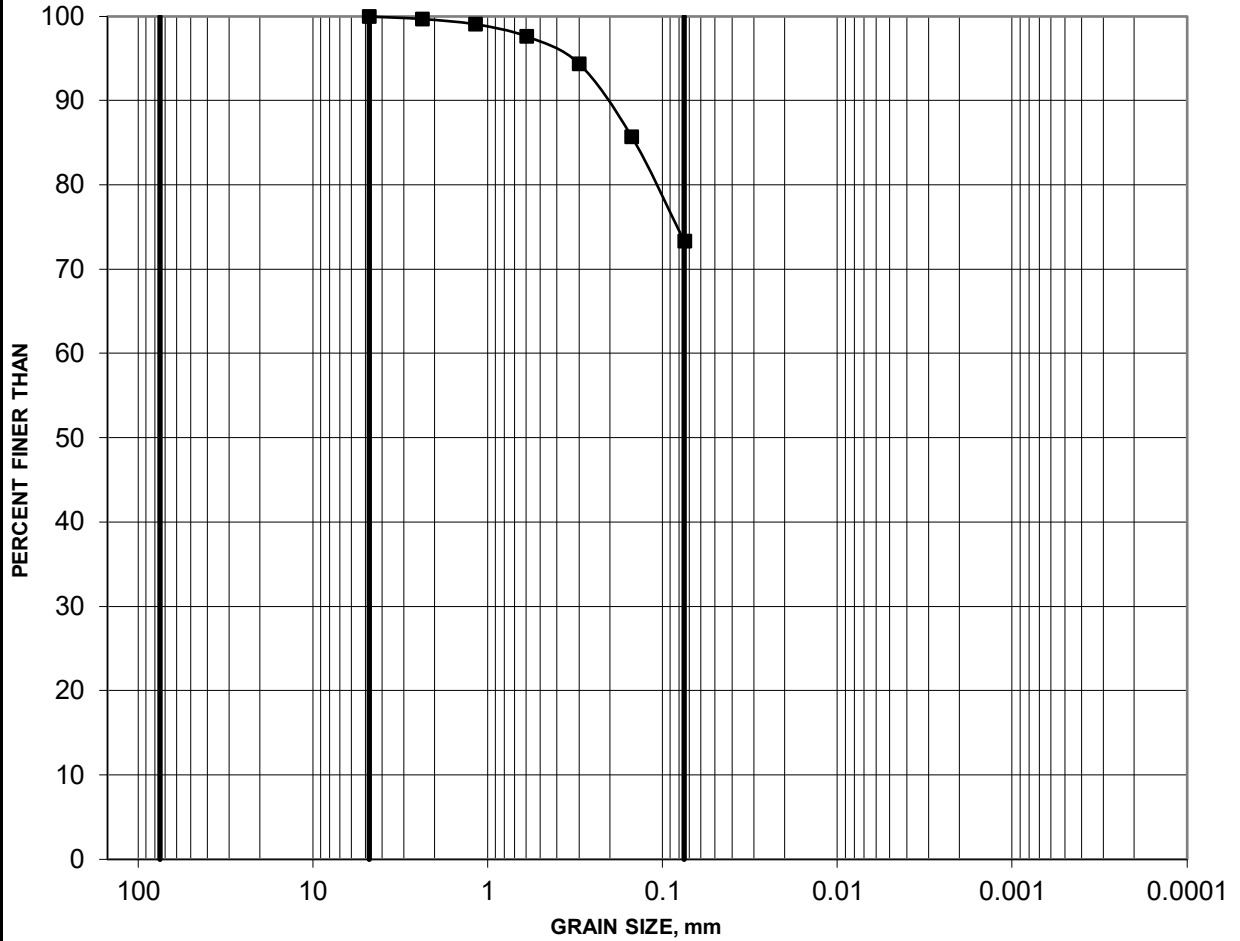
FIGURE C-3

SILTY CLAY TO CLAY (WEATHERED CRUST)

Borehole	Sample	Depth (m)	Constituents (%)			
			Gravel	Sand	Silt	Clay
■ 22-02	3A	1.52-1.83	0	27	73

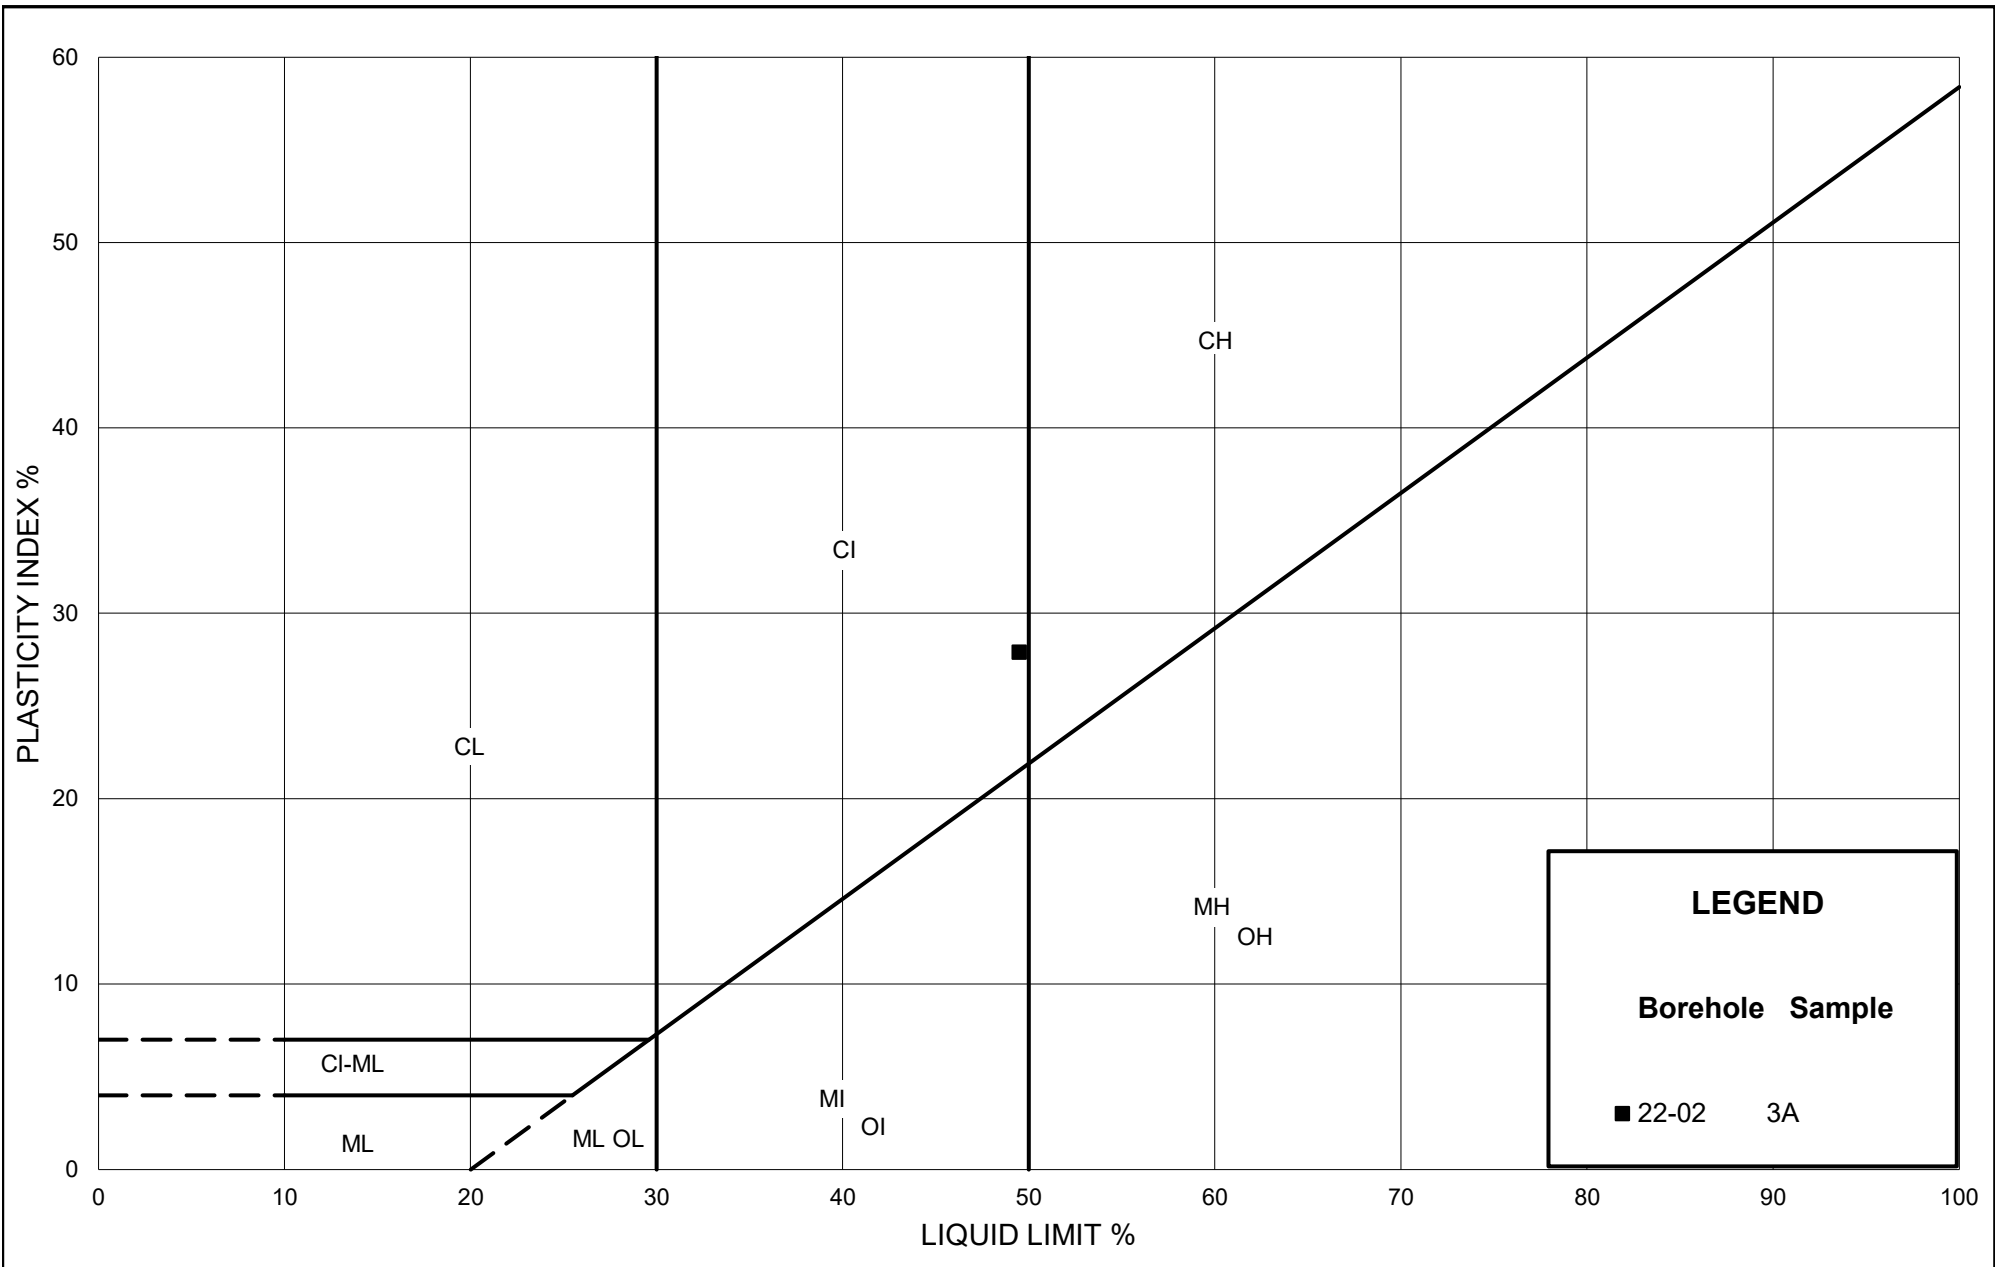
Figure:	C-4
Project:	22524317
Created By:	MI
Checked By:	JB

PLASTICITY CHART
SILTY CLAY TO CLAY (WEATHERED CRUST)

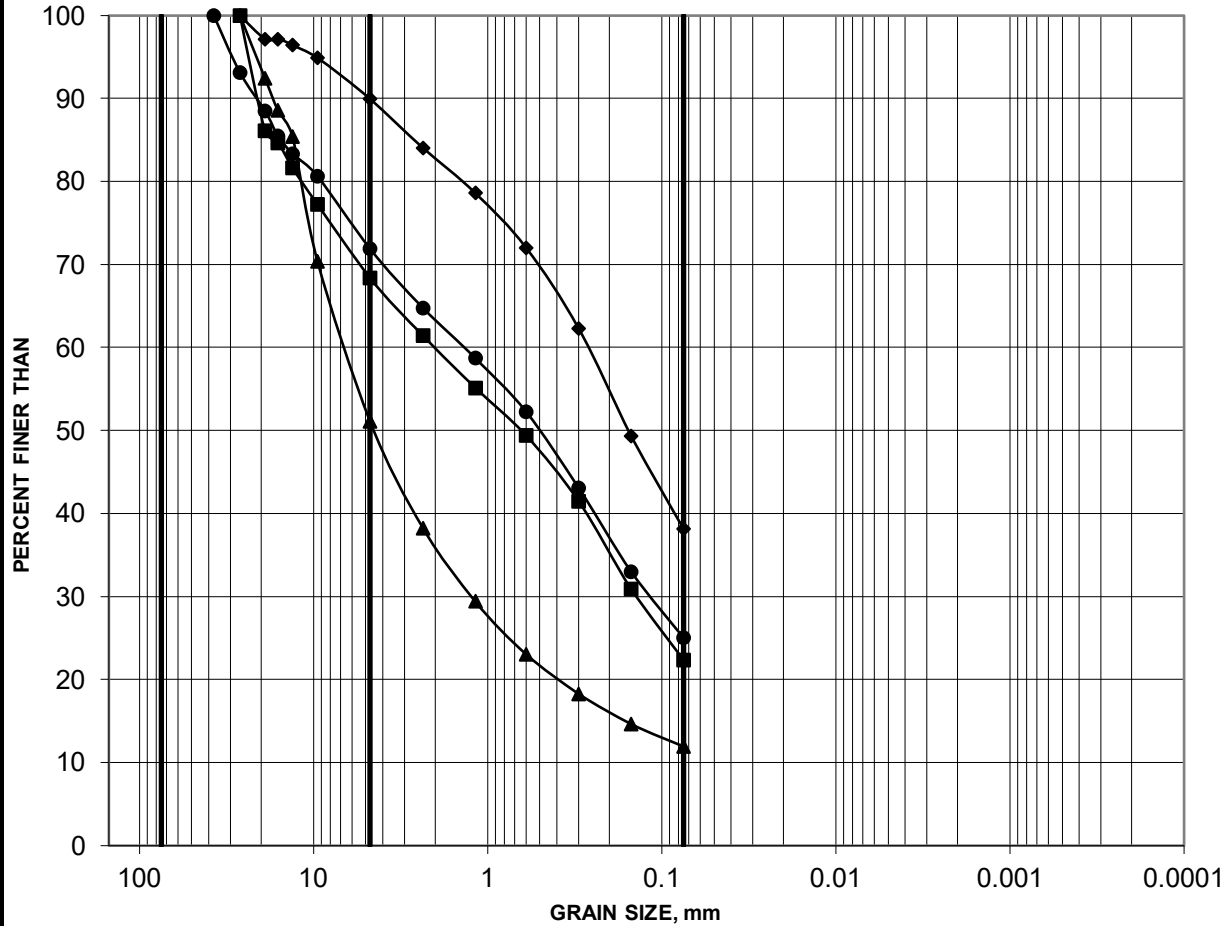
FIGURE C-5

GLACIAL TILL

Borehole	Sample	Depth (m)	Constituents (%)			
			Gravel	Sand	Silt	Clay
■	22-01	3B	1.68-2.13	32	46	22
◆	22-04	2	0.76-1.37	10	52	38
▲	22-05	3	1.52-2.13	49	39	12
●	22-07	5	3.05-3.66	28	47	25

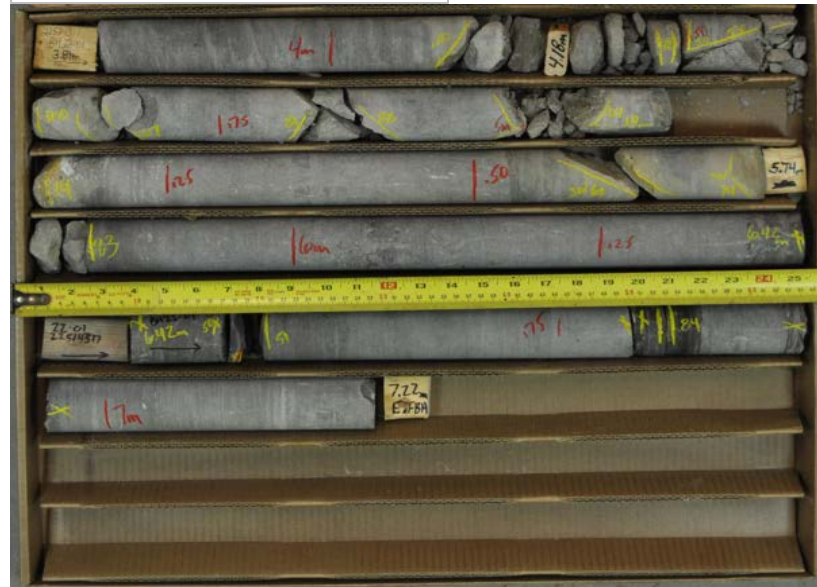
BH 22-01 (Dry)
Rock core from a depth of 3.81 m to 7.22 m
Core Box 1 to 2 of 2

Depth 3.81 m Top of Bedrock

Depth 7.22 m EOH

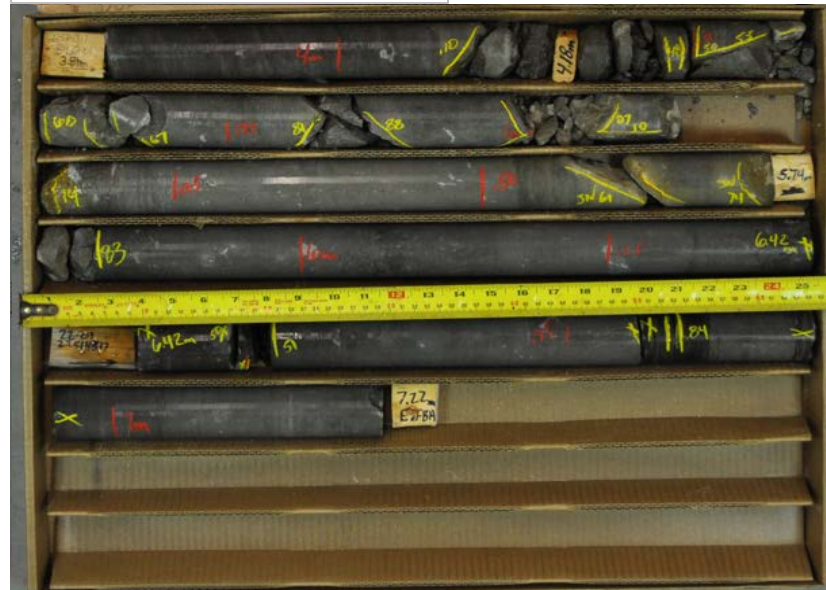
BH 22-01 (Dry)
Rock core from a depth of 3.81 m to 7.22 m
Core Box 1 to 2 of 2

Depth 3.81 m Top of Bedrock

Depth 7.22 m EOH

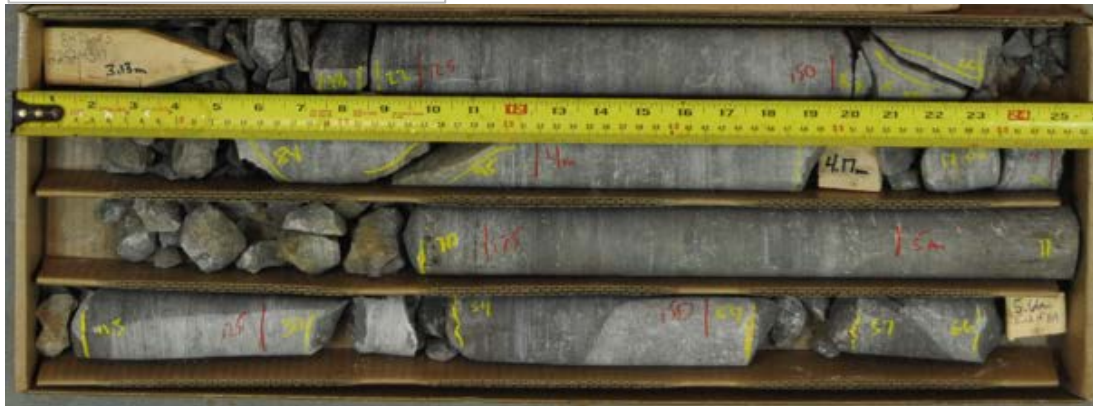
BH 21-01 (Dry)
Rock core from a depth of 3.13 m to 5.66 m
Core Box 1 to 2 of 2

Depth 3.13 m Top of Bedrock

Depth 5.66 m EOH

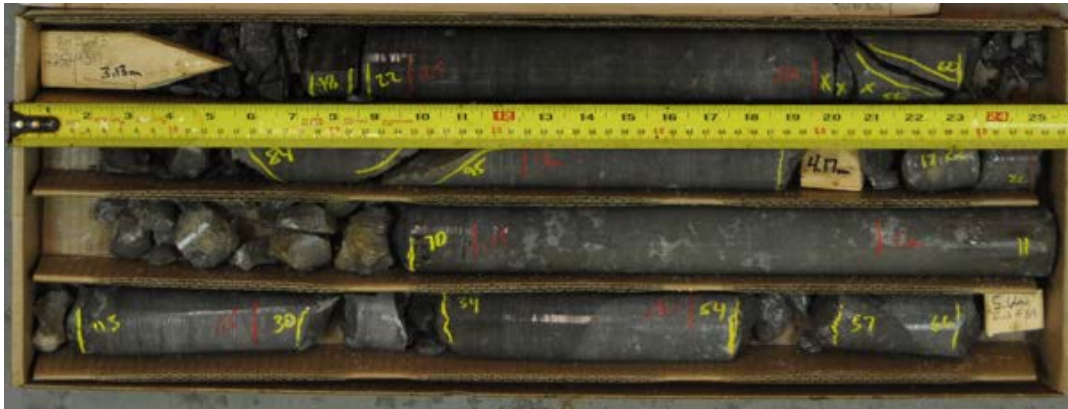
BH 22-03 (Wet)
Rock core from a depth of 3.13 m to 5.66 m
Core Box 1 to 1 of 1

Depth 3.13 m Top of Bedrock

Depth 5.66 m EOH

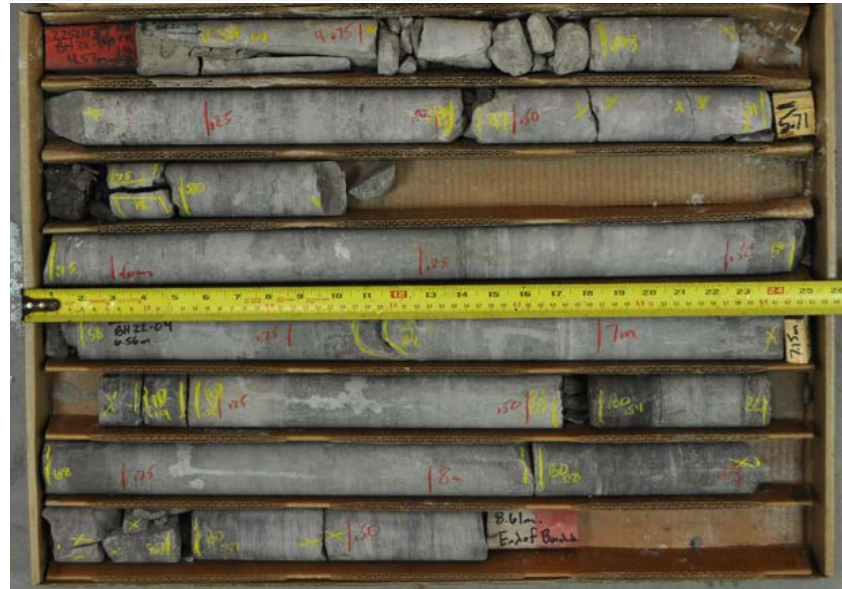
BH 21-04(Wet)
Rock core from a depth of 4.50 m to 8.61 m
Core Box 1 to 2 of 2

Depth 4.50 m Top of Bedrock

Depth 8.61 m EOH

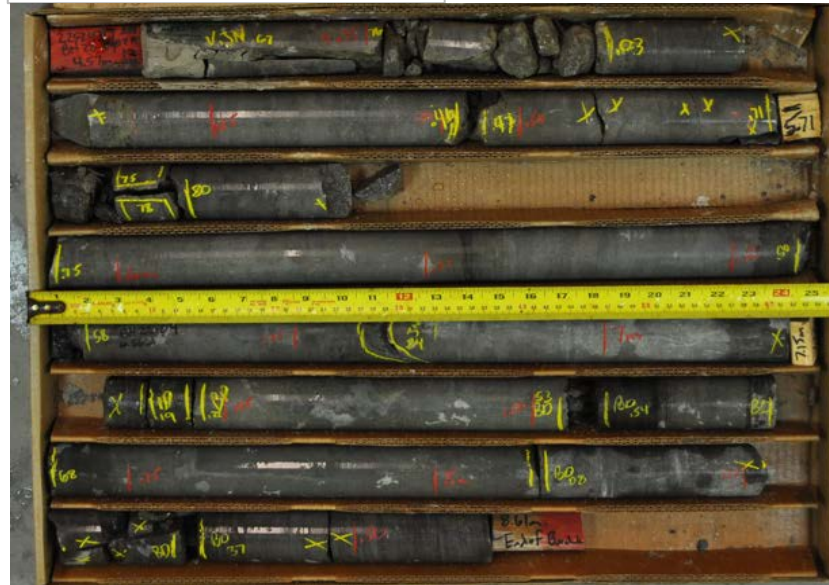
BH 22-04(Dry)
Rock core from a depth of 4.50 m to 8.61 m
Core Box 1 to 2 of 2

Depth 4.50 m Top of Bedrock

Depth 8.61 m EOH

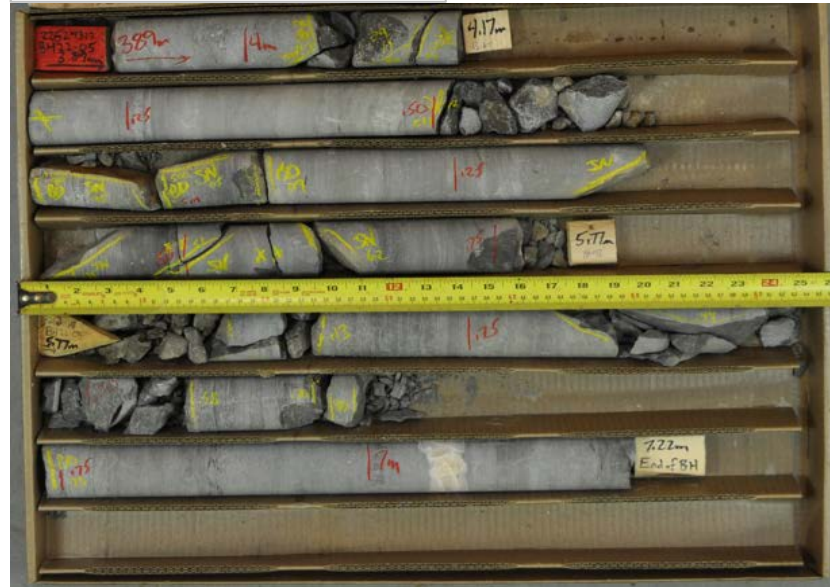
BH 21-01 (Dry)
Rock core from a depth of 3.89 m to 7.22 m
Core Box 1 to 2 of 2

Depth 3.89 m Top of Bedrock

Depth 7.22 m EOH

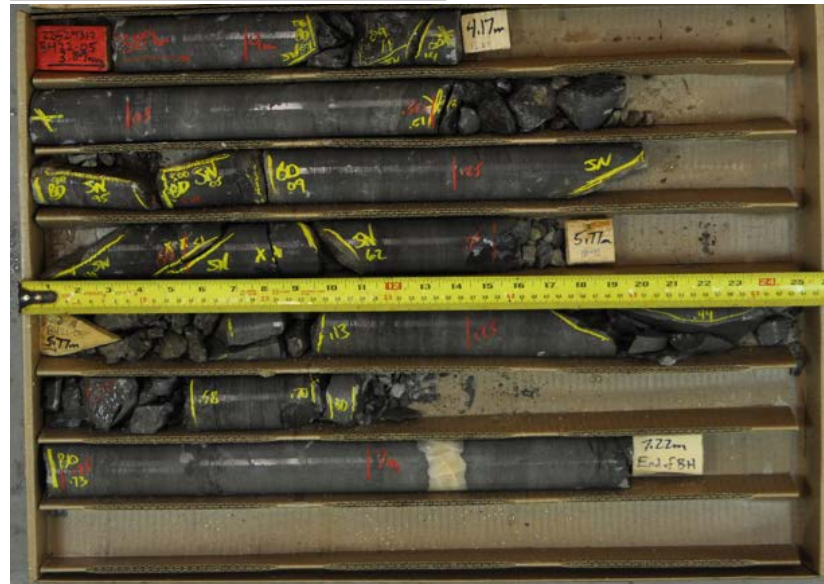
BH 22-05 (Wet)
Rock core from a depth of 3.89 m to 7.22 m
Core Box 1 to 2 of 2

Depth 3.89 m Top of Bedrock

Depth 7.22 m EOH

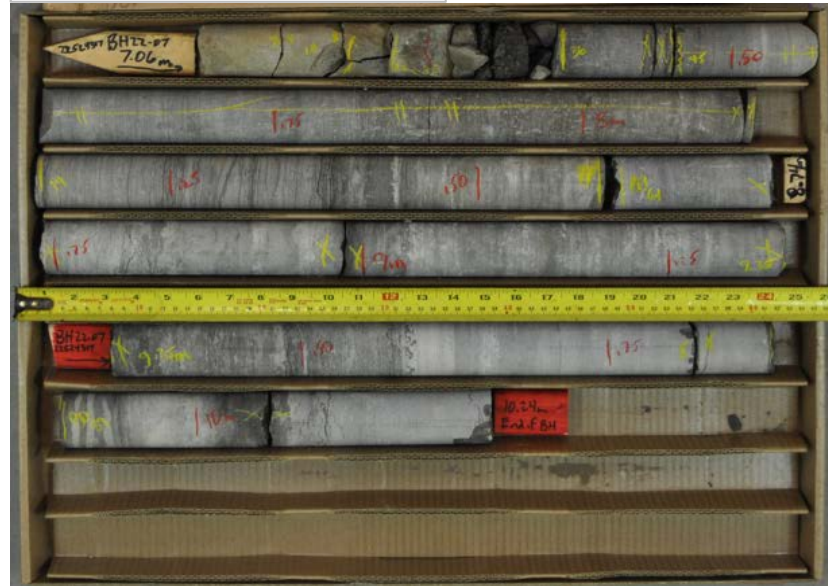
BH 22-07 (Dry)
Rock core from a depth of 7.06 m to 10.24 m
Core Box 1 to 2 of 2

Depth 7.06 m Top of Bedrock

Depth 10.24 m EOH

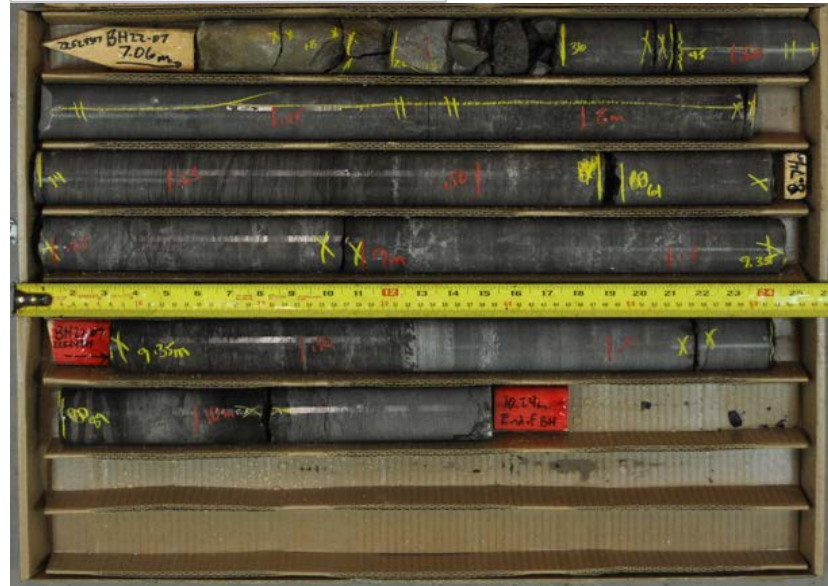
BH 22-07 (Wet)
Rock core from a depth of 7.06 m to 10.24 m
Core Box 1 to 2 of 2

Depth 7.06 m Top of Bedrock

Depth 10.24 m EOH

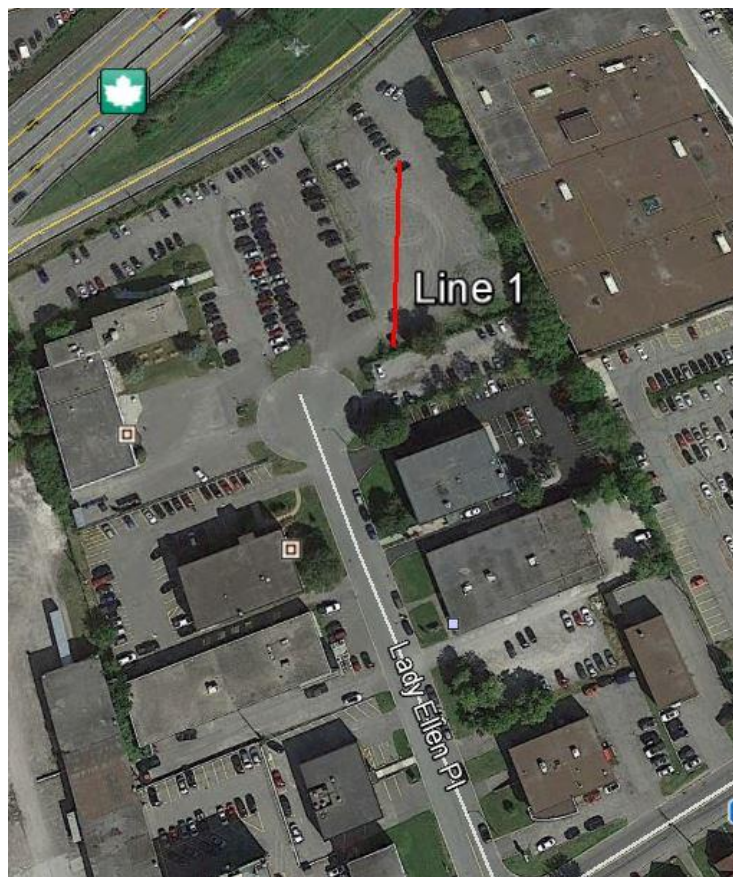
Figure 1: MASW Location Site Map (MASW Line in red)

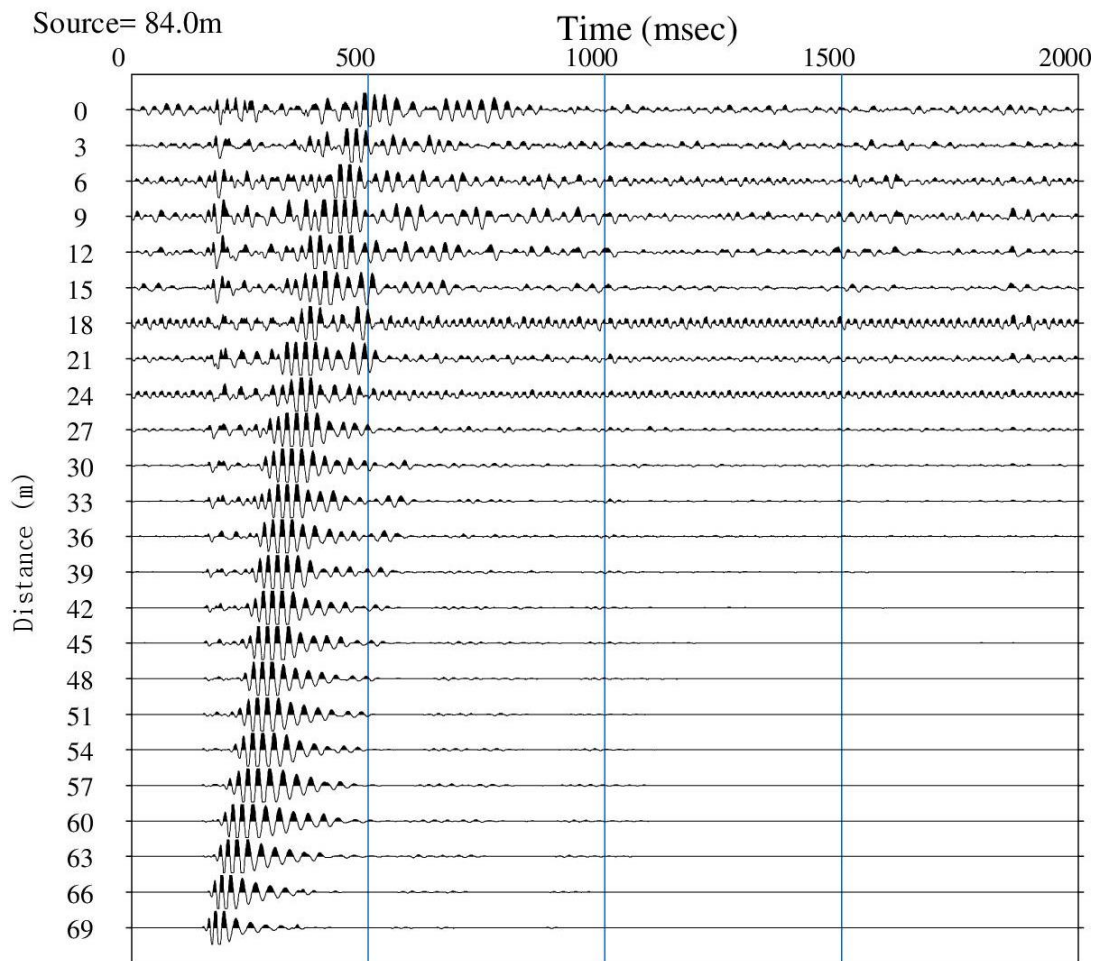
The MASW field work was conducted on December 11, 2018, by a geophysicist from the Golder Mississauga office. For the MASW line, a series of 24 low frequency (4.5 Hz) geophones were laid out at 3 metre intervals. Both active and passive readings were recorded along the MASW line. For the active investigation, a seismic drop of 45 kg and a 9.9 kg sledge hammer were used as seismic sources. Active seismic records were collected with seismic sources located 5, 10, and 15 metres from and collinear to the geophone array. An example of active seismic record collected along the MASW line is shown in Figure 2 below.

Figure 2: Typical seismic record collected at the site of the MASW line.

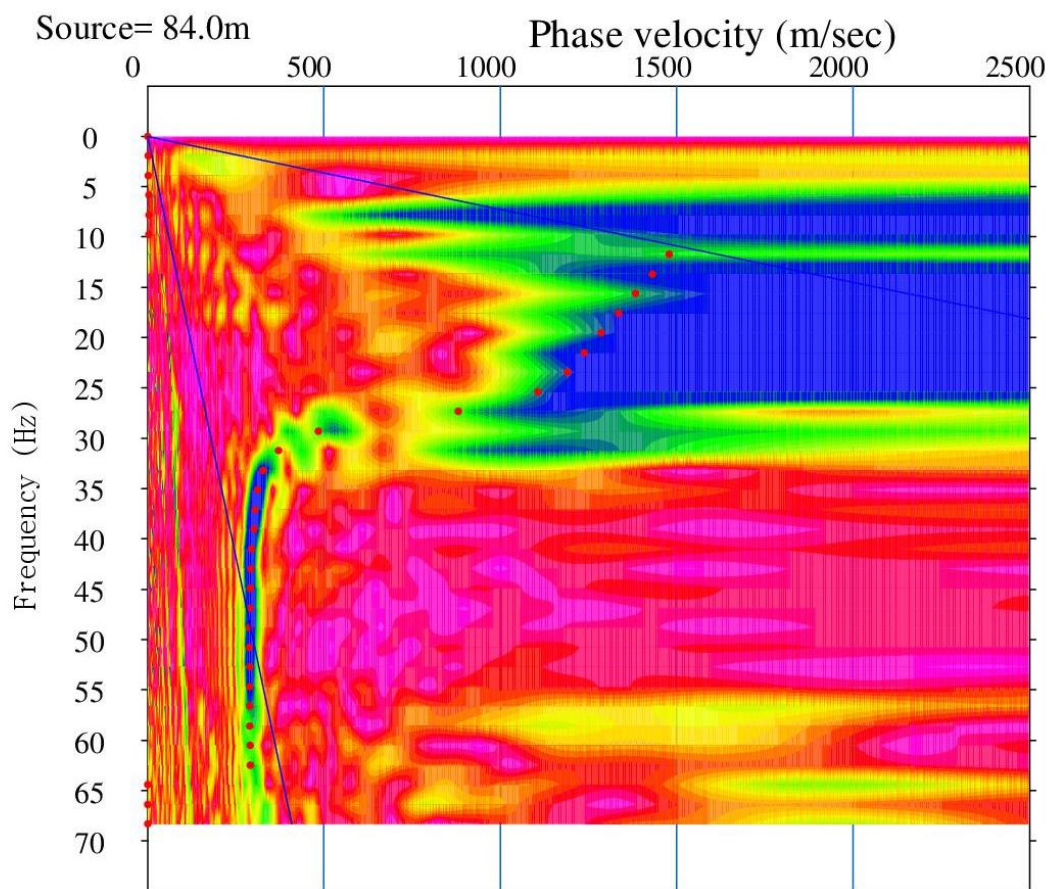
Processing of the MASW data was completed using the SeisImager/SW software package (Geometrics Inc.). The calculated phase velocities for a seismic shot point were combined and the dispersion curve generated by choosing the minimum phase velocity calculated for each frequency component as shown on Figure 3. Shear wave velocity profiles were generated through inverse modelling to best fit the calculated dispersion curves. The active survey provided a dispersion curve with a suitable frequency range (11 to 60 Hz). The minimum measured surface wave frequency with sufficient signal-to-noise ratio to accurately measure phase velocity was approximately 11 Hz.

Figure 3: Active MASW Dispersion Curve Picks (red dots) along the MASW line

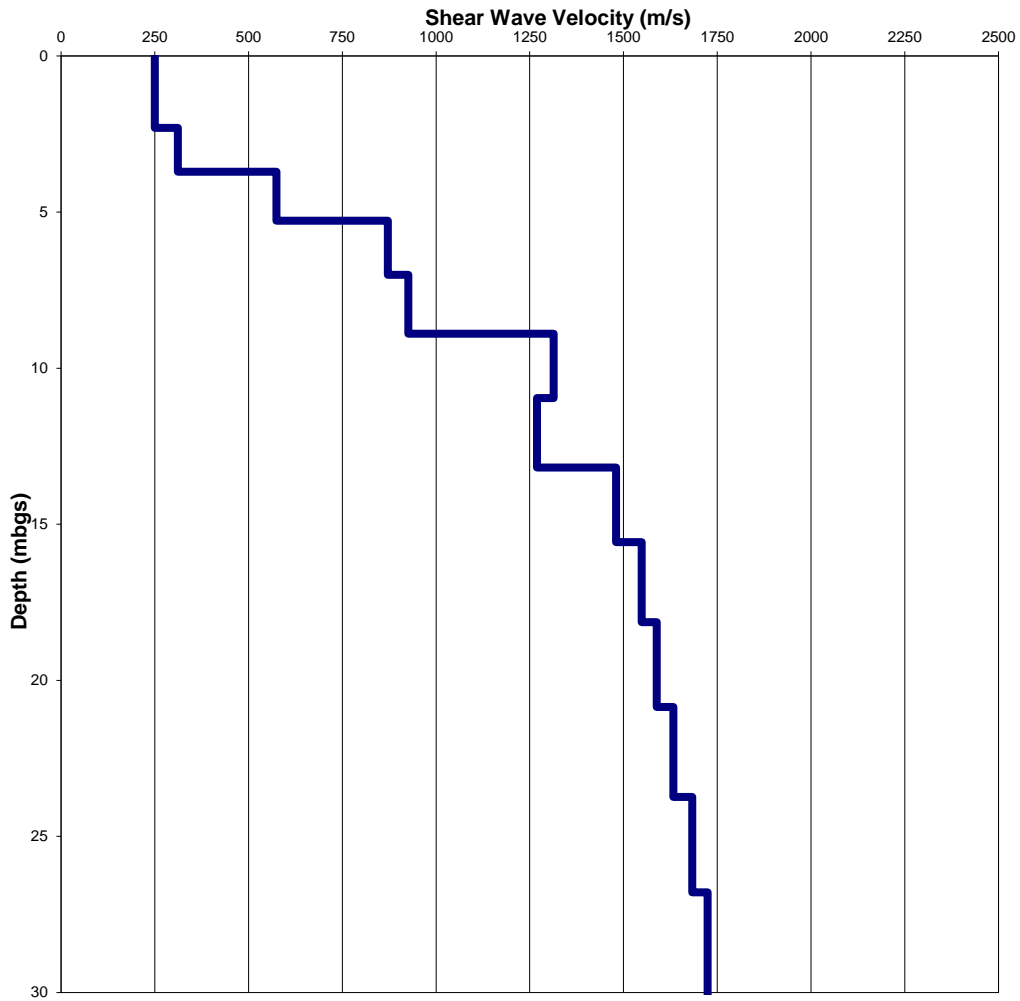
The MASW test results are presented in Figure 4, which present the calculated shear wave velocity profile derived from the field testing along the MASW line. The results along the MASW line have been calculated using weight-drop located at 10 metres from the last geophone. The field collected dispersion curves are compared with the model generated dispersion curves on Figure 5 for the MASW line. There is a satisfactory correlation between the field collected and model calculated dispersion curves, with a root mean squared error of less than 7% along the MASW line.

Figure 4: MASW Modelled Shear-Wave Velocity Depth profile along the MASW Line

To calculate the average shear-wave velocity as required by the NBCC 2015, the results were modelled to 30 metres below ground surface. The average shear-wave velocity along the MASW line was found to be 877 m/s (Table 1). The NBCC 2015 requires special site specific evaluation if certain soil types are encountered on the site, so the site classification stated here should be reviewed, and modified if necessary, according to borehole stratigraphy, standard penetration resistance results, and undrained shear strength measurements, if available for this site.

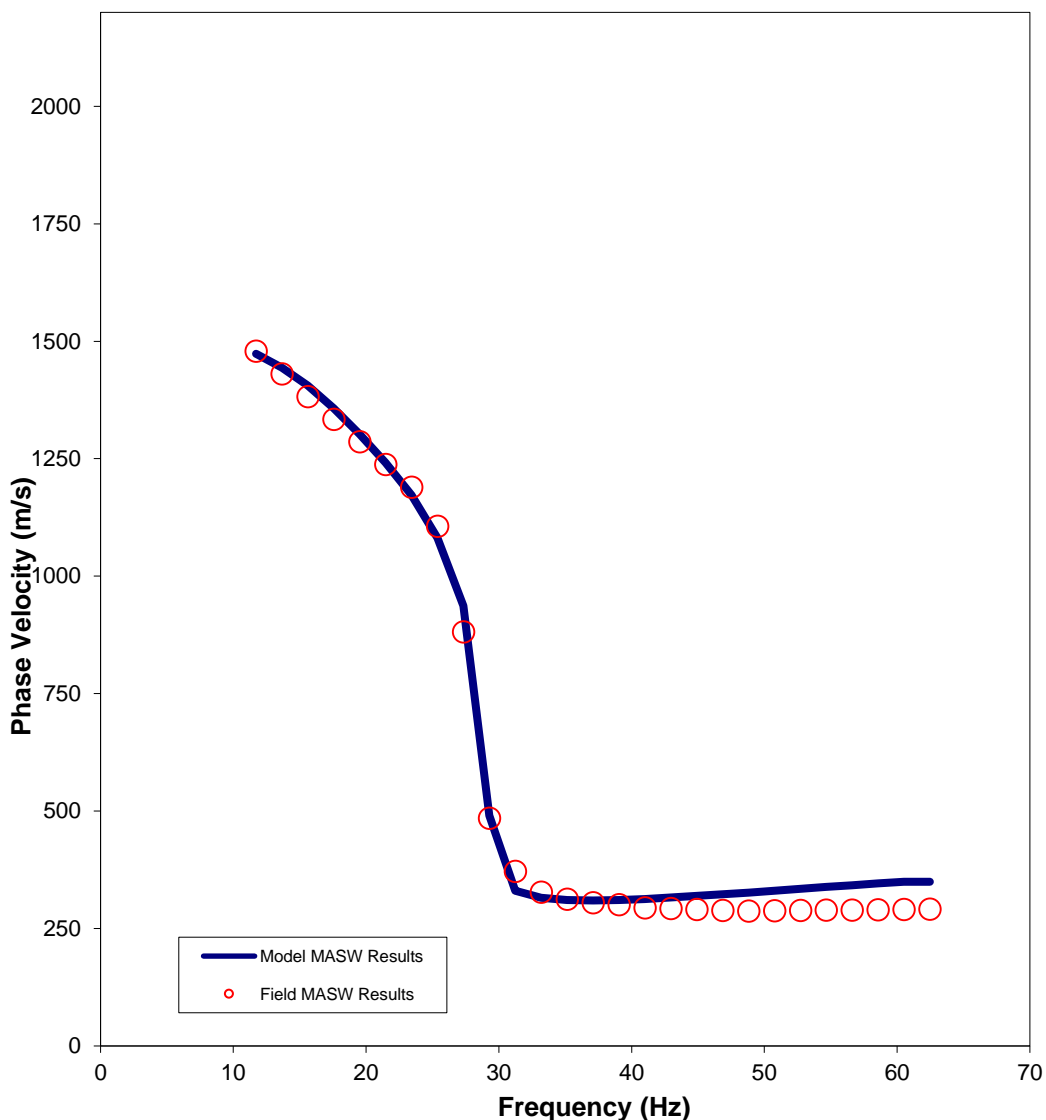
Figure 5: Comparison of Field (red dots) vs. Modelled Data (blue line) along the MASW Line
