# **Geotechnical Investigation**

## **Proposed Industrial Redevelopment**

135 Cardevo Road  
Carp, Ontario

Report PG6018-1 Revision 2 May 9, 2023

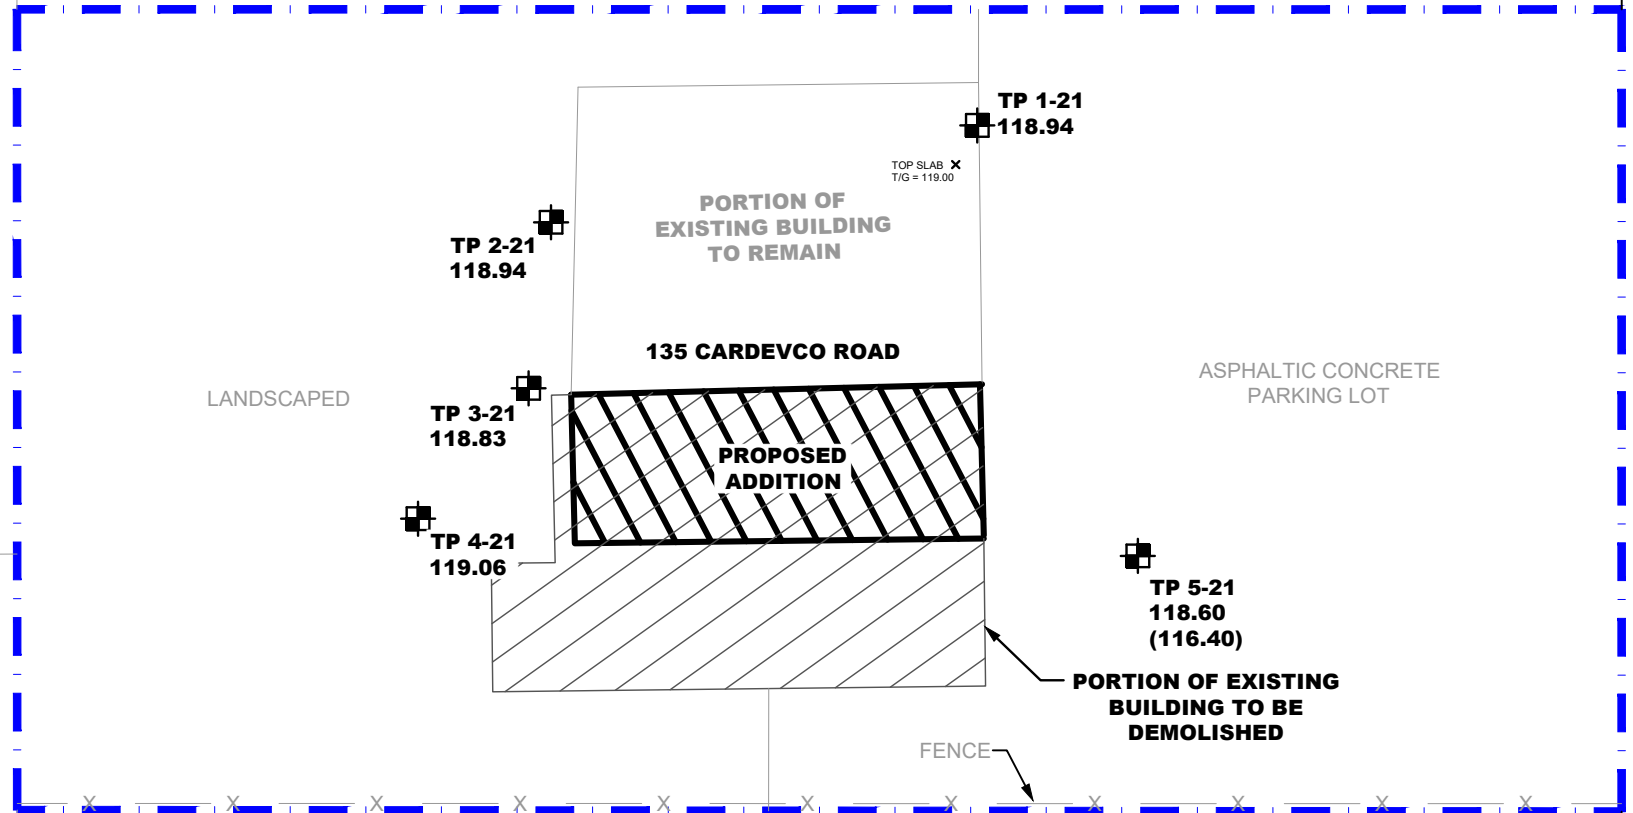
**CARDEVCO ROAD**

The field program for the geotechnical investigation was conducted on November 12, 2021. At that time, a total of **five (5) test pits** were advanced to a maximum depth of 3.5 m below the existing ground surface. The test hole locations were selected by Paterson and distributed in a manner to provide general coverage of the subject site taking into consideration existing site features and underground utilities and the nature of the proposed redevelopment (building addition within a predeveloped area). Two test pits were excavated within the vicinity of the proposed southern warehouse addition. The remaining three test holes were excavated adjacent to the exterior footings of the northern portion of the existing warehouse, in order to confirm founding conditions and to allow for scanning foundation rebars. The locations of the boreholes are shown on Drawing PG6018-1 - Test Hole Location Plan included in Appendix 2.

The test hole locations were selected by Paterson to provide general coverage of the proposed warehouse addition, taking into consideration the existing site features and underground utilities and the nature of the proposed building addition in a predeveloped area as well as our experience from adjacent sites. The test hole locations and ground surface elevation at each test hole location were surveyed by Paterson personnel using a GPS and referenced to a geodetic datum. The location of the test holes and ground surface elevation at each test hole location are presented on Drawing PG6018-1 - Test Hole Location Plan in Appendix 2.
