# **Phase I Environmental Site Assessment**

1815 Montreal Road  
Ottawa, Ontario

Prepared for Creative Development Ventures

Report: PE6021-1  
April 19, 2023

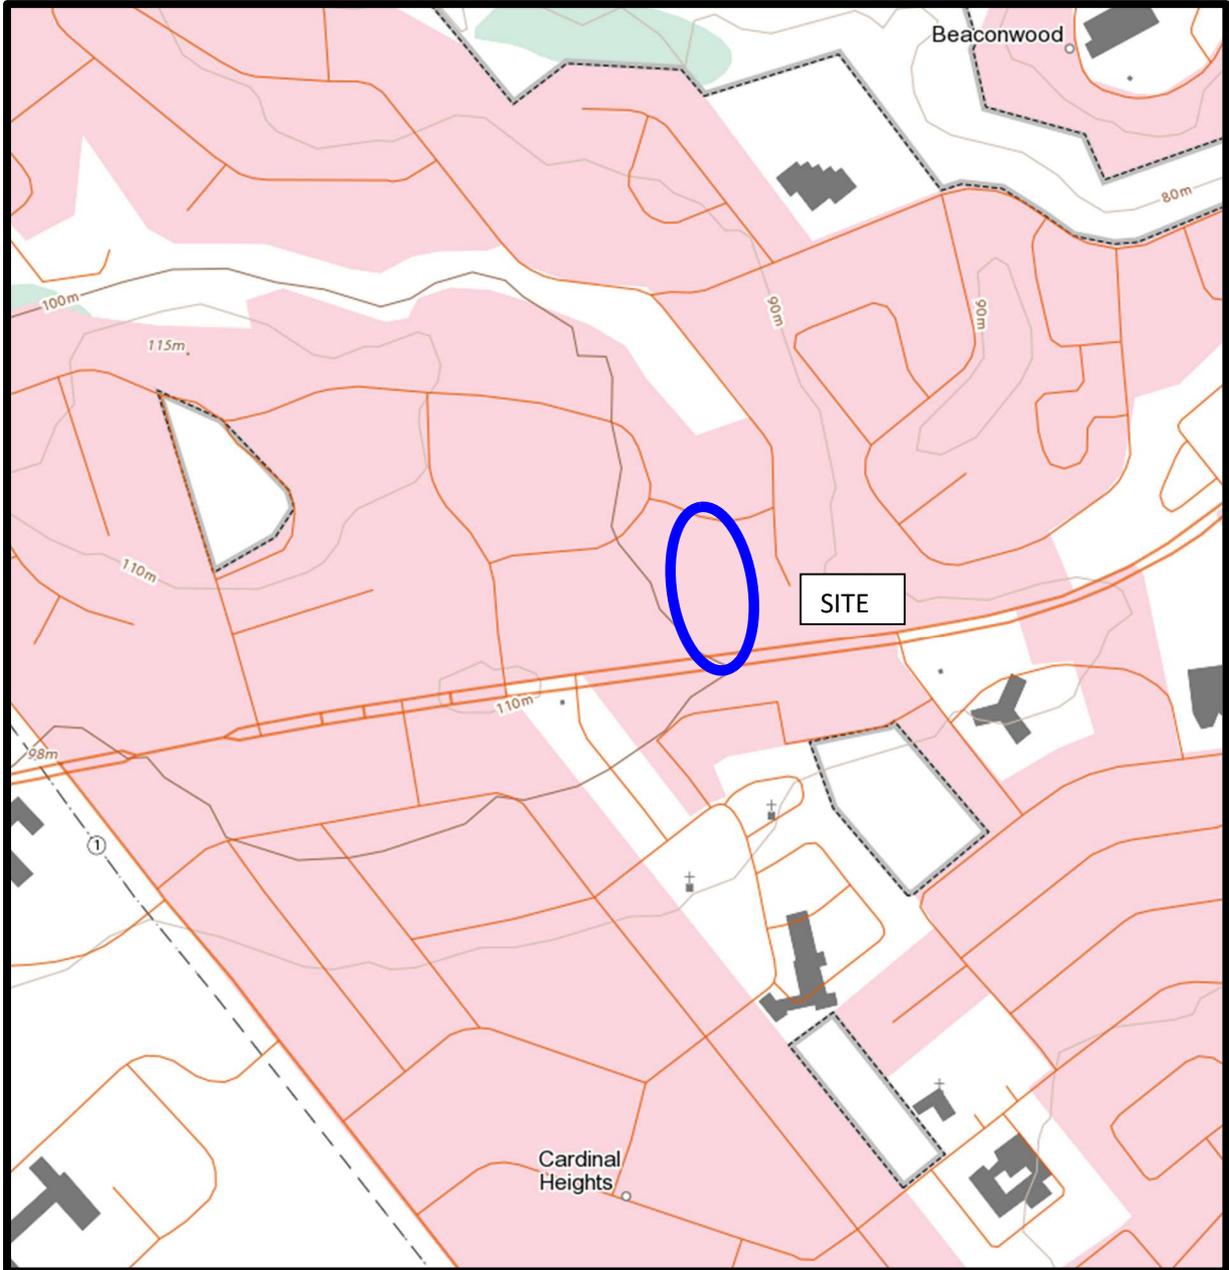
FIGURE 2  
TOPOGRAPHIC MAP

The topographic maps indicate that the regional topography in the general area of the Phase I Property slopes down in a north-easterly direction toward Green's Creek and the Ottawa River. An illustration of the referenced topographic map is presented on Figure 2 – Topographic Map, appended to this report.

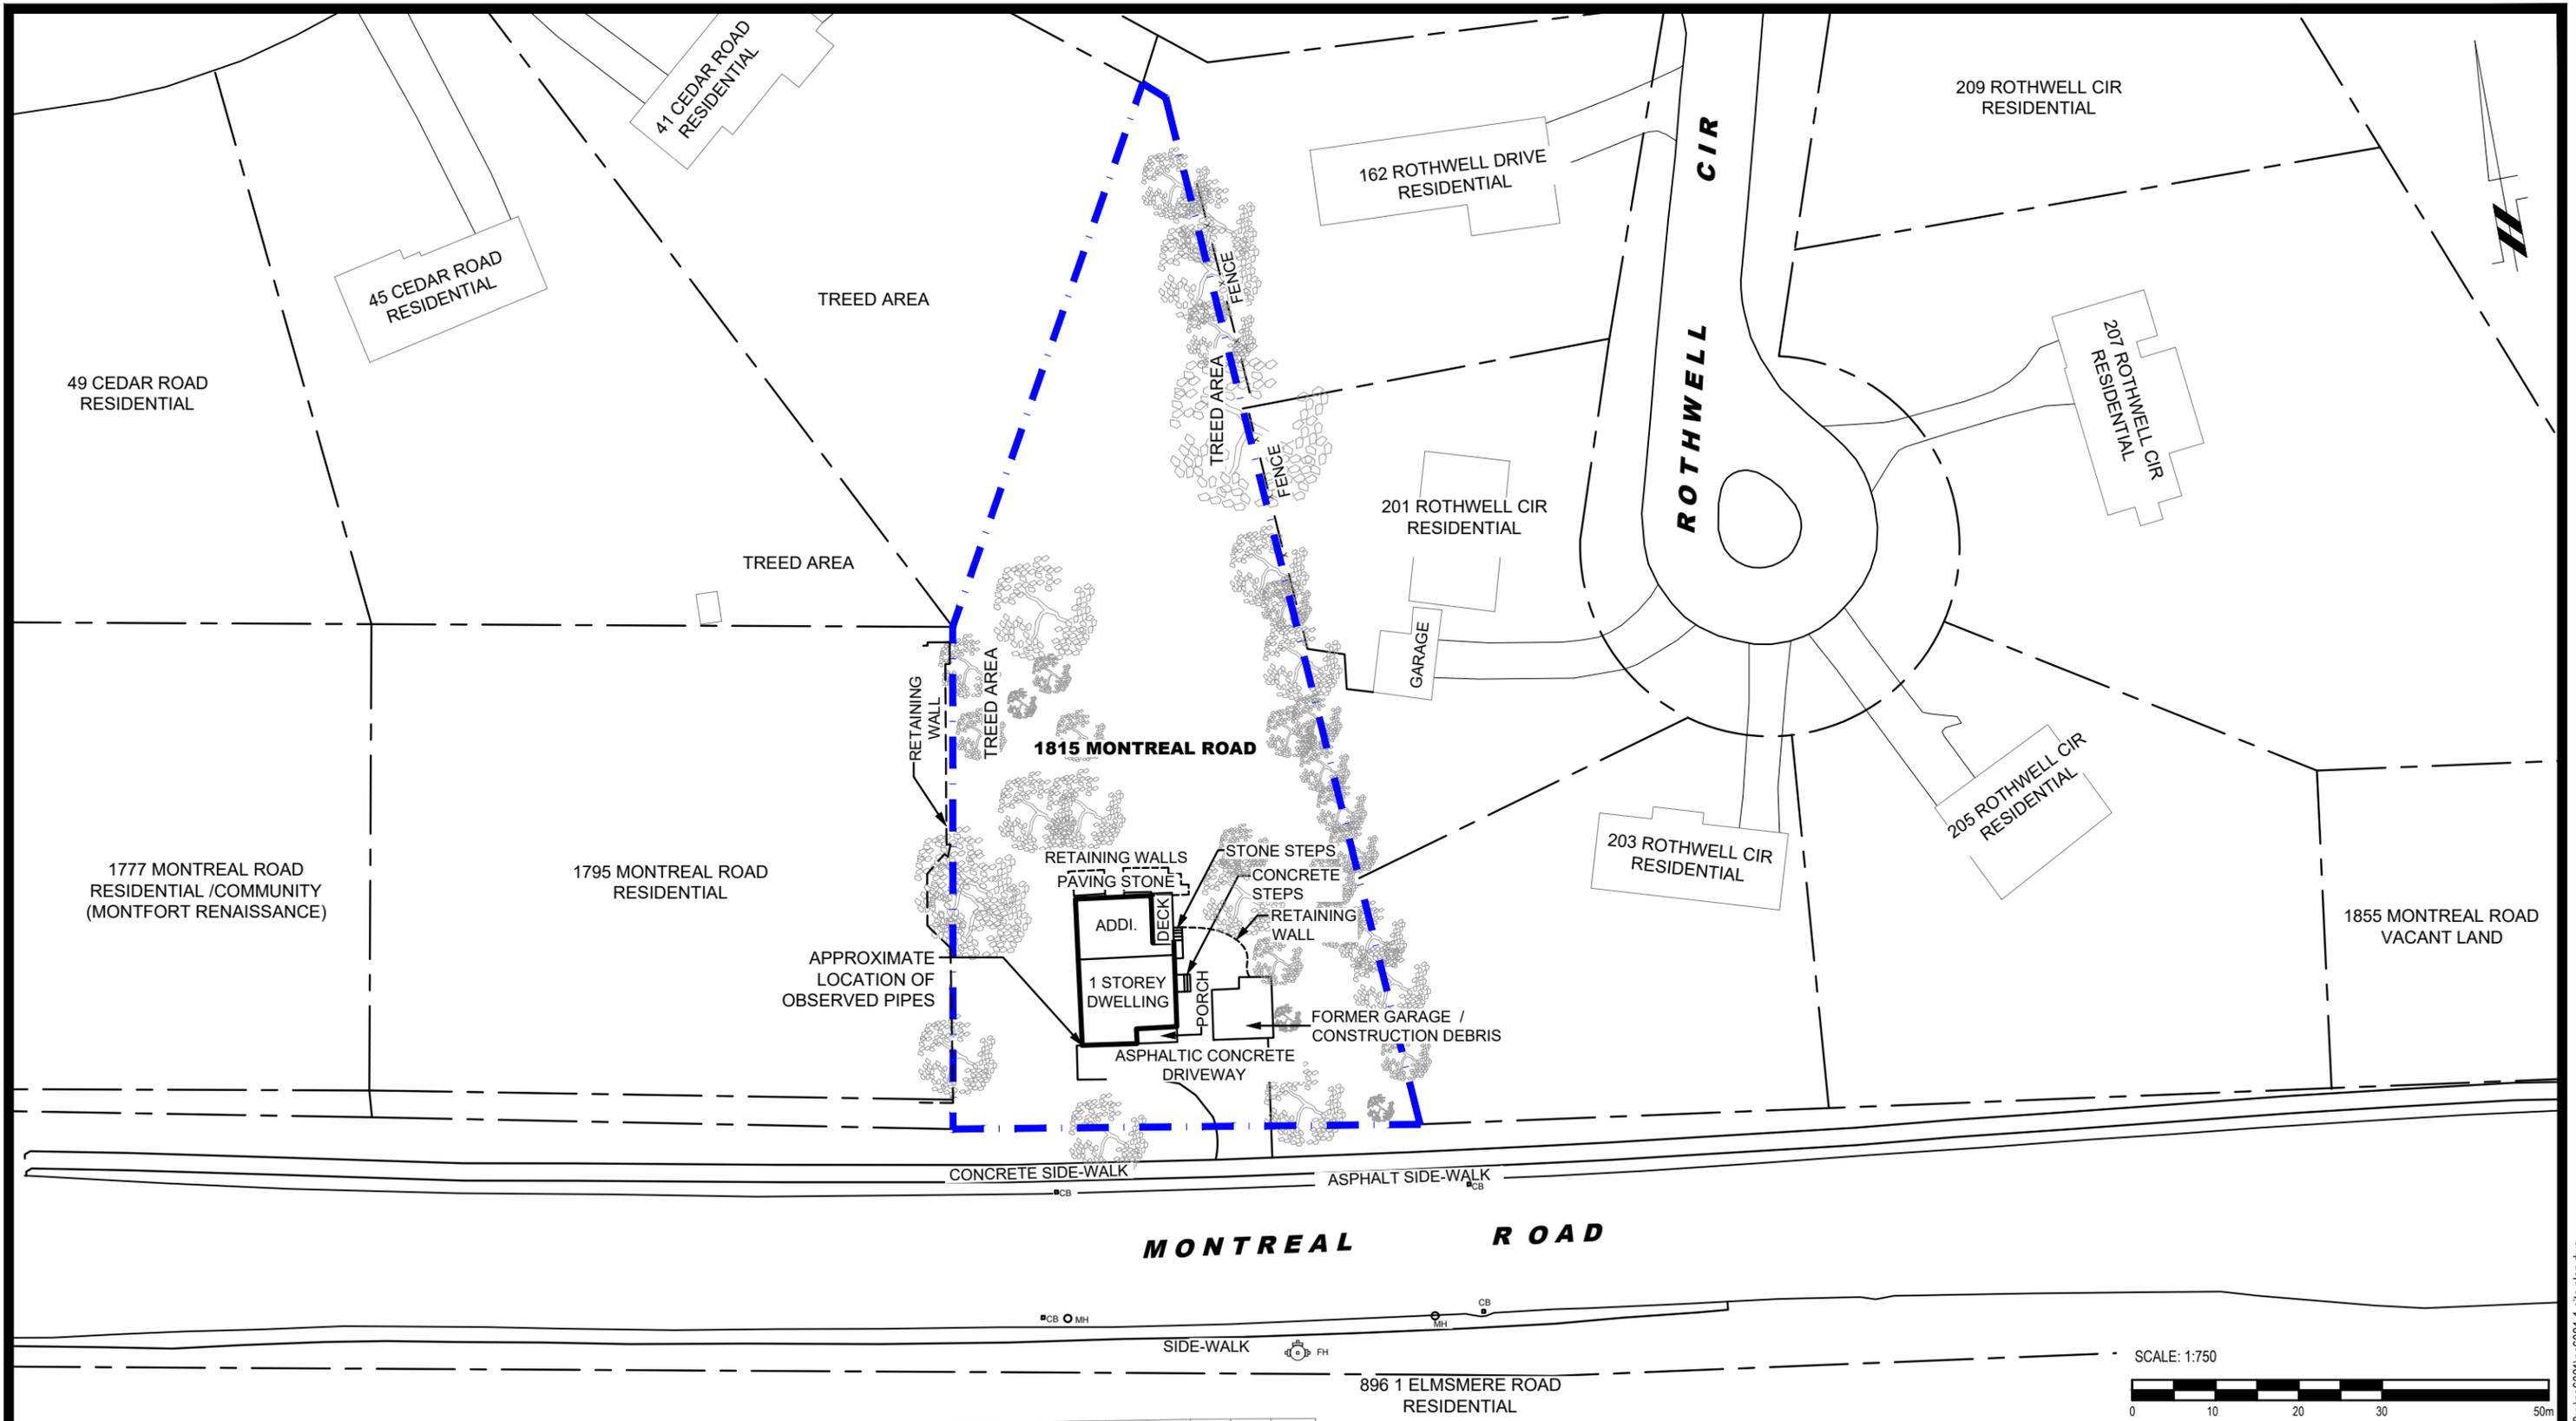
Title: **SITE PLAN**

There is a one-storey residential dwelling with a walk-out basement on the Phase I ESA Property, as well as a retaining wall north of the former private garage and the foundation of the former private garage. No other structures are present.

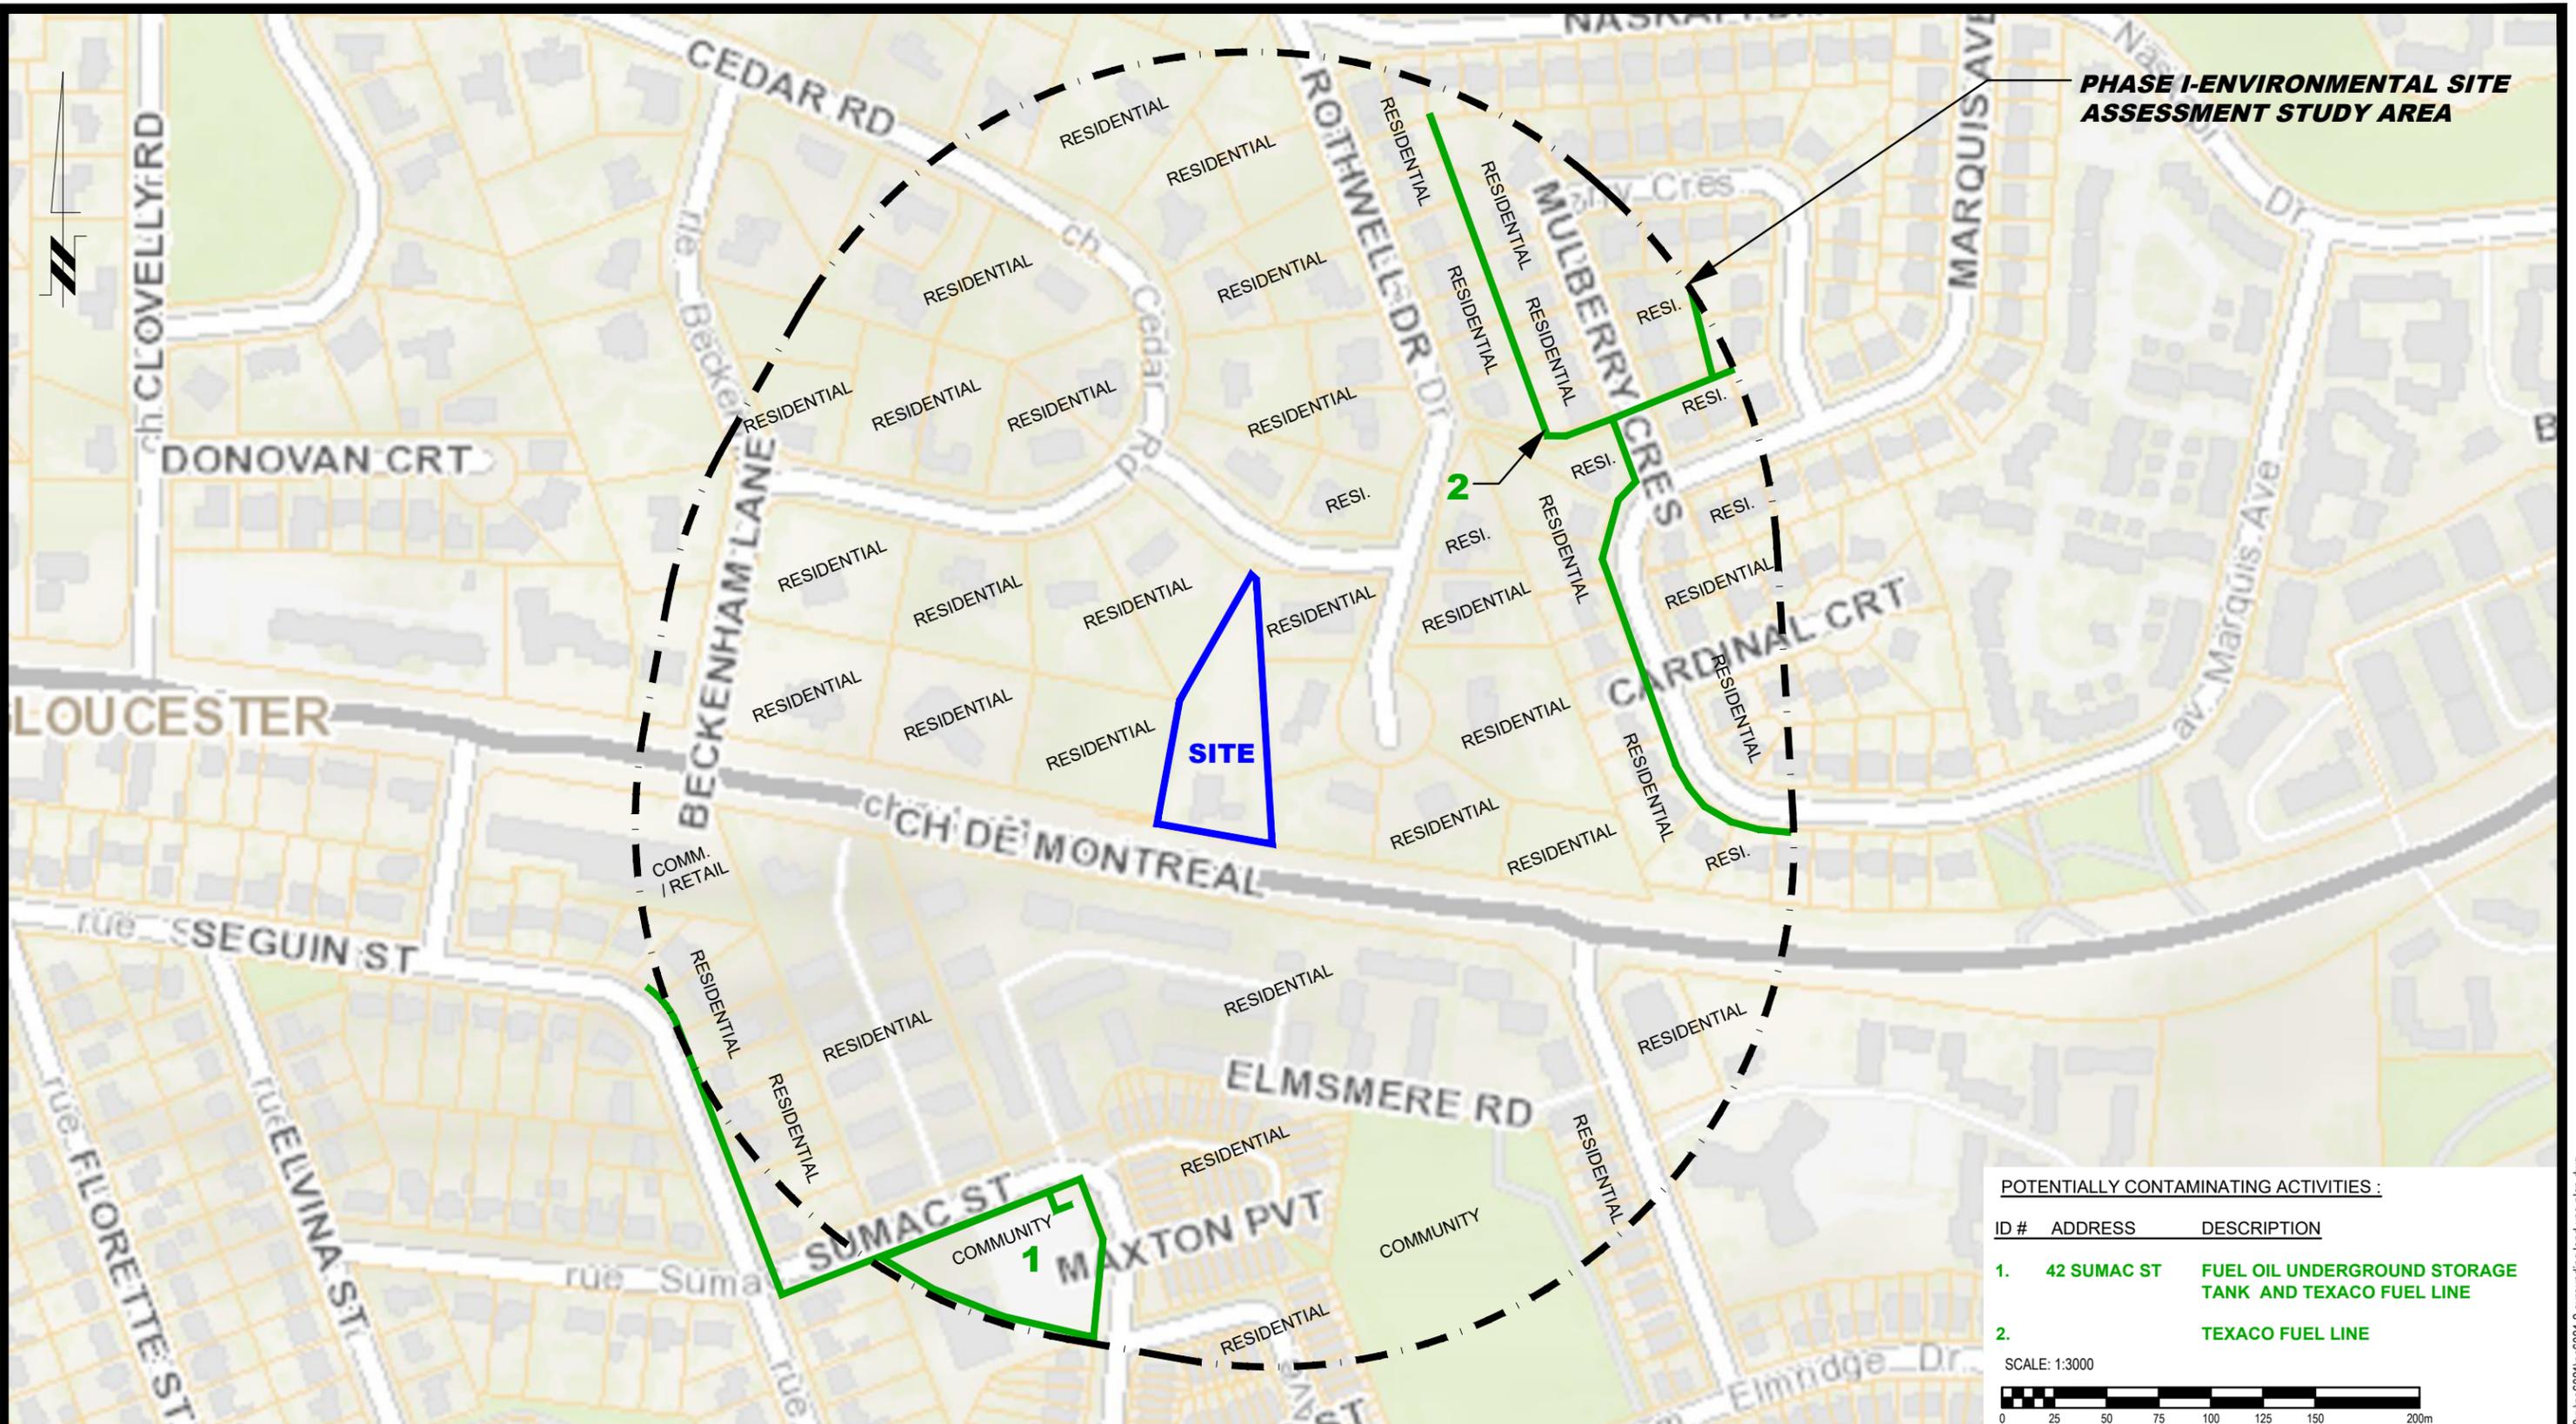
There is a one-storey residential dwelling with a walk-out basement on the Phase I Property. There is a stone façade on the front of the building, which is of wood frame construction, finished with stucco and vinyl siding with a sloped and shingled roof. The foundation of the original part of the residence is concrete blocks with cement parging. A large wooden deck is present at the north-eastern corner, off the main level kitchen. There is a retaining wall at the north end of the driveway and the foundation of the former private garage remains on-site. No other structures are present.

The Phase I Property is landscaped and slopes down from Montreal Road to the north to Rothwell Drive, which is approximately 6 m lower in elevation. An asphalt driveway connects the former private garage to the roadway and the carport/portico at the front of the building. Mature trees are also present on-site. Site drainage consists primarily of infiltration. Regional topography slopes down to the northeast.

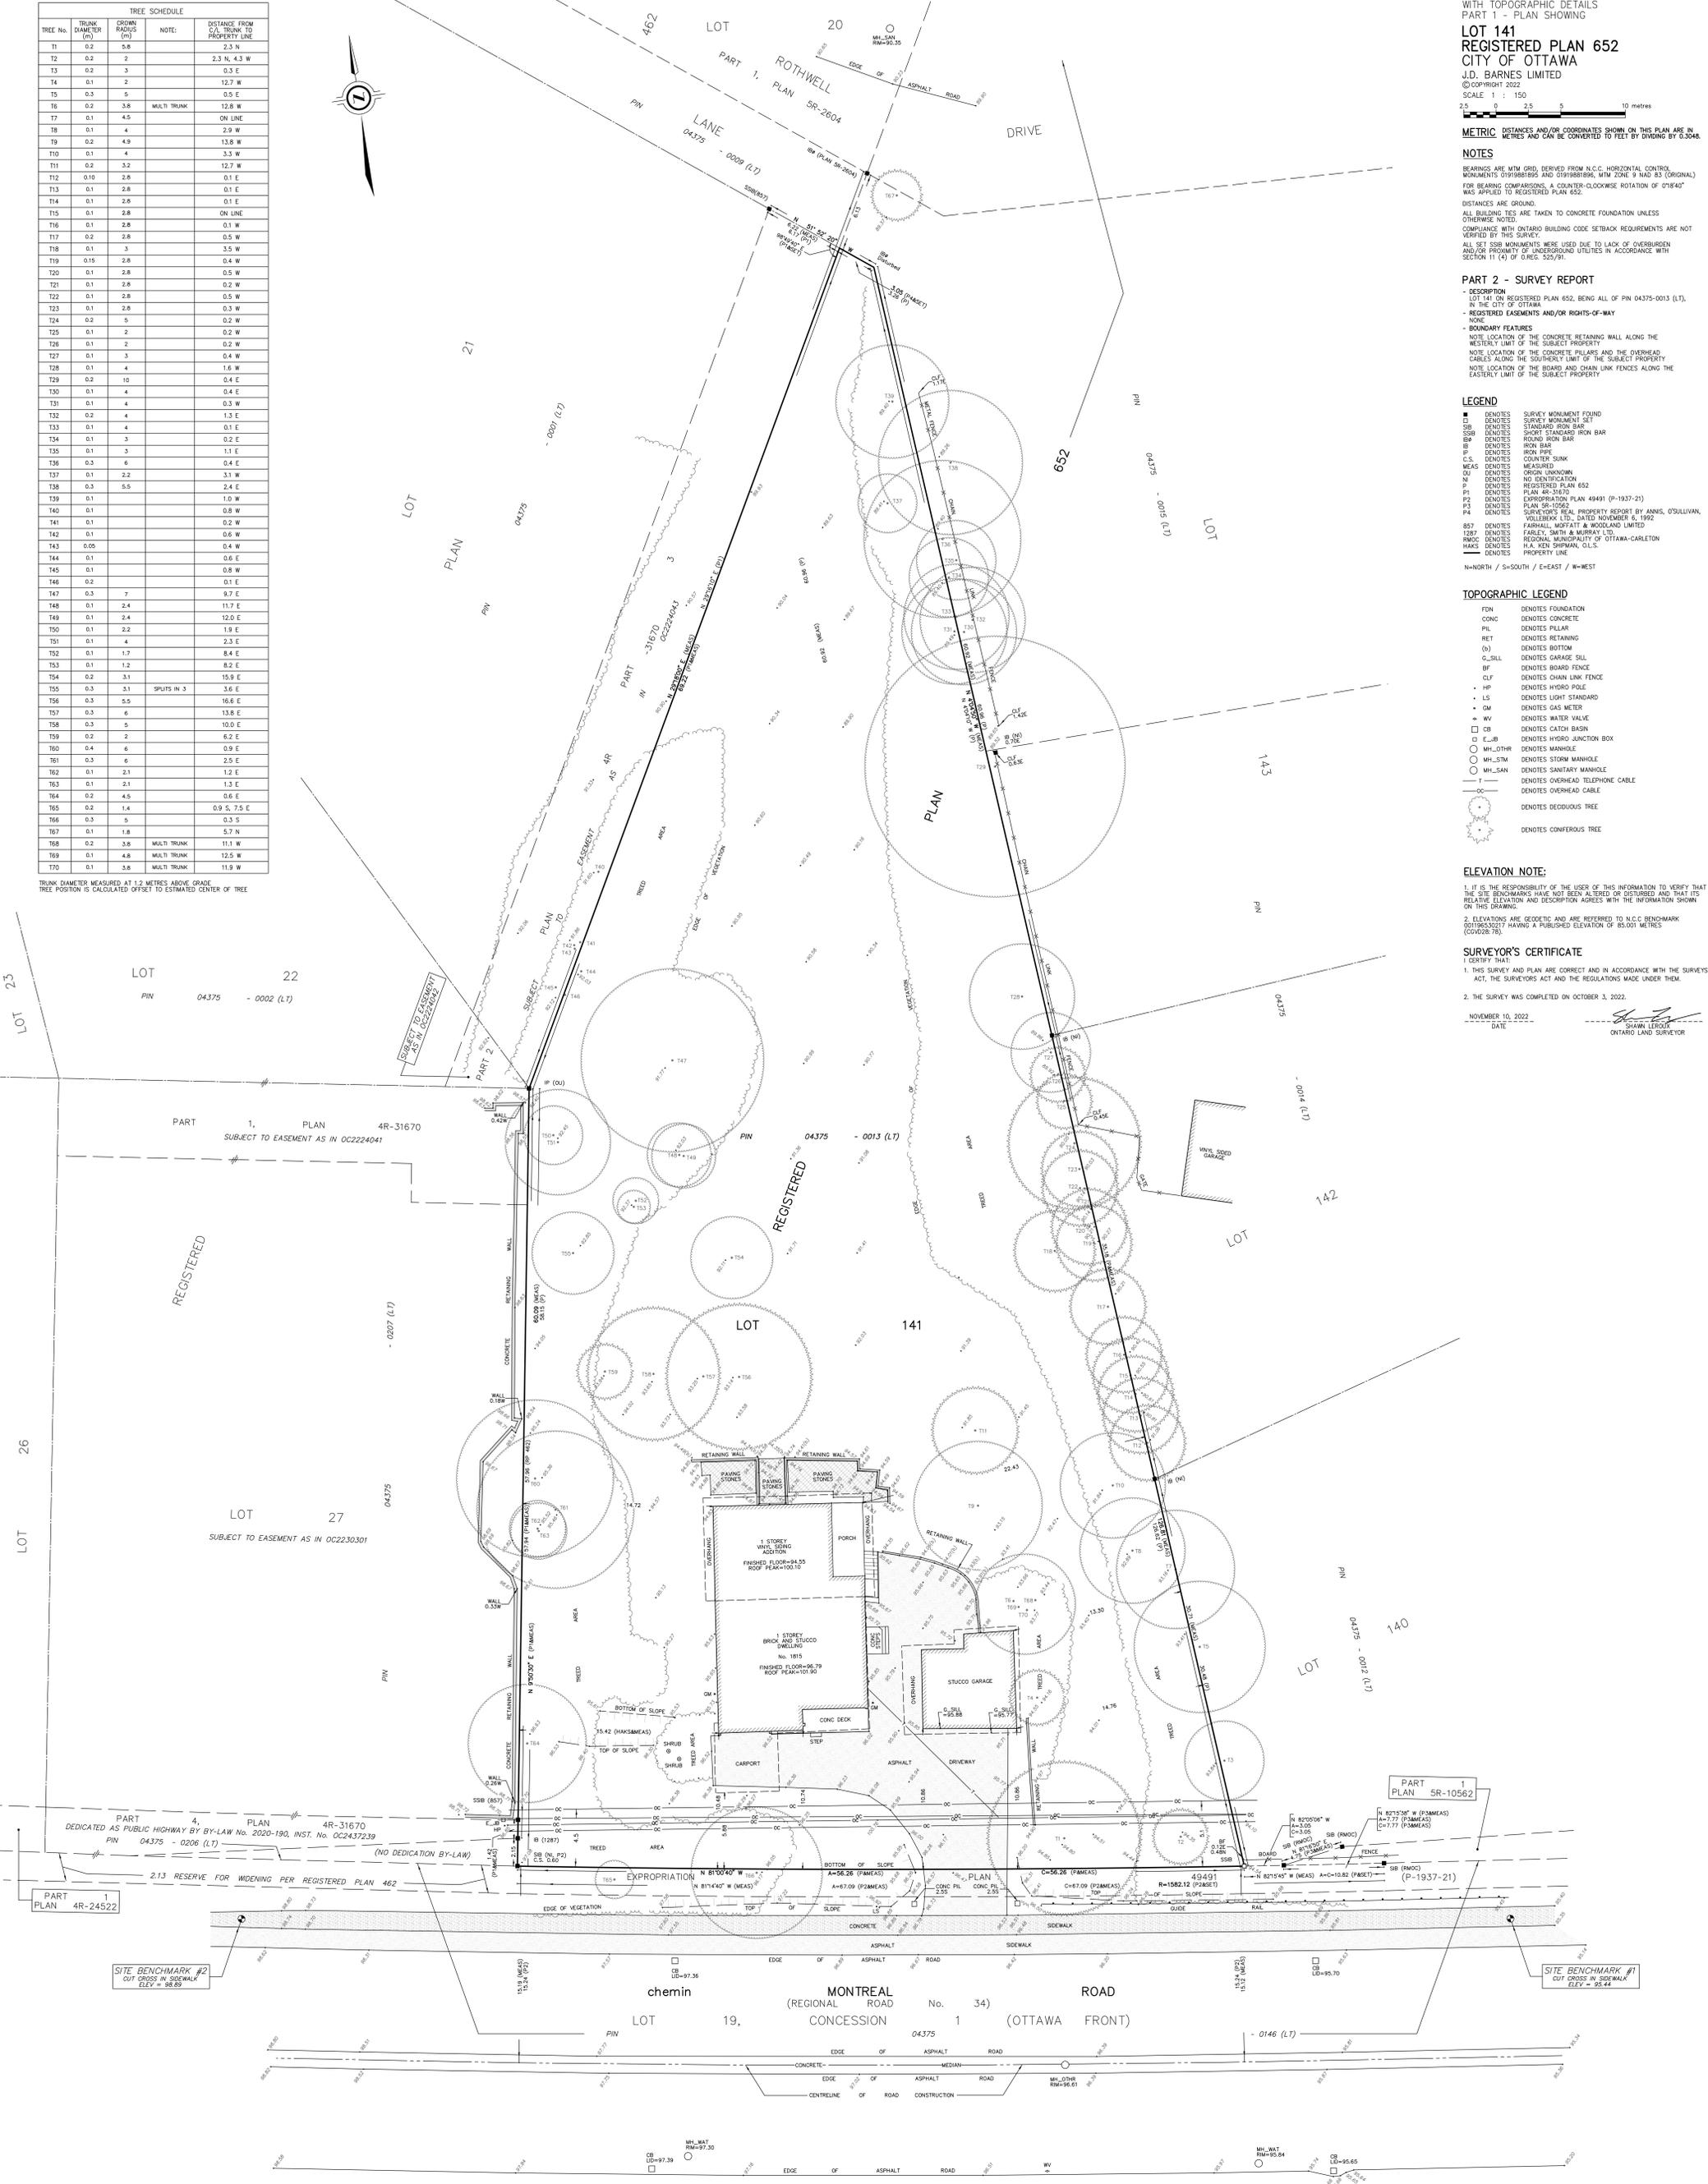
**SURVEYOR'S REAL PROPERTY REPORT WITH TOPOGRAPHIC DETAILS PART 1 - PLAN SHOWING**

**LOT 141 REGISTERED PLAN 652 CITY OF OTTAWA**  
J.D. BARNES LIMITED  
© COPYRIGHT 2022  
SCALE 1 : 150

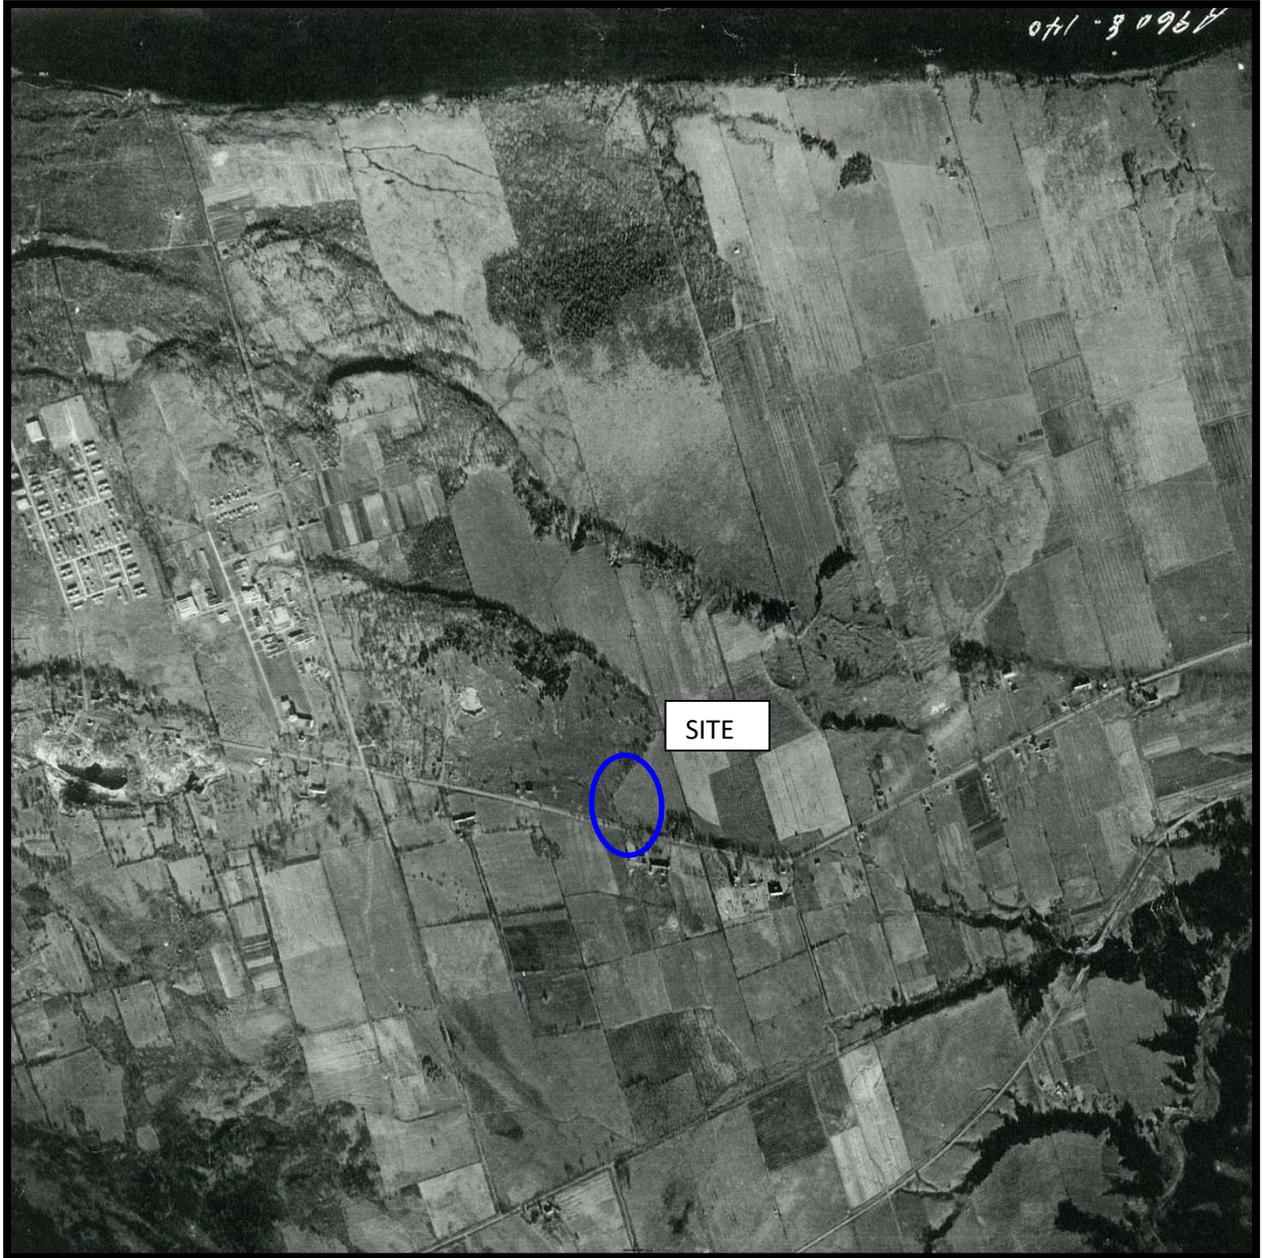
AERIAL PHOTOGRAPH  
1945

According to the historical research, the Phase I Property was first developed for residential purposes between 1945 and 1955 and has been used for that purpose since that time. The historical use of the surrounding lands has consisted of primarily residential with some commercial and community land use. Several historical off-site potentially contaminating activities (PCAs) were identified within the Phase I Study Area. Based on orientation and/or separation distances, these off-site PCAs are not considered to represent APECs on the Phase I ESA Property.

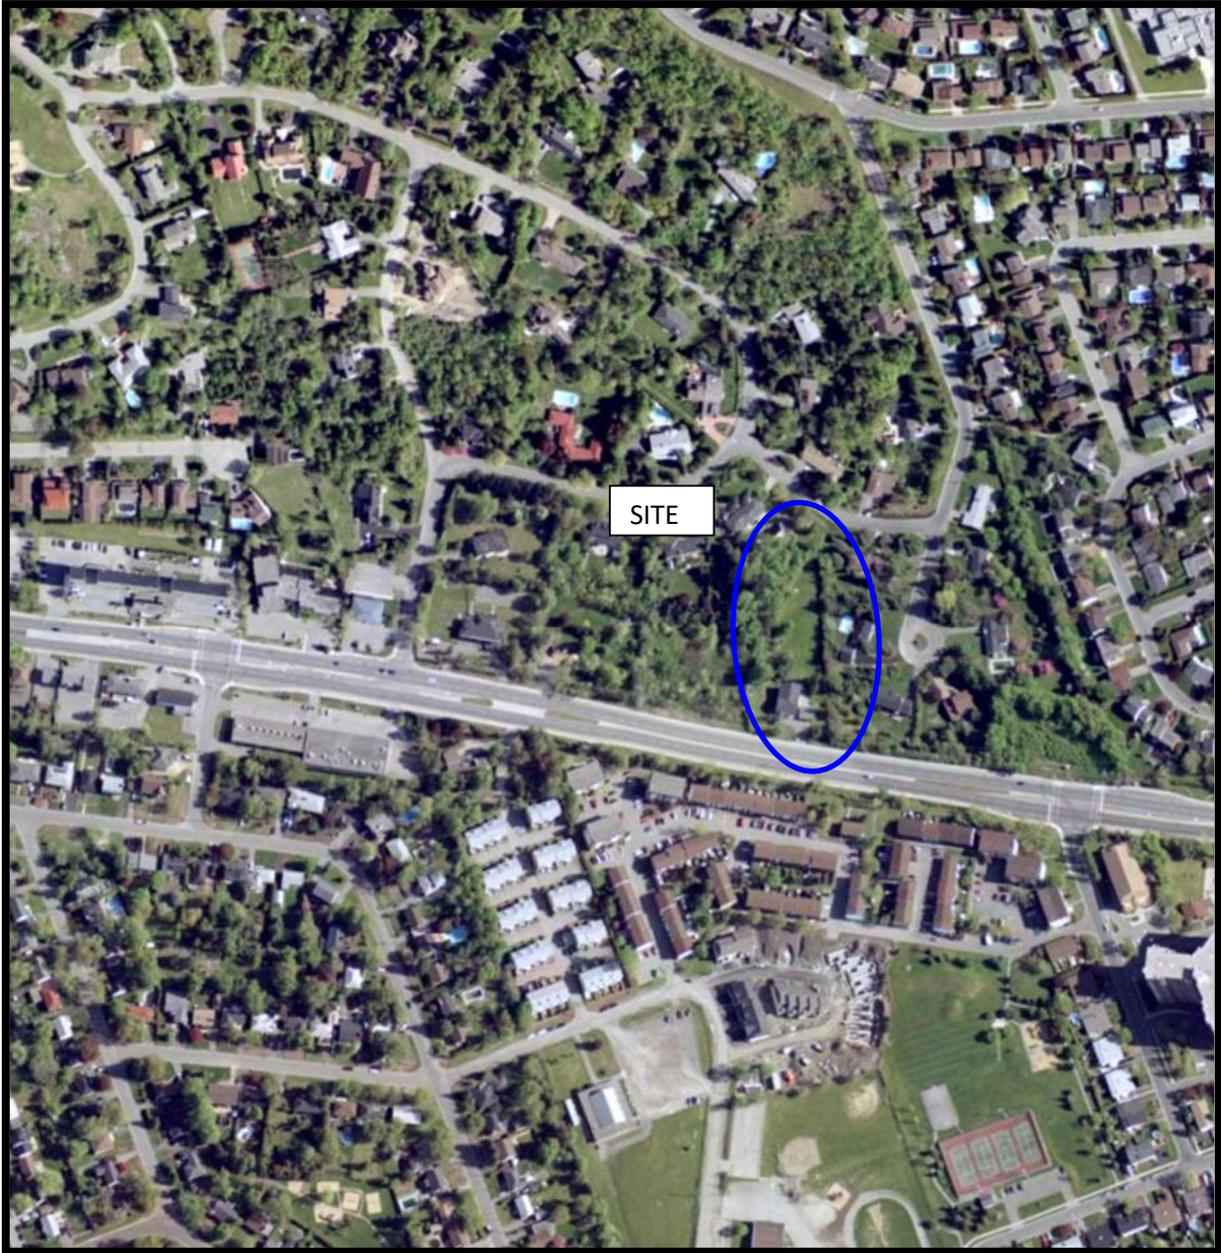
AERIAL PHOTOGRAPH  
2002

- 2002 No significant changes appear to have been made to the Phase I Property or neighbouring properties within the Phase I Study Area. One residence west of the Phase I Property has been demolished.
- 2011 There are no apparent changes on the Phase I Property and surrounding lands remain largely unchanged from the previous photograph. The residential property noted previously has been redeveloped with a larger residential complex (Montfort Renaissance).
- 2021 The Phase I Property remains unchanged from the previous photograph. The adjacent property to the west appears to be under development. No other significant changes are apparent in the Phase I Study Area.

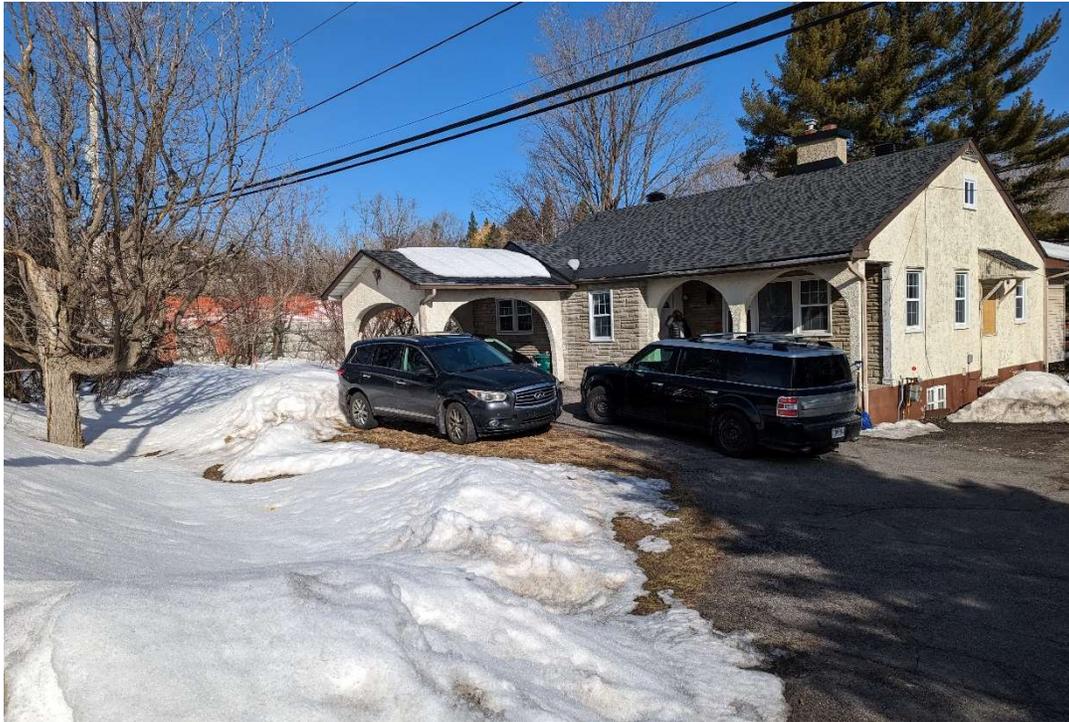
Photograph 1: View of 1815 Montreal Road from the roadway, looking northwest.

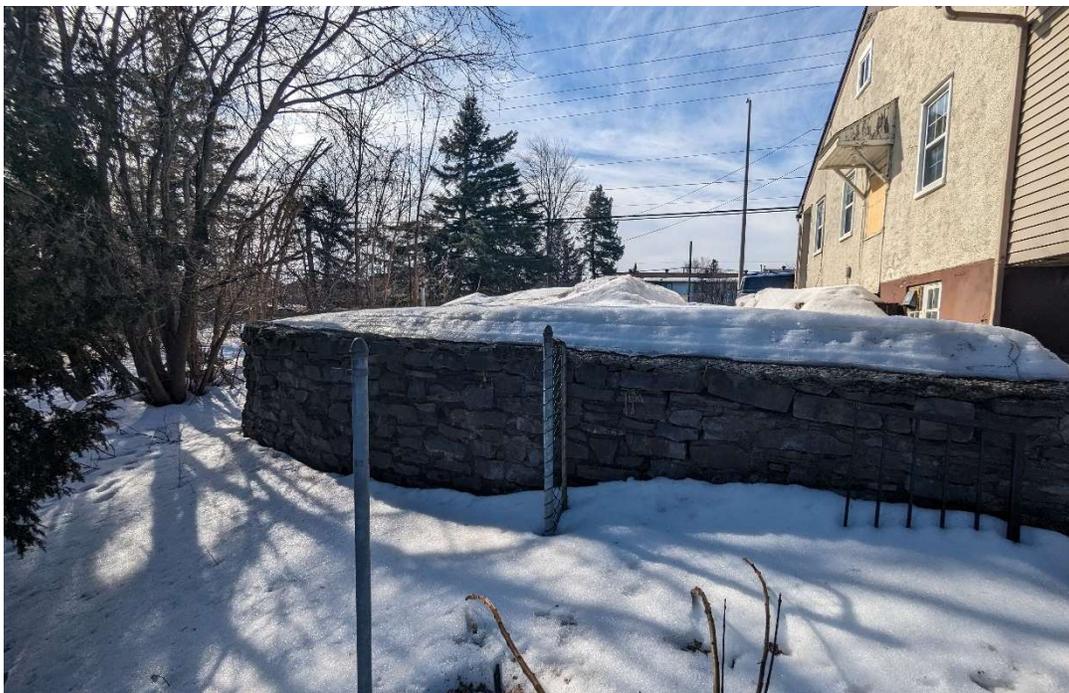
No imported fill is suspected on the Phase I Property. Based on the observed slope of the site, engineered fill material is likely present on the south-eastern portion of the Phase I Property in the area supported by the retaining wall near the former private garage.

Photograph 2: View of retaining wall north of former private garage, looking south.

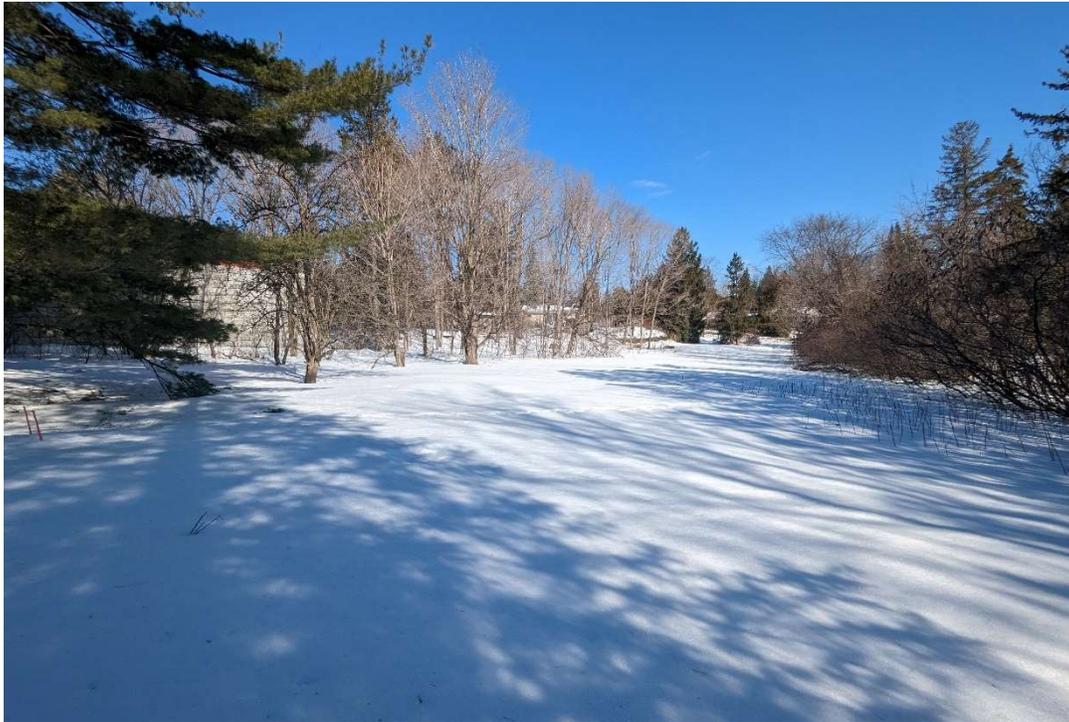
Photograph 3: View of northern portion of the Phase I Property, looking north.

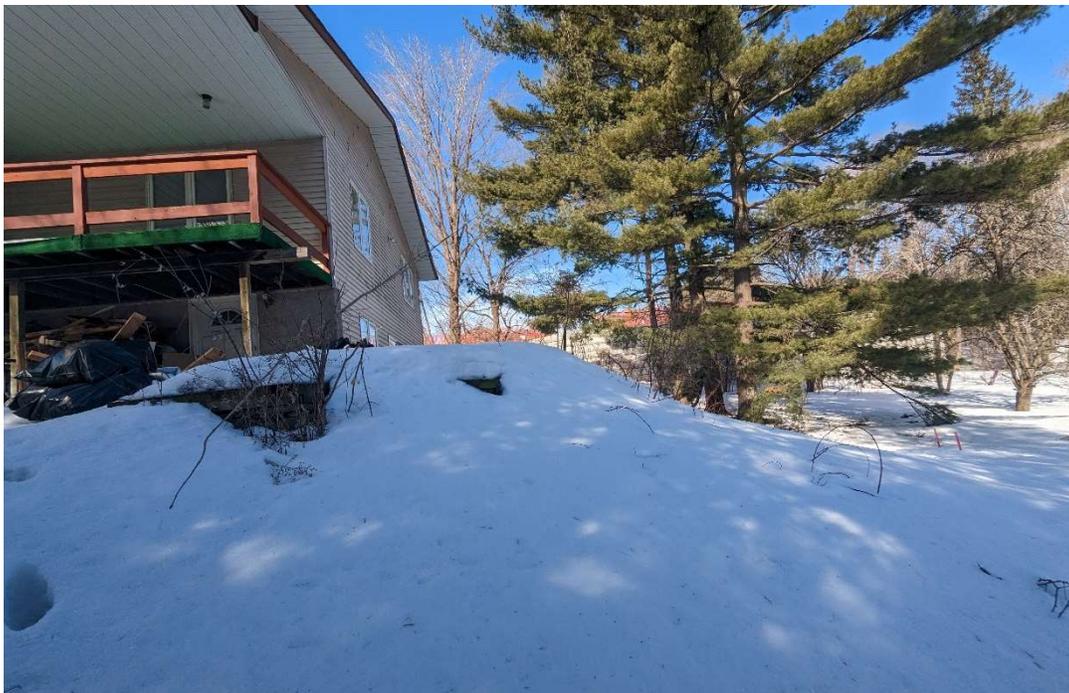
Following the historical research, a site visit was conducted. The Phase I ESA Property is currently occupied by a residential dwelling. The foundation of the former on-site private garage is present, along with the demolition debris. No PCAs were identified on the Phase I ESA Property.

Photograph 4: Rear of building, looking west. Construction debris visible below the deck.

As the demolition debris from the former private garage was observed on-site during the site visit, it is recommended that the debris be removed and transported to an approved waste facility.

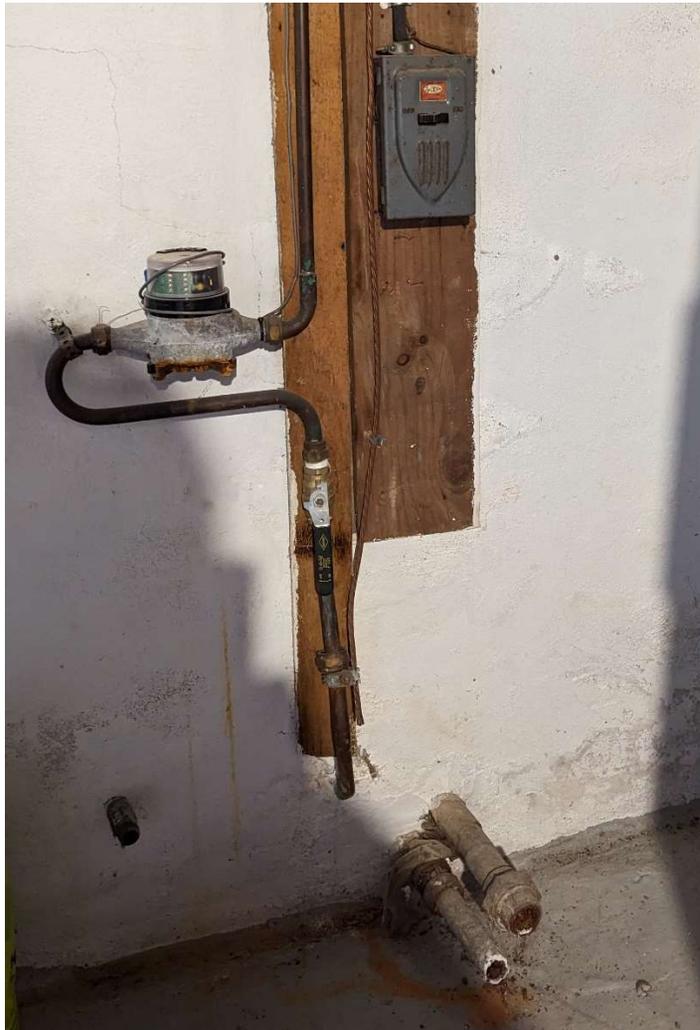
Pipes were observed on the interior of an exterior wall in the basement of the building (southwest corner), though there was no evidence of them on the exterior of the building. These pipes are located near the water line and hot water tank and, although they could have been associated with a former fuel oil tank, given the location and position of the pipes as well as evidence of staining caused by oxidation, it is likely that these are the original water lines associated with a former domestic well. There were no other indications of fuel or chemical storage in the building.

Photograph 5: Original pipes and water meter in basement.

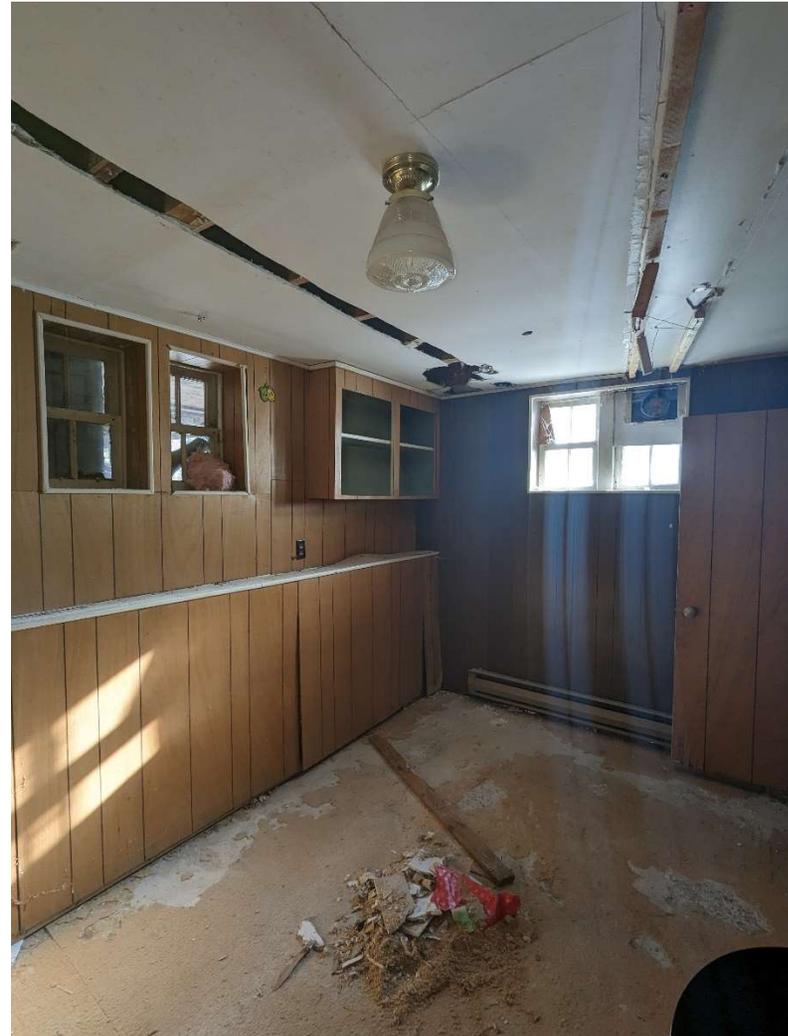
A general assessment of the building's interior noted that the floors were finished with a combination of hardwood, ceramic tiles, concrete, and laminate flooring. Carpet was also observed on the stairs. The walls generally consisted of painted drywall, although wood panelling as well as ceramic tiles were also observed. The ceilings were painted drywall. Ceilings also had a stipple finish in some areas. The observed lighting was provided primarily by LEDs in areas that have recently been renovated. Some incandescent fixtures are still present in some areas of the basement that have not been recently renovated. The house is heated by a natural gas-fired furnace as well as electric baseboard heaters in the basement. A fireplace is present in the main floor living room. There are 2 attic spaces: one associated with the original residential dwelling and one associated with the addition at the rear.

Photograph 6: Unrenovated room in basement.
