# **Geotechnical Investigation**

Proposed High Rise Development 1531 St. Laurent Boulevard, Ottawa, Ontario

OTT-23005035-A0

June 14, 2023 Draft Report

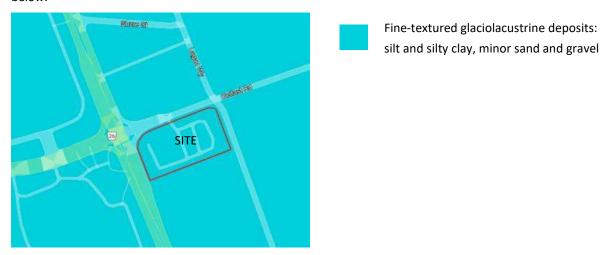
Image 1 - Surficial Geology

The surficial geology was reviewed via the Google Earth applications published by the Ontario Ministry of Energy, Northern Development and Mines available via www.mndm.gov.on.ca/en/mines-and-minerals/applications/ogsearth/surficial-geology and was last modified on May 23, 2017. The map indicates that beneath any fill the site is underlain by fine-textured glaciolacustrine deposits consisting of silt and silty clay, minor sand and gravel. The surficial deposits are shown in Image 1 below.

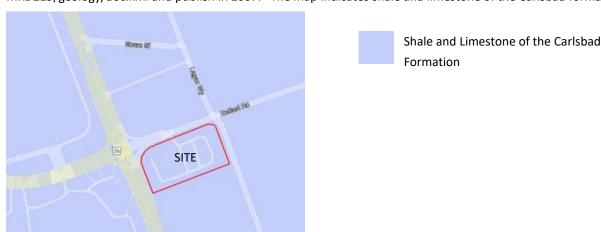
Image 2 - Bedrock Geology

The bedrock geology was reviewed via the Google Earth applications published by the Ontario Ministry of Energy, Northern Development and Mines available via <a href="http://www.geologyontario.mndm.gov.on.ca/mines/data/google/">http://www.geologyontario.mndm.gov.on.ca/mines/data/google/</a> MRD219/geology/doc.kml and publish in 2007. The map indicates shale and limestone of the Carlsbad formation.

As previously mentioned, the shale bedrock at the site is of the Carlsbad formation. This type of shale is prone to deterioration when exposed to the elements. It also heaves due to a complex mechanism caused in part from the bio-oxidation of the sulphides in the rock, which react with calcite seams to form expanding gypsum. This occurs when oxygen is permitted to enter the rock, usually by lowering of the water table and this process is accelerated by the presence of heat. Therefore, special treatment of the Carlsbad shale bedrock will need to be incorporated into the design and construction of the proposed buildings.

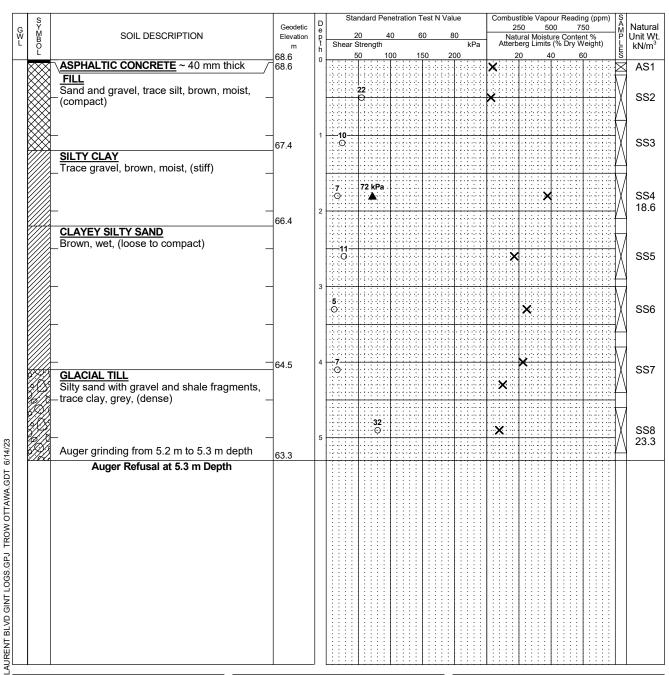
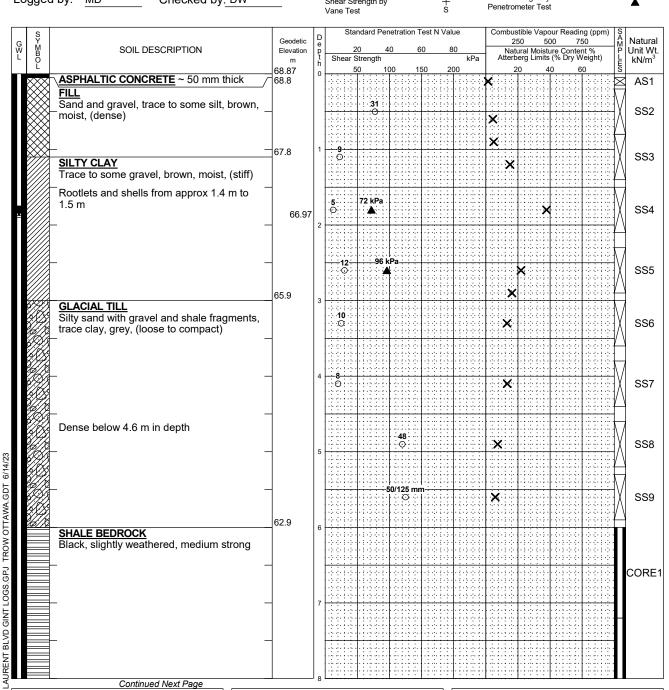
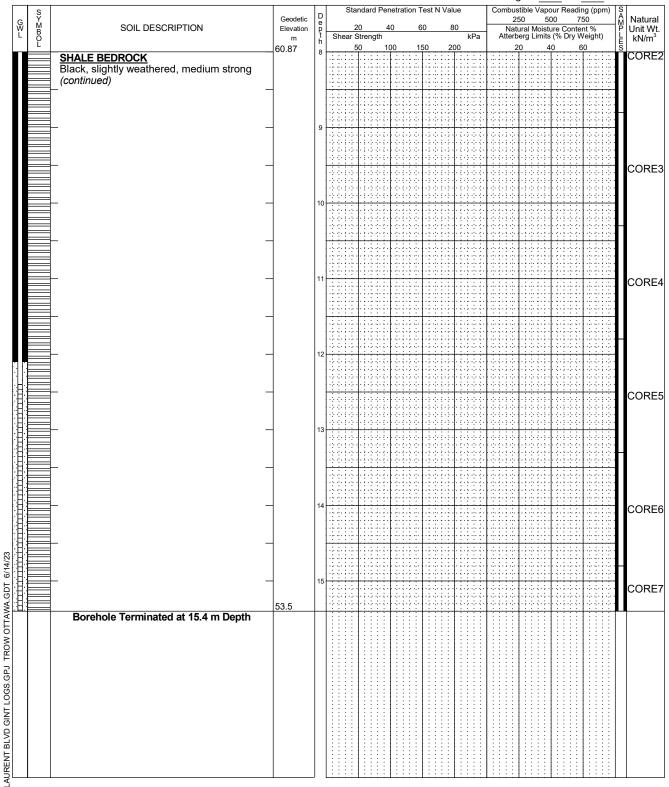
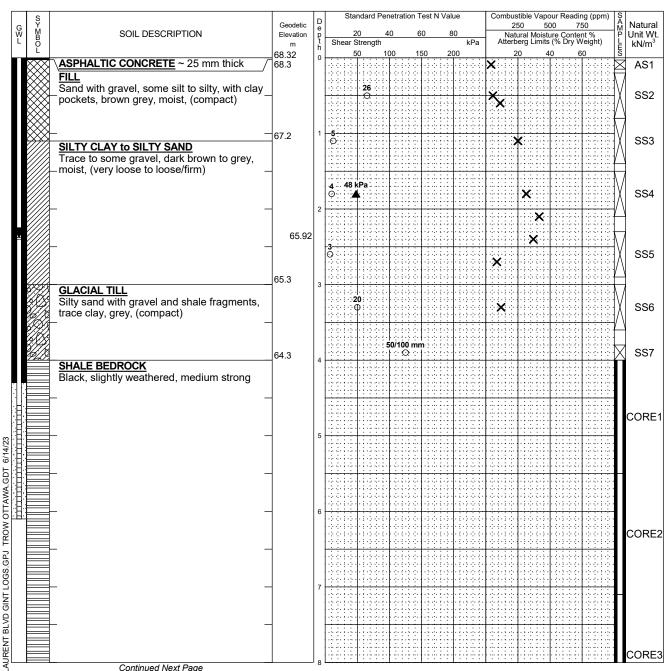
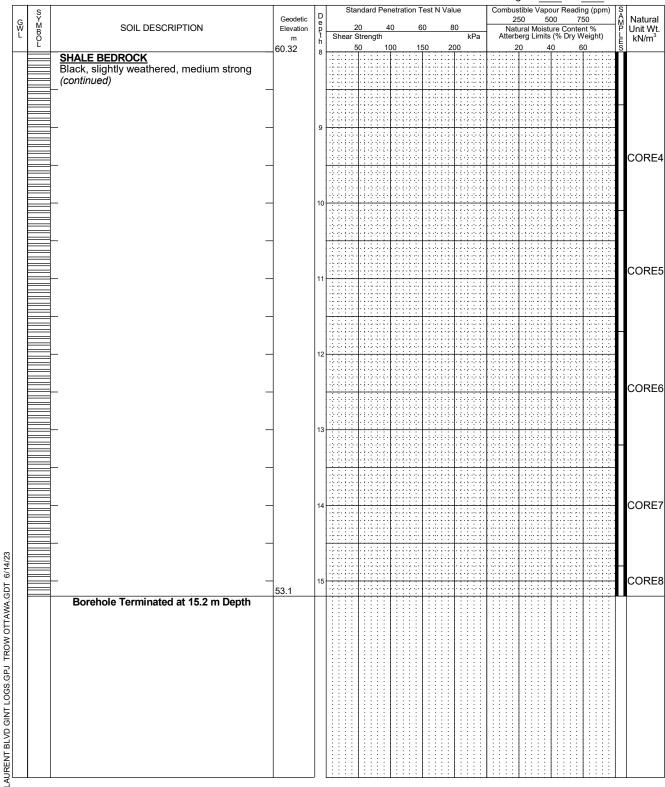
A detailed description of the subsurface conditions and groundwater levels from this geotechnical investigation are given on the attached Borehole Logs, Figure Nos. 3 to 7 inclusive. The borehole logs and related information depict subsurface conditions only at the specific locations and times indicated. Subsurface conditions and water levels at other locations may differ from conditions at the locations where sampling was conducted. The passage of time also may result in changes in the conditions interpreted to exist at the locations where sampling was conducted.

It should be noted that the soil and rock boundaries indicated on the borehole logs are inferred from non-continuous sampling and observations during drilling operations. These boundaries are intended to reflect approximate transition zones for the purpose of geotechnical design and should not be interpreted as exact planes of geological change. The "Note on Sample Descriptions" preceding the borehole logs form an integral part of this report and should be read in conjunction with this report.

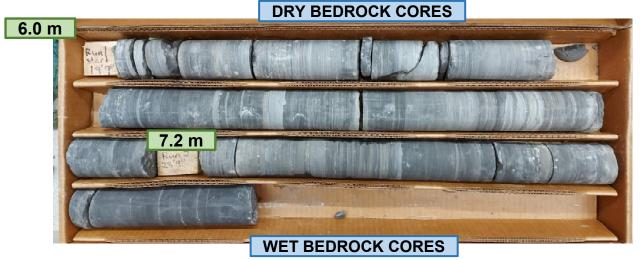
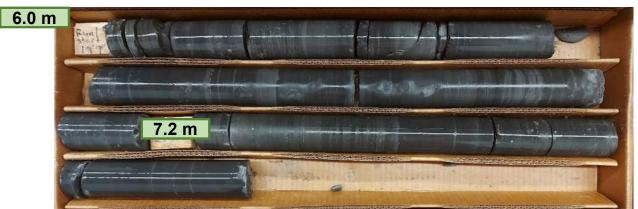
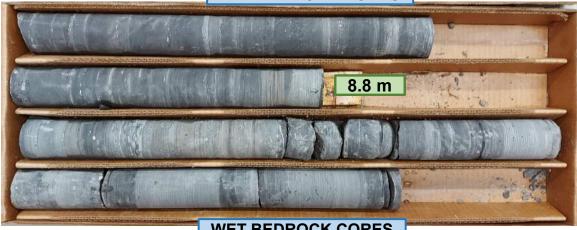
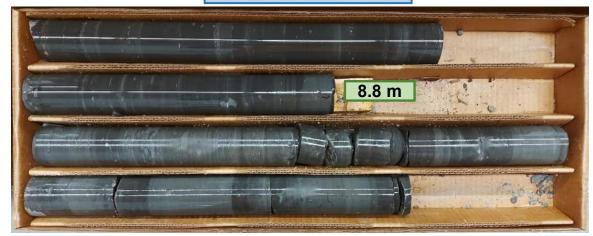
| Borehole No: | | Geotechnical Investigation - | Project N0: |
|---|--|--|---|
| 'June 5, 2023 | | Rock Core Photographs | FIG C-1 |

#### DRY BEDROCK CORES

#### **WET BEDROCK CORES**

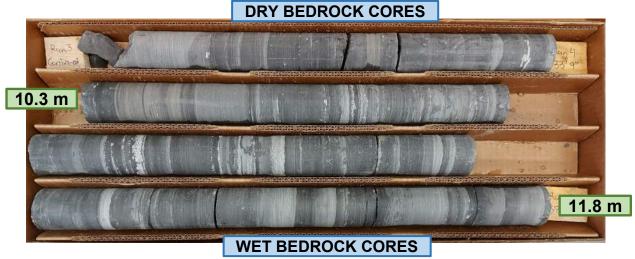
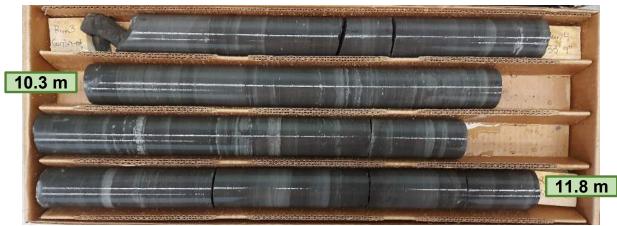
| | Core Runs<br>Run 2: 7.2 m - 8.8 m<br>Run 3: 8.8 m - 10.3 m | Geotechnical Investigation - Proposed High-Rise Development 1531 St. Laurent Boulevard | Project N0: OTT-23005035-A0 |
|---|--|--|---|
| June 5, 2023 | | Rock Core Photographs | FIG C-2 |

| | Core Runs<br>Run 2: 7.2 m - 8.8 m<br>Run 3: 8.8 m - 10.3 m | Geotechnical Investigation - Proposed High-Rise Development 1531 St. Laurent Boulevard | Project N0: OTT-23005035-A0 |

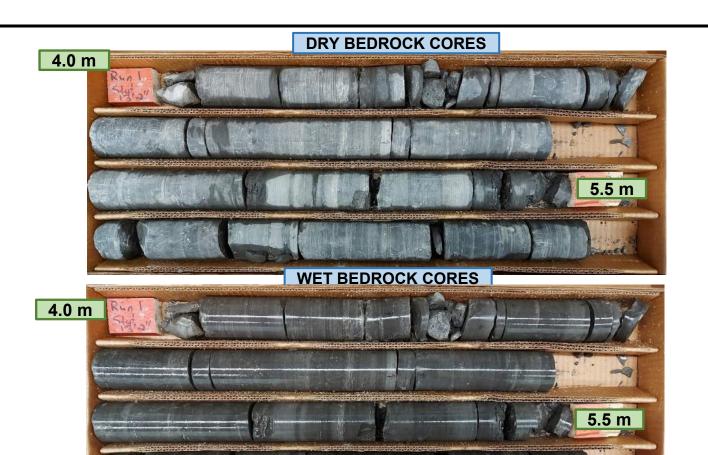
| | Core Runs | Geotechnical Investigation - | Project N0: |
|---|---|--|---|
| 'June 5, 2023 | | Rock Core Photographs | FIG C-5 |

| | Core Runs | Geotechnical Investigation - | Project N0: |
|---|---|--|---|
| | Run 6: 13.3 m - 14.8 m<br>Run 7: 14.8m - 15.4 m | Proposed High-Rise Development<br>1531 St. Laurent Boulevard | OTT-23005035-A0 |

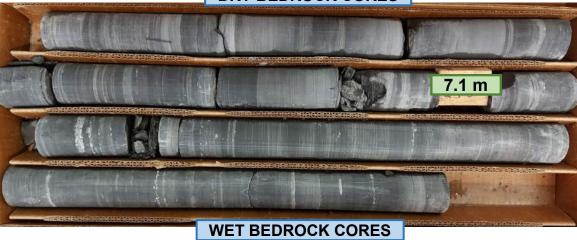
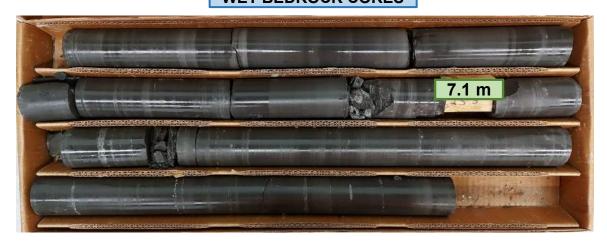
| Borehole No: | Core Runs | Geotechnical Investigation - | Project N0: |
|---|--|--|---|
| Date Cored | | Rock Core Photographs | FIG C-6 |

| Borehole No: | Core Runs | Geotechnical Investigation - | Project N0: |
|---|--|--|---|
| BH5 | Run 1: 4.0 m - 5.5 m<br>Run 2: 5.5 m - 7.1 m | Proposed High-Rise Development<br>1531 St. Laurent Boulevard | OTT-23005035-A0 |

### DRY BEDROCK CORES

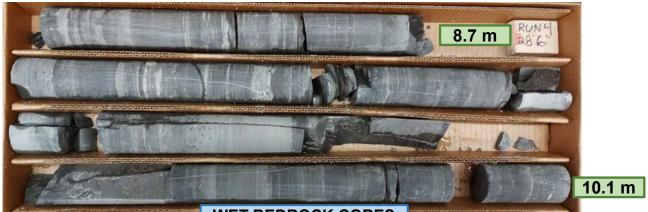
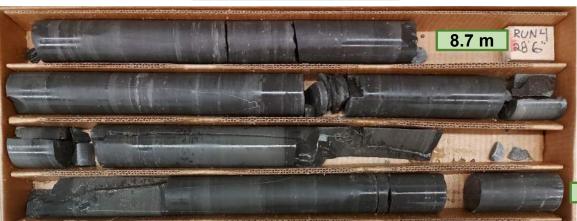
| | | Geotechnical Investigation - | Project N0: |
|---|--|--|---|
| 'June 5, 2023 | | Rock Core Photographs | FIG C-7 |

#### DRY BEDROCK CORES

WET BEDROCK CORES

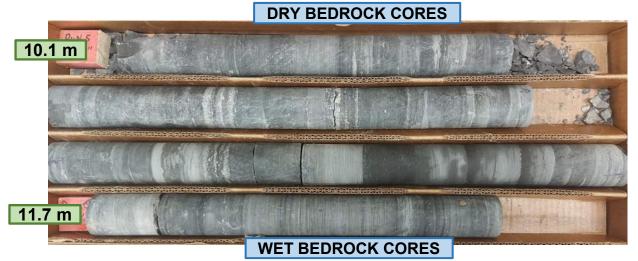
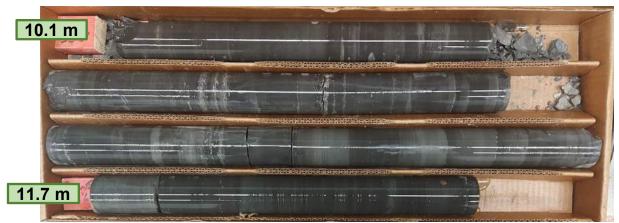
| | | project Geotechnical Investigation - | Project N0: |
|---|---|--|---|
| Date Cored 'June 5, 2023 | | Rock Core Photographs | FIG C-8 |

| | | project Geotechnical Investigation - | Project N0: |
|---|---|--|---|
| | Run 3: 7.1 m - 8.7 m<br>Run 4: 8.7 m - 10.1 m | Proposed High-Rise Development<br>1531 St. Laurent Boulevard | OTT-23005035-A0 |

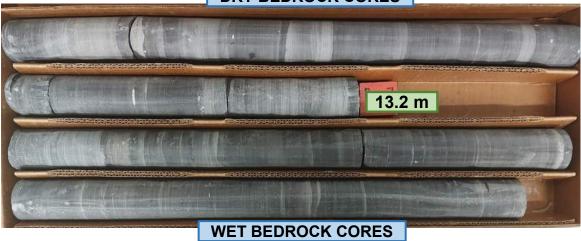
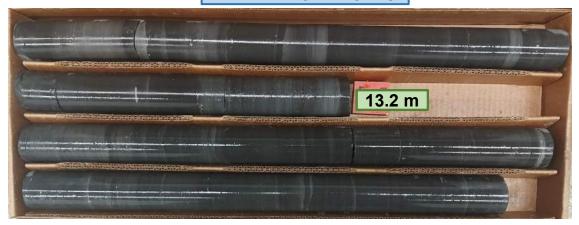
| | Core Runs<br>Run 5: 10.1 m-11.7 m<br>Run 6: 11.7 m-13.2 m | Geotechnical Investigation - Proposed High-Rise Development 1531 St. Laurent Boulevard | Project N0: OTT-23005035-A0 | | | |
|---|---|--|---|--|--|--|
| June 5, 2023 | | Rock Core Photographs | FIG C-9 | | | |

| | Core Runs<br>Run 5: 10.1 m-11.7 m<br>Run 6: 11.7 m-13.2 m | Geotechnical Investigation - Proposed High-Rise Development 1531 St. Laurent Boulevard | Project N0: OTT-23005035-A0 | | | |

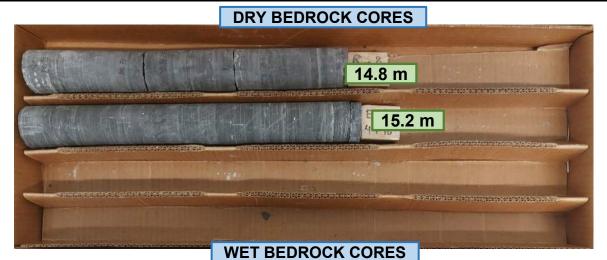
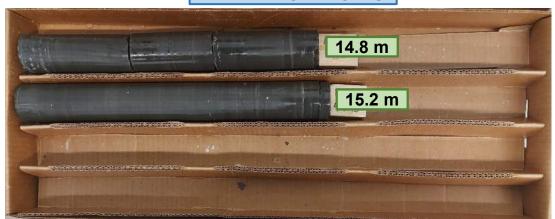
| Borehole No: | Core Runs | project Geotechnical Investigation - | Project N0: |
|---|--|--|---|
| Date Cored 'June 5, 2023 | | Rock Core Photographs | FIG C-10 |

| Borehole No: | Core Runs | project Geotechnical Investigation - | Project N0: |
|---|--|--|---|
| | Run 6: 11.7 m-13.2 m<br>Run 7: 13.2 m-14.8 m | Proposed High-Rise Development<br>1531 St. Laurent Boulevard | OTT-23005035-A0 |
