Geotechnical Investigation – Proposed Mixed-Use Development

150 Kanata Avenue & 1200 Canadian Shield Avenue,
Kanata, Ontario

March 9, 2023

Pinchin File: 290435.001

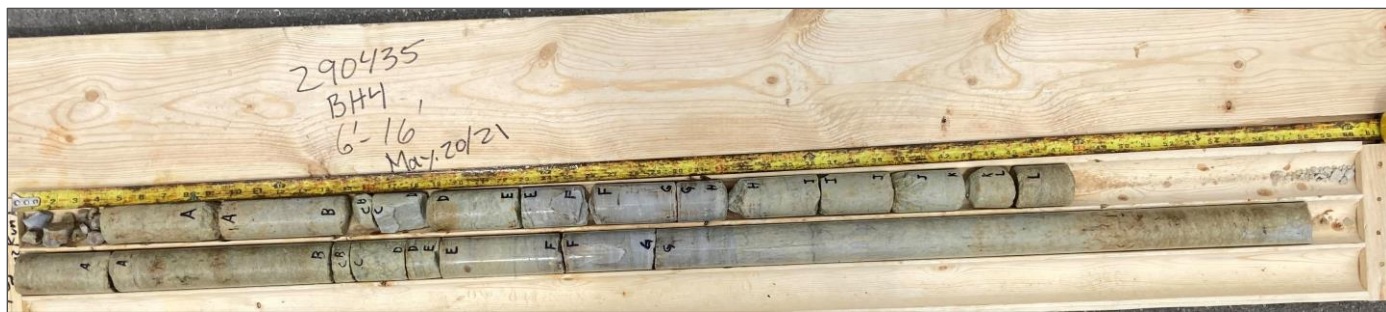
Photo 1 – Borehole BH4, Rock Core (Runs 1 and 2)

Refusal was encountered on bedrock within all boreholes and bedrock probes at depths ranging from approximately 0.2 to 14.0 mbgs (i.e., elevations 85.4 to 98.8 m). The bedrock cores recovered consisted of an upper layer of sandstone bedrock overlying granitic bedrock. The sandstone was noted to be moderately weathered, while the granite was noted to be faintly weathered. The bedrock was predominantly brownish grey with white and black banding, fine to medium grained, and contained some natural fractures with little oxidation. The bedrock at the fracture locations was mostly sharp and angular, which indicates minor water migration. Natural fractures were closely to moderately spaced and were generally found to occur in sets oriented at approximately 45 to 90° to the core axis. An approximate 70% wash return within the rock cores was observed. The wash return was milky white in colour. The rock core recovery ranged between 27 and 97%, with RQDs ranging from 0 to 88%, indicating a very poor to good rock quality. A photograph of the rock cores is provided in Appendix IV.

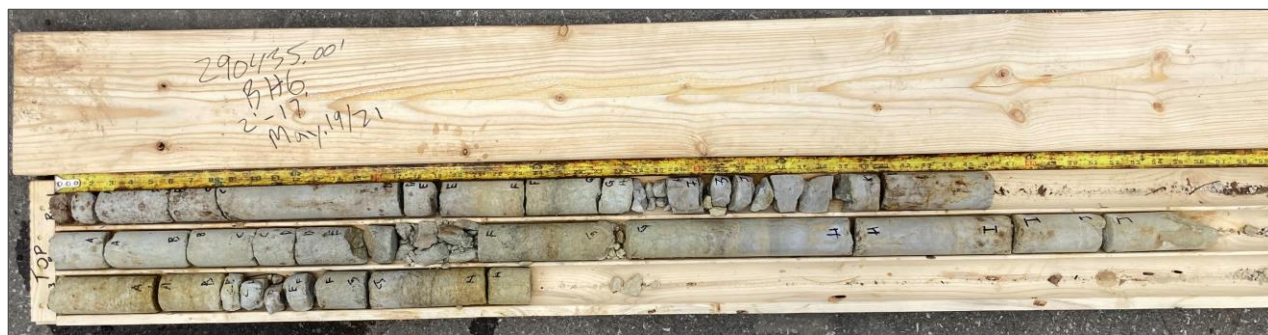
Photo 2 – Borehole BH6, Rock Core (Runs 1 to 3)

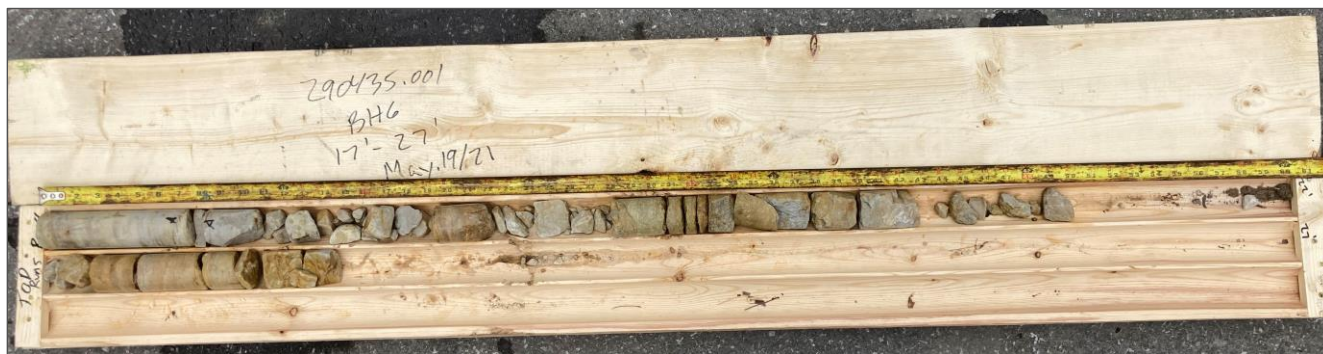
Photo 3 – Borehole BH6, Rock Core (Runs 4 and 5)

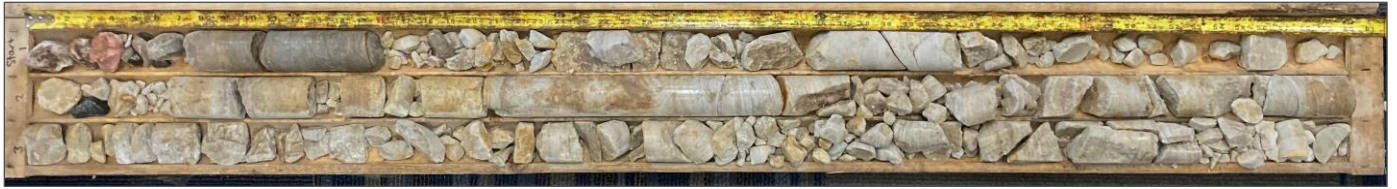
Photo 4 – Bedrock Probe RP4, Rock Core (Runs 1 to 3)

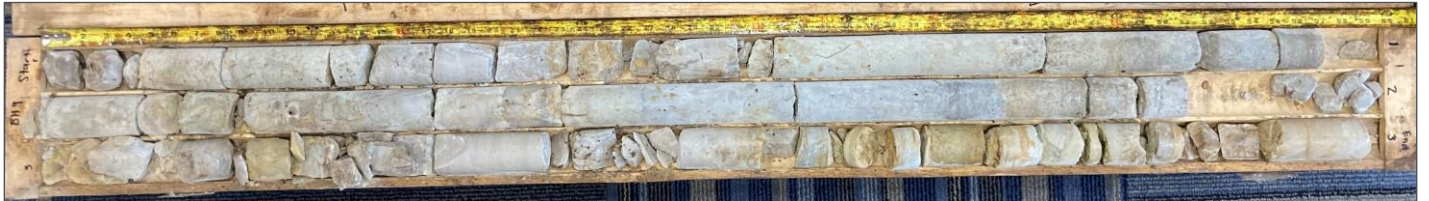
Photo 6 – Bedrock Probe RP9, Rock Core (Runs 1 to 3)
