Phase II Environmental Site Assessment

Part of 1615 Orleans Boulevard
Ottawa, Ontario

Orleans Garden Developments Inc.

Report: PE1962-4

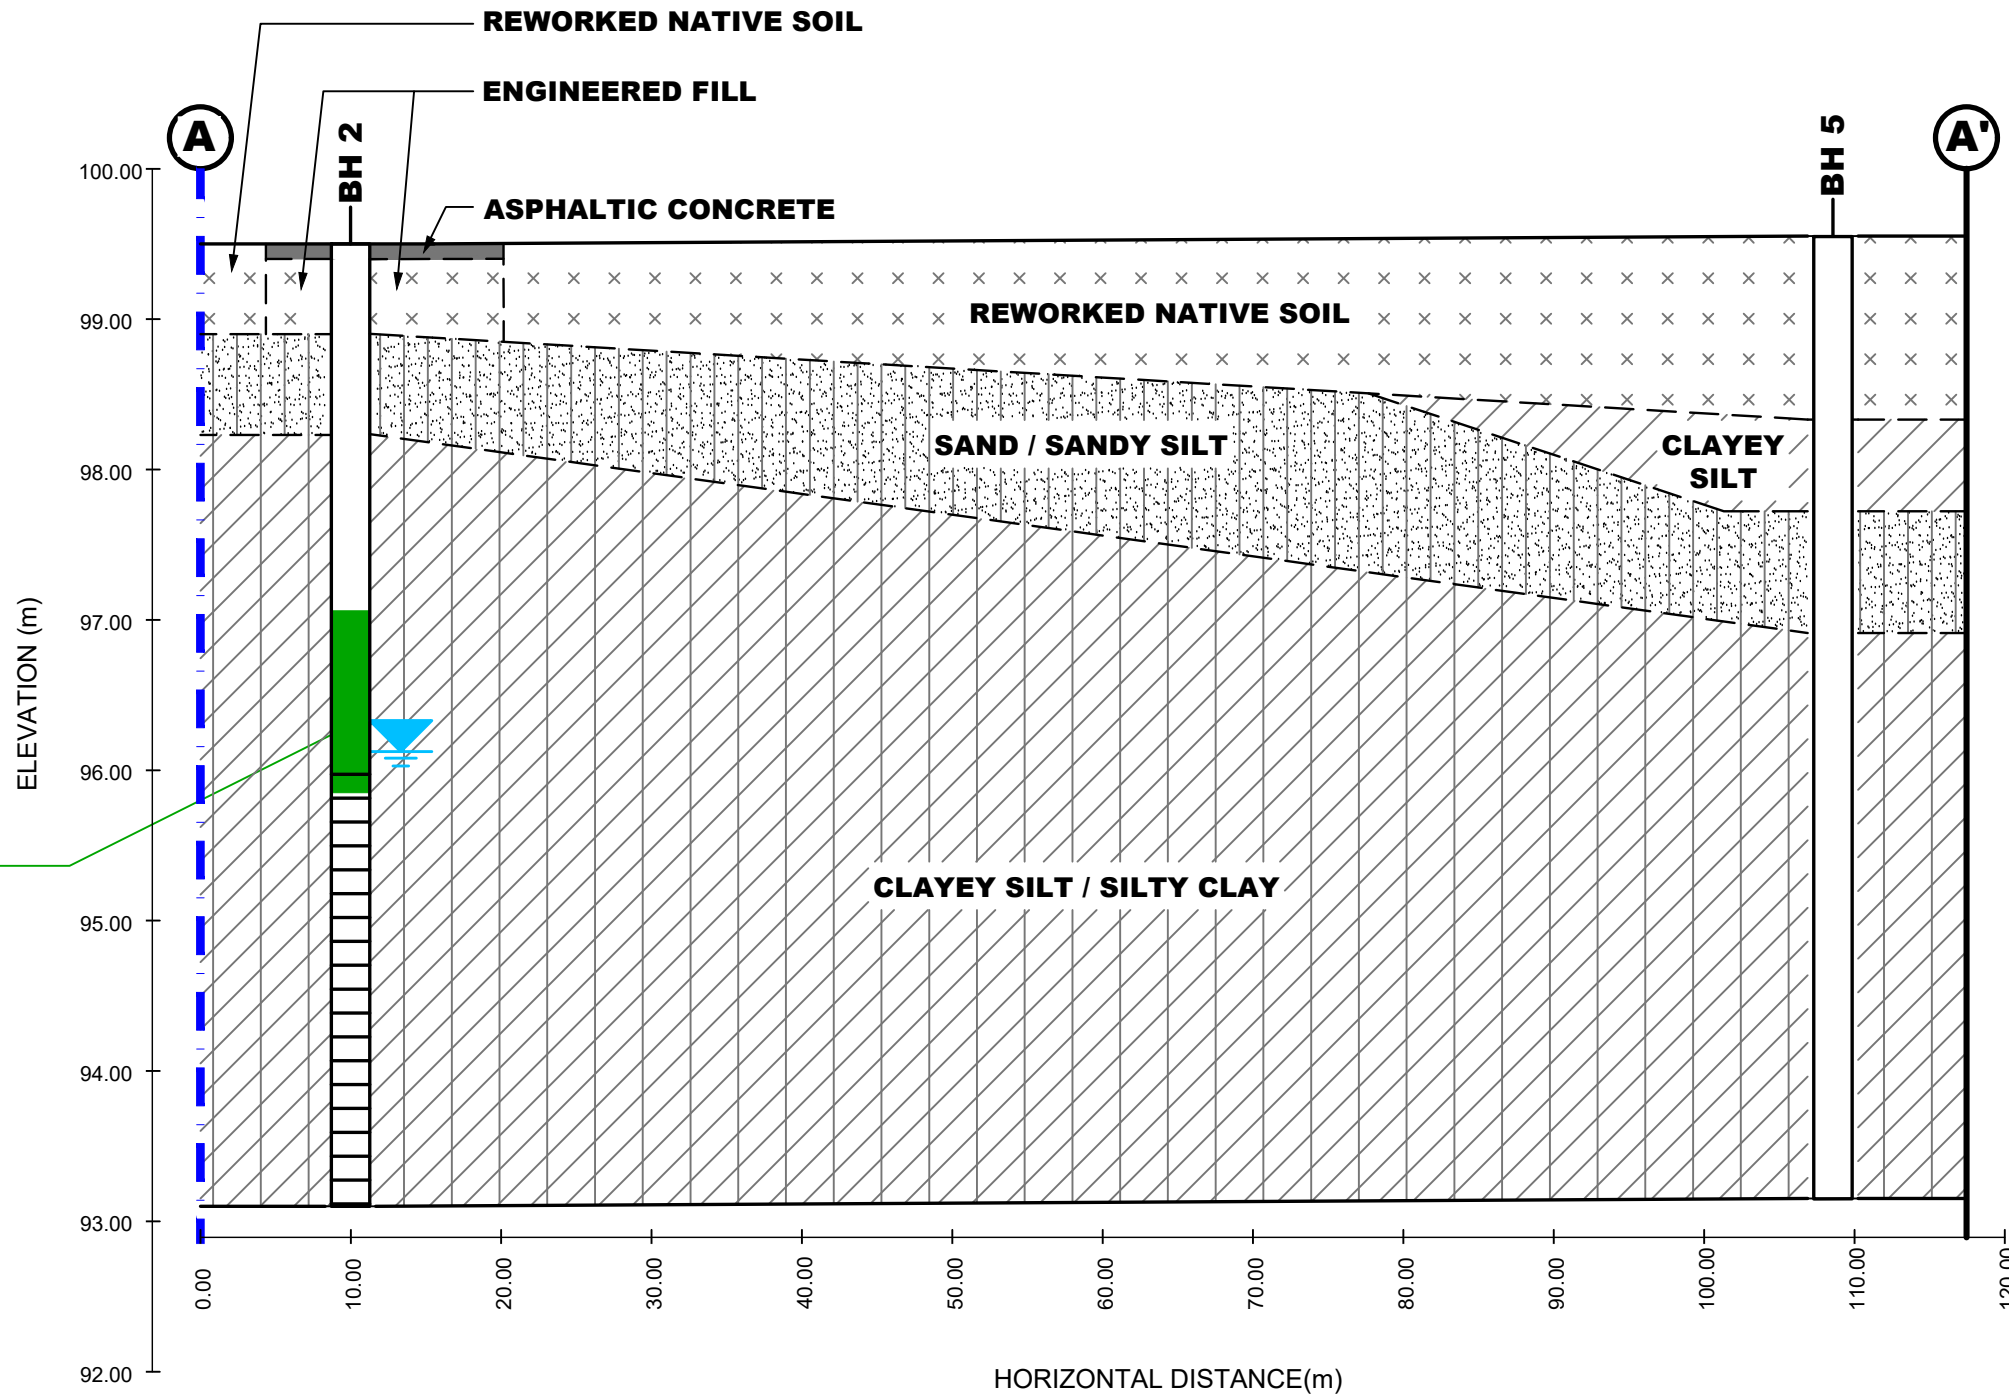
Scale:	AS SHOWN	Date:	02/2020
Drawn by:	RCG	Report No.:	PE1962-4
Checked by:	MB	Dwg. No.:	PE1962-7A
Approved by:	MSD	Revision No.:

BH2-SS5 2.44-3.65m 10-July-19
 BTEXs COMPLIES WITH TABLE 3 STANDARDS
 PHCs COMPLIES WITH TABLE 3 STANDARDS

SOIL RESULT IN COMPLIANCE WITH MECP TABLE 3 STANDARDS

ORLEANS GARDEN DEVELOPMENTS INC
 PHASE II - ENVIRONMENTAL SITE ASSESSMENT
 PART OF 1615 ORLEANS BOULEVARD
 ORLEANS, ONTARIO
 Title: **CROSS SECTION A-A' - SOIL (BTEX AND PHC)**

Drawing PE1962-7A – Cross-section A – A' – Soil (BTEX, PHC)

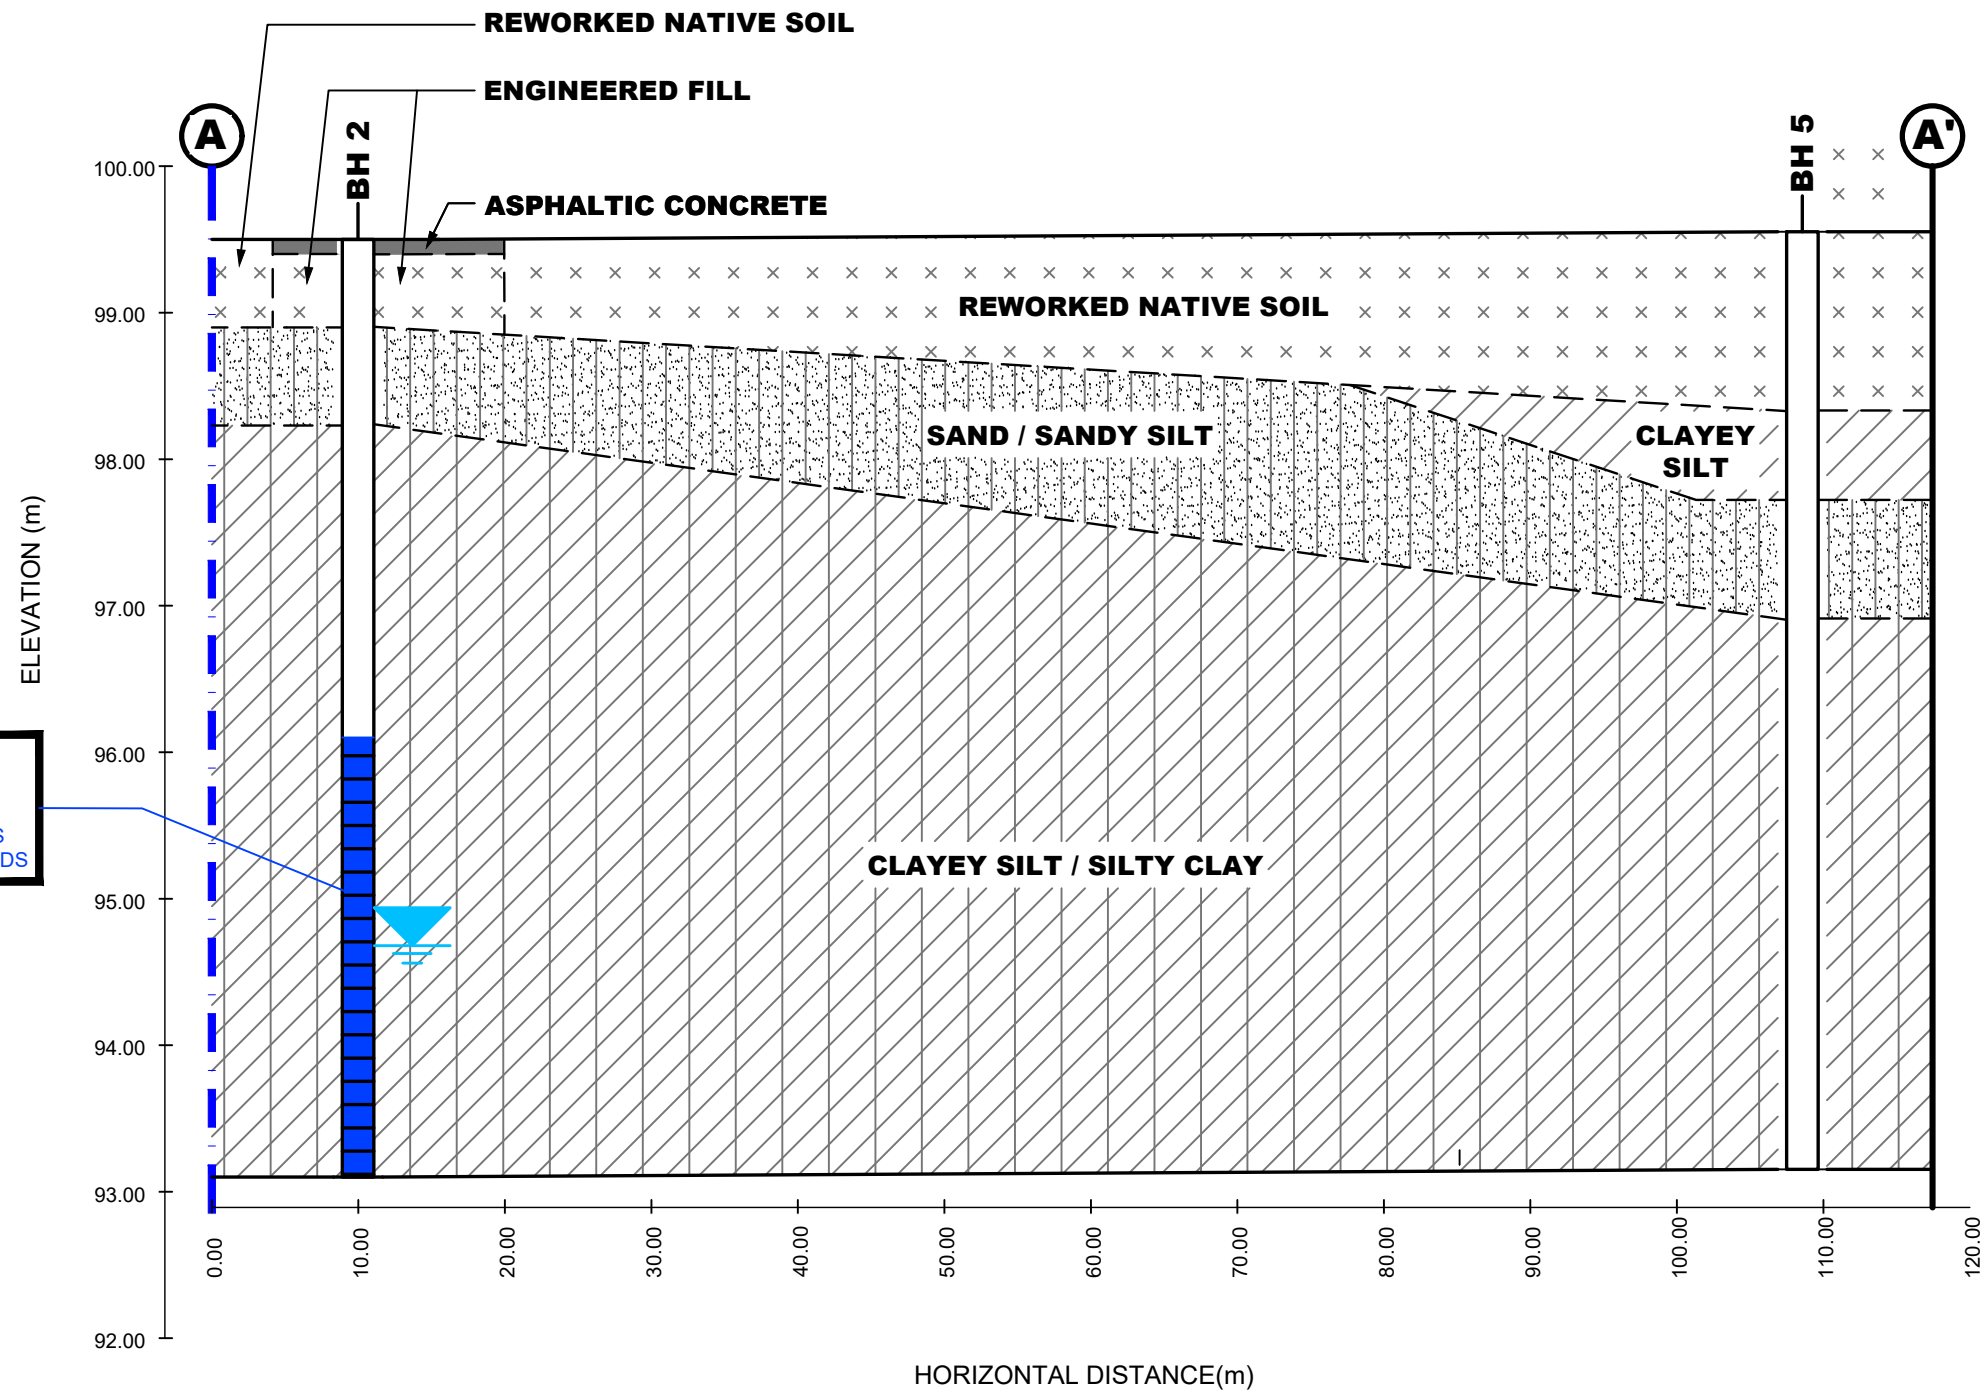
Scale:	AS SHOWN	Date:	02/2020
Drawn by:	RCG	Report No.:	PE1962-4
Checked by:	MB	Dwg. No.:	PE1962-8A
Approved by:	MSD	Revision No.:

BH2-GW1 3.40-6.40 14-JULY-19
 BTEX COMPLIES WITH MECP TABLE 3 STANDARDS
 PHCs COMPLIES WITH MECP TABLE 3 STANDARDS
 SODIUM COMPLIES WITH MECP TABLE 3 STANDARDS
 CHLORIDE COMPLIES WITH MECP TABLE 3 STANDARDS

ALL GROUNDWATER RESULTS COMPLY WITH MECP TABLE 3 STANDARDS

ORLEANS GARDEN DEVELOPMENTS INC
 PHASE II - ENVIRONMENTAL SITE ASSESSMENT
 PART OF 1615 ORLEANS BOULEVARD
 ORLEANS, ONTARIO
CROSS SECTION A-A' - GROUNDWATER

Drawing PE1962-8A – Cross-section A – A' – Groundwater

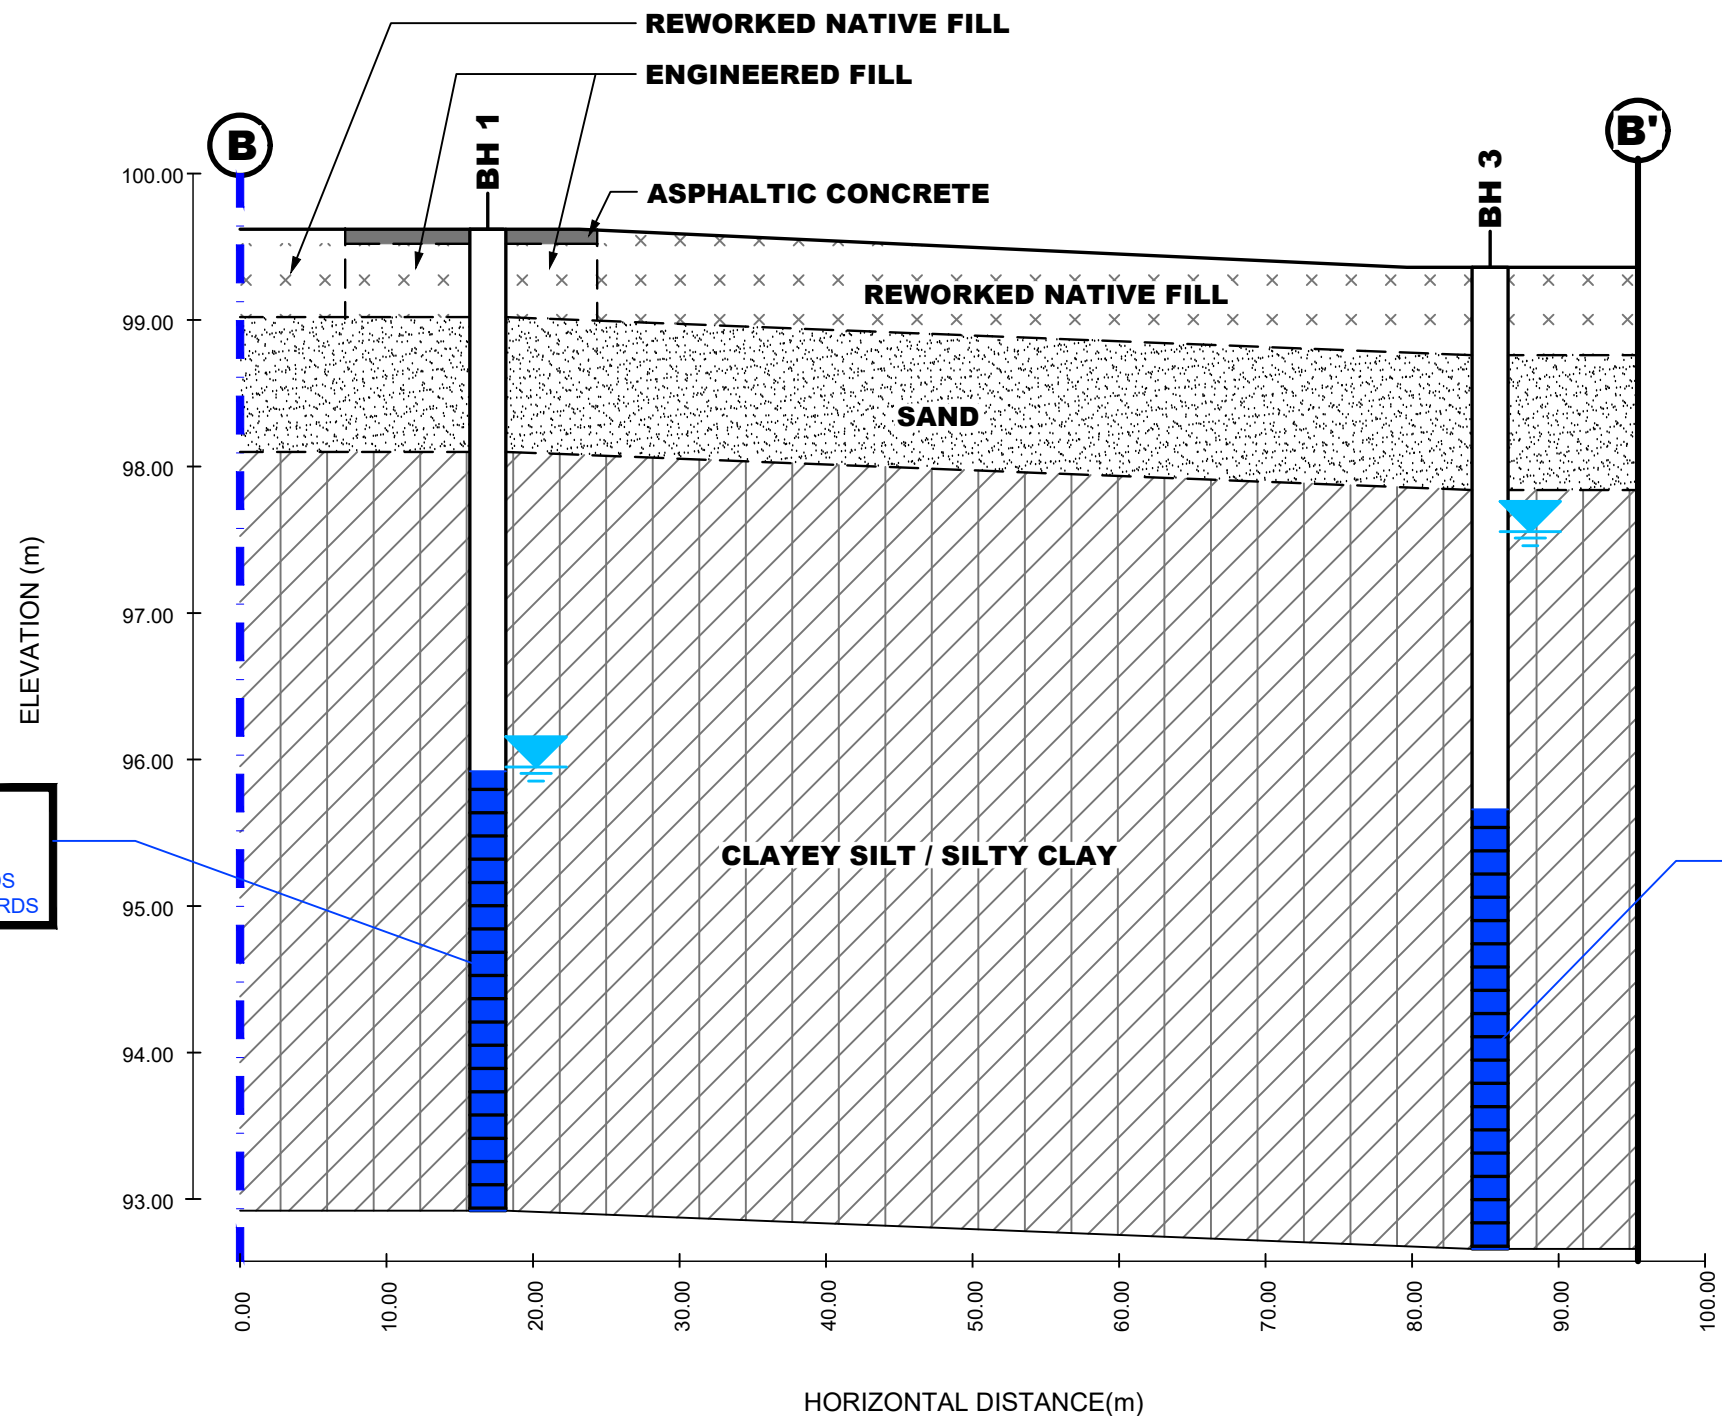
BH1-GW1 3.70-6.70 14-JULY-19
 BTEX COMPLIES WITH MECP TABLE 3 STANDARDS
 PHCs COMPLIES WITH MECP TABLE 3 STANDARDS
 SODIUM COMPLIES WITH MECP TABLE 3 STANDARDS
 CHLORIDE COMPLIES WITH MECP TABLE 3 STANDARDS

BH3-GW1 3.70-6.70 14-JULY-19
 SODIUM COMPLIES WITH MECP TABLE 3 STANDARDS
 CHLORIDE COMPLIES WITH MECP TABLE 3 STANDARDS

Drawing PE1962-8B – Cross-section B – B' – Groundwater
