Phase One Environmental Site Assessment 151 and 159 Wescar Lane Carp, Ontario

Project: 101676.001

Re: Phase One Environmental Site Assessment Update

151 and 159 Wescar Lane, Carp, Ontario, K0A 1L0

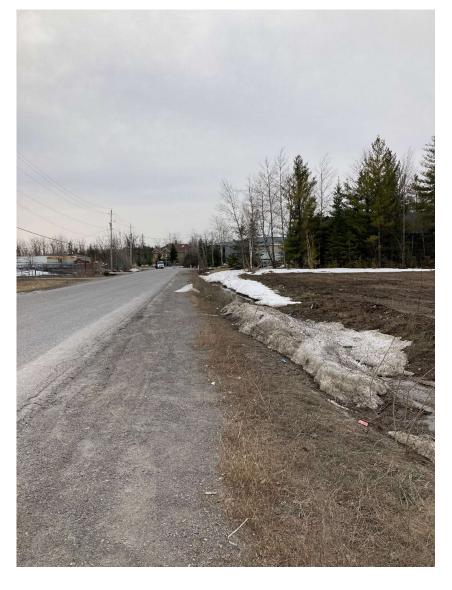
Photograph 1: Northeastern extent of the Site (151 Wescar Lane) and Wescar Lane (looking southeast)

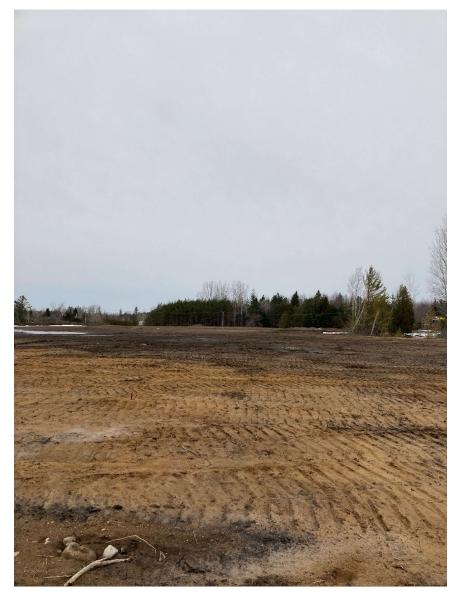
Photograph 5: Overview of 159 Wescar Lane (looking northwest)

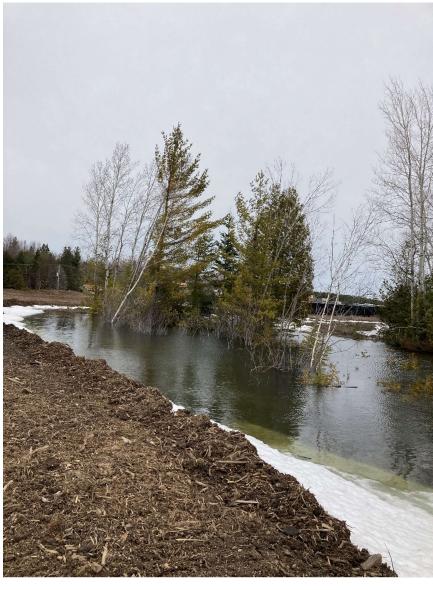
Drainage ditches were identified along both sides of Wescar Lane and Cavanmore Road. A culvert was observed to be under Wescar Lane near the intersection of Wescar Lane and Cavanmore Road. Standing water in the form of a pond was observed on Site on 159 Wescar Lane.

Photograph 6: Season spring melt standing water on 159 Wescar Lane

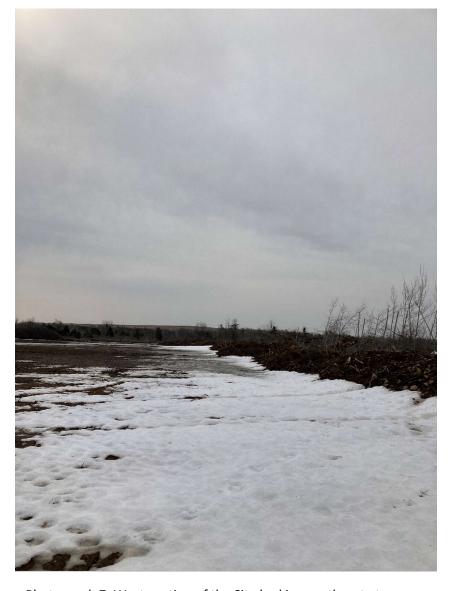
Photograph 7: West portion of the Site looking southeast at 159 and 151 Wescar Lane with a berm on the West boundary of the Site
