Geotechnical Investigation and Hydrogeological Assessment

600 March Road, Kanata (Ottawa), Ontario

First Gulf

16 June 2023

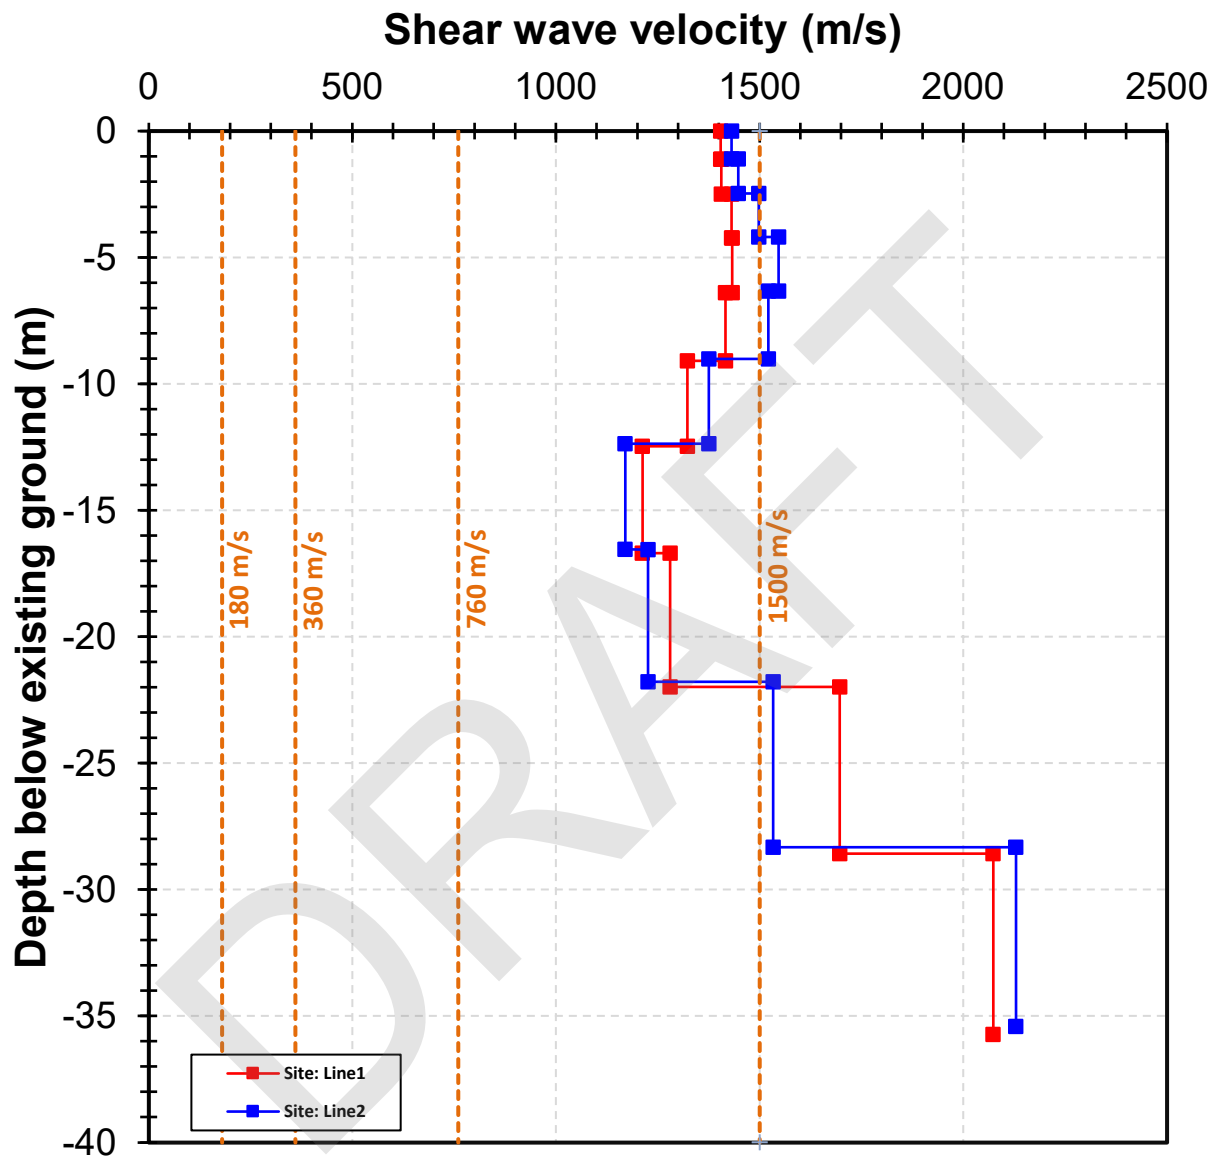
FIGURE 1

Shear wave velocity versus depth

MASW method utilizes the frequency-dependent properties of Rayleigh surface waves in order to develop the profile of shear wave velocity with depth. This method includes three stages as shown in **Figure 4.1**. In this project, generation of dispersion curves, inversion of the obtained dispersion curves and development of the 1D shear wave velocity profiles were carried out using SurfSeis© version 6.0. The dispersion curves were calculated at the middle stations along each line. At each investigation line, the dispersion images obtained from active data at different offsets were stacked to obtain a combined dispersion curve. The data inversion was carried out using a 10-layer soil velocity numerical model to obtain 1D shear wave velocity profiles at the location of each mid station. The calculated 1D velocity profile along the investigation lines is shown on the attached Shear Wave Velocity Profile. **Figure 2** shows the obtained results at the location of the proposed development. As it can be seen in this figure, values of shear wave velocity for Line 1 and Line 2 are relatively consistent in depth. The data obtained from the advanced boreholes also confirms a consistent subsurface soil profile in the vicinity of the MASW lines. The stratigraphy borehole logs are provided in **Appendix A** of the GHD (2023) geotechnical investigation report. For all investigation lines, the shear wave velocity increases with depth indicating values higher than 1200 m/s below approximate depths of 17 m.
