98 + 100 BEARBROOK LANDRIC HOMES
98 + 100 BEARBROOK ROAD
OTTAWA, ON, K1B 3B9

DRAWING TITLE:
POST-DEVELOPMENT
VEGETATION
DATE: 2021-07-26 DRAWING NO.:
SCALE: AS SHOWN
DRAWN BY: SG-RP
LA PROJECT NO.: 21813-1
L-TP2

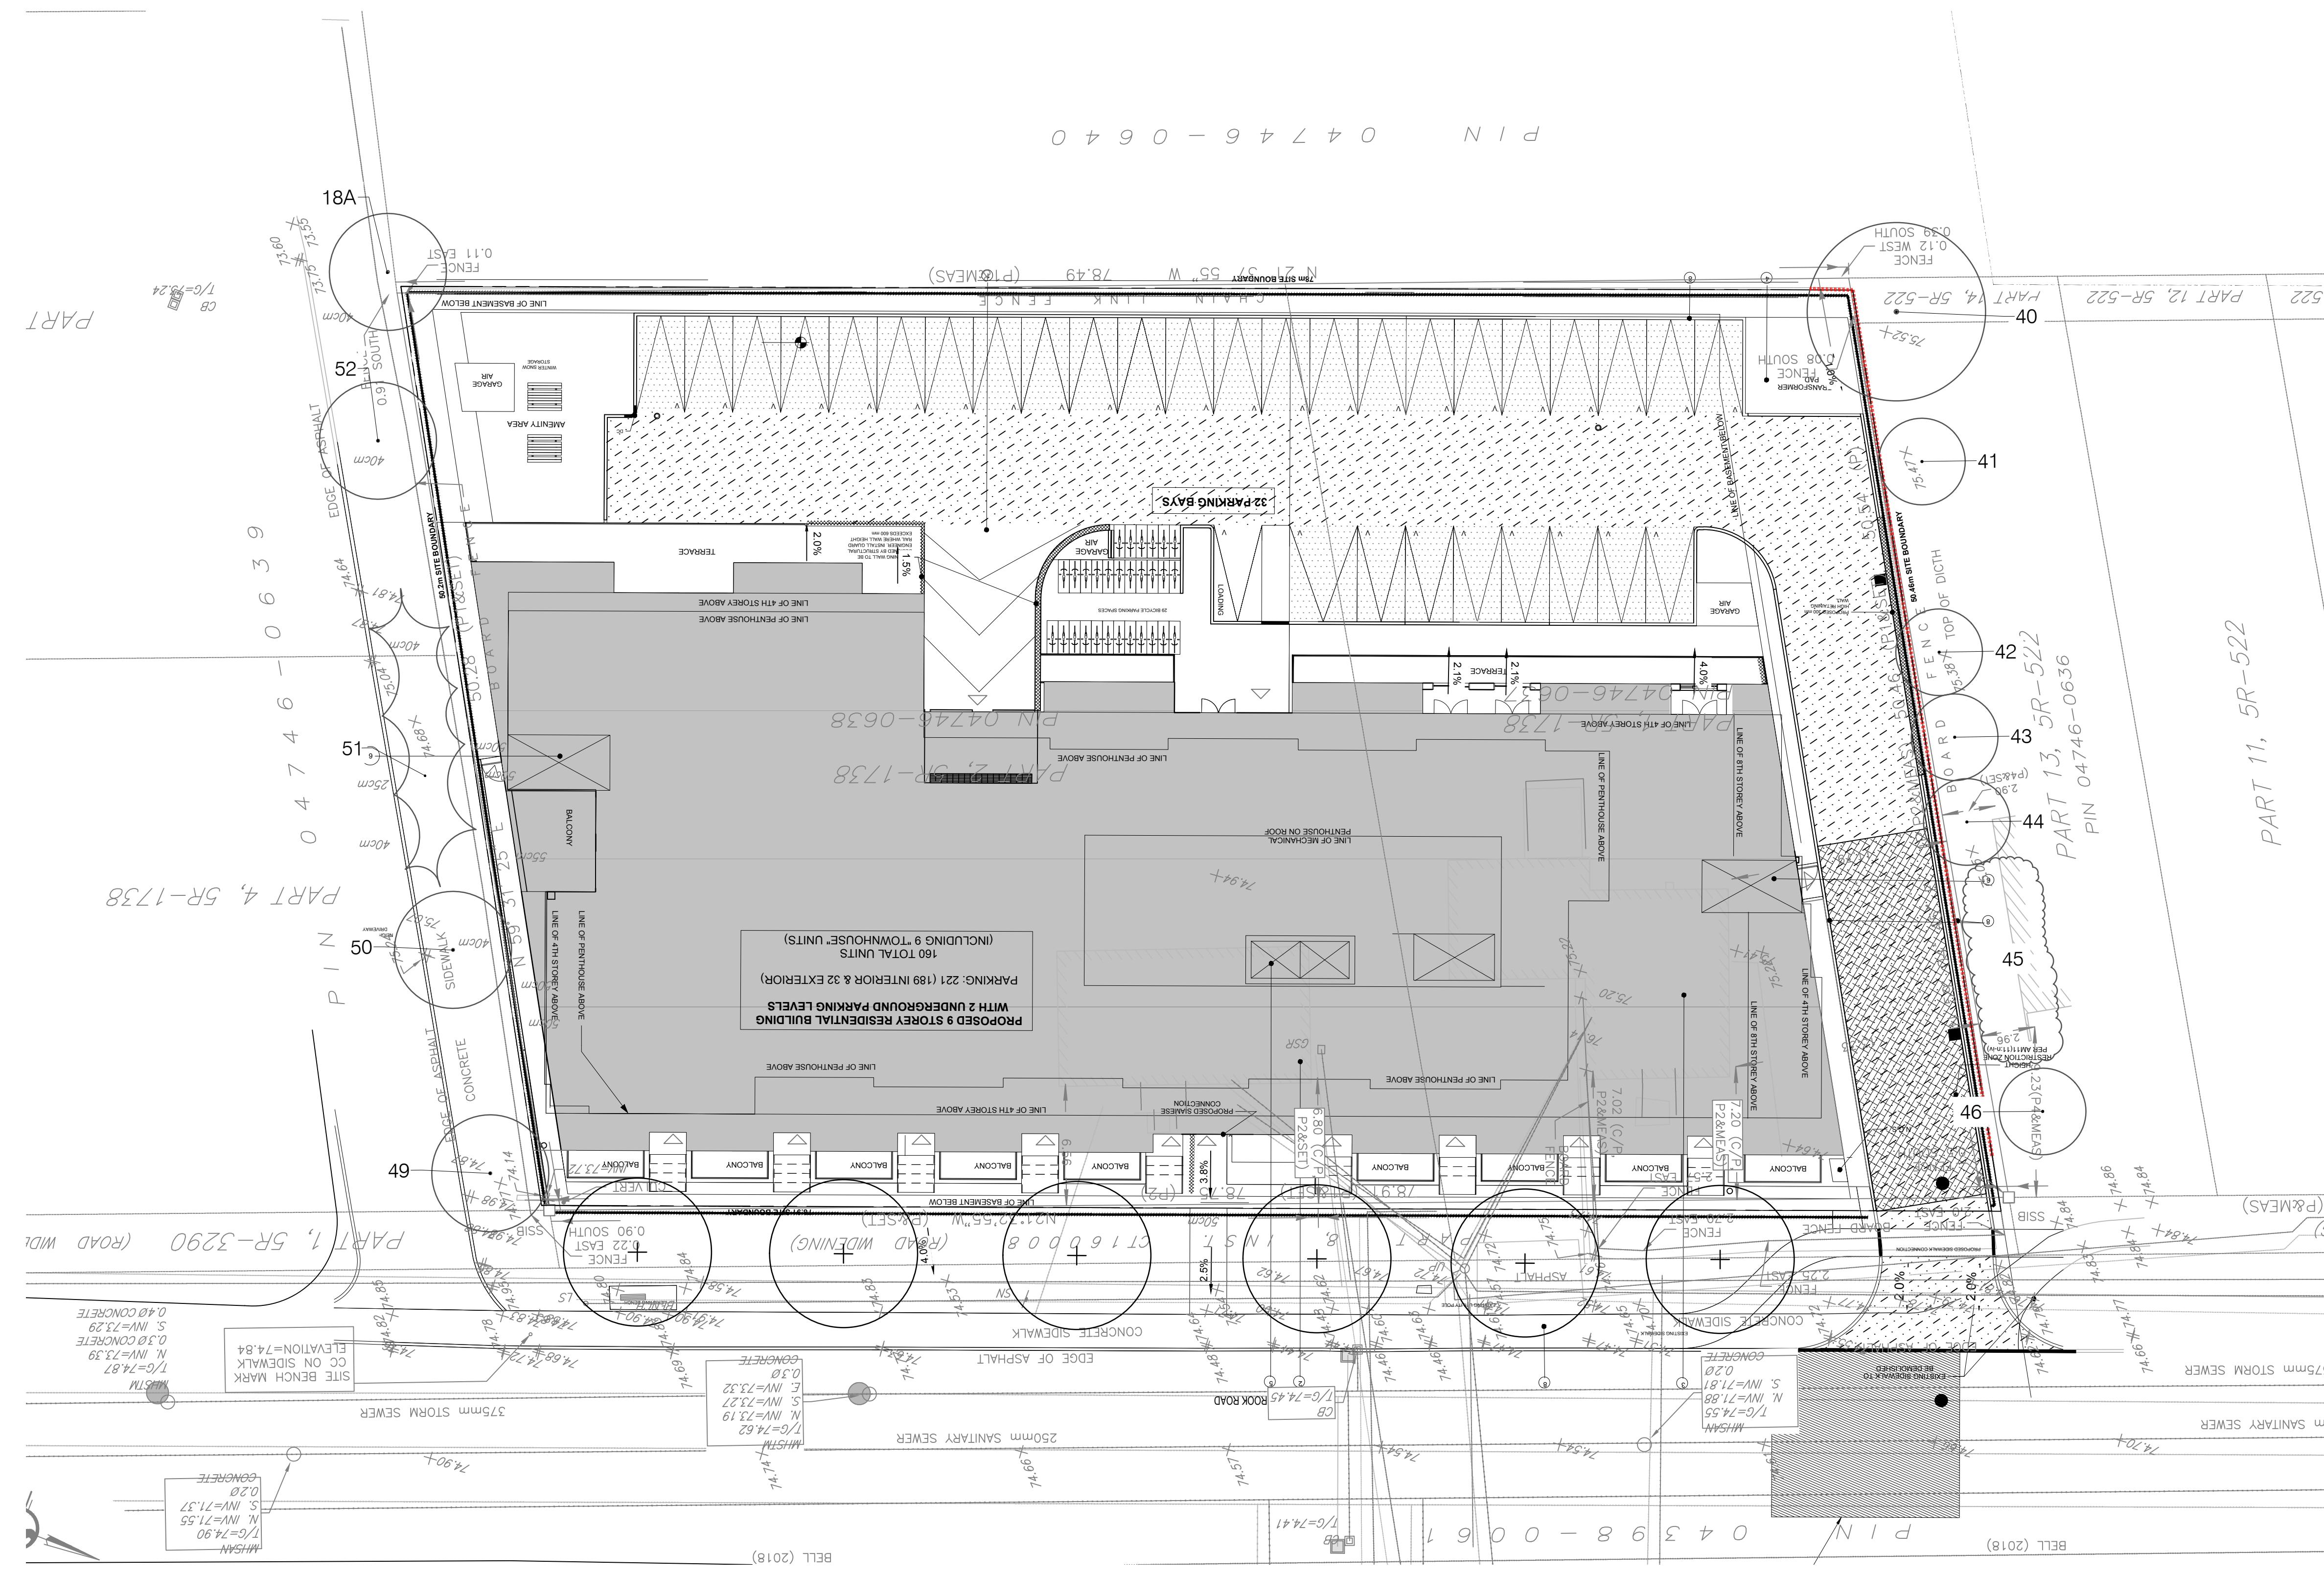
1 POST-DEVELOPMENT VEGETATION

TREES TO REMAIN				
NO.	SPECIES	DBH (CM)	HEALTH	COMMENTS
18	Trembling Aspen / <i>Populus tremuloides</i>	35	Good	Adjacent Property
40	Manitoba Maple / <i>Acer negundo</i>	52	Fair	Adjacent Property. Identified as #1 in Dendron Report
41	Manitoba Maple / <i>Acer negundo</i>	20	Poor	Adjacent Property
42	Red Maple / <i>Acer rubrum</i>	20	Good	Adjacent Property
43	Apple / <i>Malus sp.</i>	20,22, 18	Poor	Adjacent Property
44	Manitoba Maple / <i>Acer negundo</i>	33	Fair	Adjacent Property
45	European Buckthorn / <i>Rhamnus cathartica</i>	10-15	Fair	Adjacent Property, Hedge
46	Red Maple / <i>Acer rubrum</i>	16	Fair	Adjacent Property
49	Norway Maple / <i>Acer platanoides</i>	30	Poor	Adjacent Property
50	Norway Maple / <i>Acer platanoides</i>	30	Fair	Adjacent Property
51	Austrian Pine / <i>Pinus nigra</i>	20-28	Good	Adjacent Property, 4 Stems
52	Norway Maple / <i>Acer platanoides</i>	40	Good	Adjacent Property
