SEPTIC IMPACT ASSESSMENT (REV.1)

5646-5650 MANOTICK MAIN STREET

Project No.: CCO-22-2383

Original: June 14, 2023
Revision 1: March 4, 2024

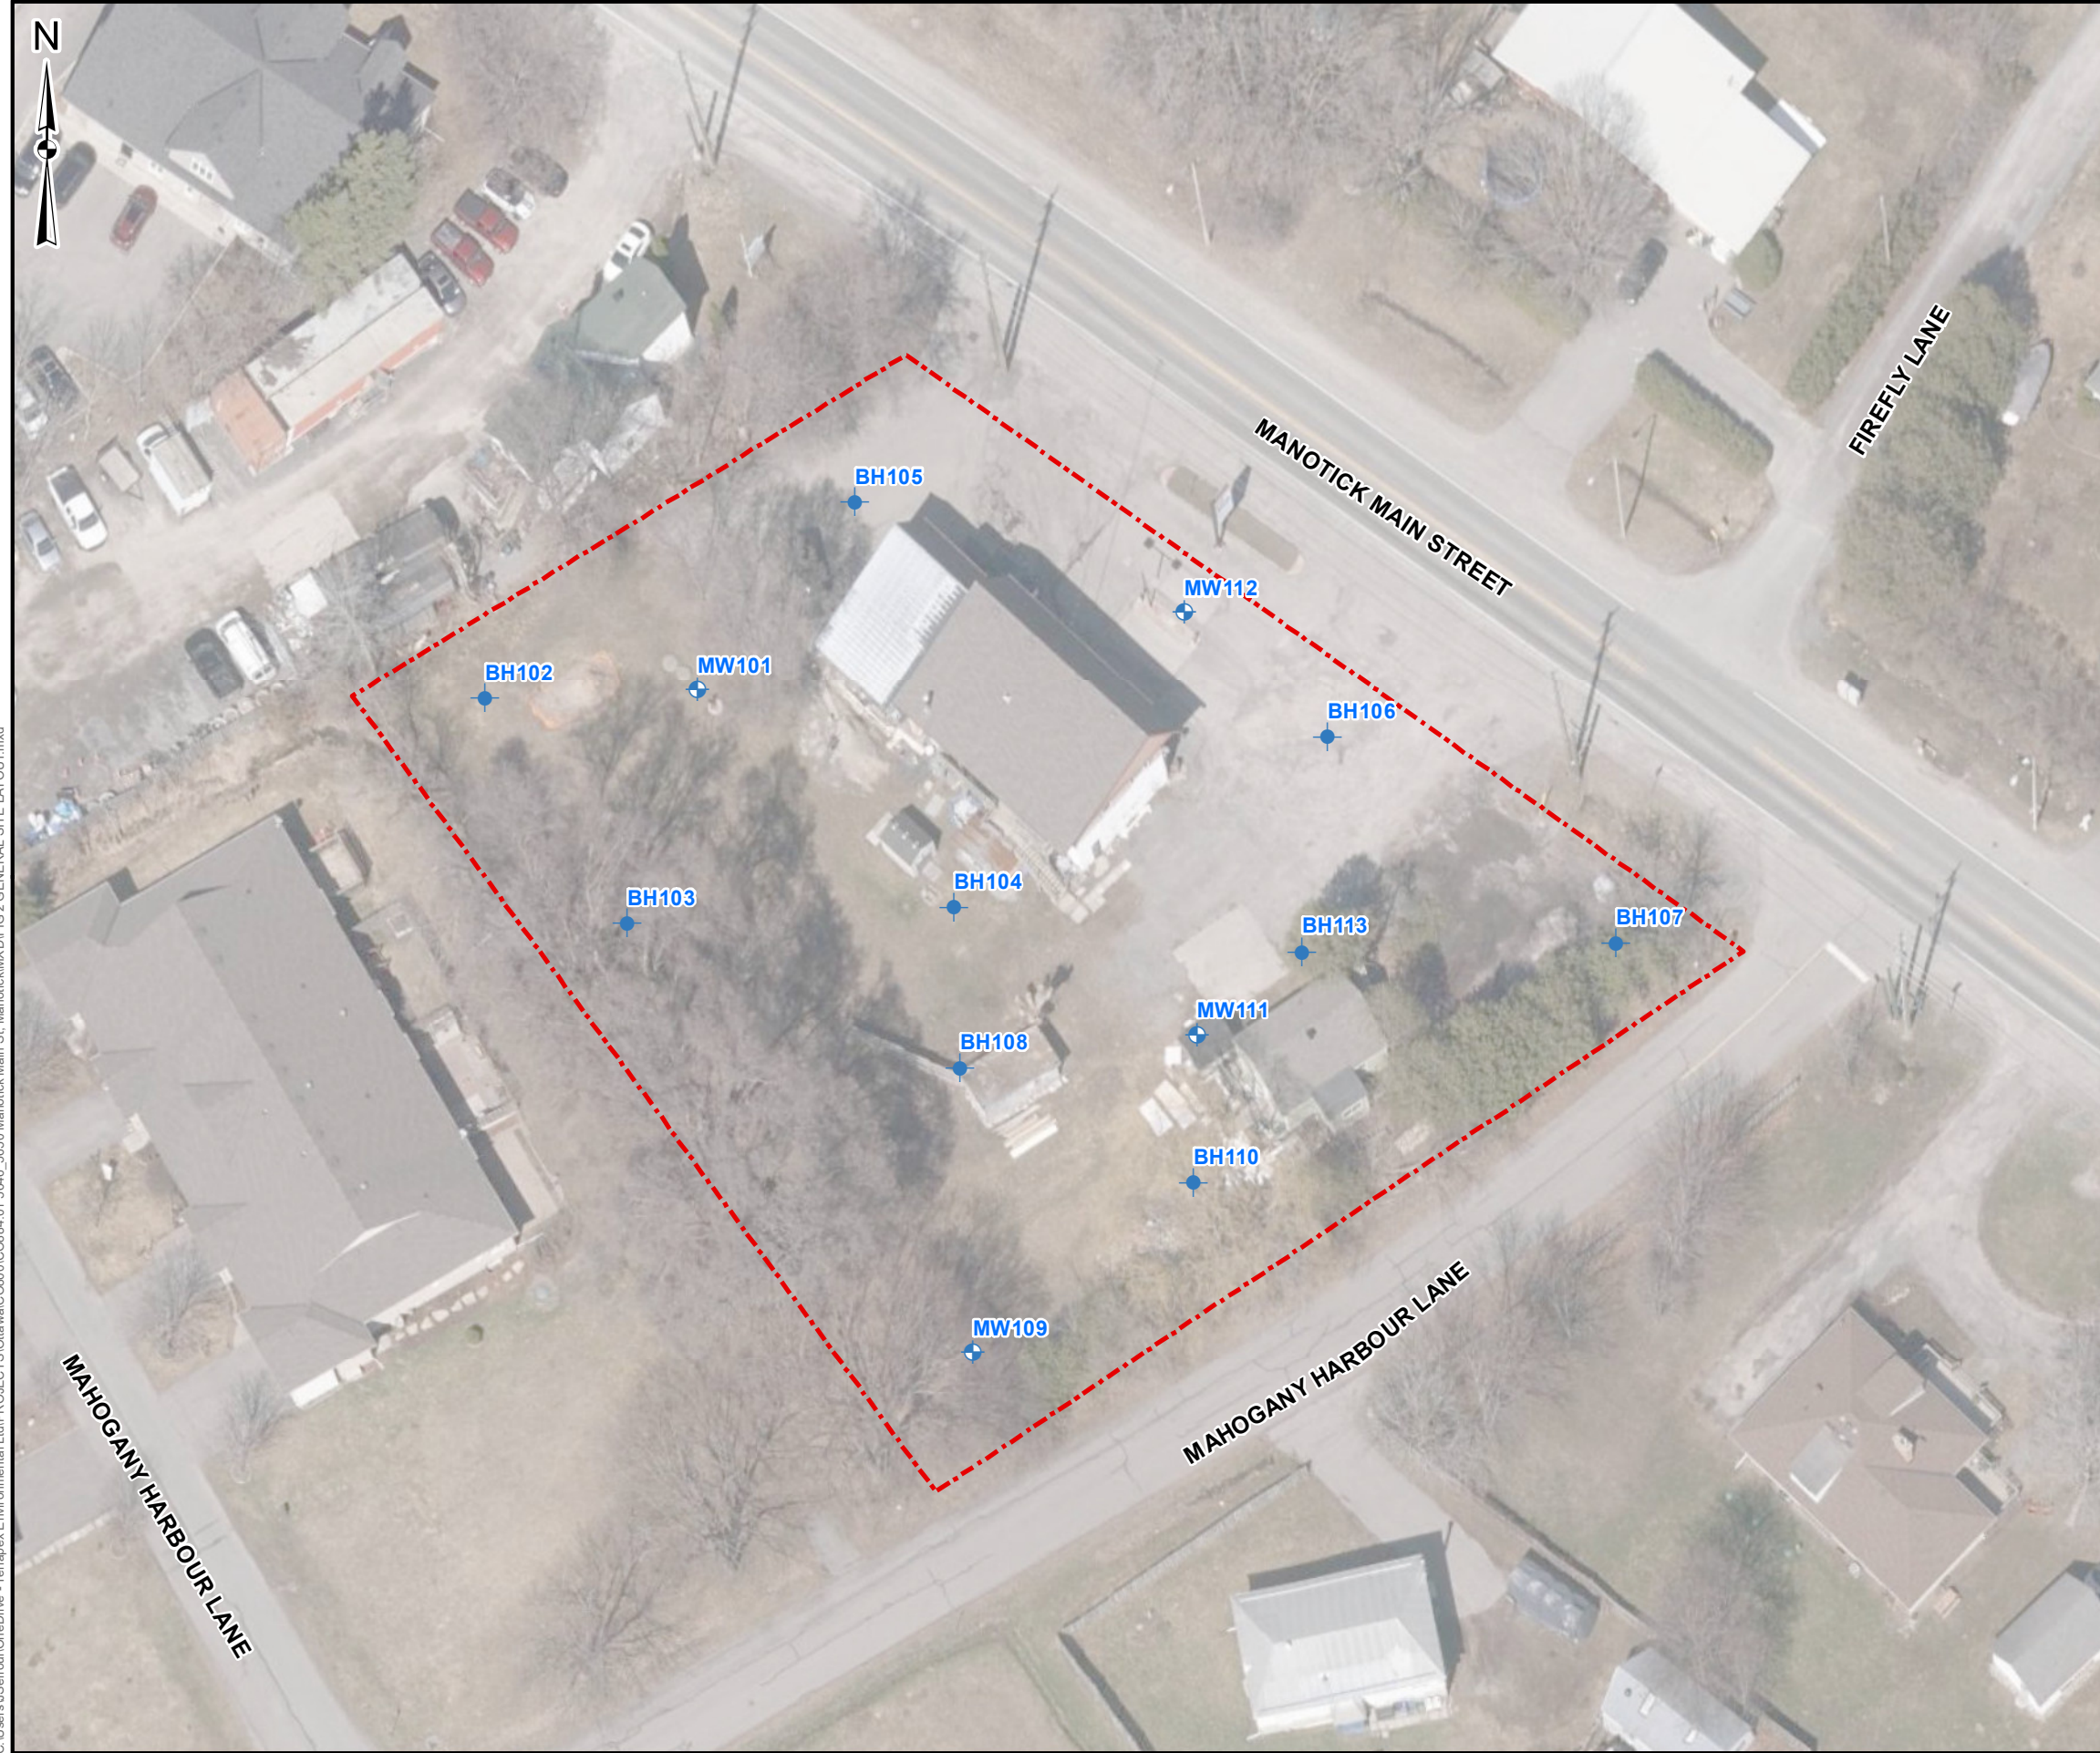
- PROPERTY BOUNDARY
- BOREHOLE
- MONITORING WELL
