## **Phase II – Environmental Site Assessment**

1166 Bank Street  
Ottawa, Ontario

Prepared for Ambassador Realty Inc.

Report: PE5590-2  
April 18, 2024

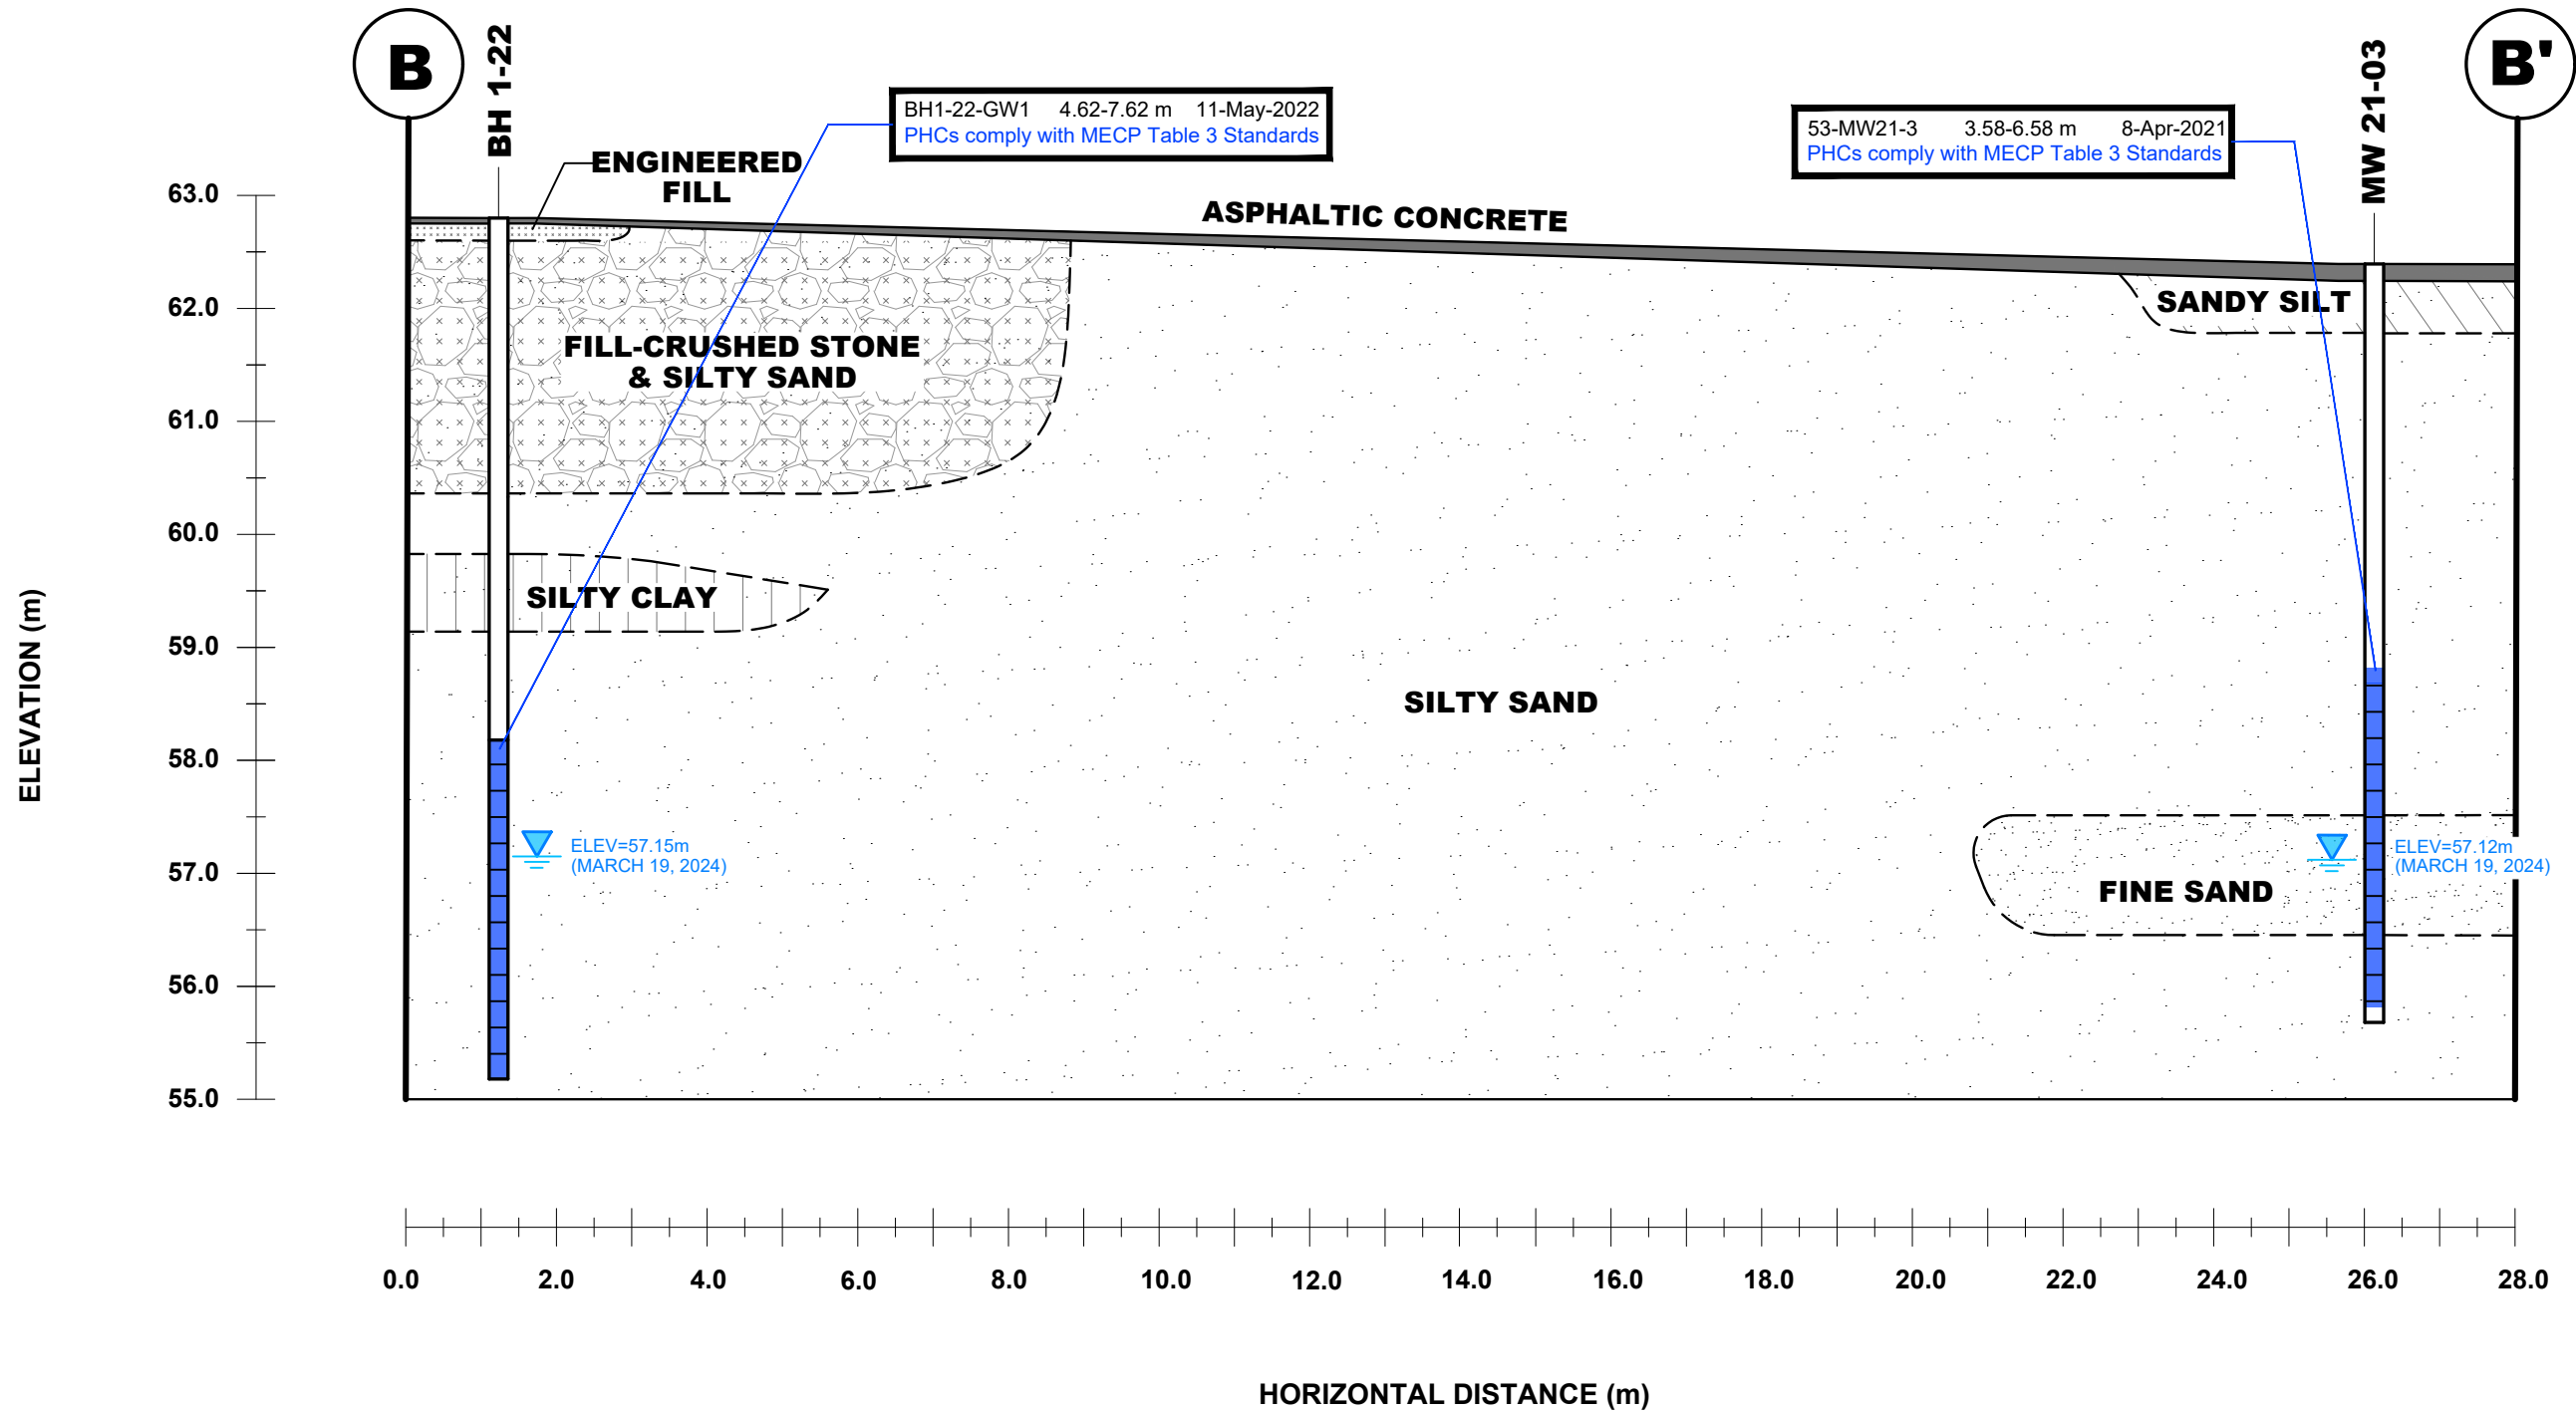
**CROSS SECTION B-B' - GROUNDWATER (PHCs)**

GROUNDWATER RESULTS COMPLY WITH MECP TABLE 3 STANDARDS
