Phase II Environmental Site Assessment

Part of 1500 Merivale Road
Ottawa, Ontario

Prepared for Claridge Homes

Report: PE5066-4

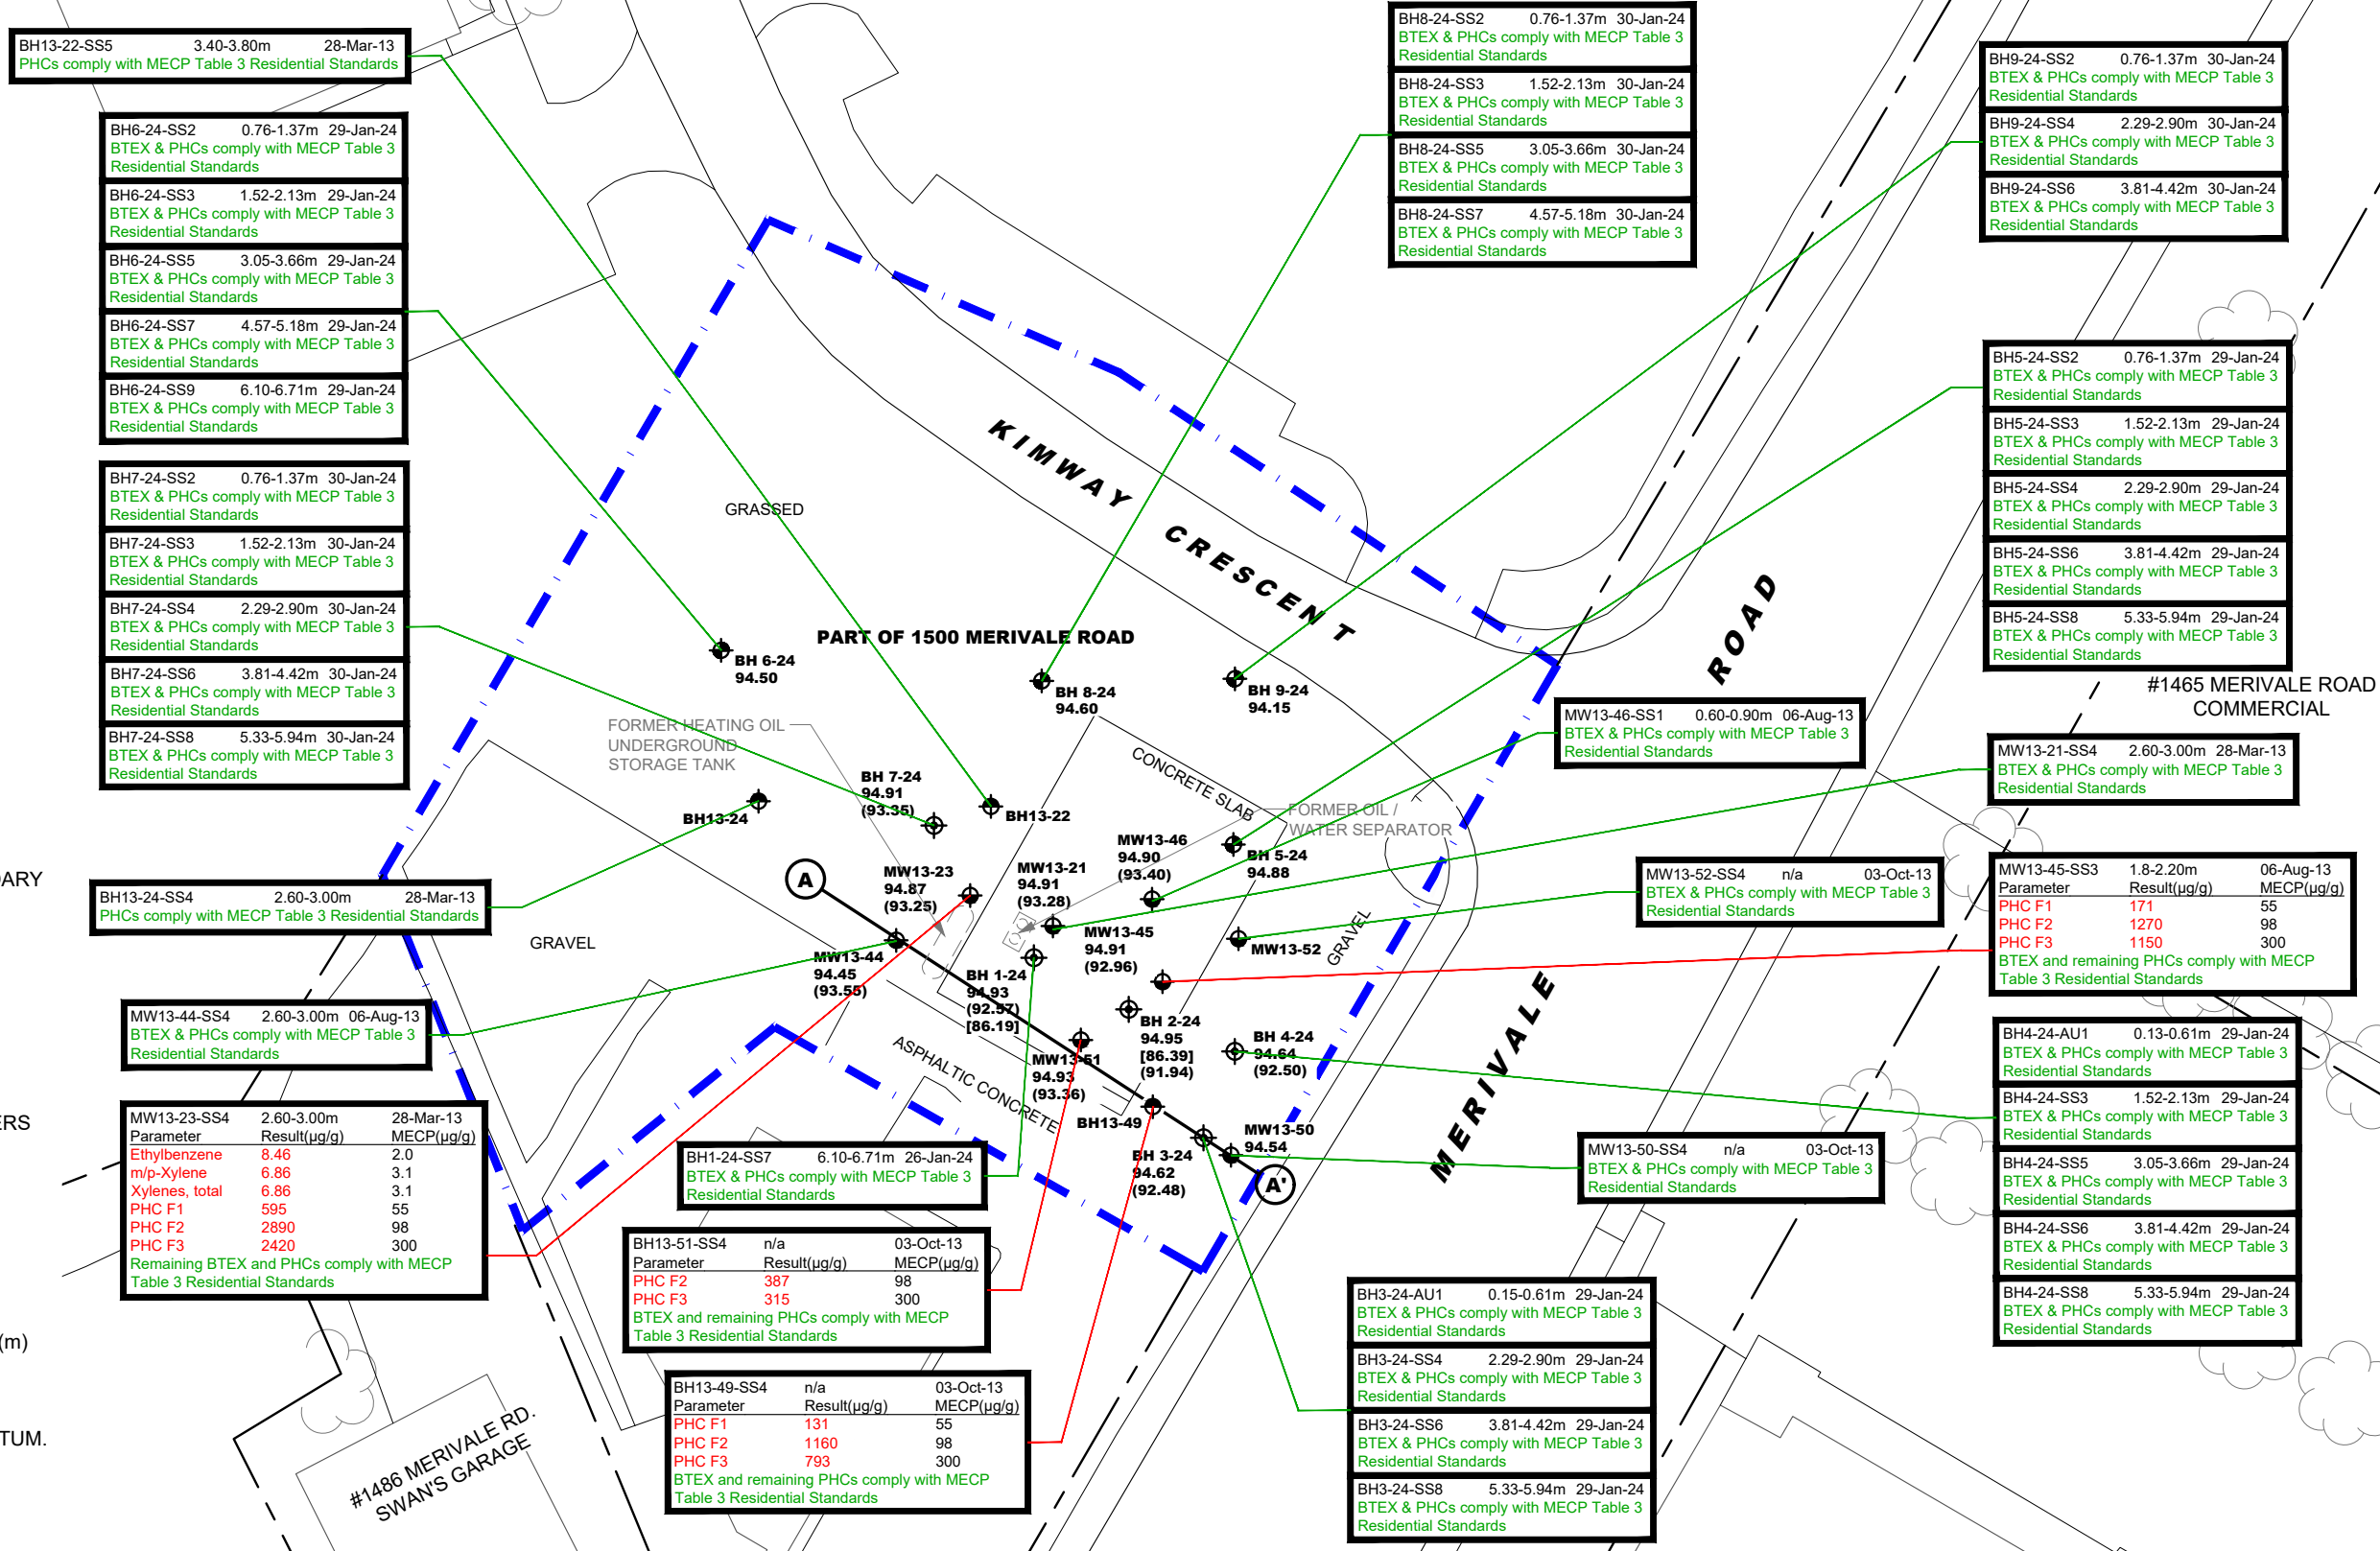
MW13-44-SS4	2.60-3.00m	06-Aug-13
BTEX & PHCs comply with MECP Table 3 Residential Standards

BH1-24-SS7	6.10-6.71m	26-Jan-24
BTEX & PHCs comply with MECP Table 3 Residential Standards
