**Phase Two
Environmental Site Assessment
Proposed Residential Development
2865 Riverside Drive
Ottawa, Ontario**

September 13, 2022
Project: 100416.001

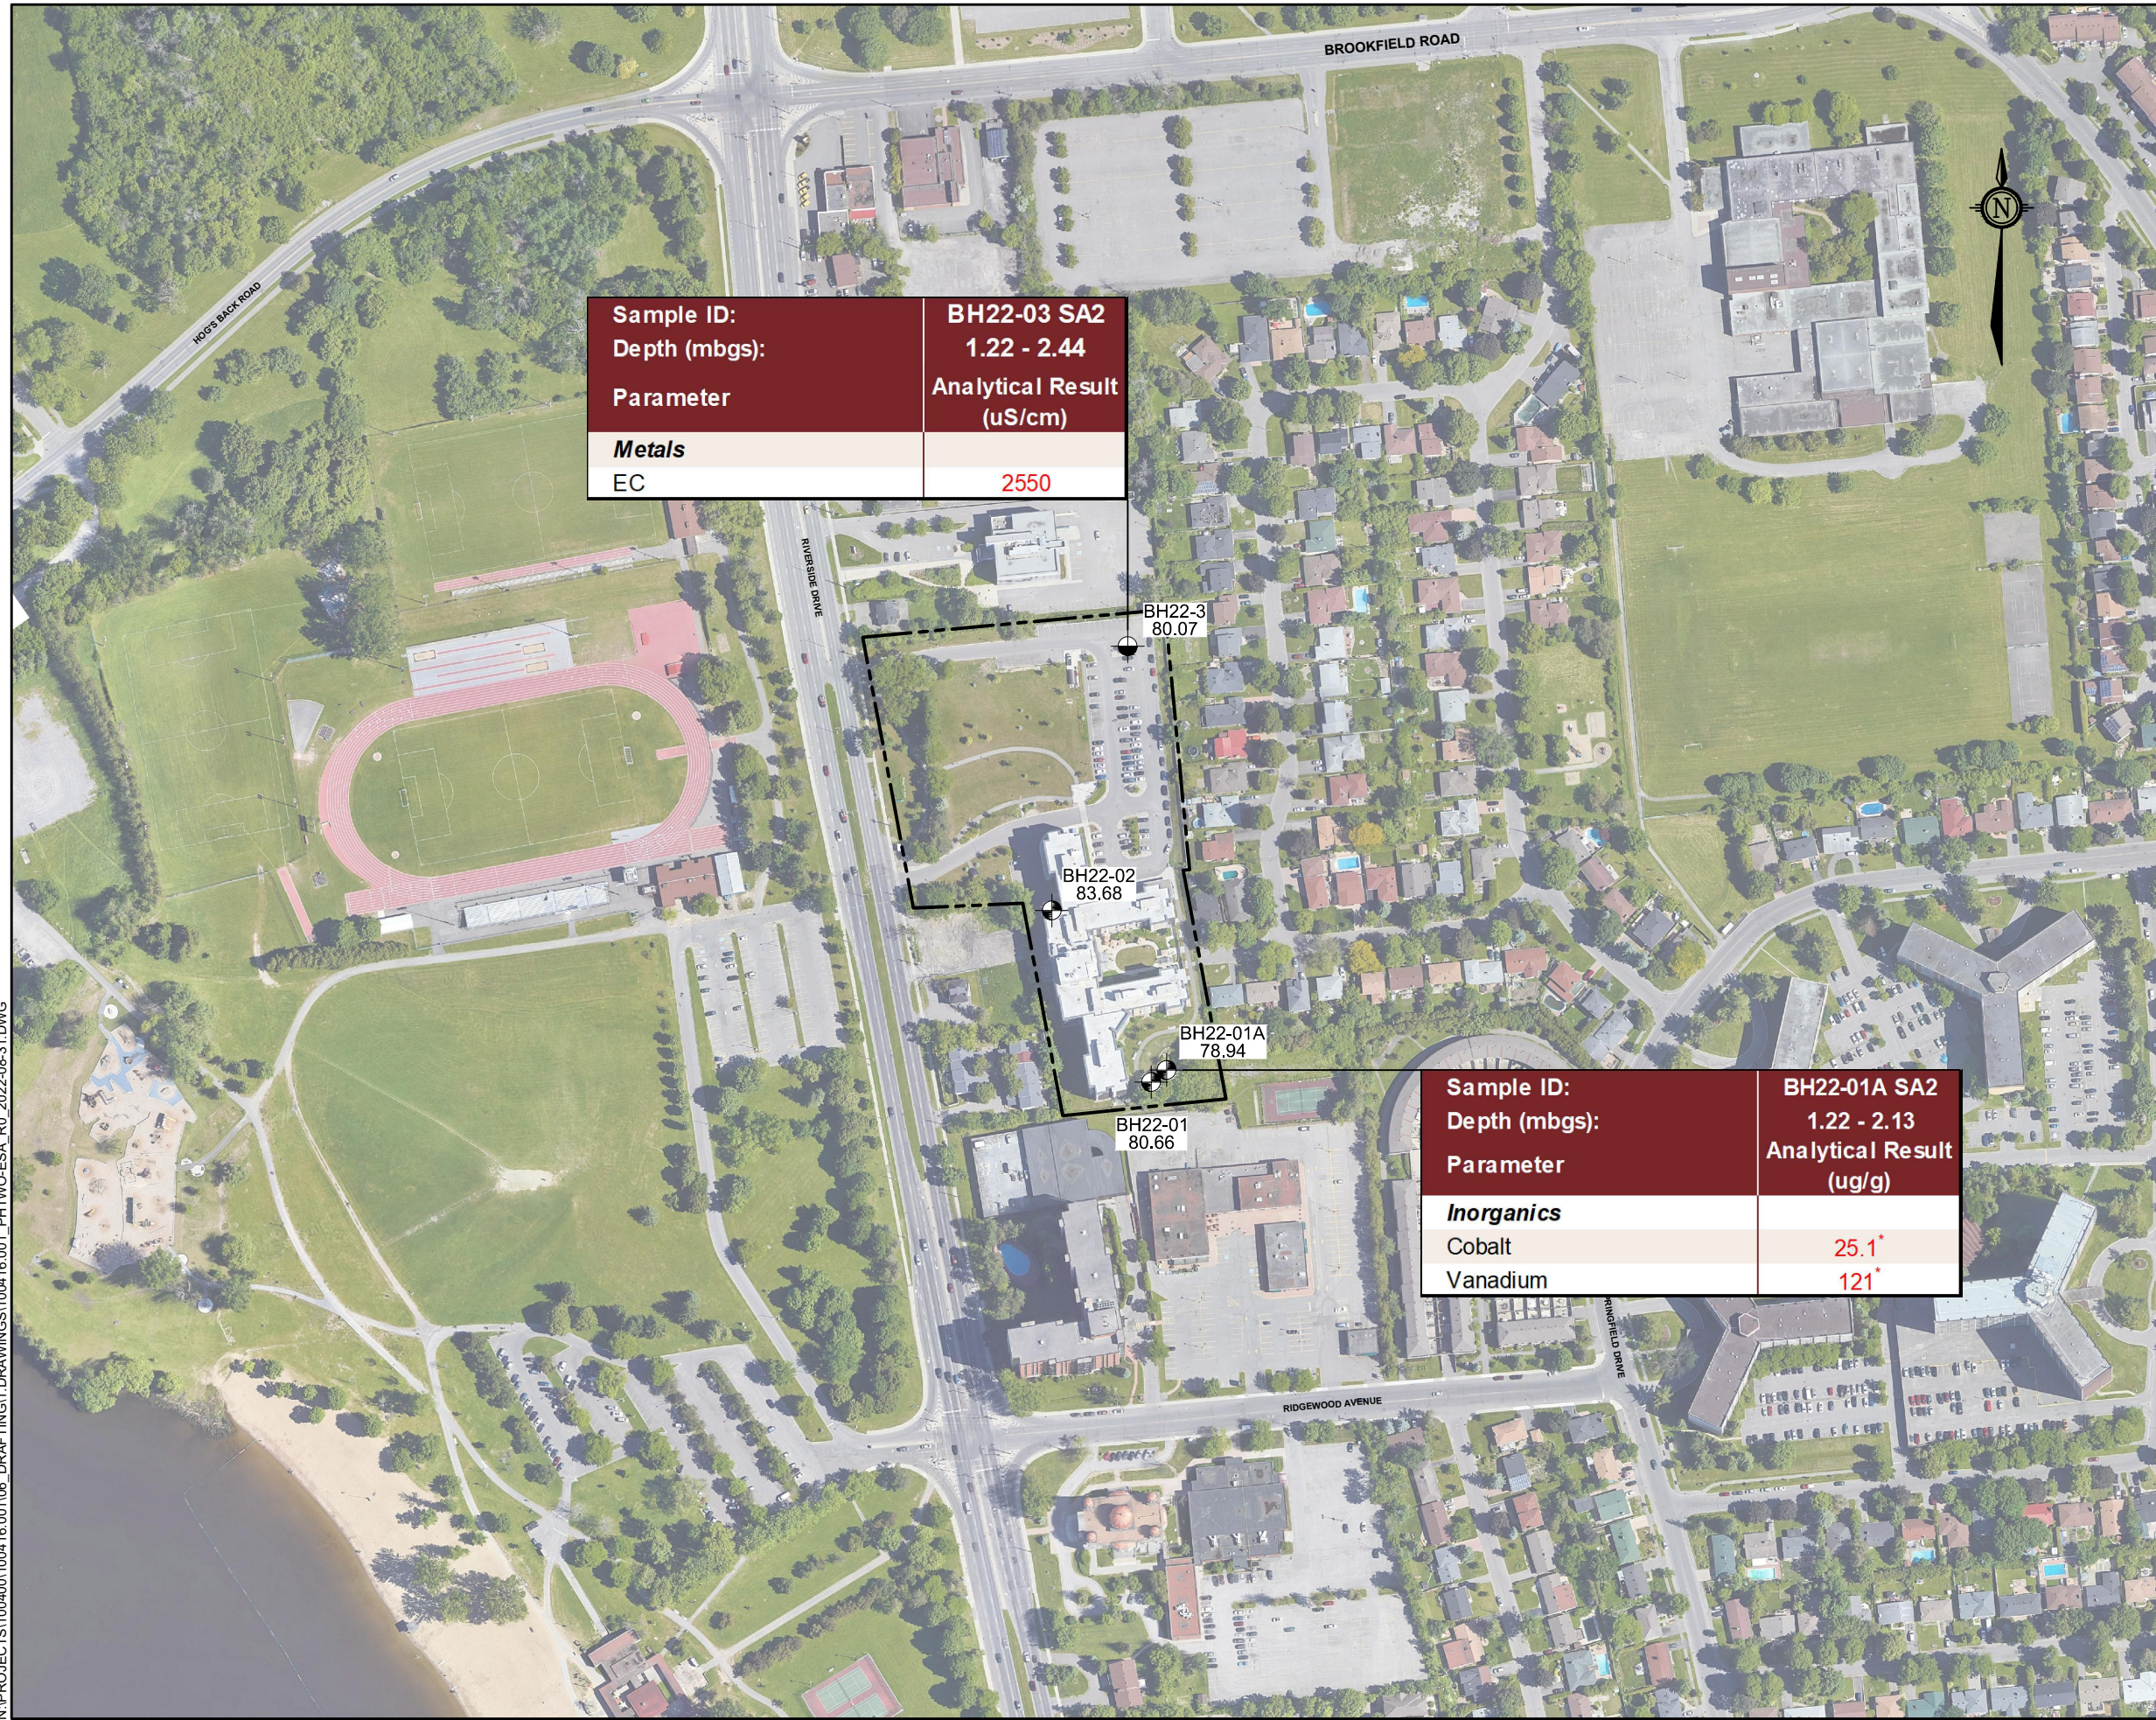
Sample ID:	BH22-03 SA2
Depth (mbgs):	1.22 - 2.44
Parameter	Analytical Result (uS/cm)
Metals	
EC	2550

Sample ID:	BH22-01A SA2
Depth (mbgs):	1.22 - 2.13
Parameter	Analytical Result (ug/g)
Inorganics	
Cobalt	25.1*
Vanadium	121*

Notes:
 NA - Not Analyzed
 mbgs - metres below ground surface
 1 - MECP Table 3 SCS: Full Depth Background Site Condition Standards in a Non-Potable Ground Water Condition (MECP 2019)
 * - Exceeded MECP Table 3 RPI SCS but did not exceed the proposed geo-regional background clay concentrations (Sterling, et al., 2017)
 Red - Exceeds MECP Table 3 RPI SCS

- Vanadium and cobalt exceeded the MECP Table 3 SCS; however, considering the geo-regional background clay concentrations for vanadium and cobalt (Sterling, et al., 2017) the sample was identified as being naturally occurring; and
- EC exceeded the MECP Table 3 SCS at BH22-03 SA2; however, this exceedance was likely attributed to salt application and de-icing activities during winter maintenance of the parking lot and pedestrian pathways and access routes
- The groundwater sample from MW22-03 submitted for analysis met the MECP Table 3 SCS for all parameters analyzed.
