**Supplemental Phase Two Environmental Site
Assessment
1055 Klondike Road
Ottawa, Ontario**

September 28, 2021
Project: 64153.85

**Re: Supplemental Phase Two Environmental Site Assessment
1055 Klondike, Ottawa, Ontario**

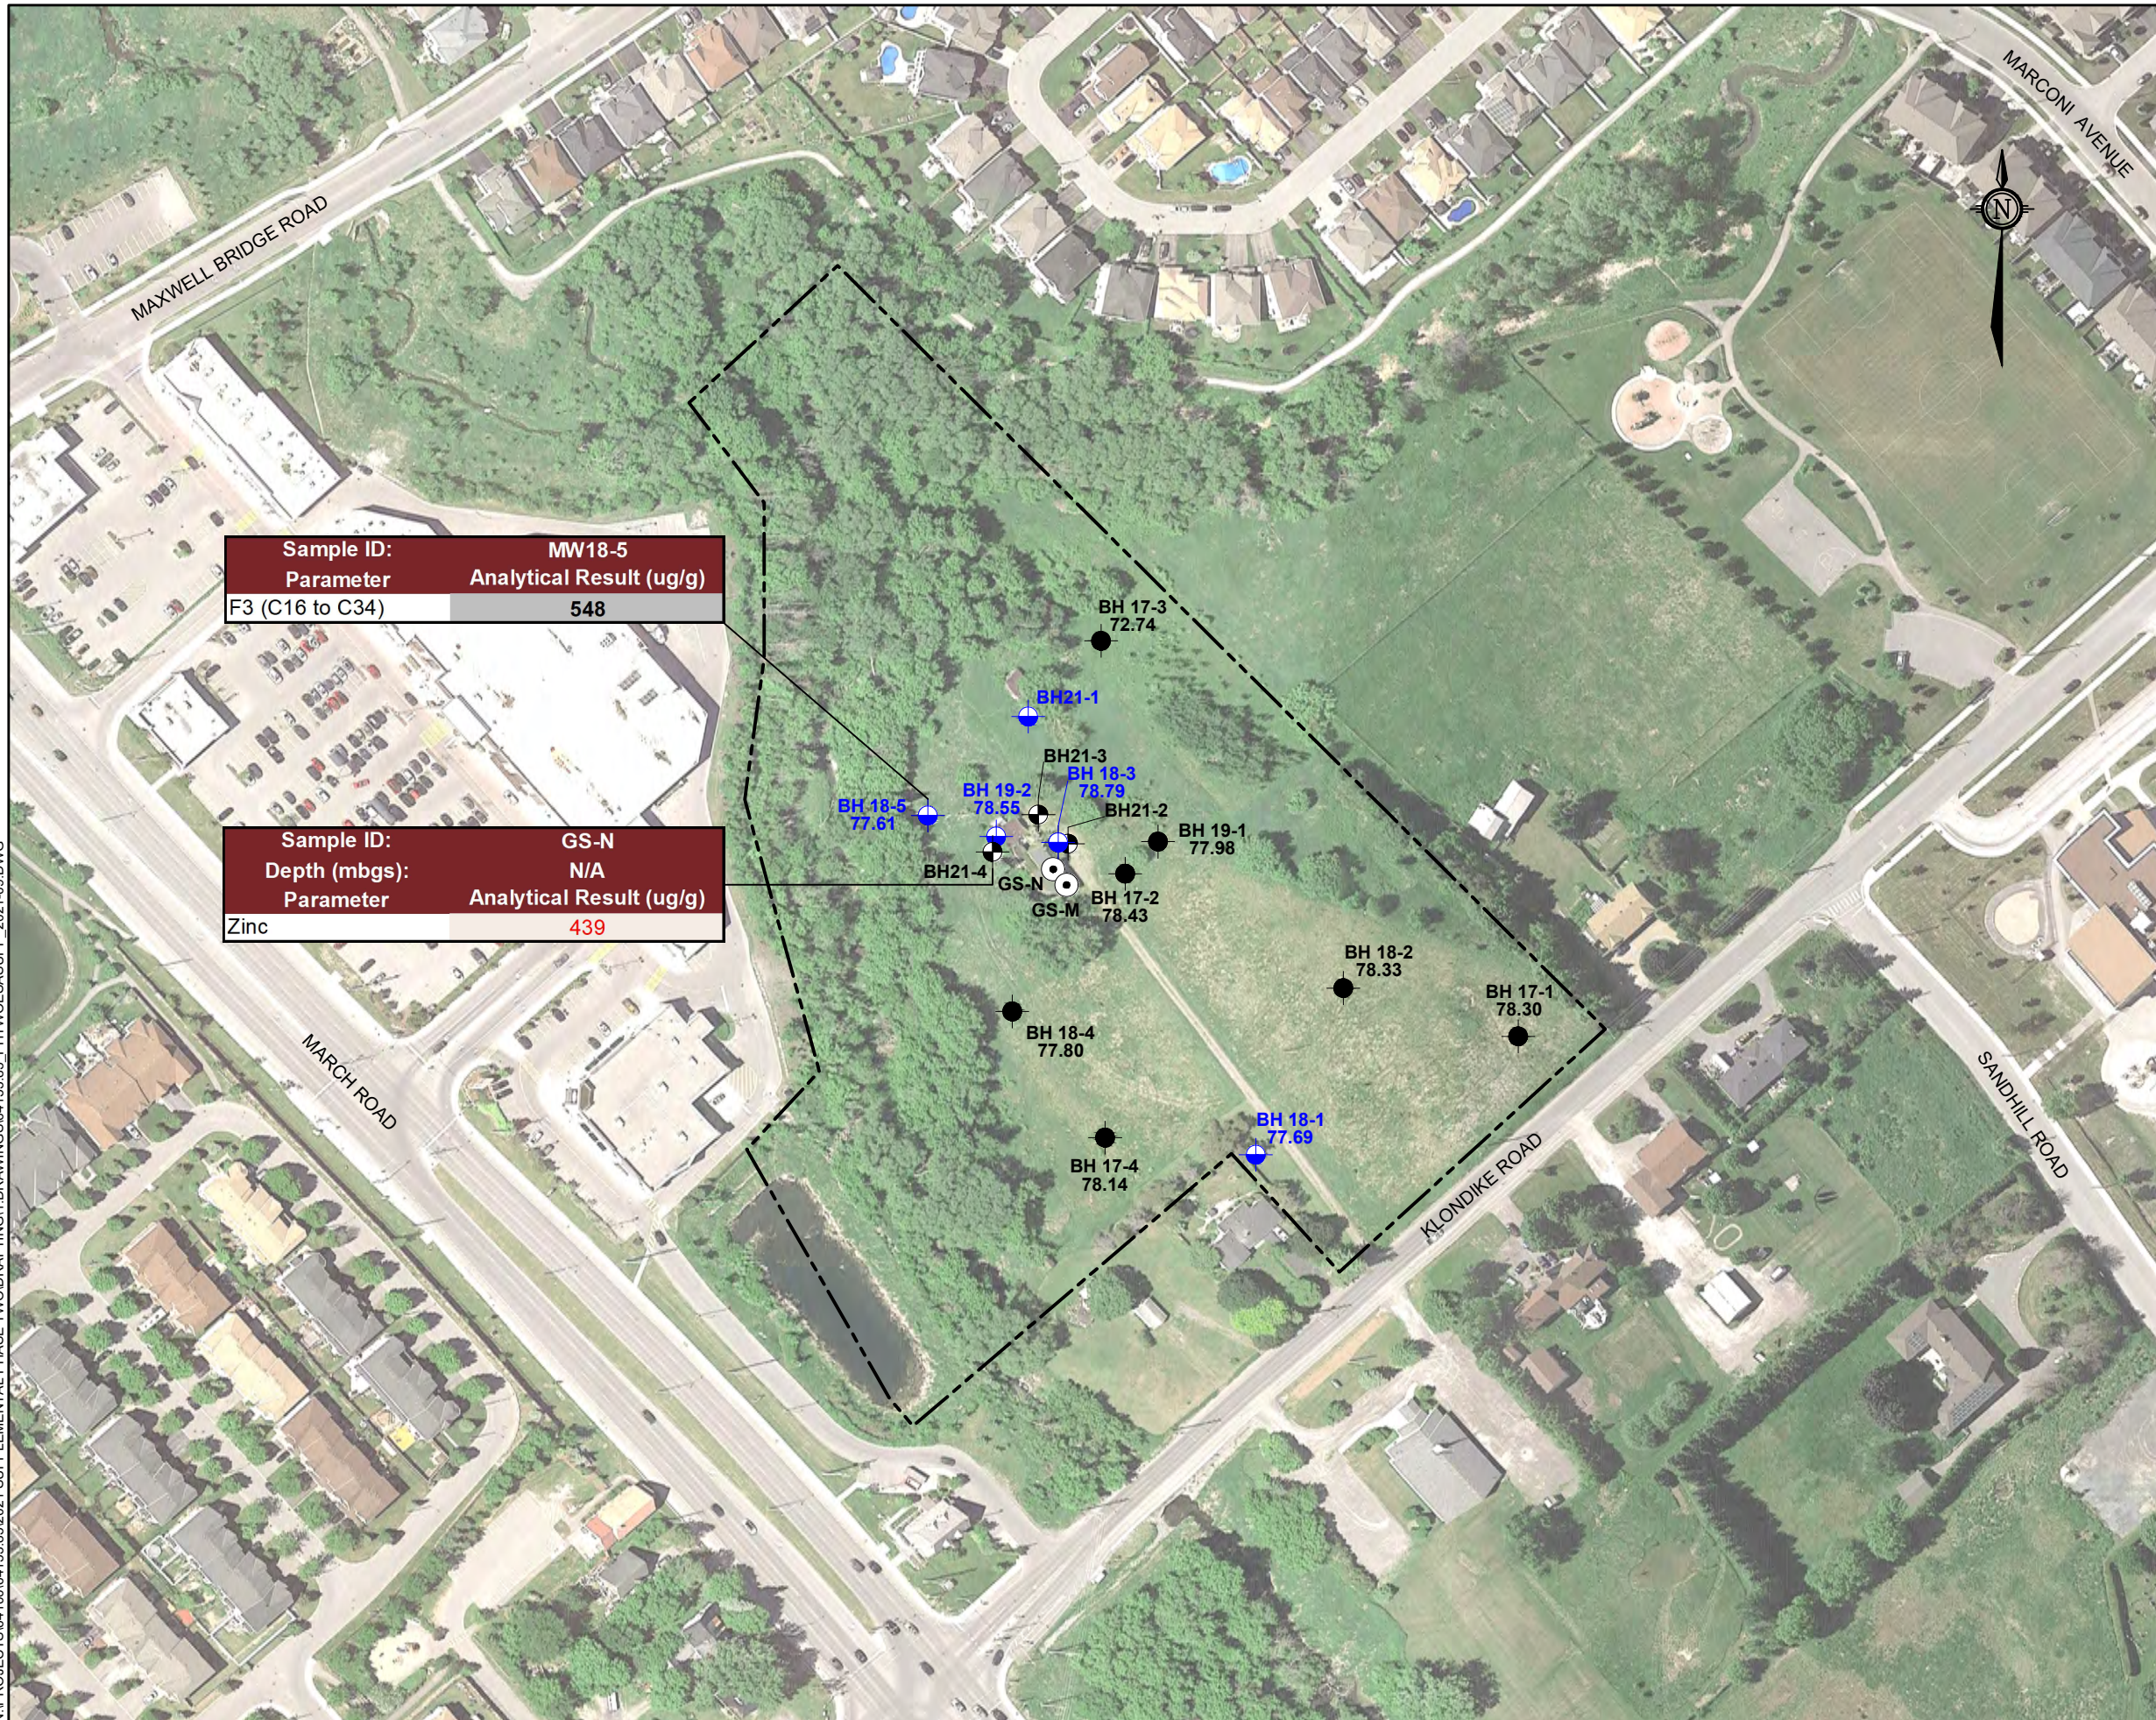
- BH # — BOREHOLE ID
- XX.XX — GROUND SURFACE ELEVATION, IN METRES GEODETIC DATUM
- BOREHOLE LOCATION (current investigation by GEMTEC)
- BOREHOLE LOCATION (previous investigation by GEMTEC, 2018)
- BOREHOLE WITH MONITORING WELL (current investigation by GEMTEC)
- GRAB SAMPLE LOCATION (APPROXIMATE) (current investigation by GEMTEC)
- SUBJECT SITE
