PHASE ONE ENVIRONMENTAL SITE ASSESSMENT UPDATE

LANSDOWNE PARK – PROPOSED EVENT CENTRE LANDS

PROJECT NO.: CA0037195.1094

DATE: AUGUST 6, 2024

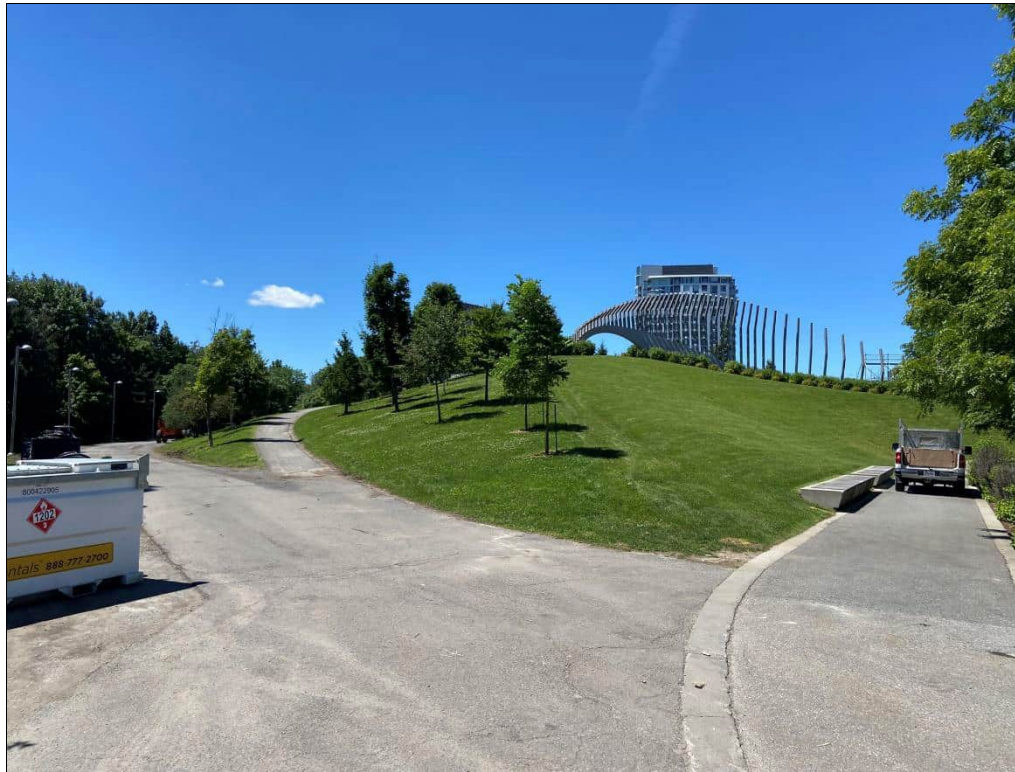
Photo 7:

General view of the southern elevation of the East Berm.

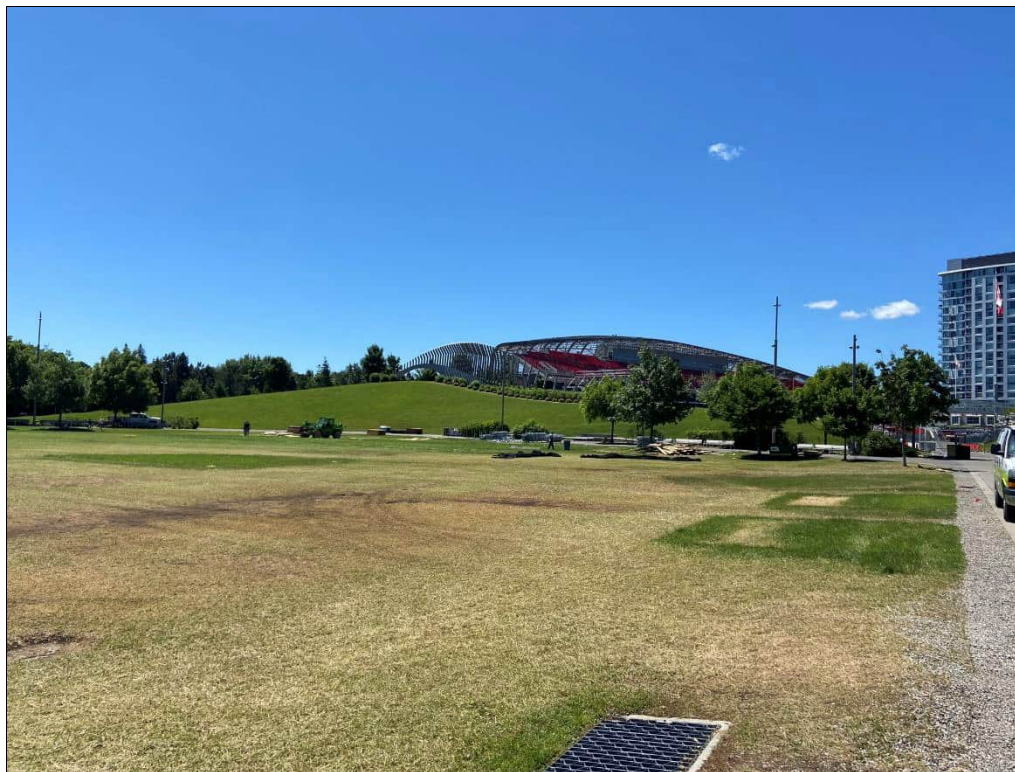
Photo 8:

General view of the eastern elevation of the East Berm.

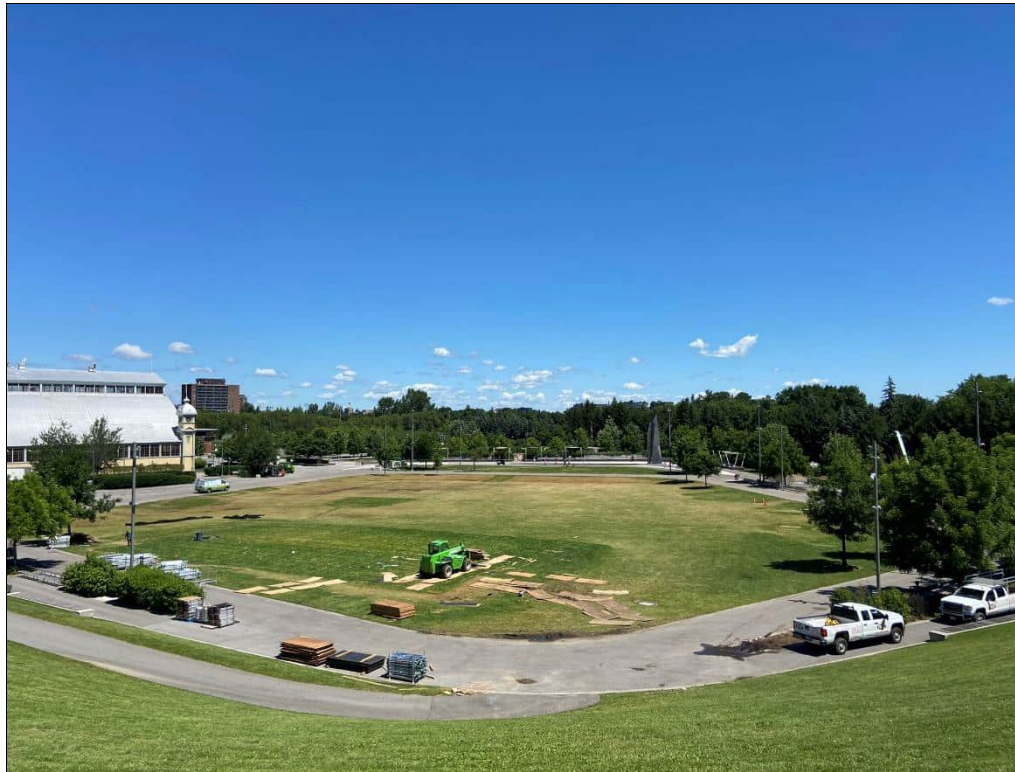
- WSP conducted a walkover of the Site to identify any areas of stressed vegetation. Areas of stressed vegetation were observed on top of the East Berm and within the Great Lawn Area due to regular foot traffic and a recent event held in that area of the park.

Photo 9:

General view of the Great Lawn area.

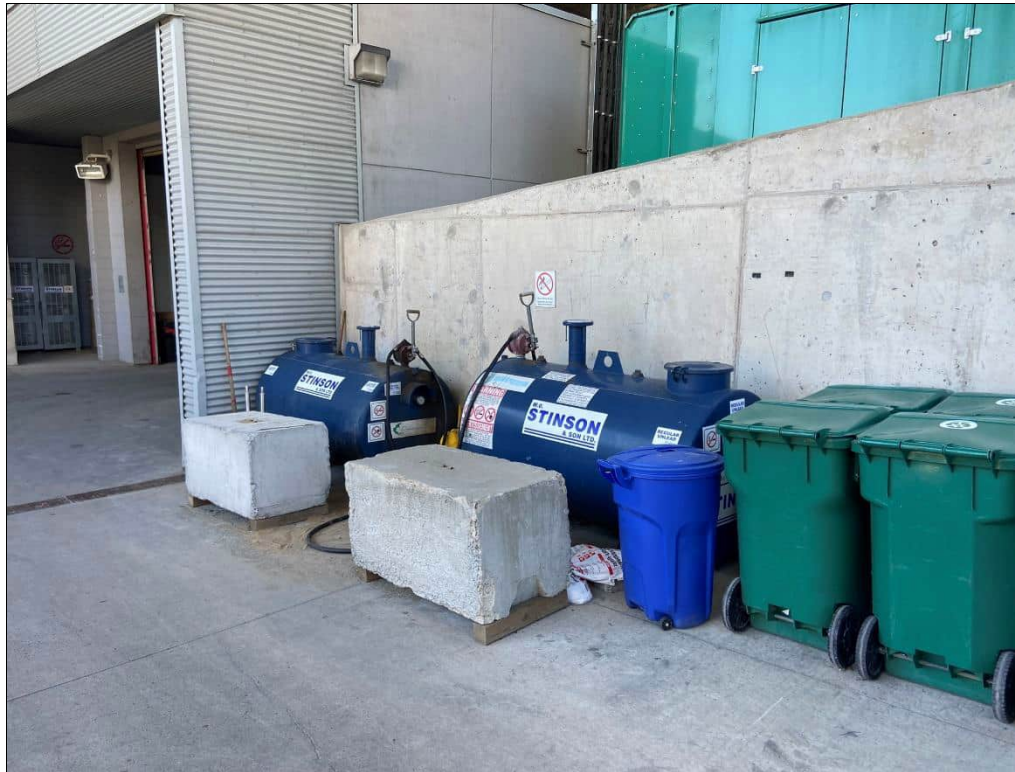
- WSP was advised by the site representative and observed the presence of three (3) ASTs at the Site during the reconnaissance. Two (2) 500 L double wall steel ASTs, one containing gasoline and one containing colored diesel, were located on the ramp leading to the service level of the facility on the east side of TD Place. These tanks are used to fuel the various equipment and vehicles used to maintain the facility. WSP observed minor staining on the gasoline AST near and below the hand pump suggesting a previous leak at the pump or hose fitting as well as some staining on the ground near the gasoline and diesel fuel ASTs suggesting incidents of overfilling or spillage when fueling equipment or gas cans in the area of the ASTs. One (1) steel AST with a capacity of 5,791 L was noted within the enclosure for the back-up generator. The Site representative advised that only small spills have occurred in the area and are cleaned with adsorbent material.

- WSP conducted a walkover of the Site to identify any areas of stained soil, vegetation or pavement or any other potential indicators of surface spills or leaks. Staining was observed on the concrete floor in the area of the two (2) fuel storage ASTs located on the ramp leading to the loading dock area. Staining was also observed on the concrete floor near the garbage compactors at the base of the ramp in the loading dock area. A trench drain connected to the building's sewer system was located at the base of the ramp in the loading dock area. The Site representative advised WSP that to his knowledge other than the staining observed noted above there are no areas of stained soil, vegetation or pavement are or were ever present at the Site.

Photo 11:
500 L capacity coloured diesel and gasoline above ground storage tanks located on the ramp outside the loading dock area. Note: fuel spills would flow down the ramp to the grate floor drain.
Date: 06/28/24
Direction: Southwest

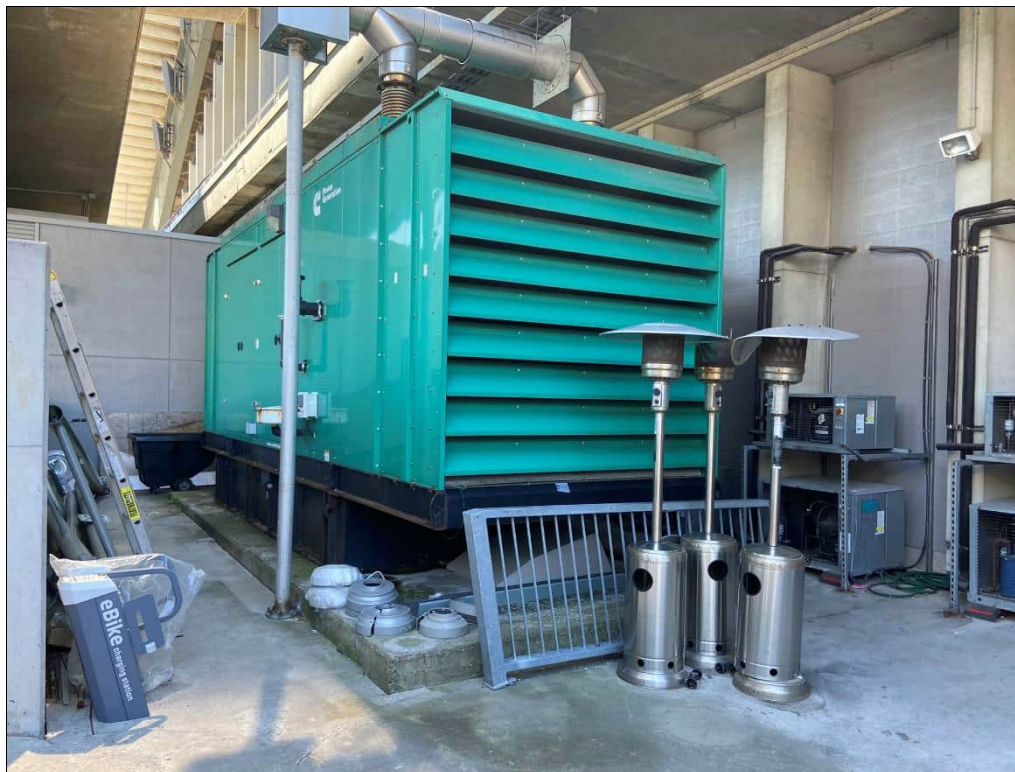
Photo 12:
Back-up generator located outside the loading dock area on the east side of TD Place Stadium. Fitted with a 5,791 L capacity diesel storage tank.
Date: 06/28/24
Direction: South
