SEPTIC IMPACT ASSESSMENT (REV.3)

5646-5650 MANOTICK MAIN STREET

Project No.: CCO-22-2383

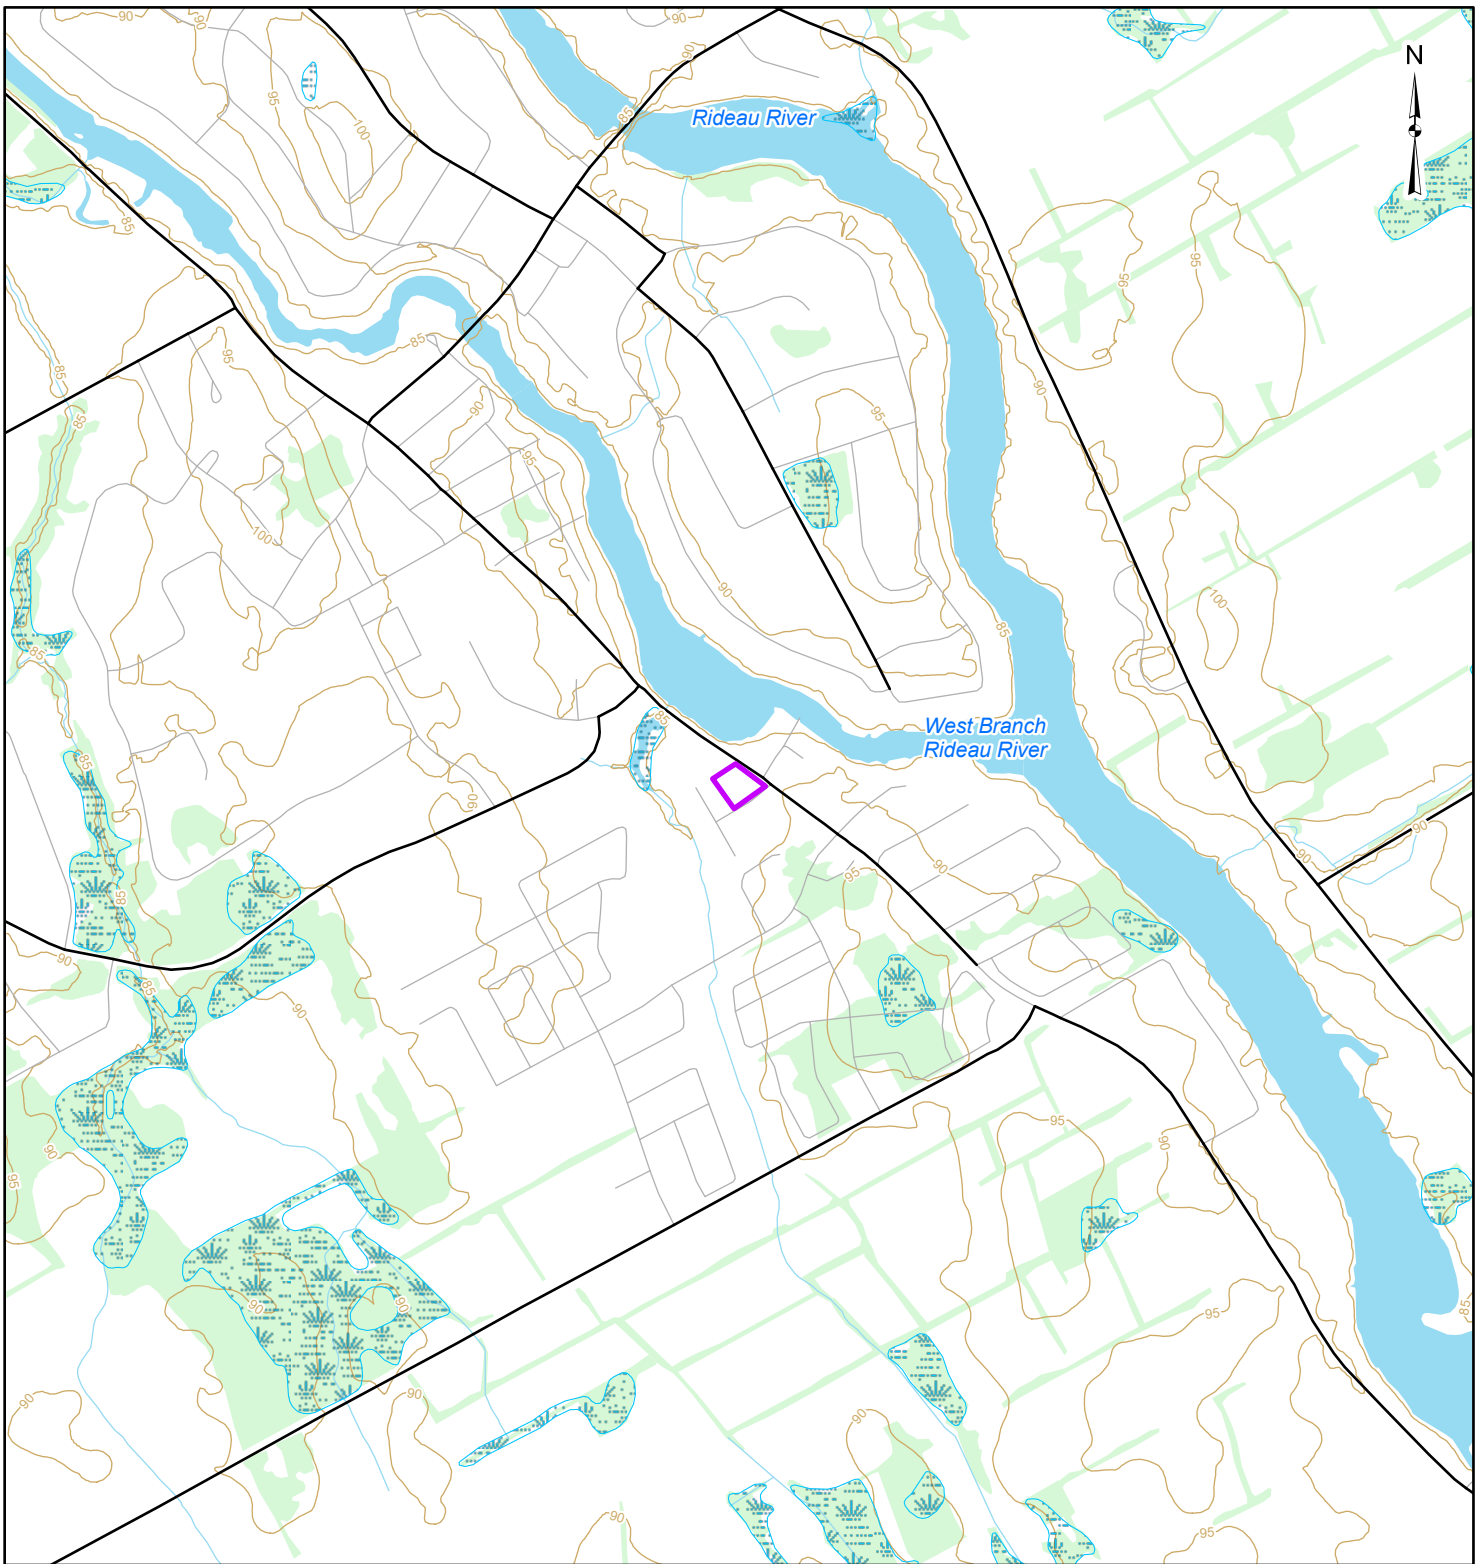
CLIENT:	HAWKINS PROPERTIES		
PROJECT:	SEPTIC IMPACT ASSESSMENT		
	5646-5650 MANOTICK MAIN STREET		
TITLE:	DRAINAGE AND TOPOGRAPHY		
	PROJECT NO: CCO-22-2383	FIGURE:	3
Date	Jun., 14, 2023		
GIS	AH		
Checked By	KC

The Site occurs within the Rideau Falls – Rideau River watershed. The closest water body to the Site is the Mahogany Harbour, part of the West Branch Rideau River, located approximately 40 metres (m) north, at its closest point. On-site infiltration of water is interpreted to occur in areas of permeable ground surface. Surface drainage at the Site appears to be largely controlled by sheet flow runoff to the northeast ditches/stormwater catchbasins along Manotick Main Street with a small part of the southwestern edge of the Site currently draining to the southwest along the tree line.

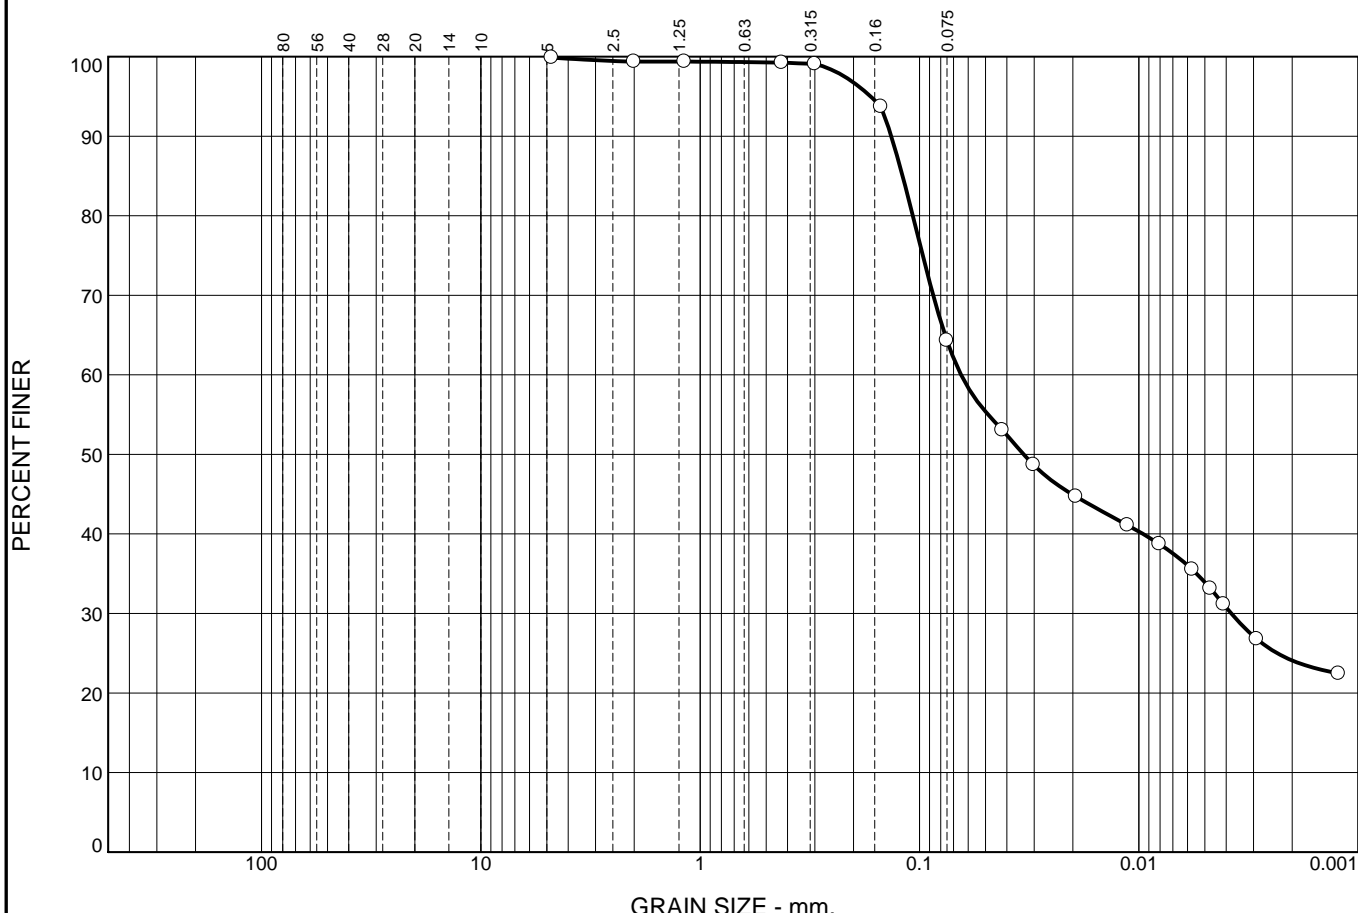
Figure 1

% +75mm	% Gravel		% Sand		% Fines	
		Coarse	Fine	Silt	Clay		
<input type="radio"/>				0.2	34.9	40.2	24.1

LL	PL	D85	D60	D50	D30	D15	D10	Cc	Cu
<input checked="" type="checkbox"/>	51	19	0.1194	0.0646	0.0335	0.0038

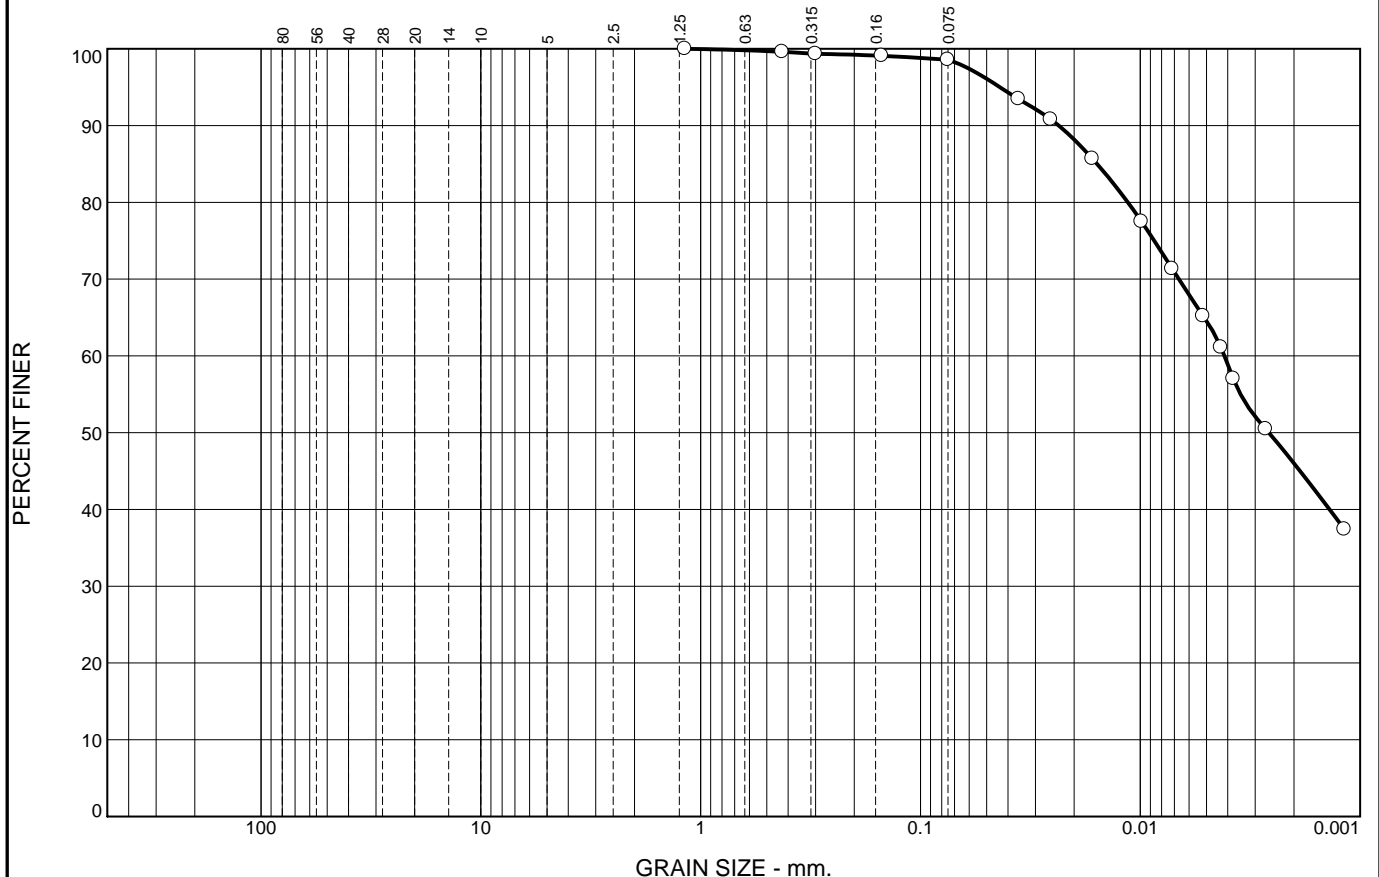
% +75mm	% Gravel	% Sand		% Fines	
			Coarse	Fine	Silt	Clay
○	0.0	0.0	0.4	1.0	52.6	46.0

⊗	LL	PL	D ₈₅	D ₆₀	D ₅₀	D ₃₀	D ₁₅	D ₁₀	C _c	C _u
○	39	18	0.0157	0.0041	0.0026

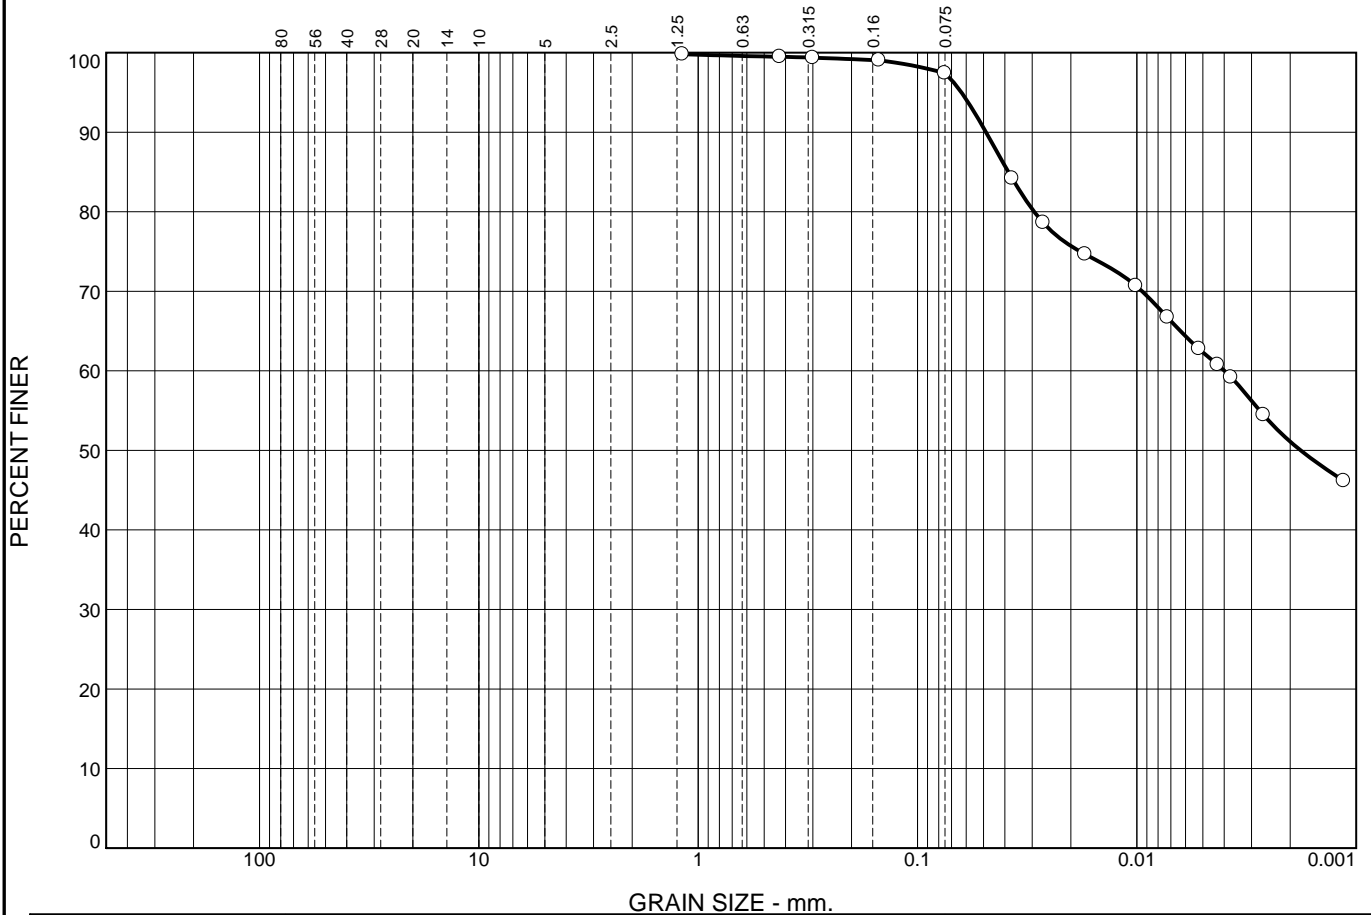
Figure 3

% +75mm	% Gravel		% Sand		% Fines	
		Coarse	Fine	Silt	Clay		
<input type="radio"/>				2.1	46.3	51.1

LL	PL	D ₈₅	D ₆₀	D ₅₀	D ₃₀	D ₁₅	D ₁₀	C _c	C _u
<input checked="" type="checkbox"/>	31	11	0.0385	0.0040	0.0018

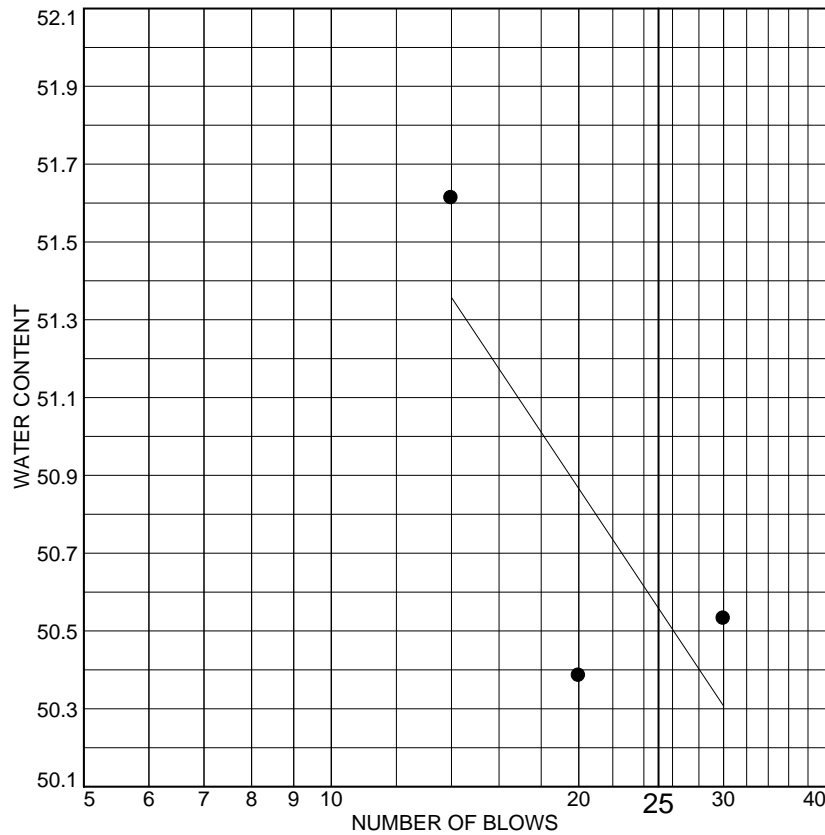
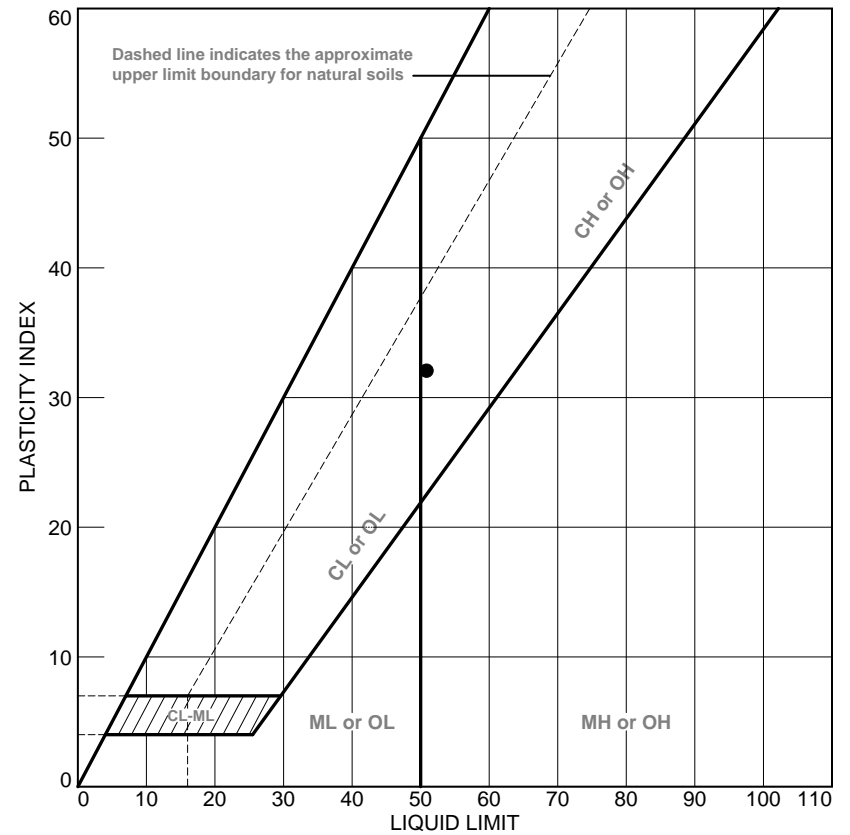
SOURCE	SAMPLE #	DEPTH/ELEV.	DATE SAMPLED	USCS	MATERIAL DESCRIPTION	NM %	LL	PI
●	BH 101-SS3			CH	sandy, SILT AND CLAY		51	32

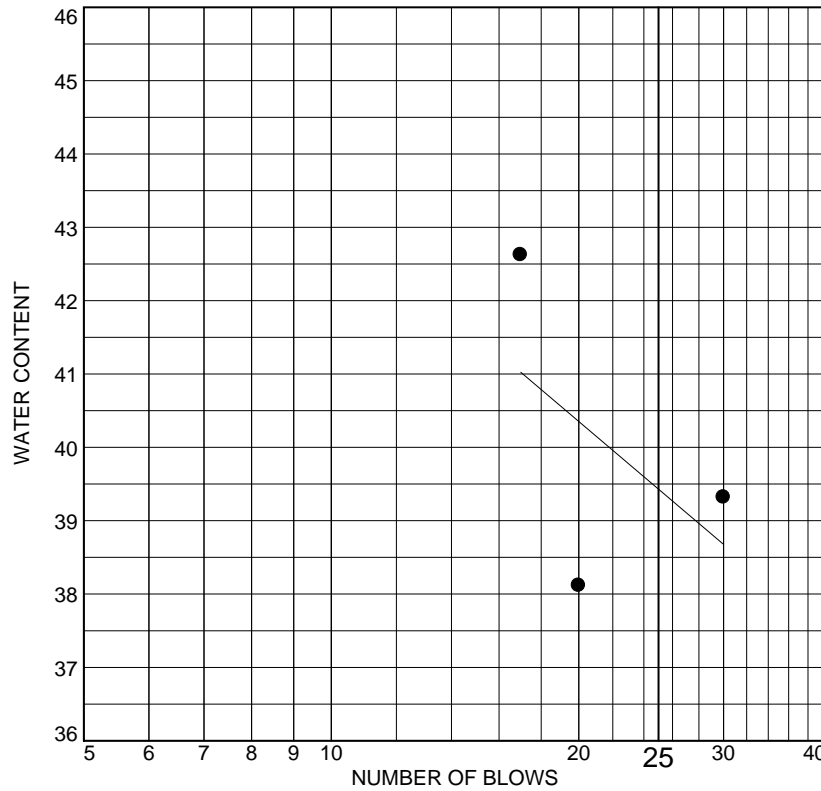
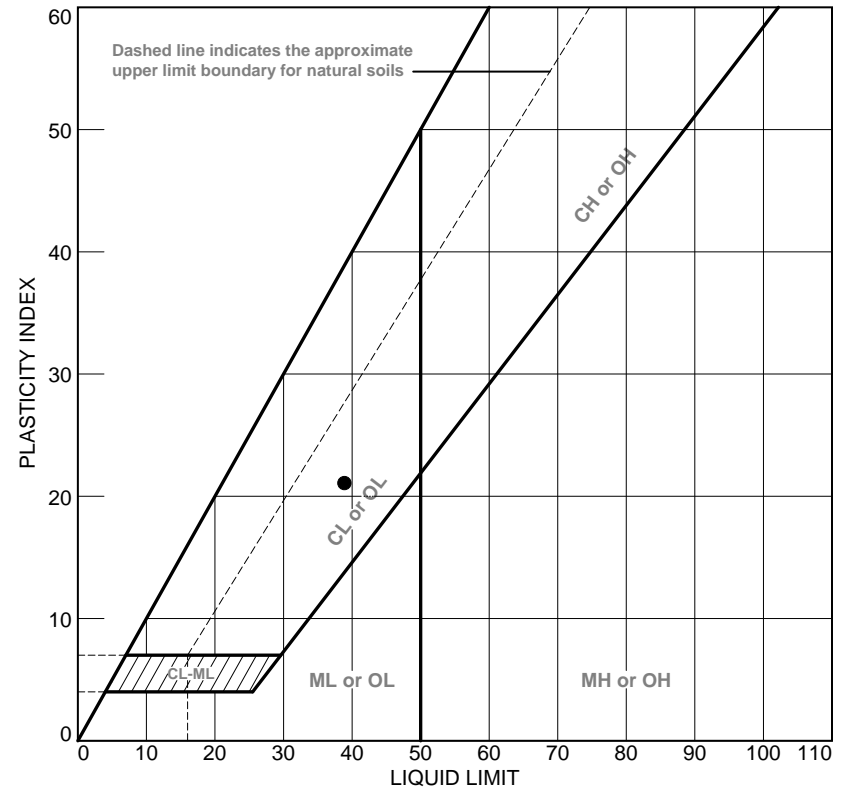
Client Hawkins Properties
 Project
 Project No. CO884.01 Figure 5

SOURCE	SAMPLE #	DEPTH/ELEV.	DATE SAMPLED	USCS	MATERIAL DESCRIPTION	NM %	LL	PI
●	BH 101-SS6			CL	SILT AND CLAY, trace sand		39	21
