## Geotechnical Investigation

Proposed Mixed-Use Development  
1518-1526 Stittsville Main Street  
Ottawa, Ontario

Inverness Homes

Report: PG5418-1  
Revision 3

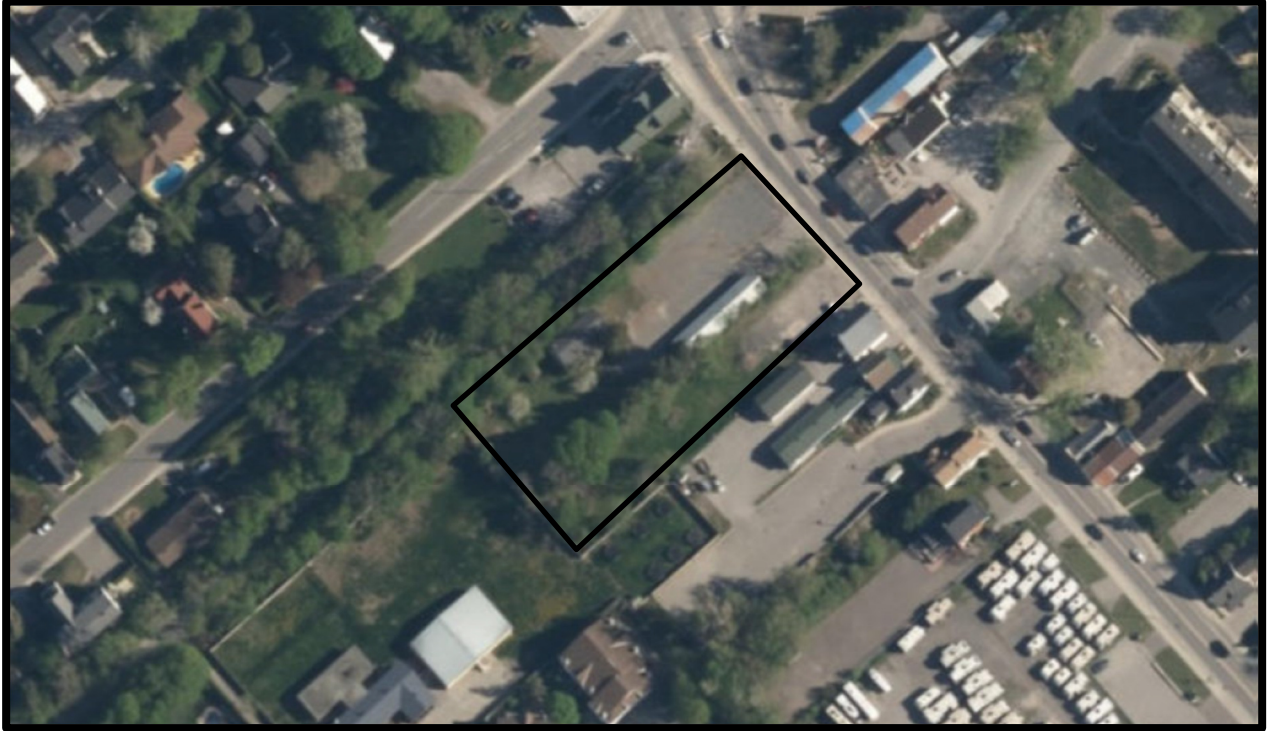
## FIGURE 2

Aerial Photograph - 2014

Based on available historical photographs of the subject site, a building was located in the northeast portion of the site fronting onto Stittsville Main Street as recently as 2014, and was no longer present in 2017. Reference should be made to the aerial photographs in Figure 2 - Aerial Photograph - 2014 and Figure 3 - Aerial Photograph - 2017 which illustrate the former and present site conditions, respectively.
