**Geotechnical Investigation
Proposed Industrial Development
1319 Johnston Road
Ottawa, Ontario**

May 13, 2024
Project: 101481.008

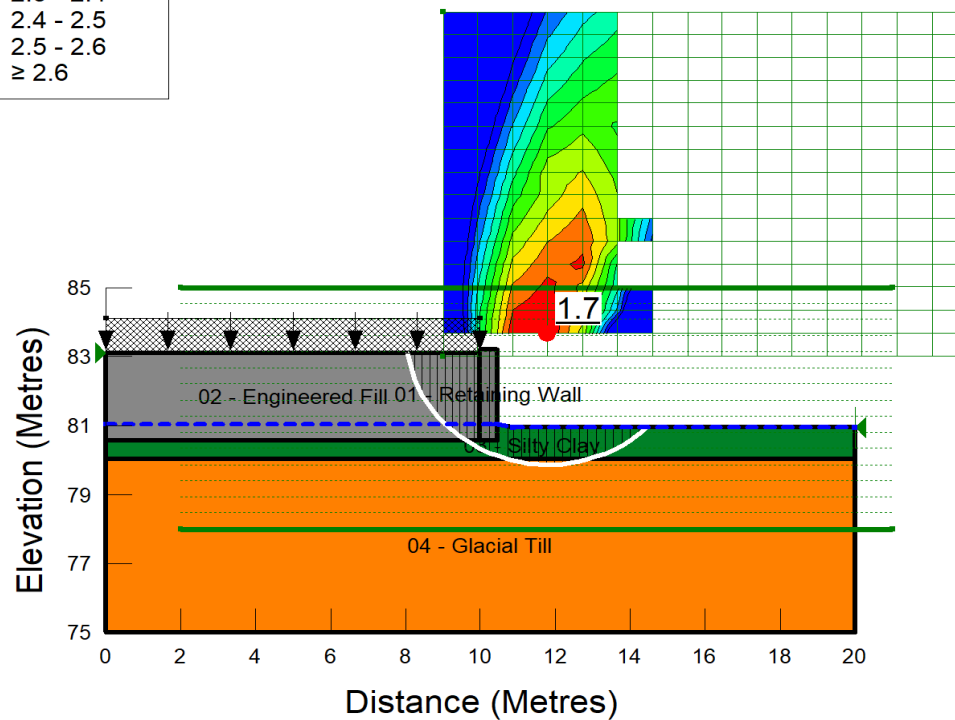
Name: Slope Stability Static
 Method: Morgenstern-Price
 Direction of movement: Left to Right
 Surcharge (Unit Weight): 12 kN/m³
 Horz Seismic Coef.: 0

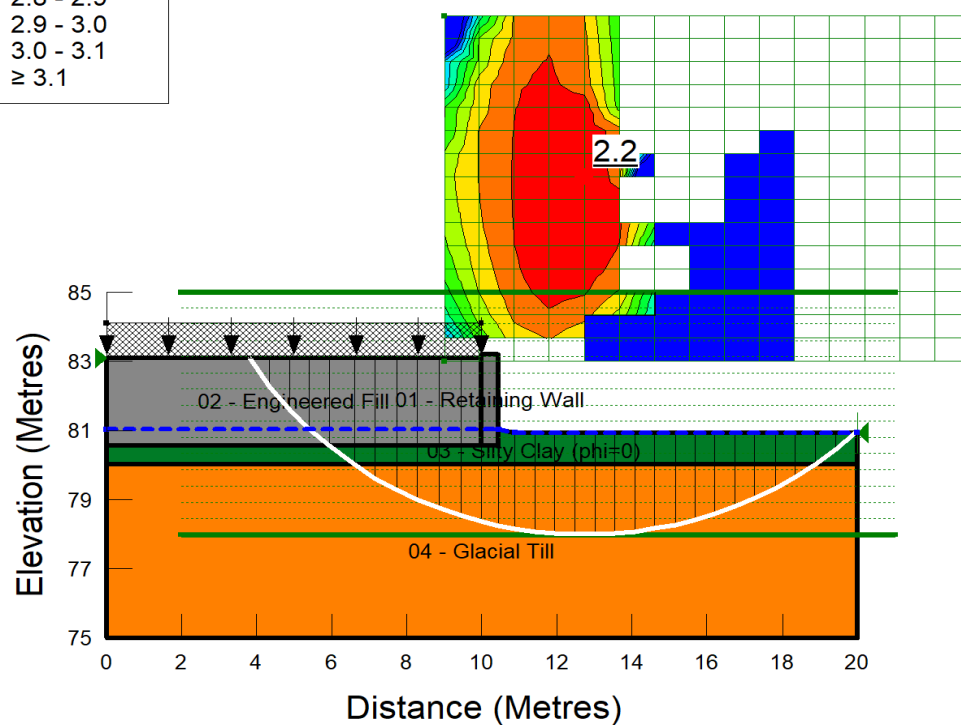
Name: Slope Stability Seismic
Method: Morgenstern-Price
Direction of movement: Left to Right
Surcharge (Unit Weight): 12 kN/m³
Horz Seismic Coef.: 0.153
