September 13, 2023 (Revised August 27, 2024)

Our File Ref.: 220487

Subject: Hydrogeological Assessment & Terrain Analysis –
Proposed Warehouse Development
363 Entrepreneur Crescent, Ottawa, Ontario

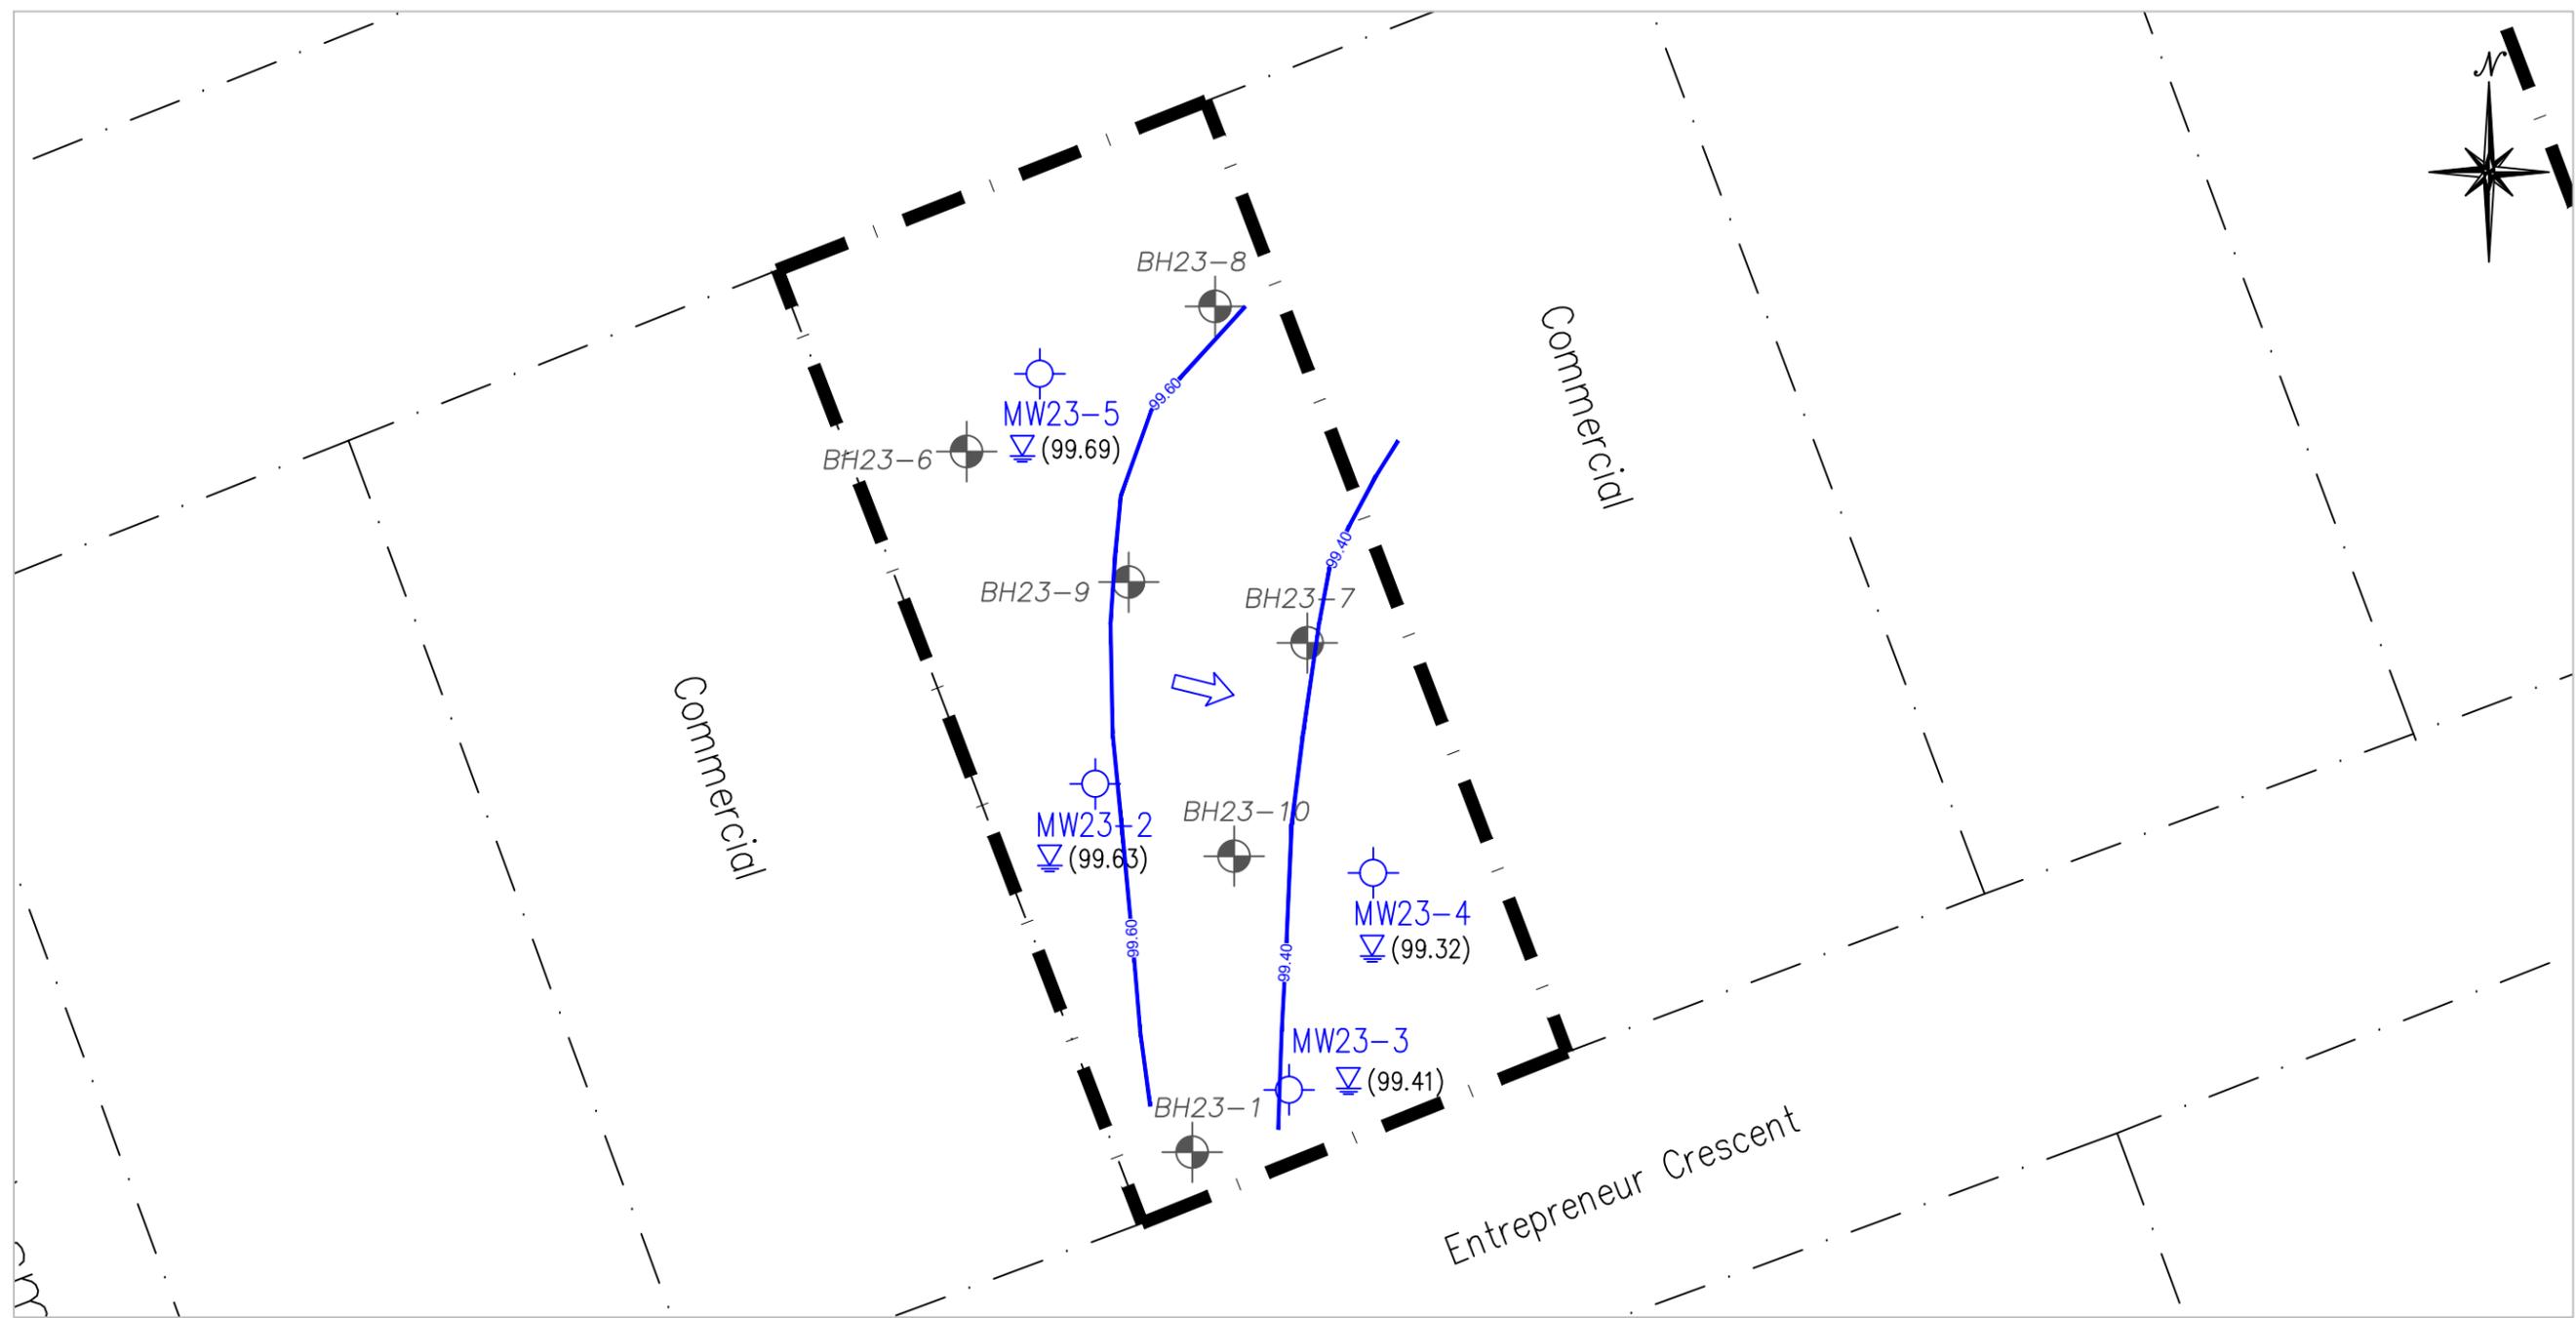
FIGURE5B

Property Line - Subject Site (363 Entrepreneur Crescent)		Neighbouring Property Boundaries
	Borehole		Groundwater Elevation
	Monitoring Well		Groundwater Elevation Contour
	Inferred Groundwater Flow Direction

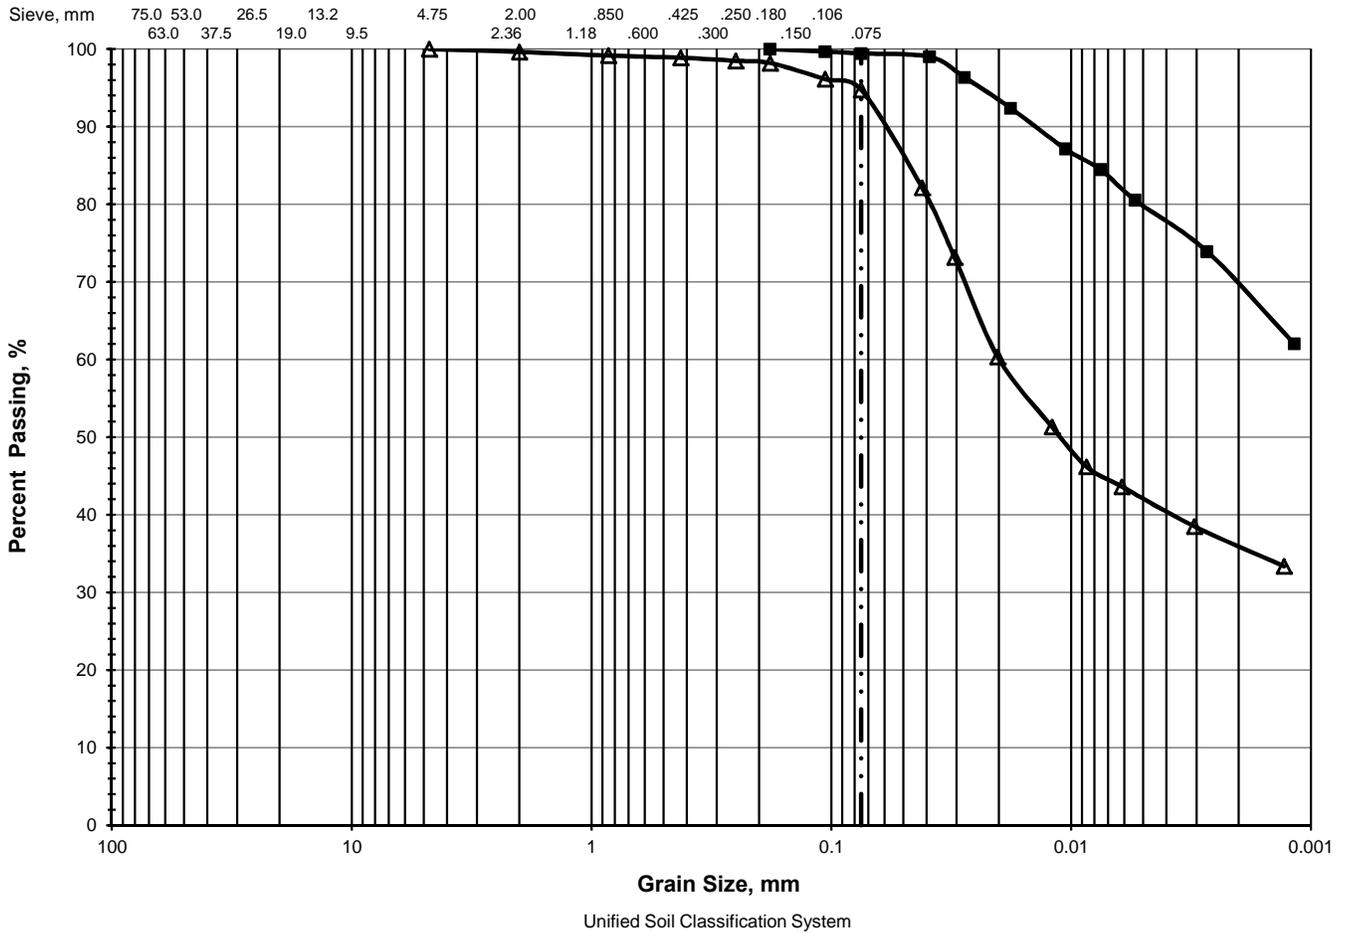
File No.: 220487
Report No.: 2
Date: November 17, 2022

> 75 mm	% GRAVEL		% SAND			% FINES	
	Coarse	Fine	Coarse	Medium	Fine	Silt	Clay
△	0.0	0.0	0.4	0.8	4.1	59.3	35.4
■	0.0	0.0	0.0	0.0	0.6	31.0	68.4

Location	Sample	Depth, m	D ₆₀	D ₅₀	D ₃₀	D ₁₅	D ₁₀	C _c	C _u
△	BH 1	1.52 - 2.13	0.0199	0.0111					
■	BH 2	6.10 - 6.71

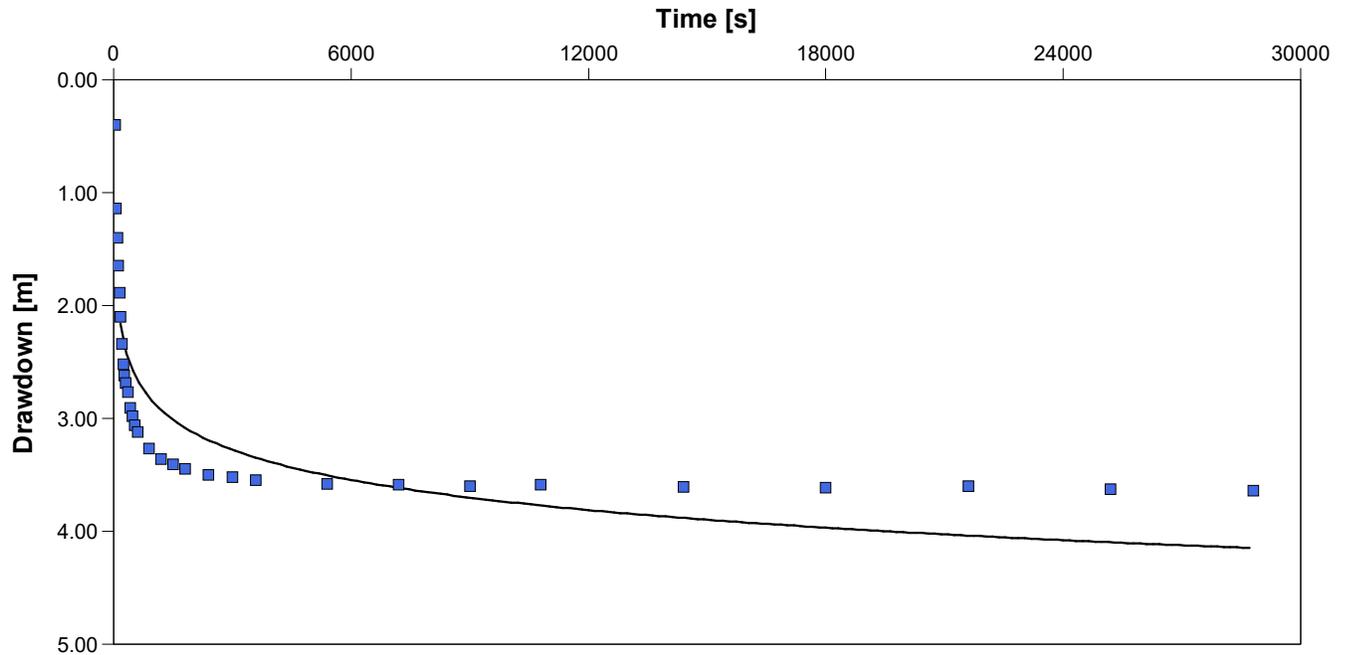
Location: 363 Entrepreneur Cresnet	Pumping Test: Pumping Test 1	Pumping Well: Well 1
Test Conducted by: LRL Engineering		Test Date: 2023-08-30
Analysis Performed by: LRL Engineering	Draw Down - August 30 2023	Analysis Date: 2023-09-07
Aquifer Thickness:	Discharge Rate: 0.022 [m ³ /min]

Calculation using Theis				
Observation Well	Transmissivity [m ² /s]	Storage coefficient	Radial Distance to PW [m]	
Well 1	7.59×10^{-5}	4.51×10^{-3}	0.15

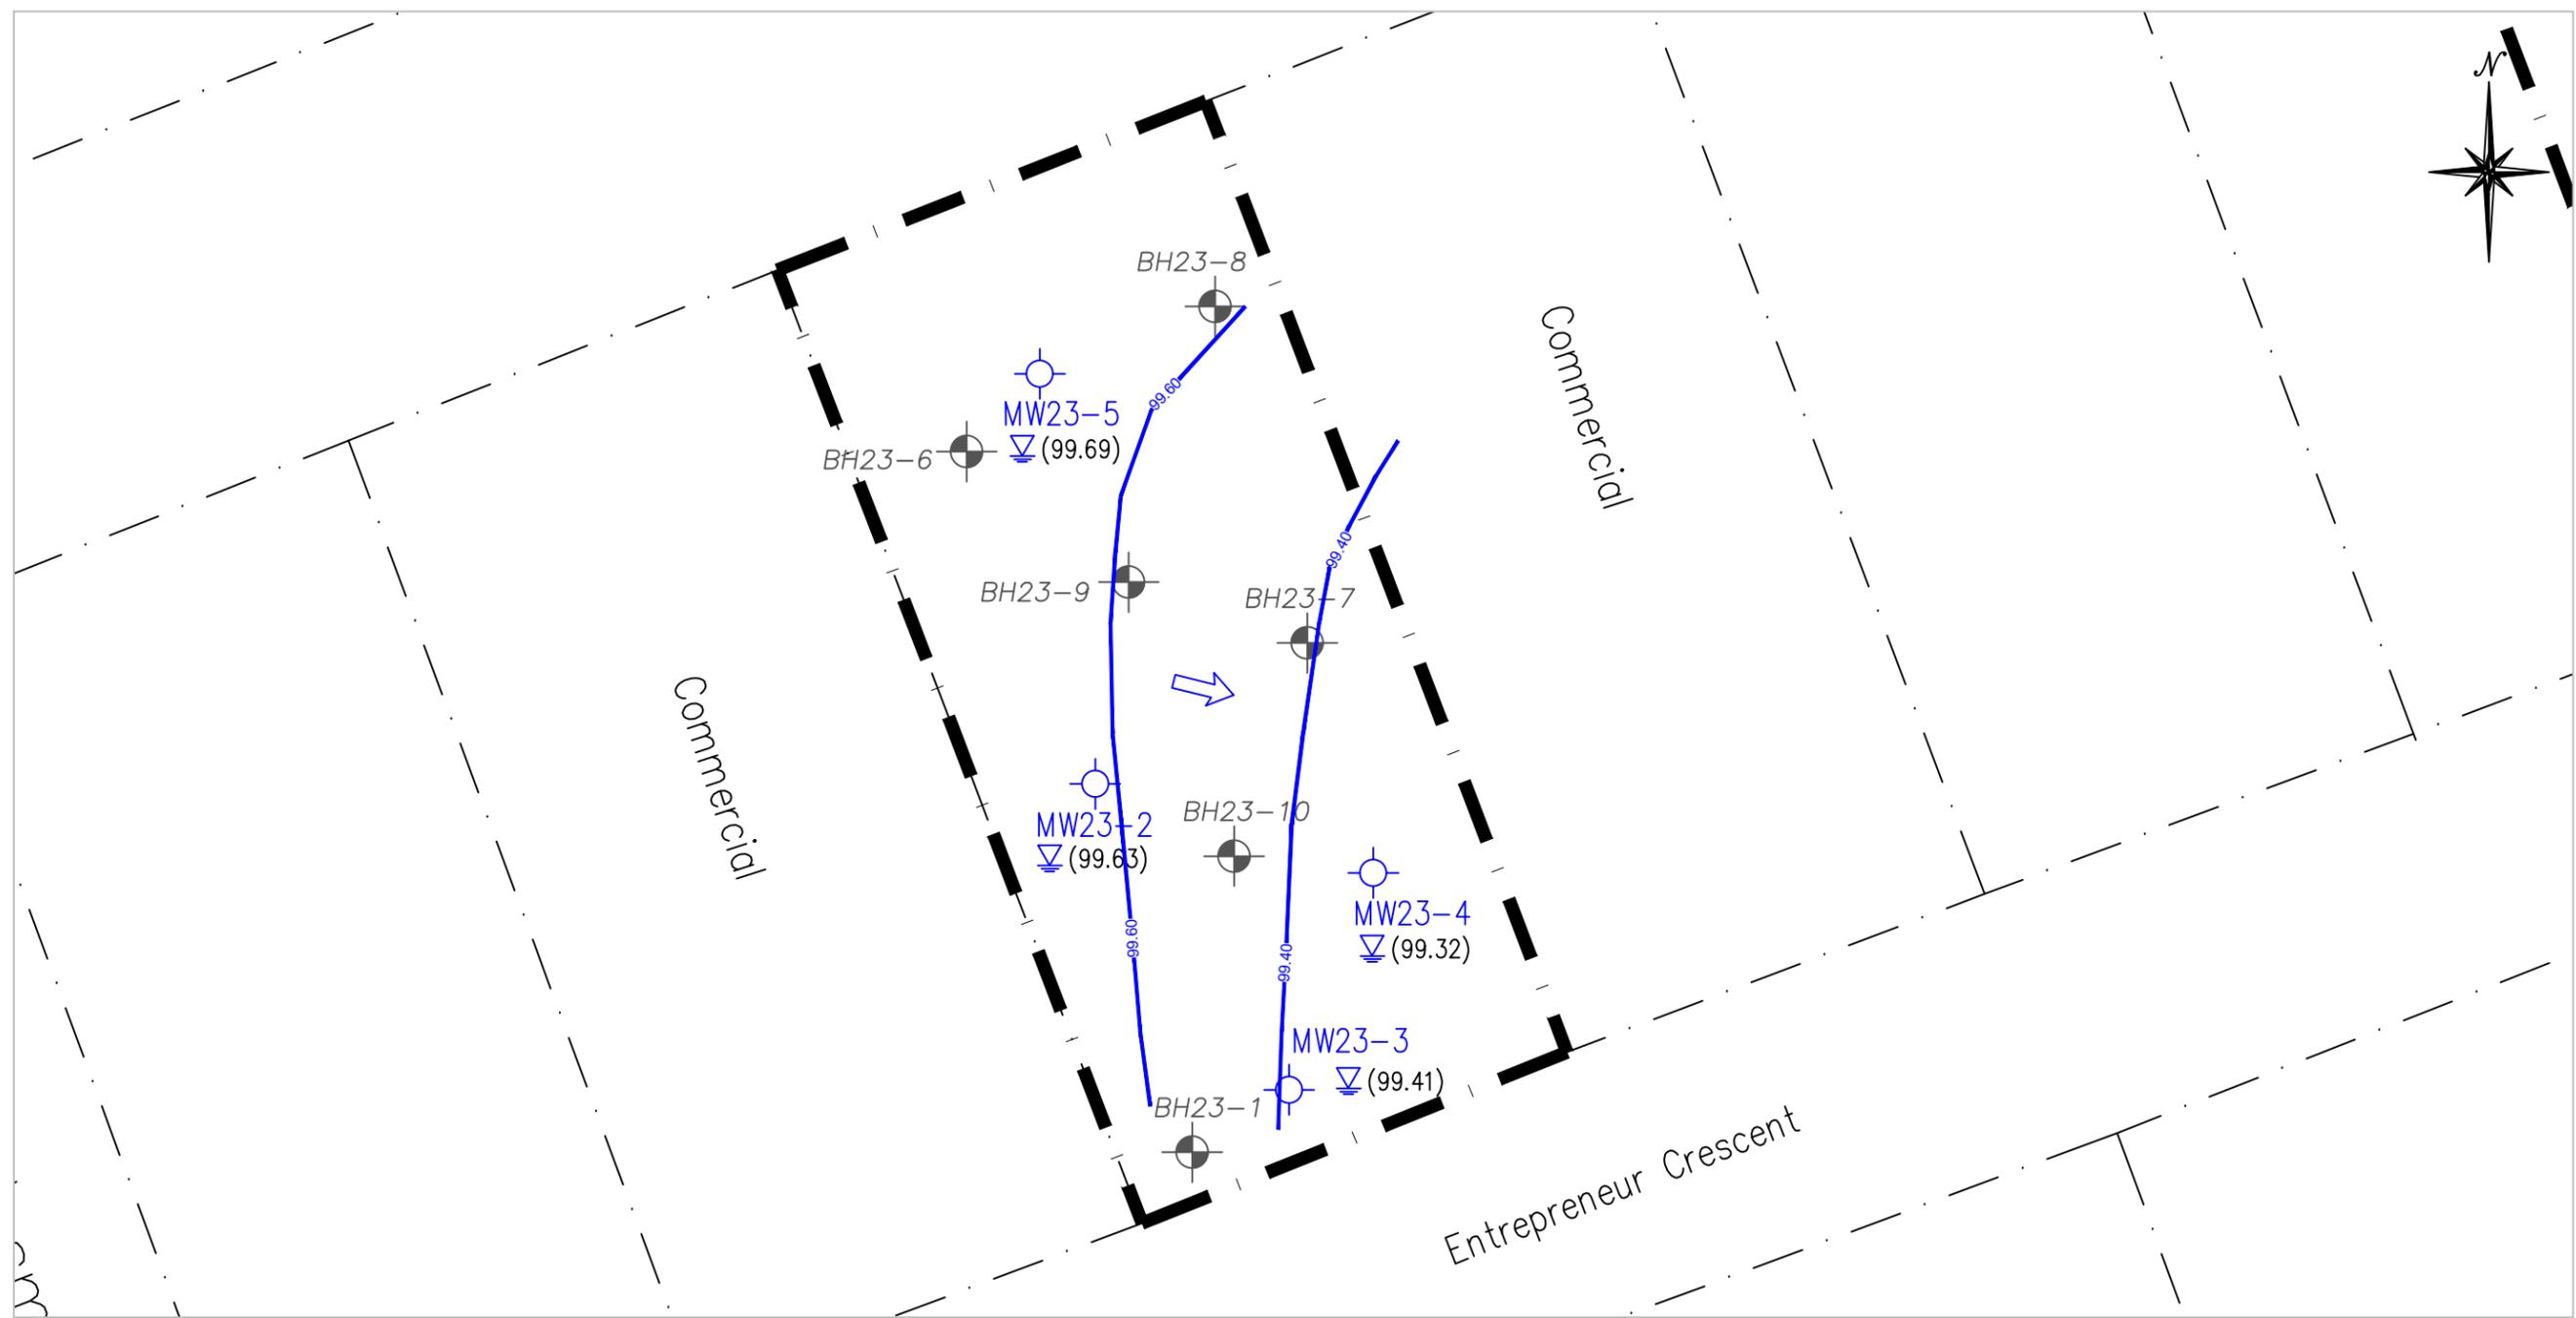
FIGURE5B

Property Line - Subject Site (363 Entrepreneur Crescent)		Neighbouring Property Boundaries
	Borehole		Groundwater Elevation
	Monitoring Well		Groundwater Elevation Contour
	Inferred Groundwater Flow Direction

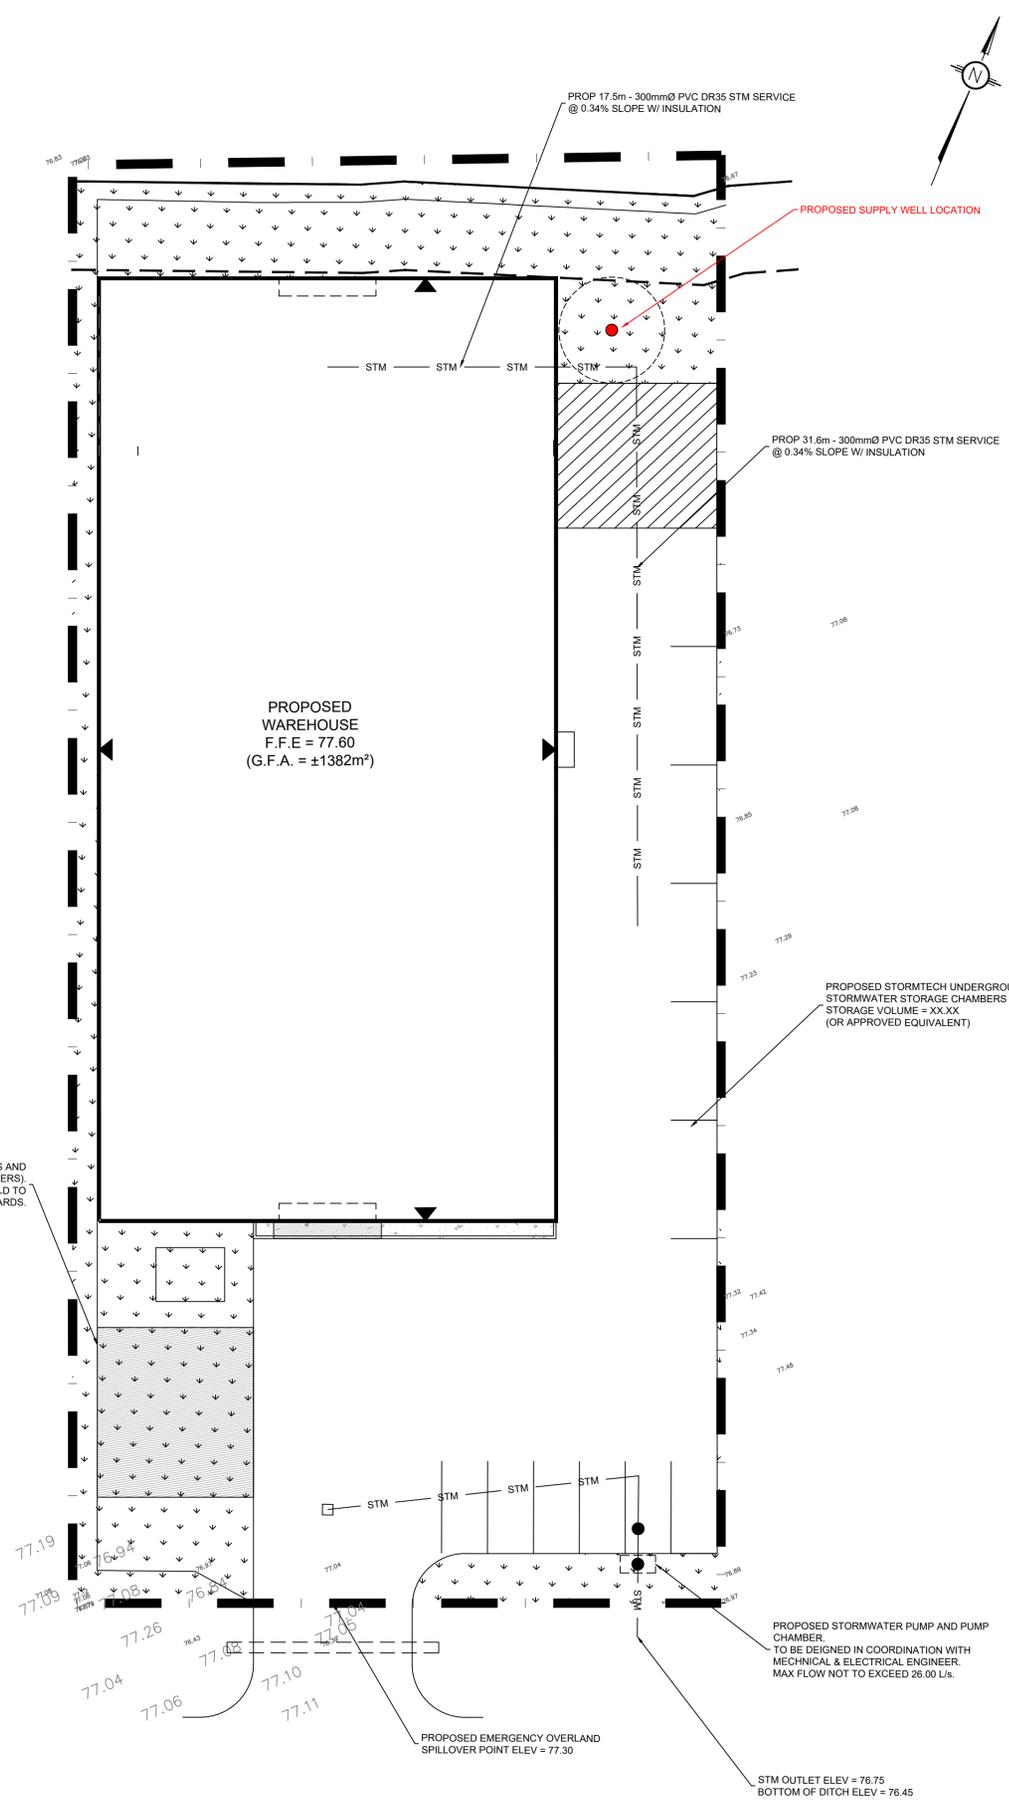
PROPOSED SEPTIC TANKS AND LEACHING FIELD (DESIGN BY OTHERS). SEPTIC TANKS AND LEACHING FIELD TO BE PROTECTED BY BOLLARDS.

PROPOSED STORMWATER PUMP AND PUMP CHAMBER TO BE DESIGNED IN COORDINATION WITH MECHANICAL & ELECTRICAL ENGINEER. MAX FLOW NOT TO EXCEED 26.00 L/s.

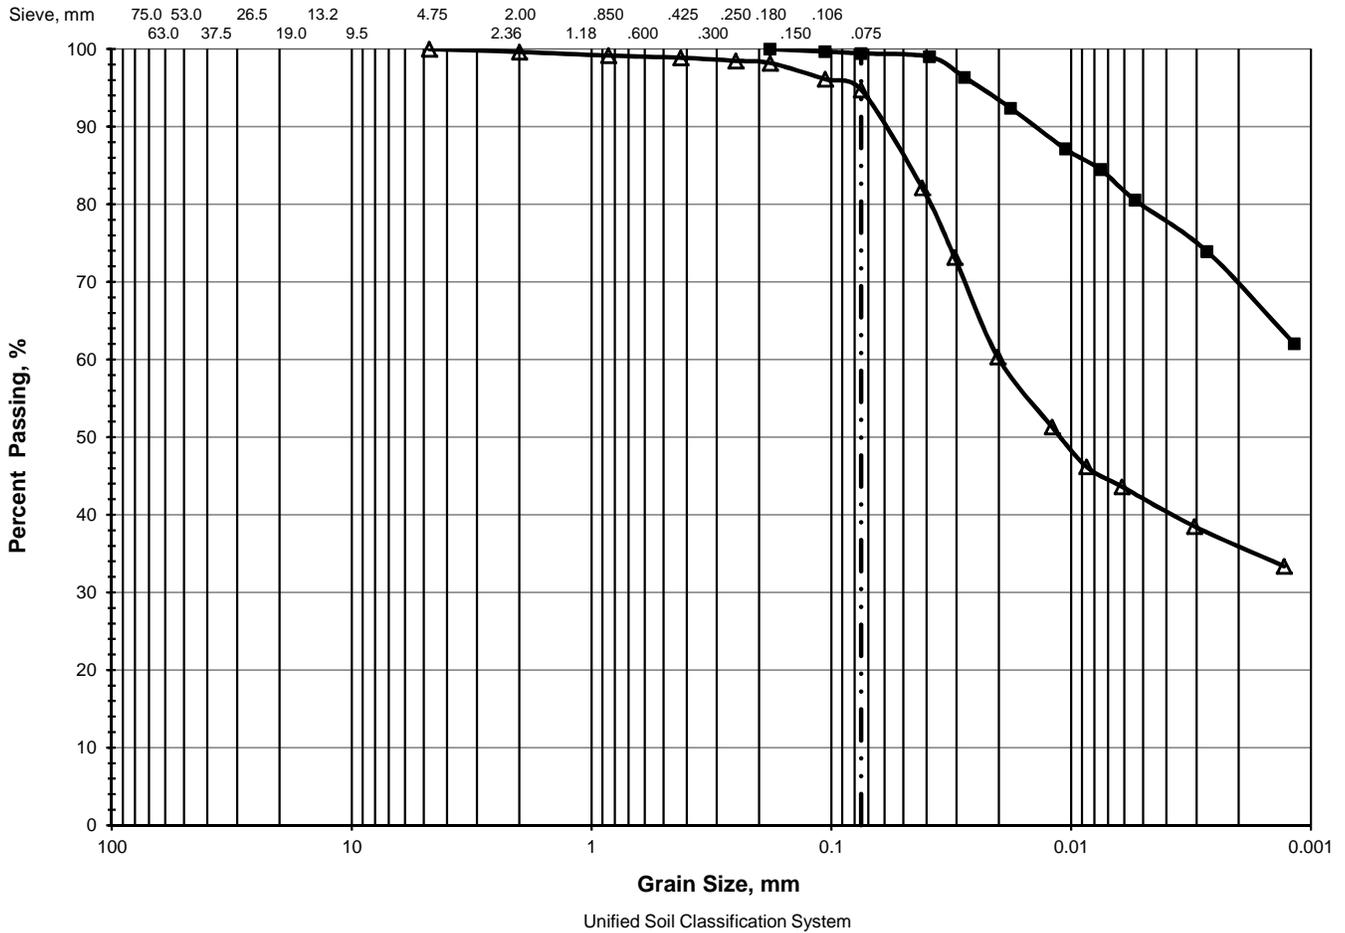
File No.: 220487
Report No.: 2
Date: November 17, 2022

> 75 mm	% GRAVEL		% SAND			% FINES	
	Coarse	Fine	Coarse	Medium	Fine	Silt	Clay
△	0.0	0.0	0.4	0.8	4.1	59.3	35.4
■	0.0	0.0	0.0	0.0	0.6	31.0	68.4

Location	Sample	Depth, m	D ₆₀	D ₅₀	D ₃₀	D ₁₅	D ₁₀	C _c	C _u
△	BH 1	1.52 - 2.13	0.0199	0.0111					
■	BH 2	6.10 - 6.71

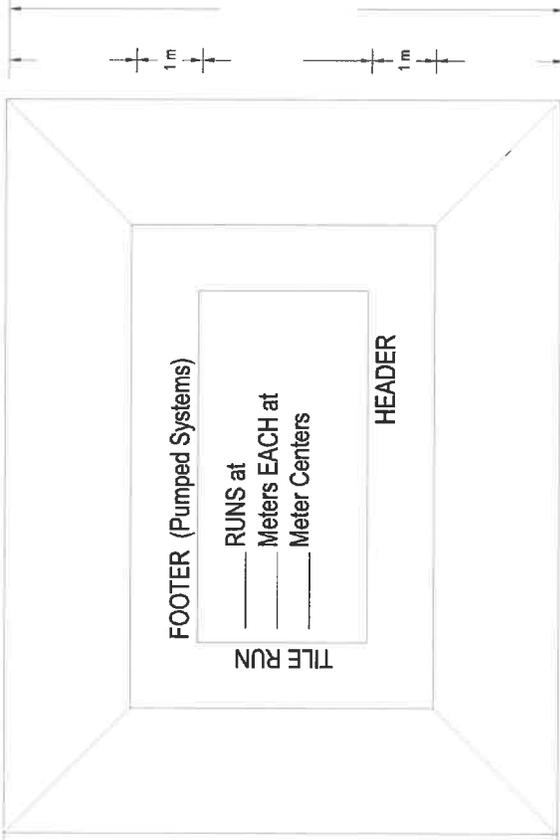
Ottawa Septic System Office Bureau des systèmes septiques d'Ottawa
TYPICAL DRAWING C
 BURIED OR RAISED BED - BMEC ELJEN System

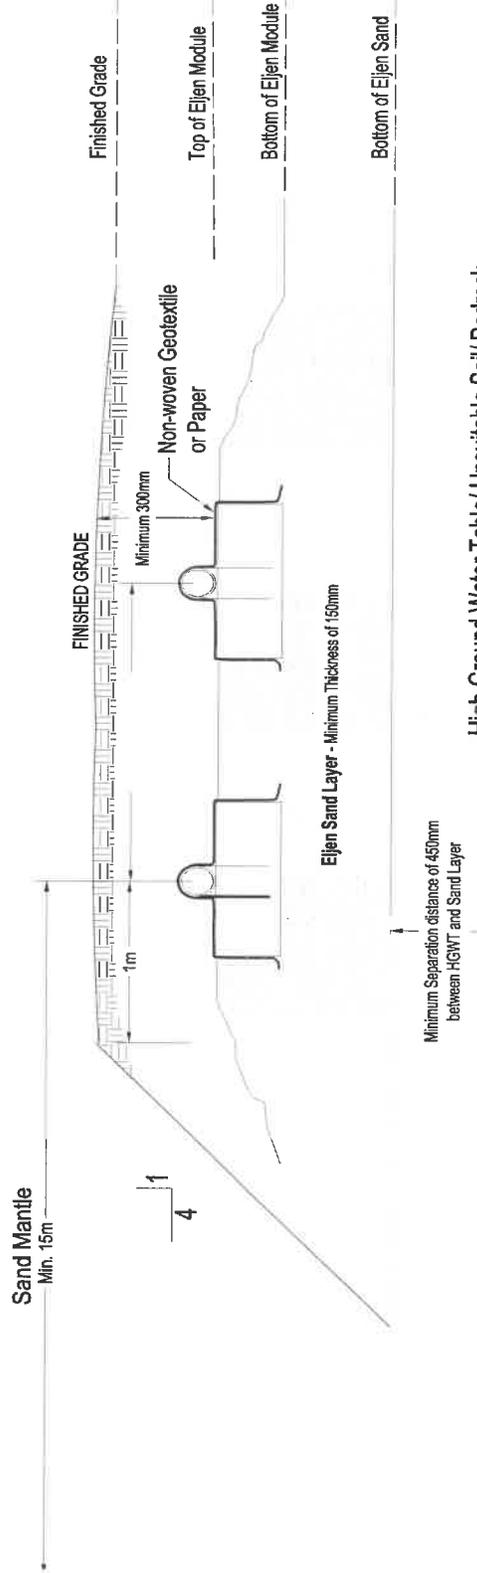
Cross-Section Profile

Proposed Installation Grades	Approved Installation Grades	Existing Grade

High Ground Water Table/ Unsuitable Soil/ Bedrock

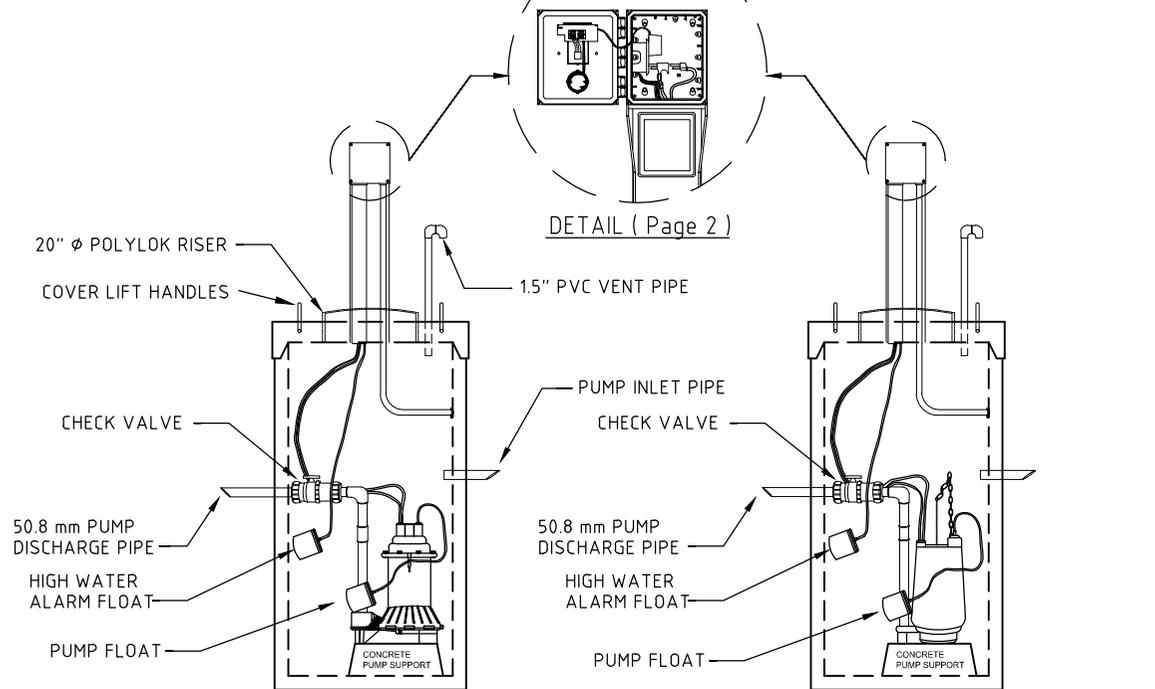
ALARMS, ELECTRICAL BOXES AND CHECK VALVES MAY DIFFERS FROM ONE PUMP STATION SYSTEMS TO ANOTHER. SIMPLEX AND DUPLEX TIME DOSING CONTROL PANEL AVAILABLE.

SRM 4 0.40 HP PUMP SYSTEM

MRG 20 2.0 HP GRINDER PUMP SYSTEM

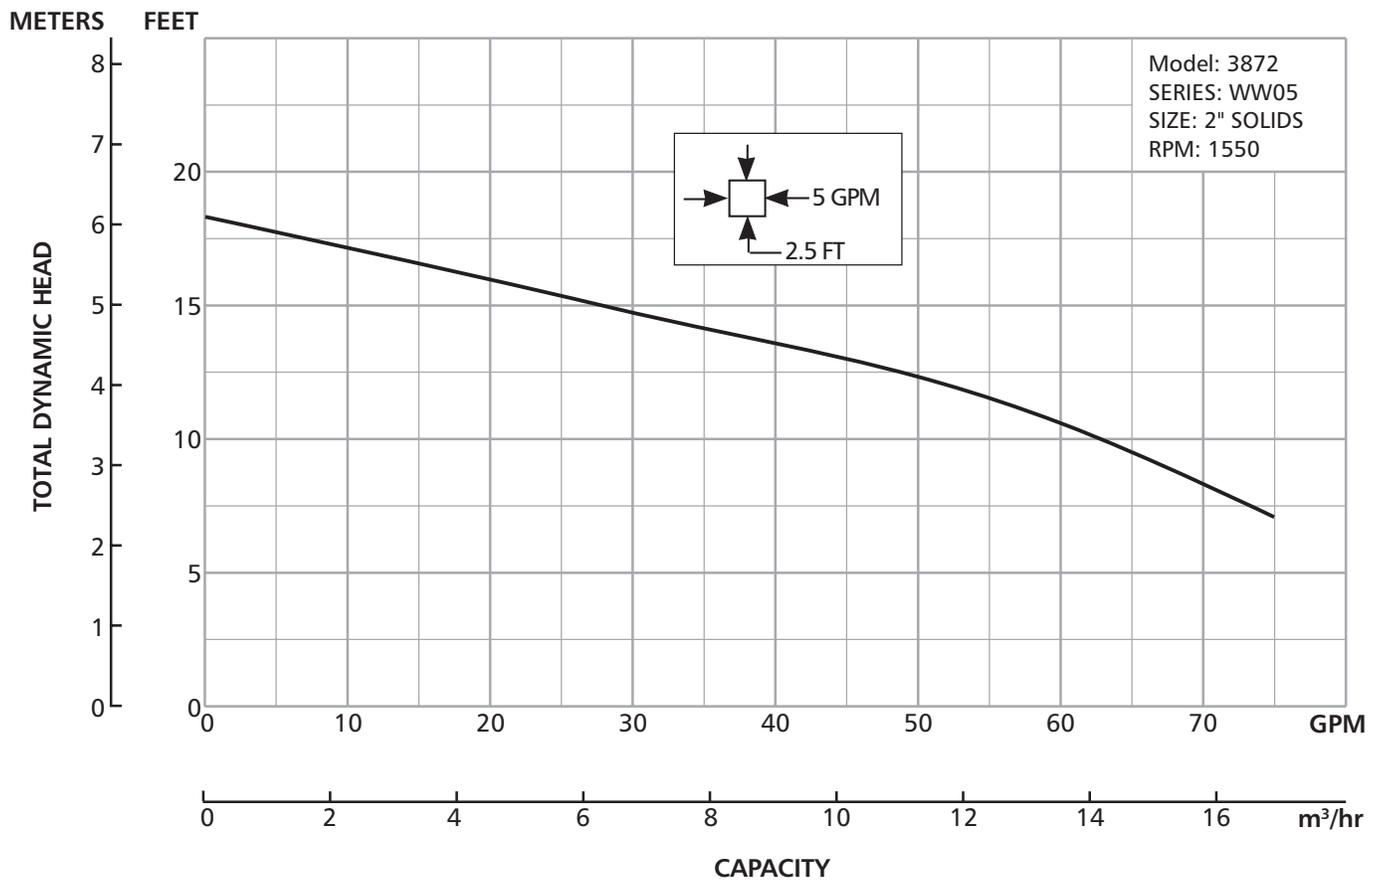
PERFORMANCE CHARTS

Order No.	HP	Volts	Amps	Minimum Circuit Breaker	Phase	Float Switch Style	Cord Length	Discharge Connection	Minimum On Level	Minimum Off Level	Minimum Basin Diameter	Maximum Solids Size	Shipping Weight lbs/kg
WW0511	.5	115	13	20	1	Plug / No Switch	10'	2"	Manual	Manual	18"	2"	22 / 10
WW0511A						Piggyback / Wide-Angle	10'	2"	15"	9"	18"		23 / 10.4
WW0511F						Plug / No Switch	20'	2"	Manual	Manual	18"		22 / 10
WW0511AC						Piggyback / Wide-Angle	20'	2"	15"	9"	18"		23 / 10.4
WW0512		230	6.5	10		Plug / No Switch	10'	2"	Manual	Manual	18"		22 / 10
WW0512F						Plug / No Switch	20'	2"	Manual	Manual	18"		22 / 10

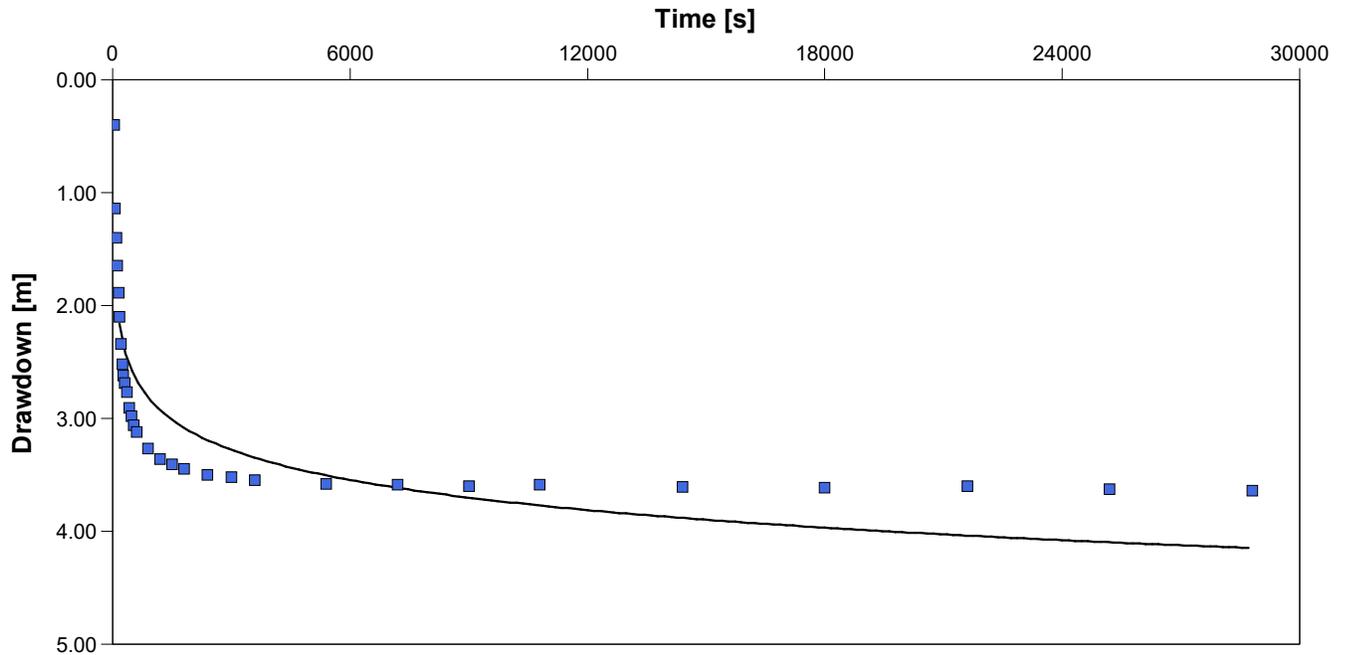
Location: 363 Entrepreneur Cresnet	Pumping Test: Pumping Test 1	Pumping Well: Well 1
Test Conducted by: LRL Engineering		Test Date: 2023-08-30
Analysis Performed by: LRL Engineering	Draw Down - August 30 2023	Analysis Date: 2023-09-07
Aquifer Thickness:	Discharge Rate: 0.022 [m ³ /min]

Calculation using Theis
