Phase II Environmental Site Assessment

2506 Innes Road
Ottawa, Ontario

Prepared for Concorde Properties

Report: PE6214-3
September 24, 2024

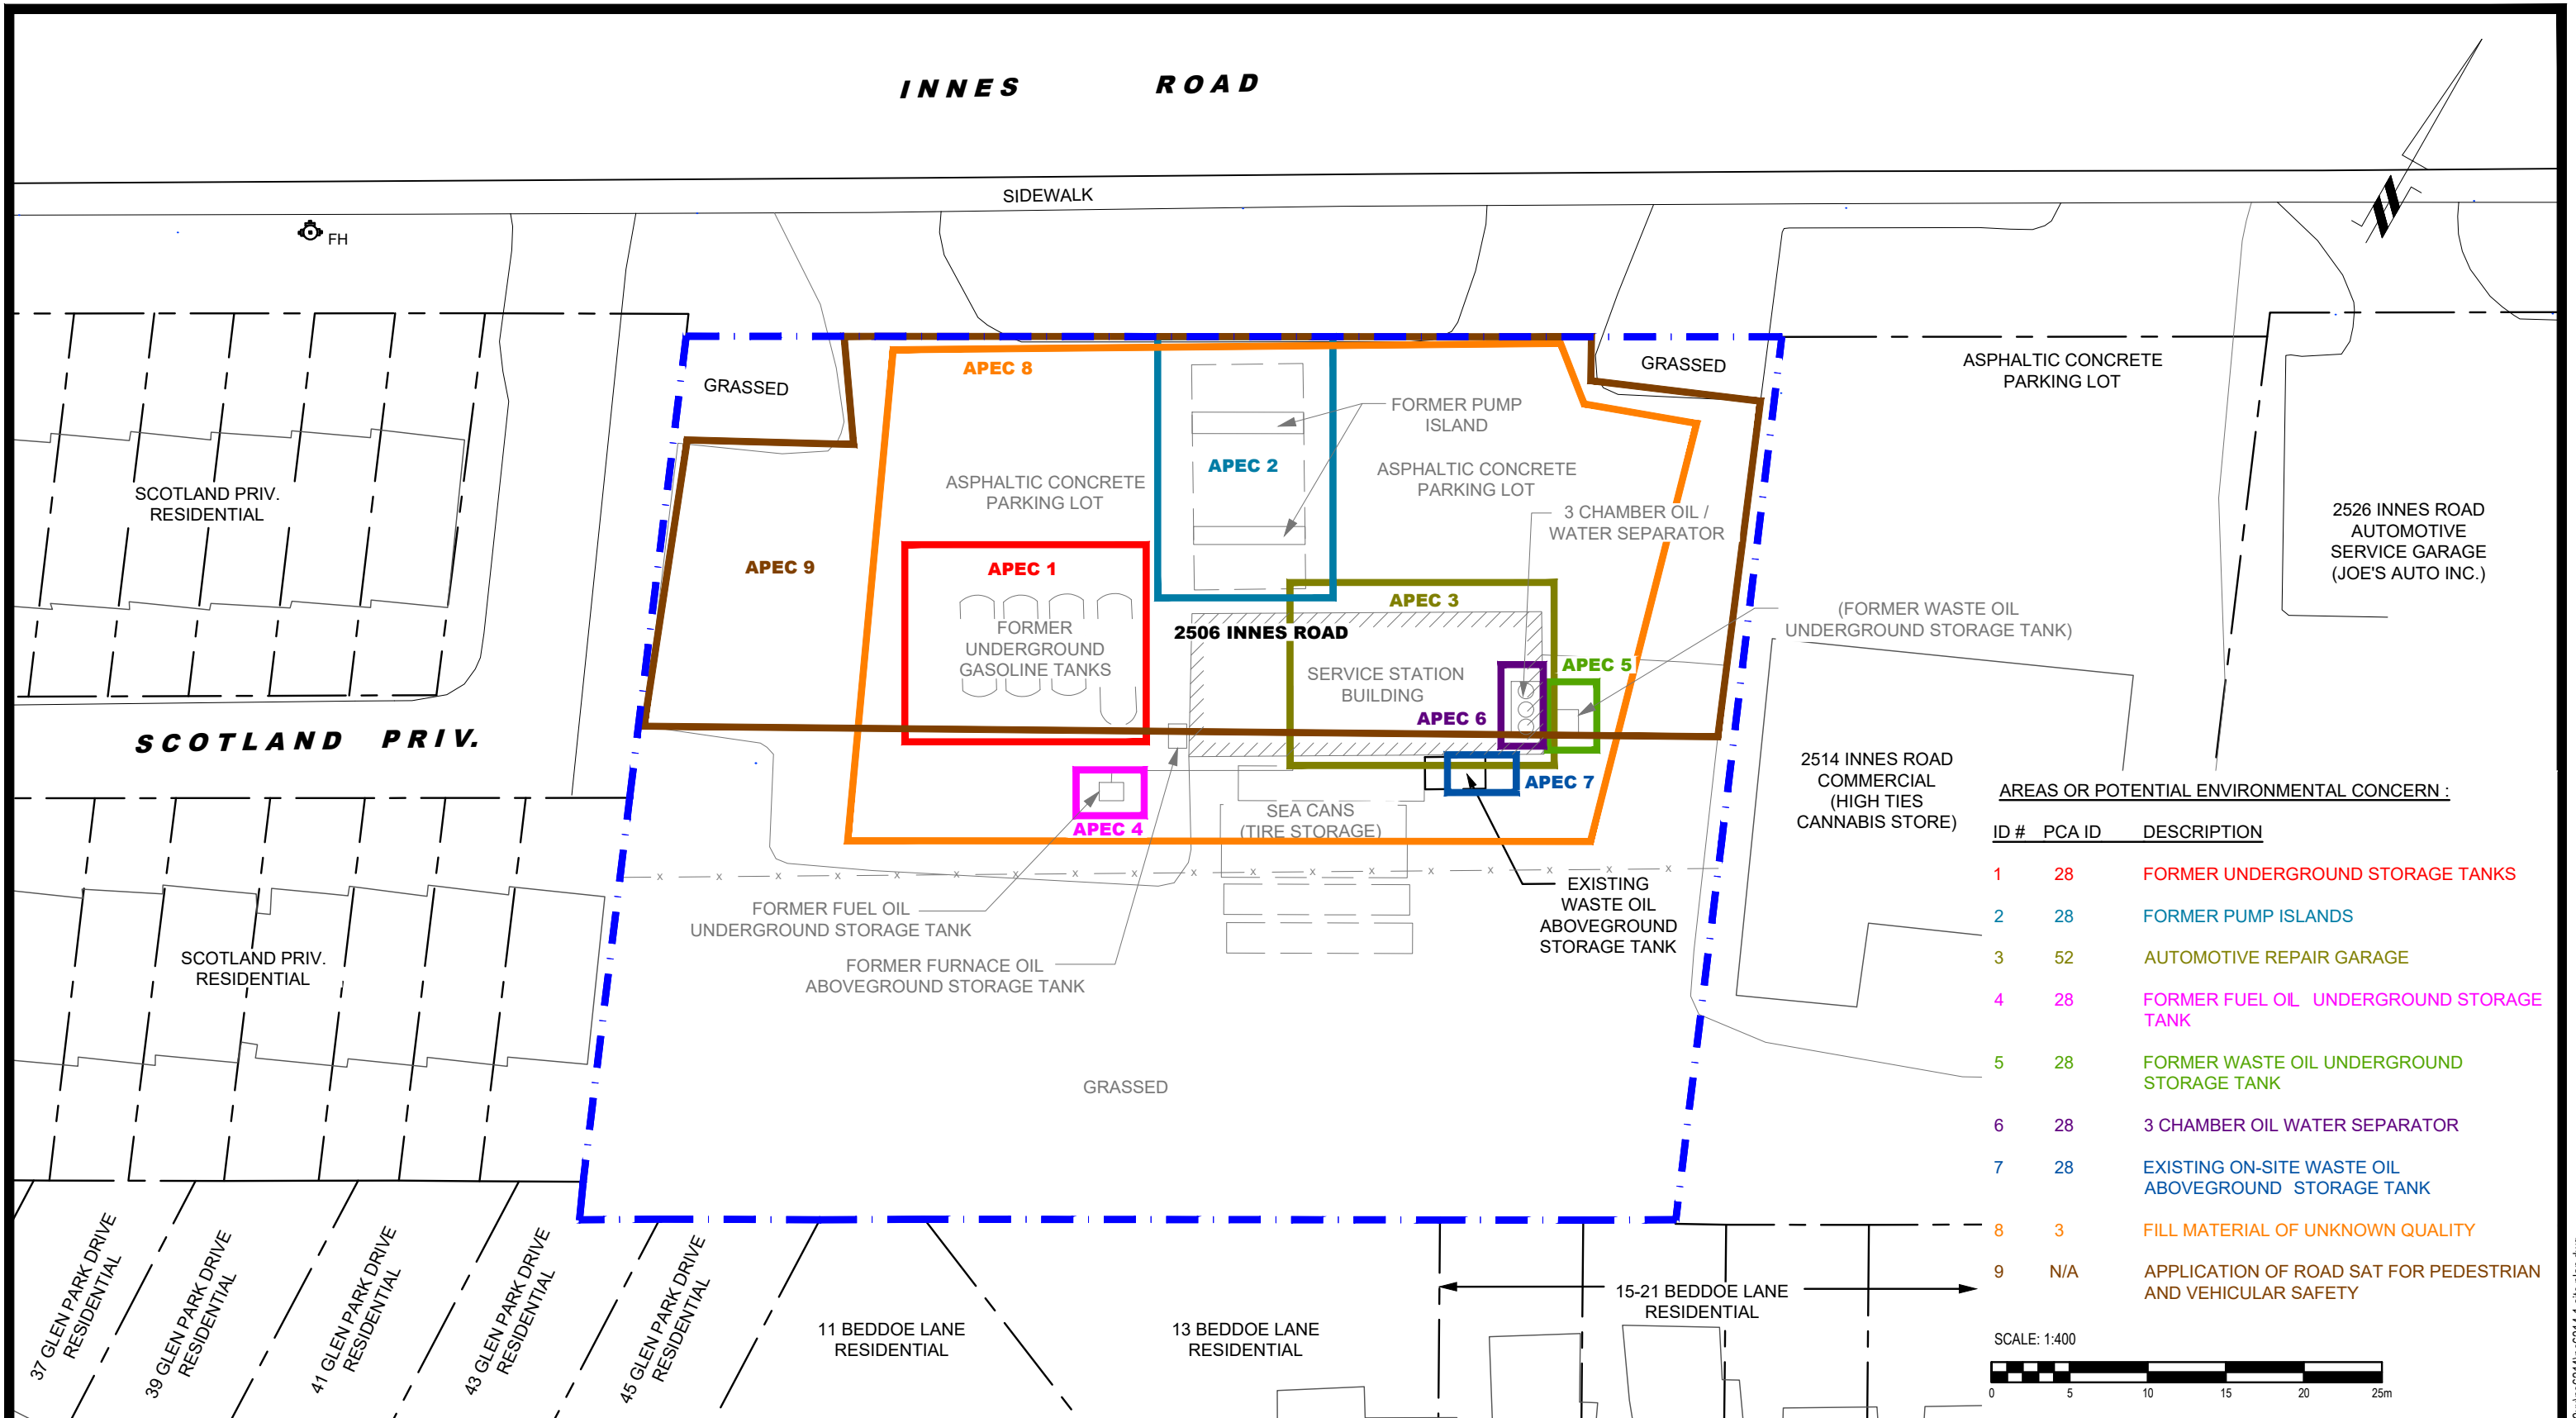
SITE PLAN

AREAS OR POTENTIAL ENVIRONMENTAL CONCERN :

ID #	PCA ID	DESCRIPTION
1	28	FORMER UNDERGROUND STORAGE TANKS
2	28	FORMER PUMP ISLANDS
3	52	AUTOMOTIVE REPAIR GARAGE
4	28	FORMER FUEL OIL UNDERGROUND STORAGE TANK
5	28	FORMER WASTE OIL UNDERGROUND STORAGE TANK
6	28	3 CHAMBER OIL WATER SEPARATOR
7	28	EXISTING ON-SITE WASTE OIL ABOVEGROUND STORAGE TANK
8	3	FILL MATERIAL OF UNKNOWN QUALITY
9	N/A	APPLICATION OF ROAD SAT FOR PEDESTRIAN AND VEHICULAR SAFETY

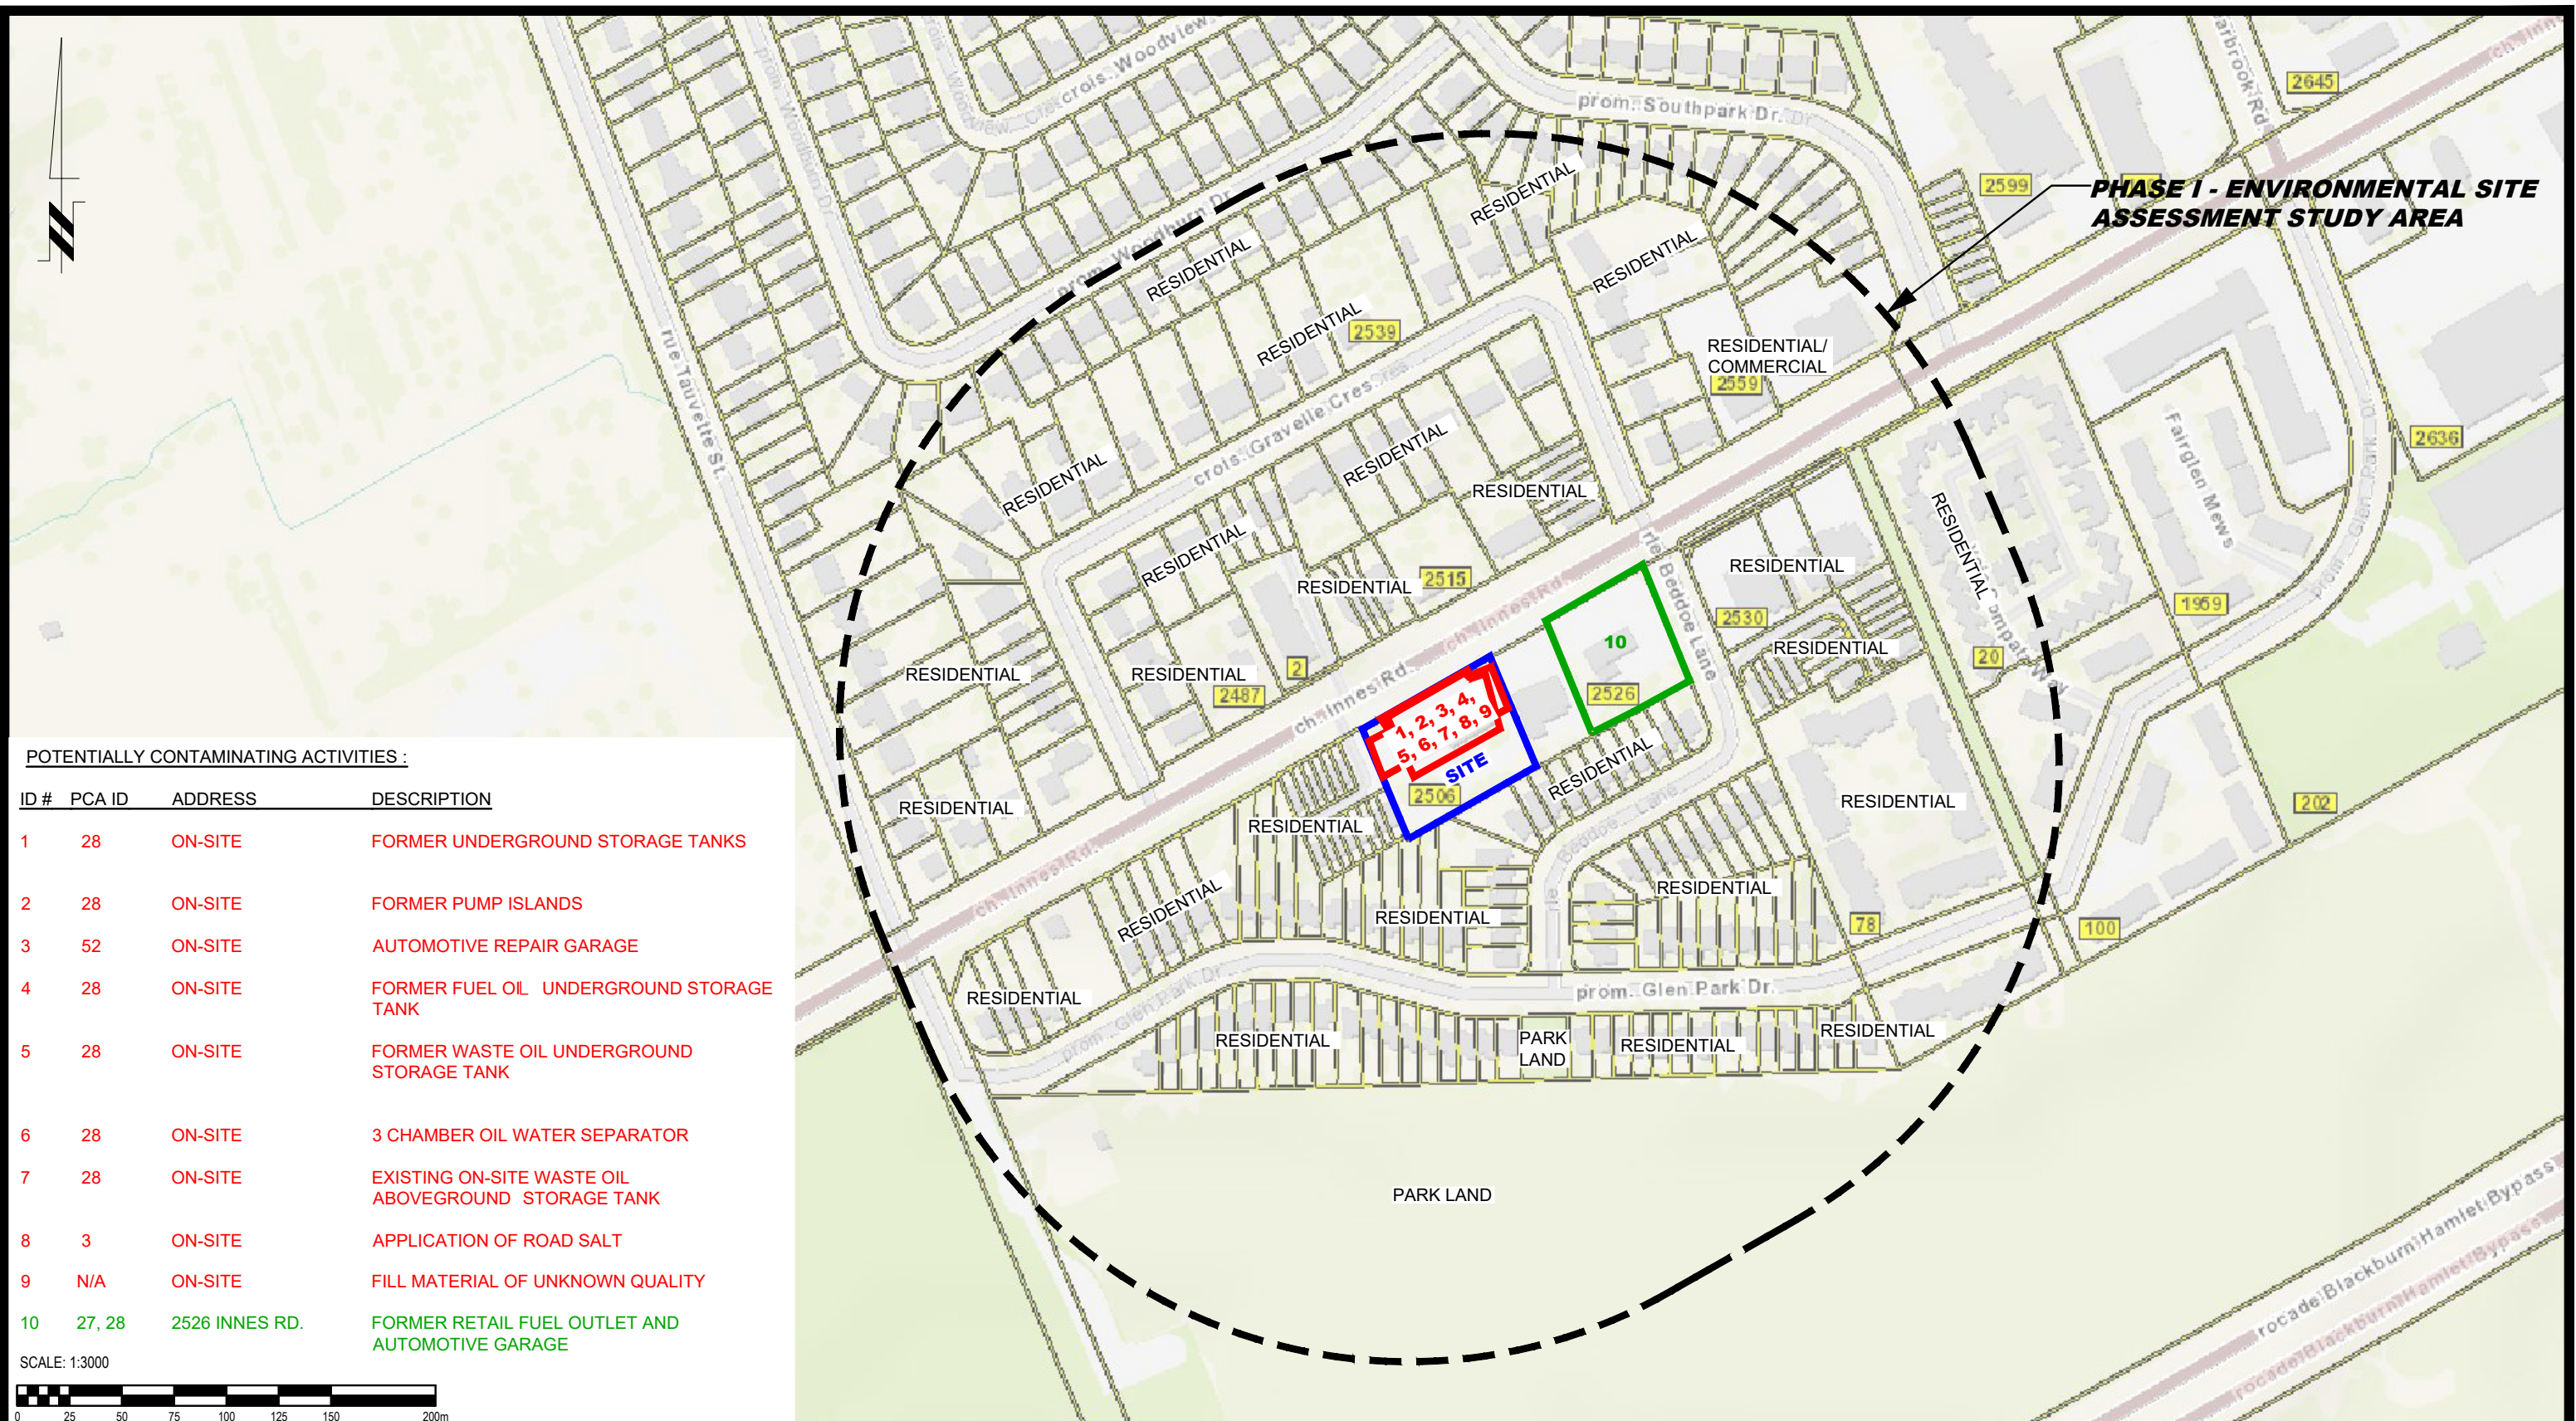
PHASE I - ENVIRONMENTAL SITE ASSESSMENT STUDY AREA

POTENTIALLY CONTAMINATING ACTIVITIES :

ID #	PCA ID	ADDRESS	DESCRIPTION
1	28	ON-SITE	FORMER UNDERGROUND STORAGE TANKS
2	28	ON-SITE	FORMER PUMP ISLANDS
3	52	ON-SITE	AUTOMOTIVE REPAIR GARAGE
4	28	ON-SITE	FORMER FUEL OIL UNDERGROUND STORAGE TANK
5	28	ON-SITE	FORMER WASTE OIL UNDERGROUND STORAGE TANK
6	28	ON-SITE	3 CHAMBER OIL WATER SEPARATOR
7	28	ON-SITE	EXISTING ON-SITE WASTE OIL ABOVEGROUND STORAGE TANK
8	3	ON-SITE	APPLICATION OF ROAD SALT
9	N/A	ON-SITE	FILL MATERIAL OF UNKNOWN QUALITY
10	27, 28	2526 INNES RD.	FORMER RETAIL FUEL OUTLET AND AUTOMOTIVE GARAGE

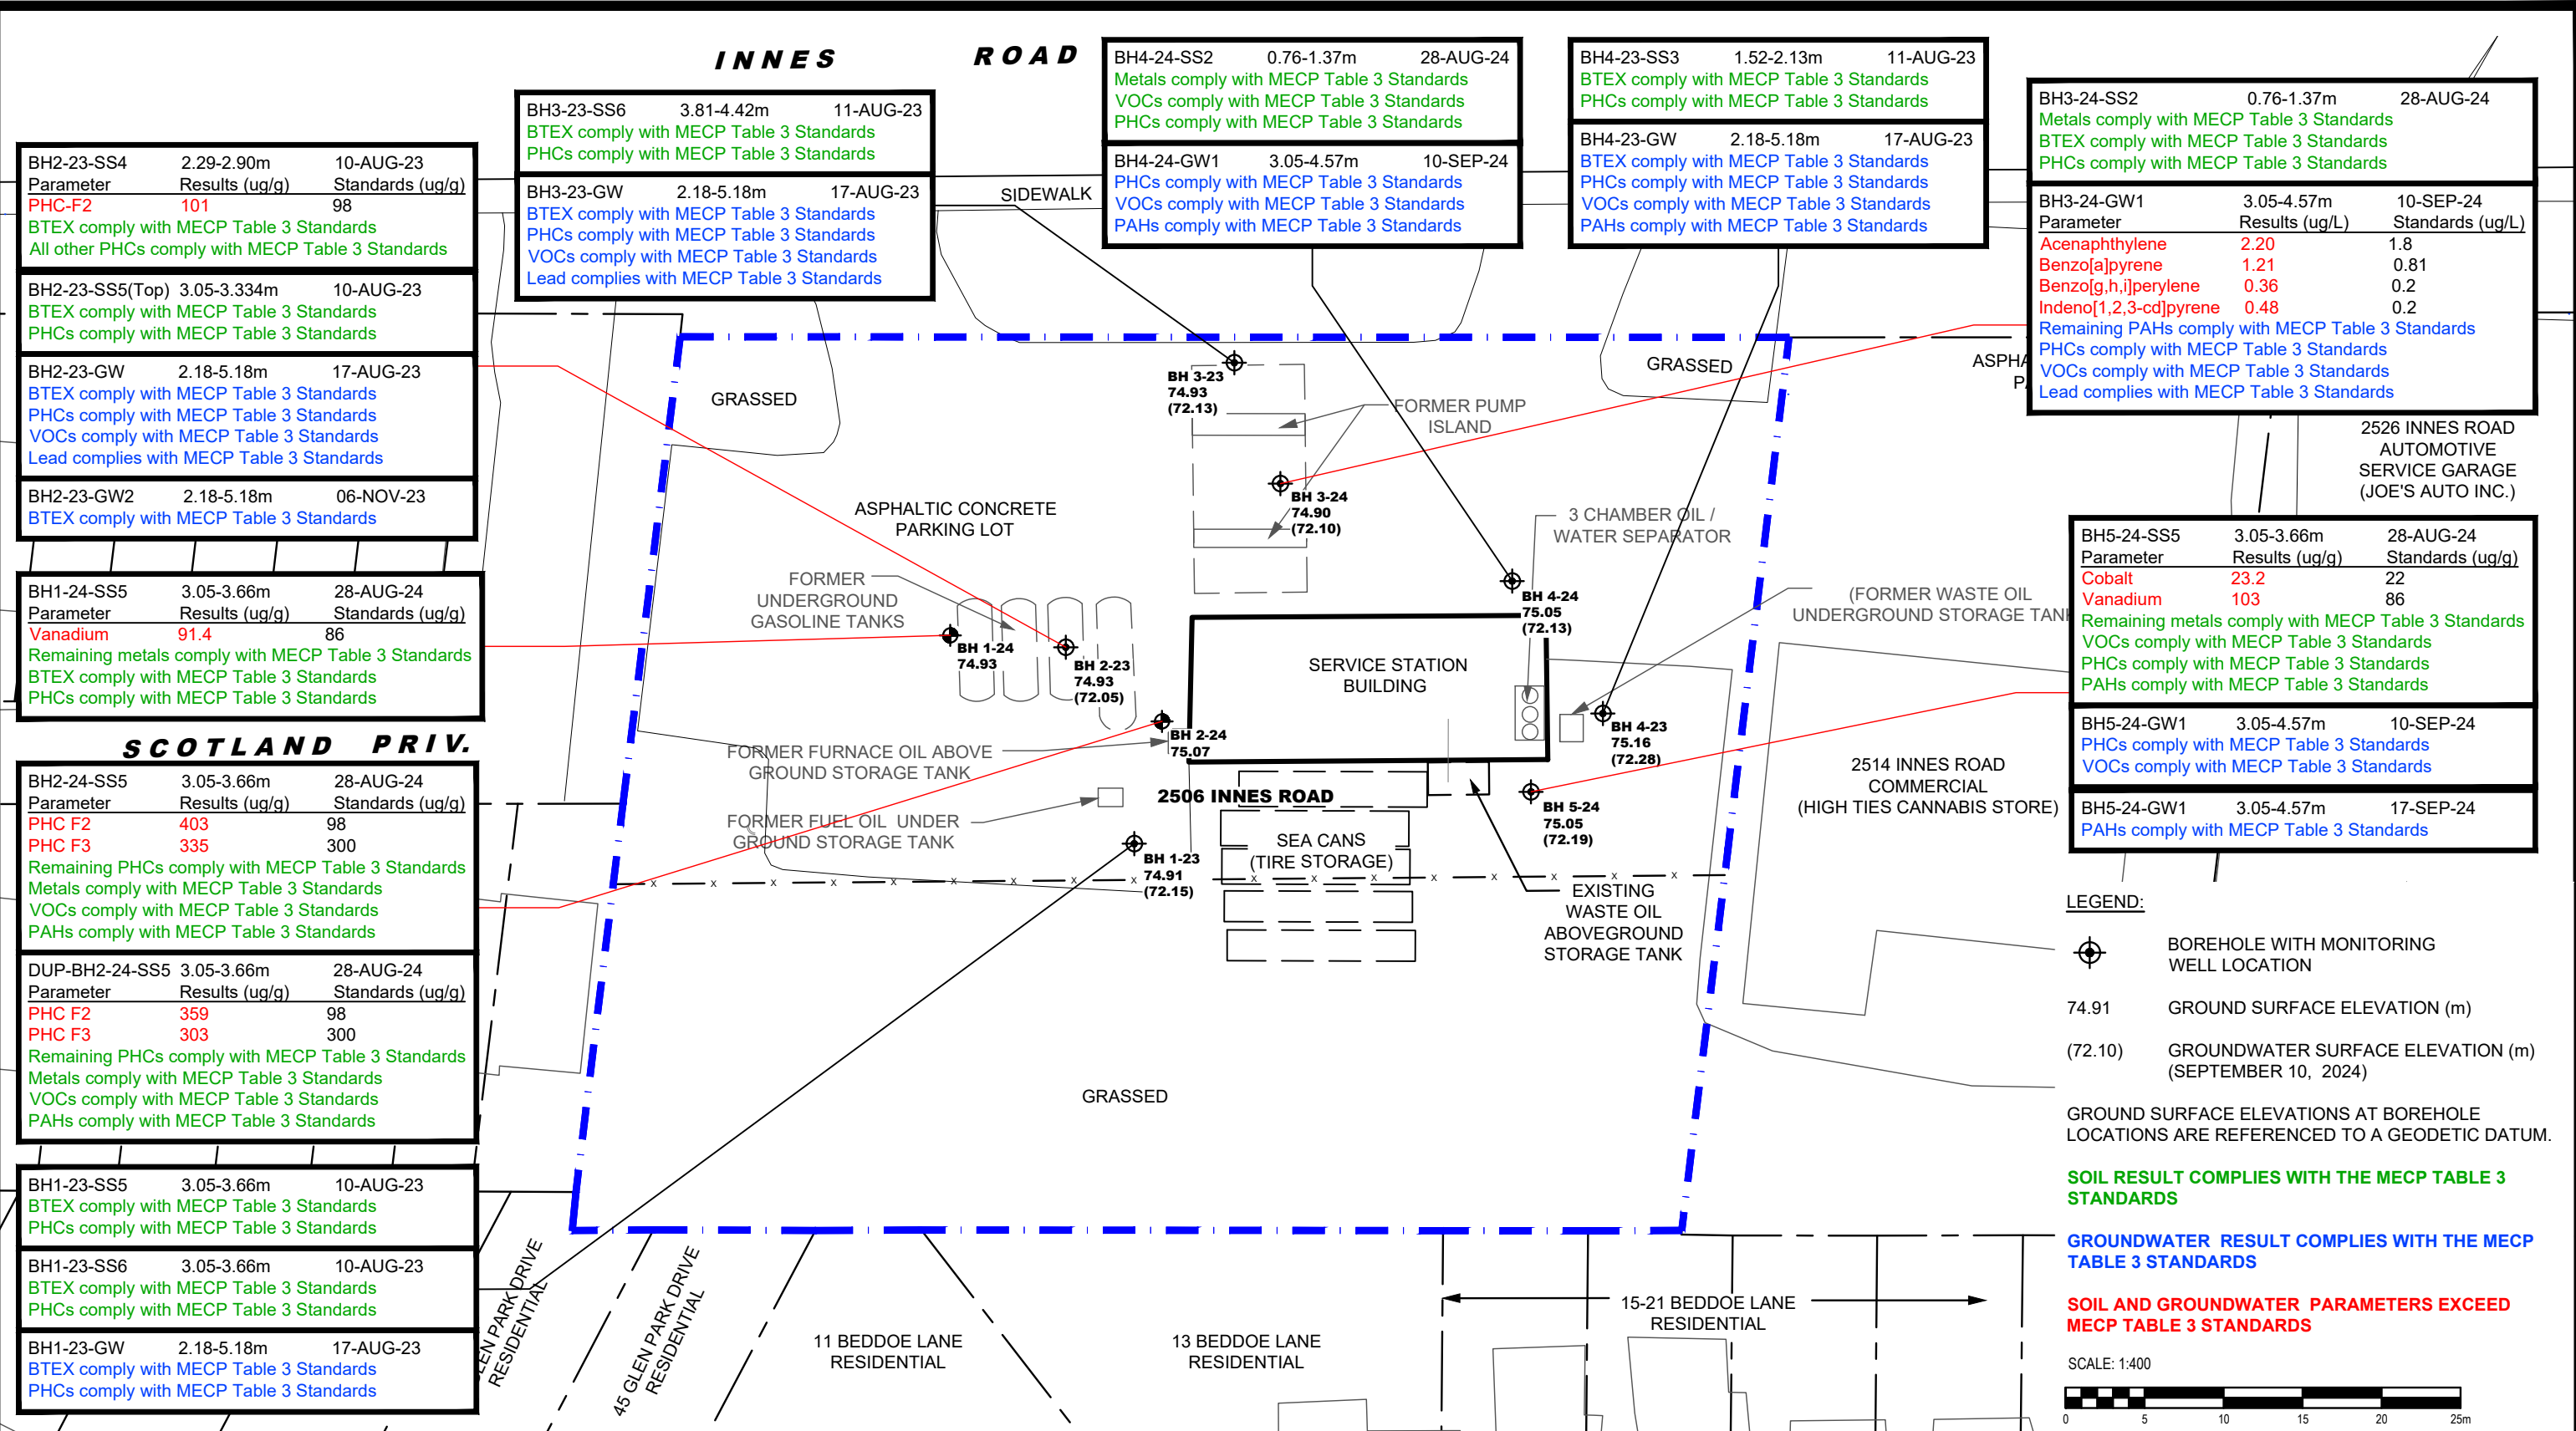
BH2-23-SS4	2.29-2.90m	10-AUG-23
Parameter	Results (ug/g)	Standards (ug/g)
PHC-F2	101	98
BTEX comply with MECP Table 3 Standards		
All other PHCs comply with MECP Table 3 Standards

BH2-23-SS5(Top)	3.05-3.334m	10-AUG-23
BTEX comply with MECP Table 3 Standards		
PHCs comply with MECP Table 3 Standards

SOIL AND GROUNDWATER PARAMETERS EXCEED MECP TABLE 3 STANDARDS

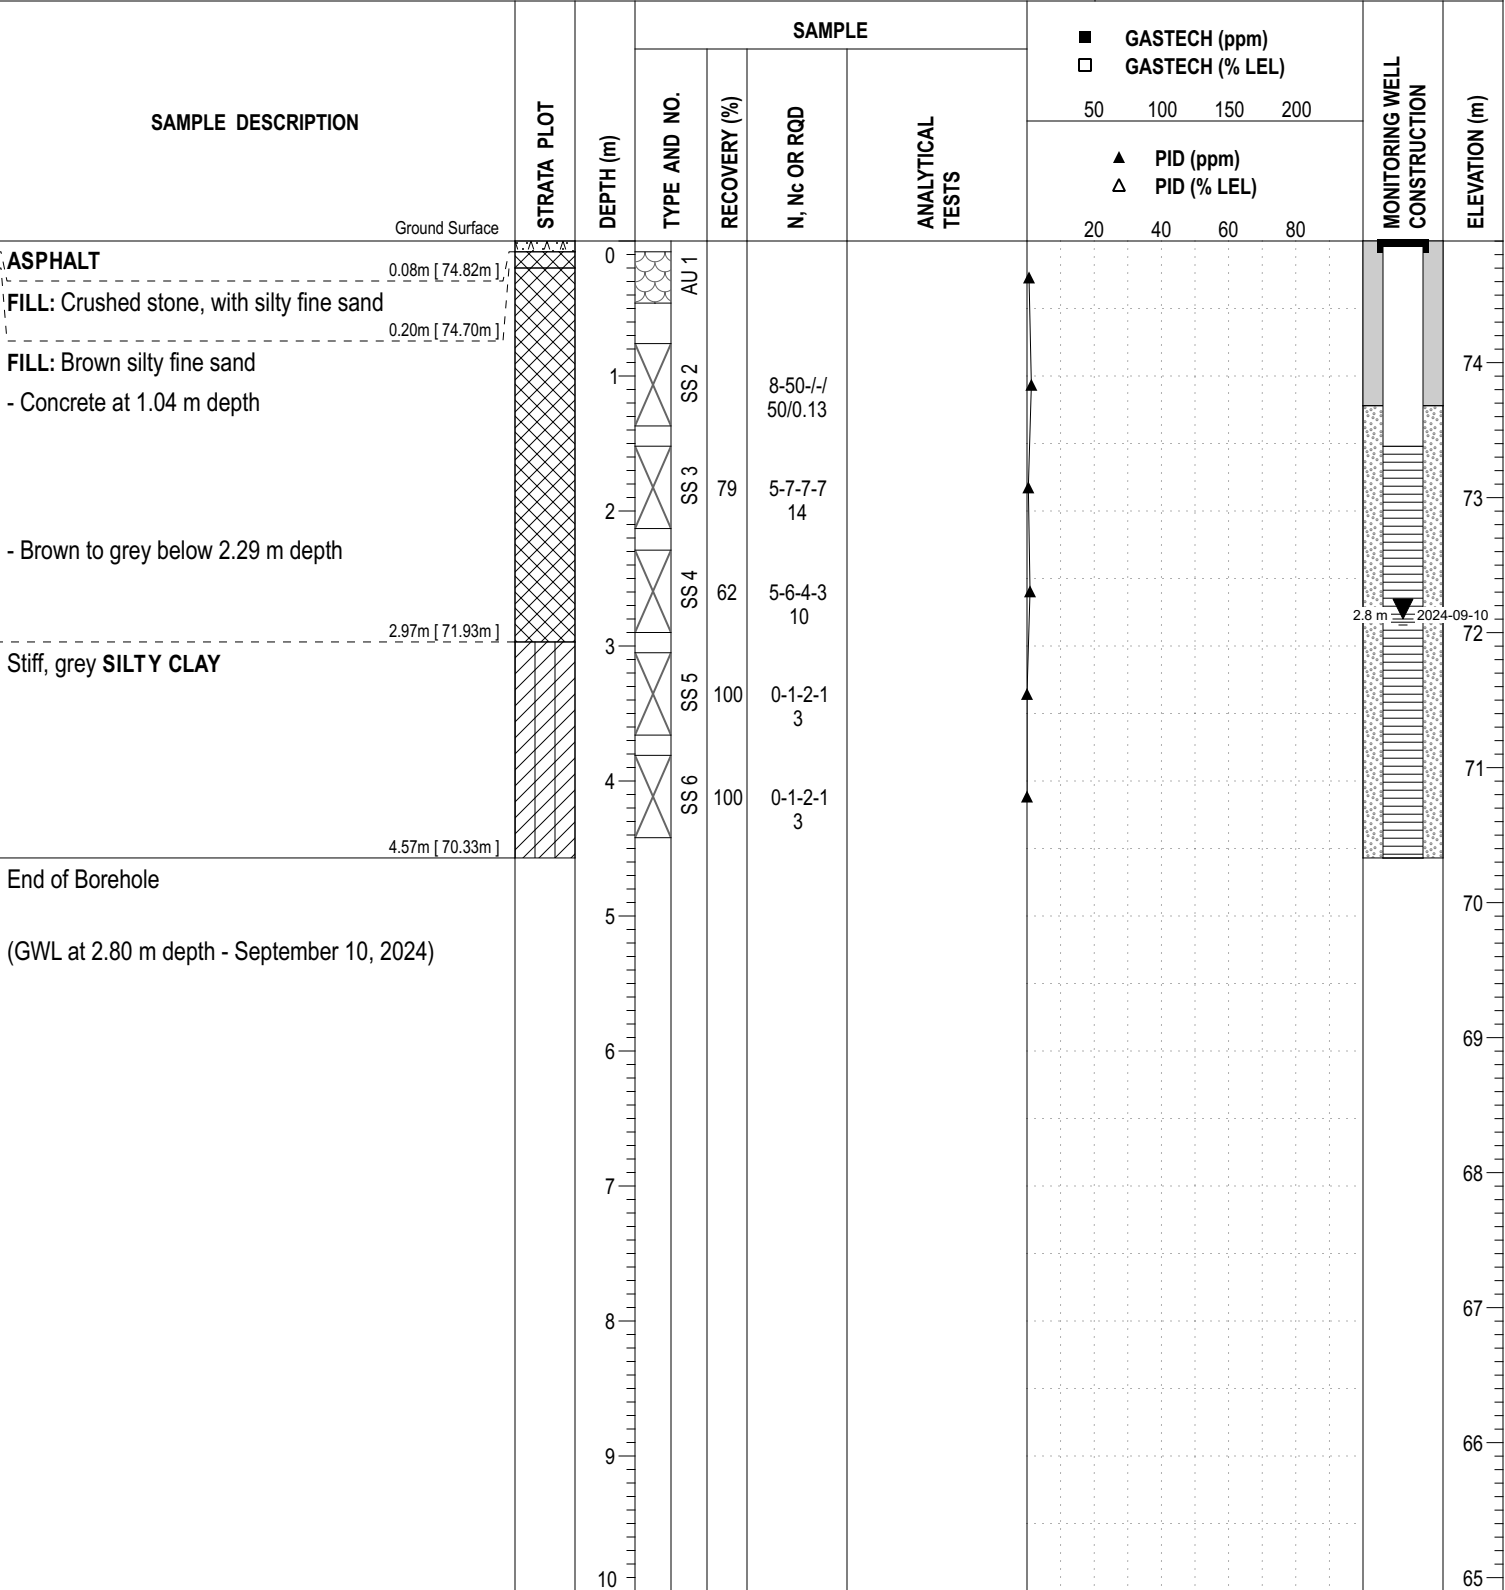
REMARKS: **DATE:** August 28, 2024 **HOLE NO. :** BH 3-24

BORINGS BY: CME-55 Low Clearance Drill

It is our recommendation that BH3-24 be retested in the future, to confirm the compliance of acenaphthylene, benzo[a]pyrene, benzo[g,h,i]perylene and indeno[1,2,3-cd]pyrene within the groundwater.

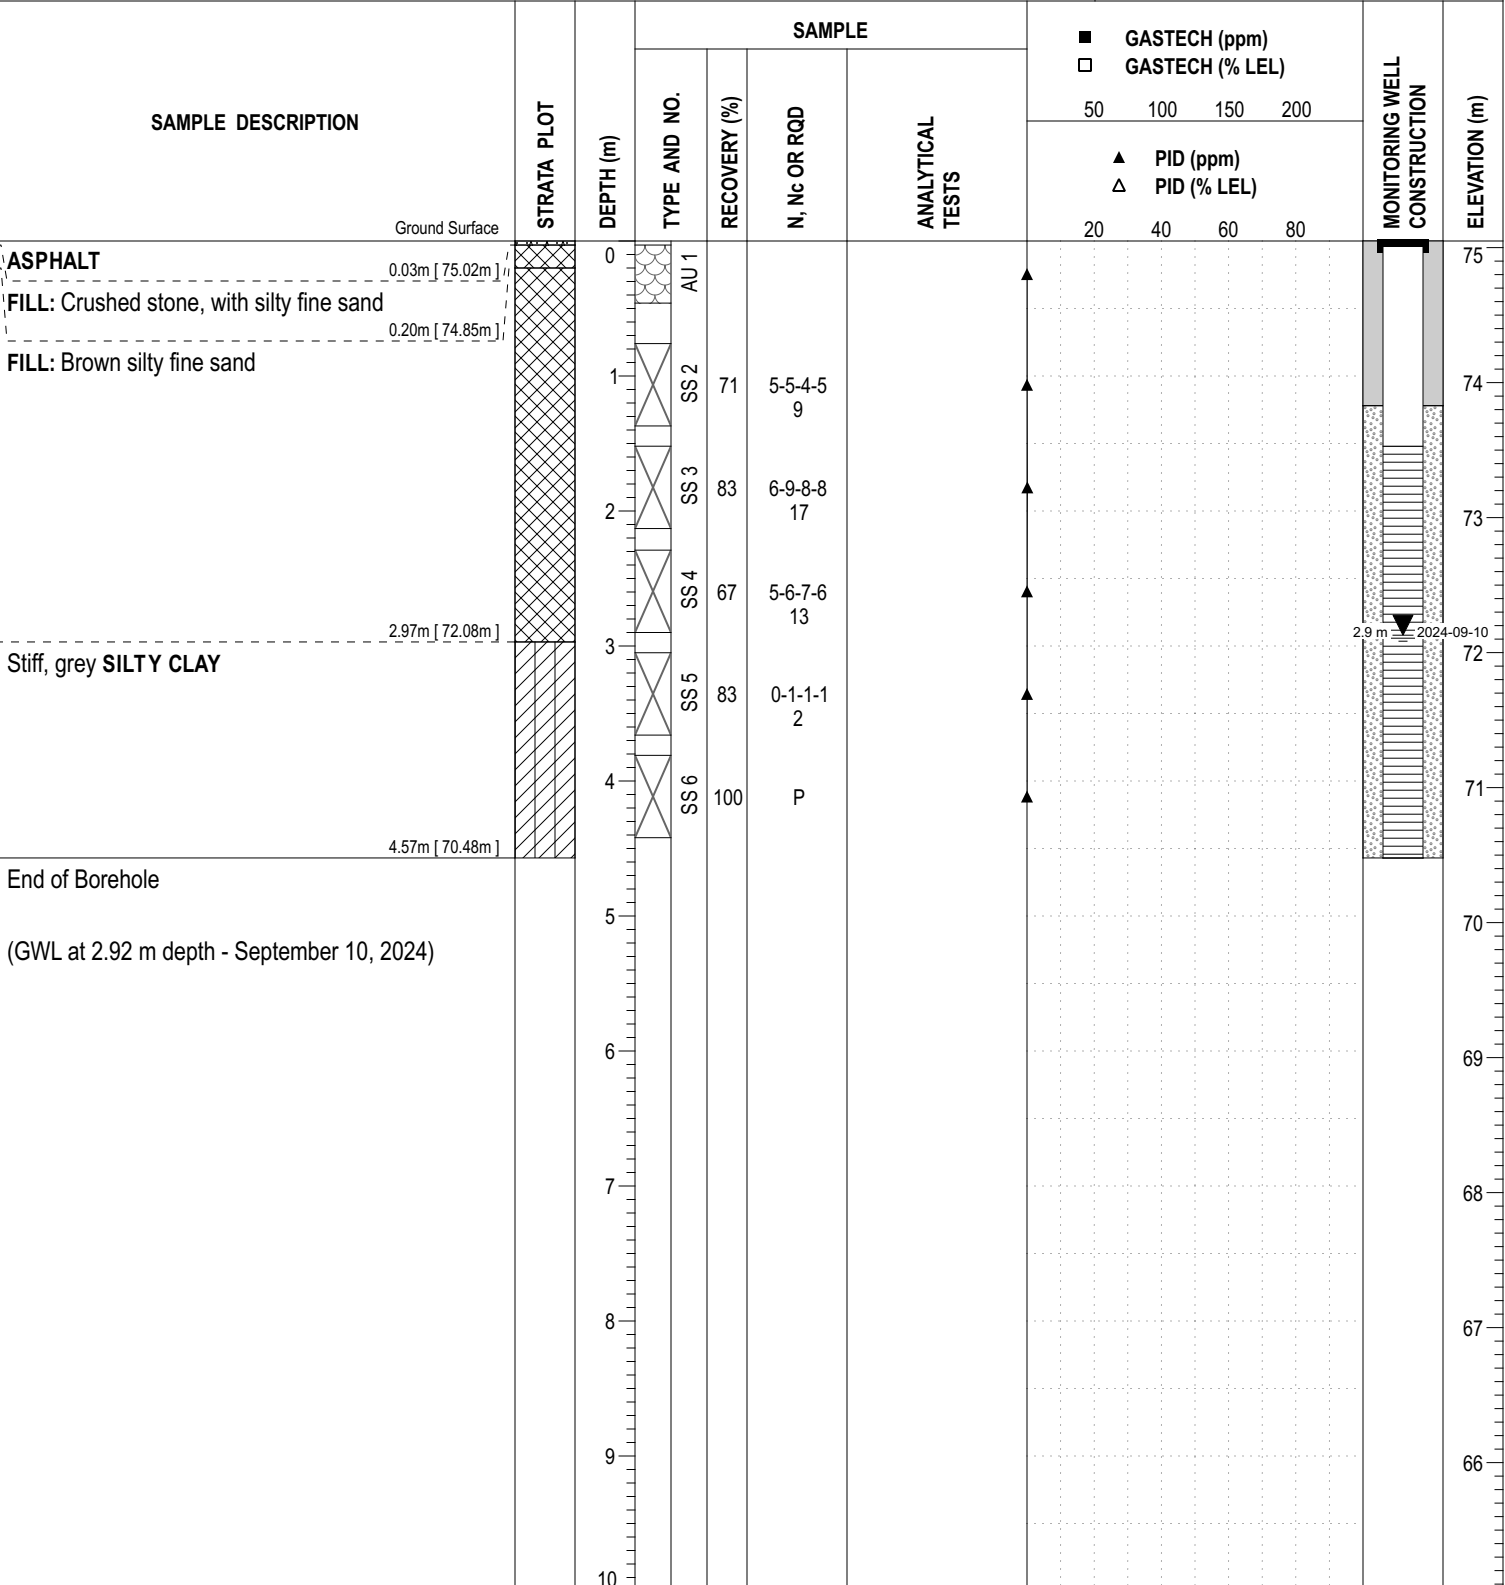
REMARKS: DATE: August 28, 2024 HOLE NO.: BH 4-24

BORINGS BY: CME-55 Low Clearance Drill

COORD. SYS.: MTM ZONE 9 **EASTING:** 377623.87 **NORTHING:** 5032575.07 **ELEVATION:** 75.05
