Environmental Impact Study and Tree Conservation Report for 3555 Borrisokane Road, Ottawa

Final Report

KILGOUR & ASSOCIATES LTD.
www.kilgourassociates.com

Project Number: PAI 1461.4

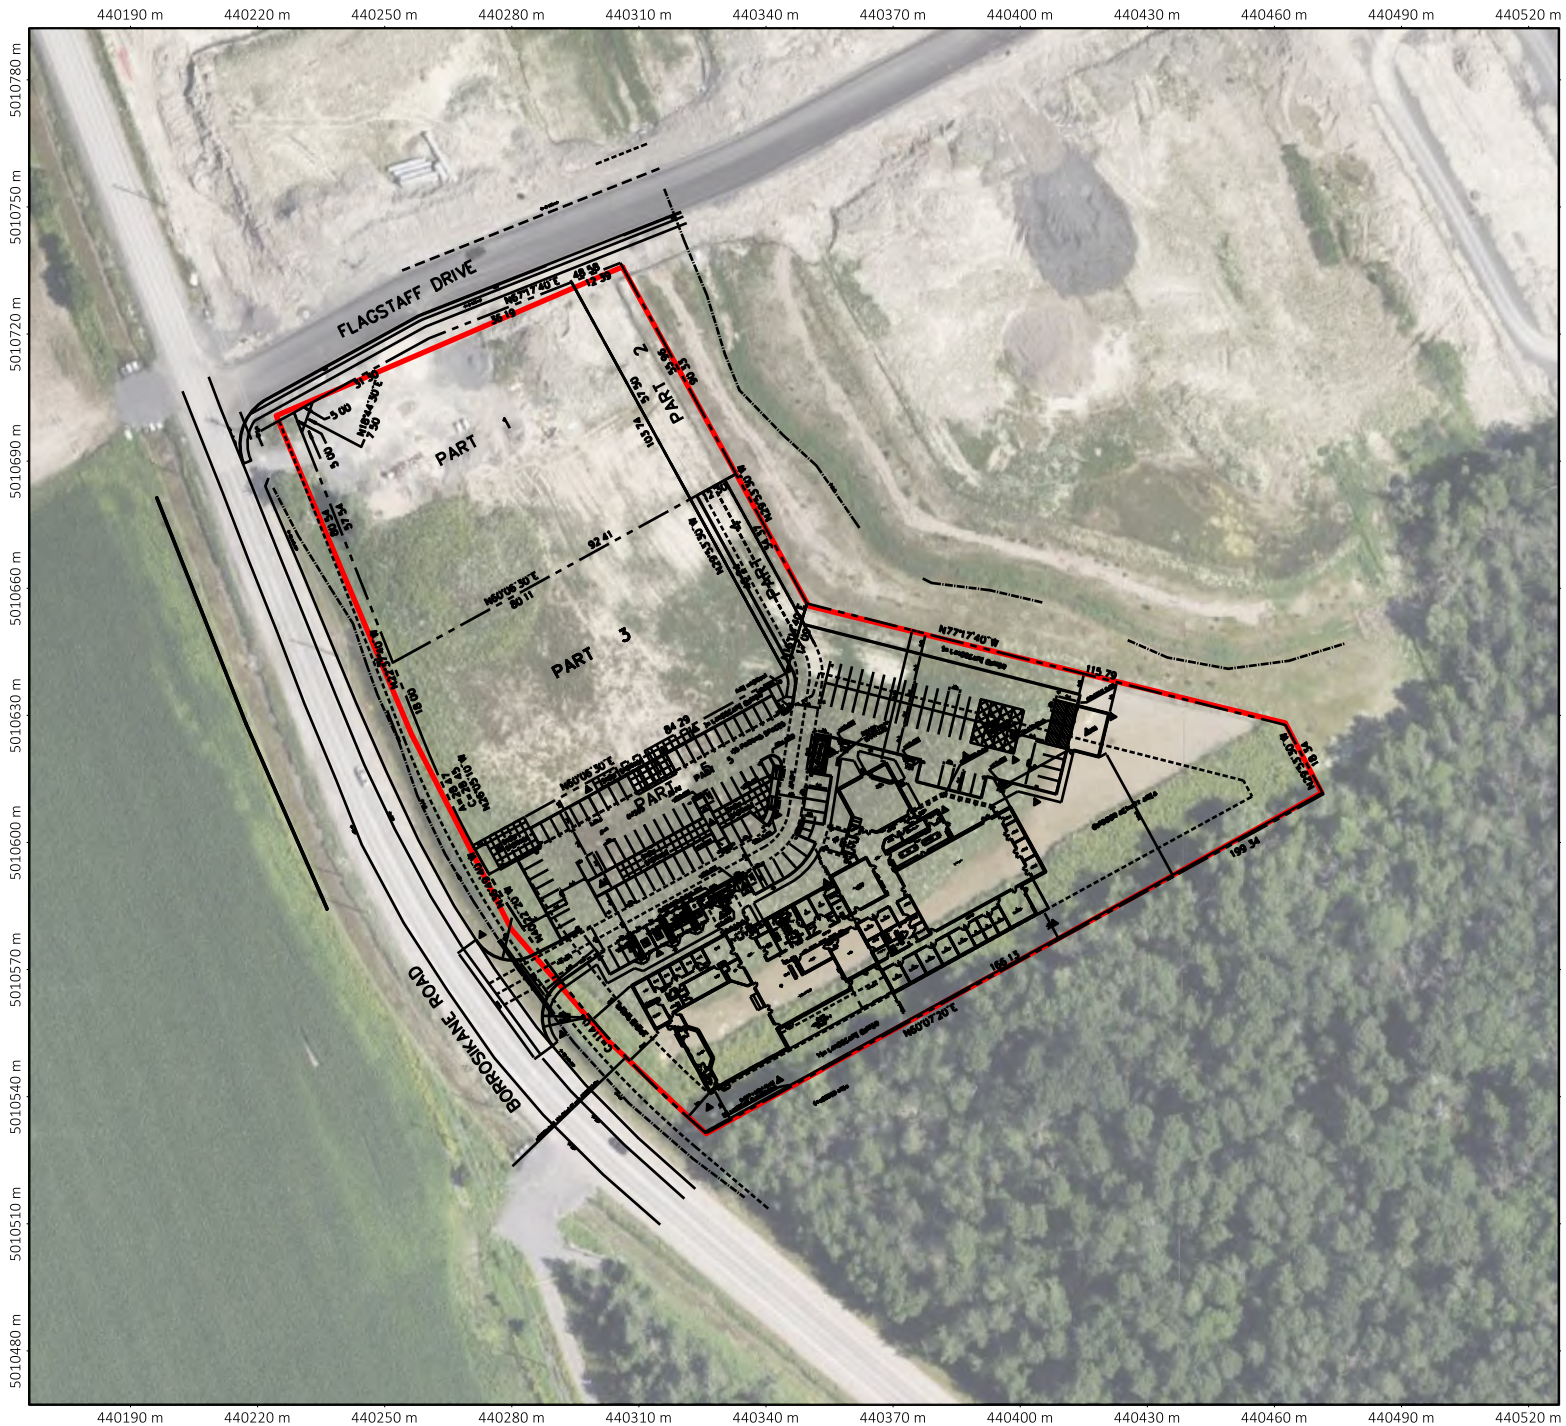
Figure 3 Site Development Plans

In consideration of the Ottawa Bird- Safe Design Guidelines, Walker/Vitro Architectural Glass “AviProtek E” bird friendly vertical etched glass will be utilized for the large windows along the southern church facade, the main lobby area and adjacent Ainos room. Windows are a double glazed Solarban 60(2) Solargray + Clear Glass Insulating Glass Unit. This is a tinted glass specification with Visible Light Transmittance (VLT) of 35% and an exterior reflectance of 6%. Windows have also been divided into smaller panes using a contrasting clear anodized aluminum framing system to avoid a large monolithic glass facade.

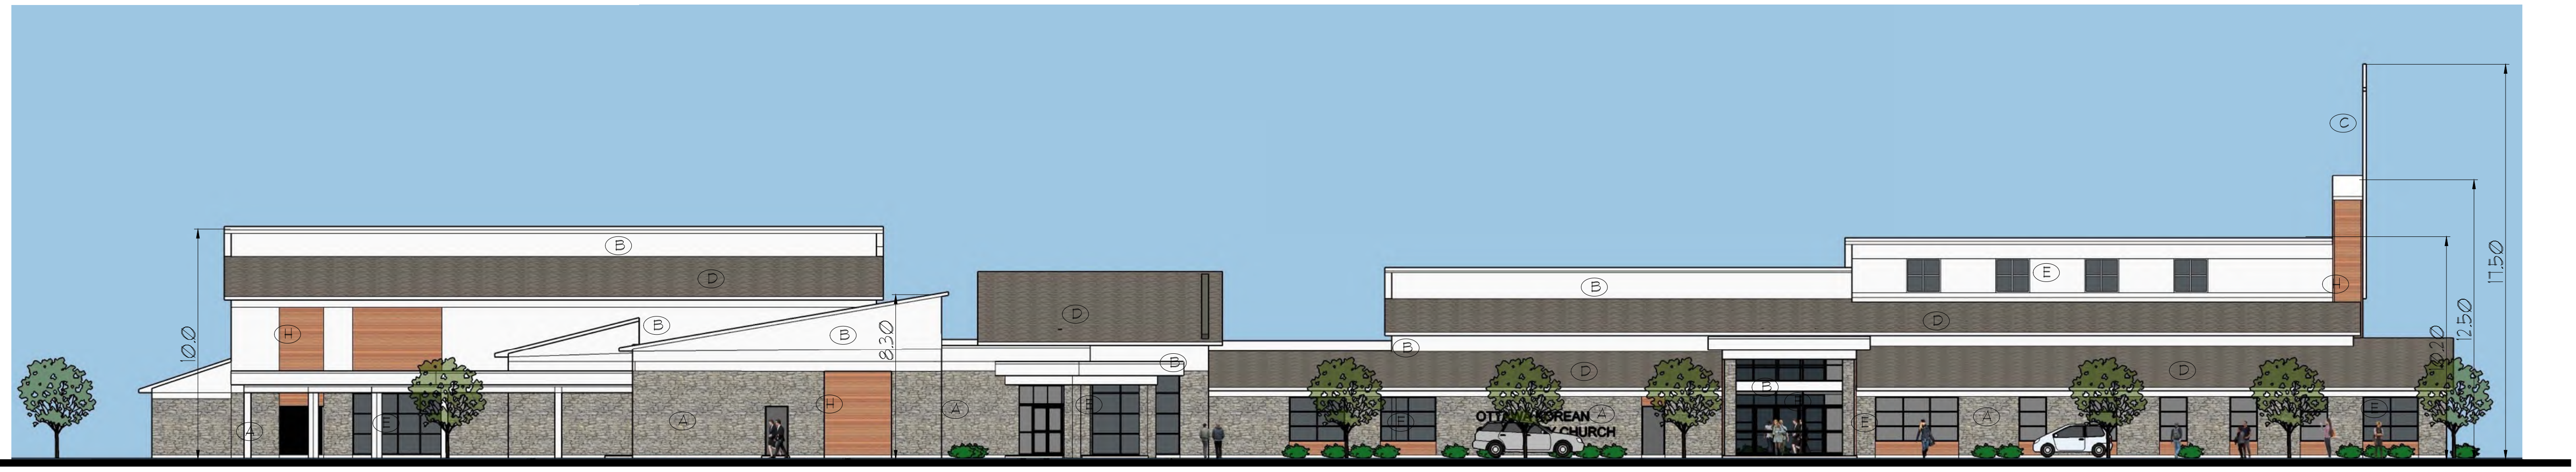
FRONT (NORTHWEST) ELEVATION
SCALE 1:150

- (A) STONE
- (B) STUCCO FINISH (EIFS)
- (C) METAL CROSS
- (D) ASPHALT SHINGLES
- (E) DOOR & WINDOW (TINTED GLASS)
- (F) GARAGE DOOR & MAN DOOR
- (G) AVI PROTEK E ETCHED (BIRD SAFE GLASS) PATTERN 211 VERTICAL
- (H) WOOD LOOK METAL SIDING

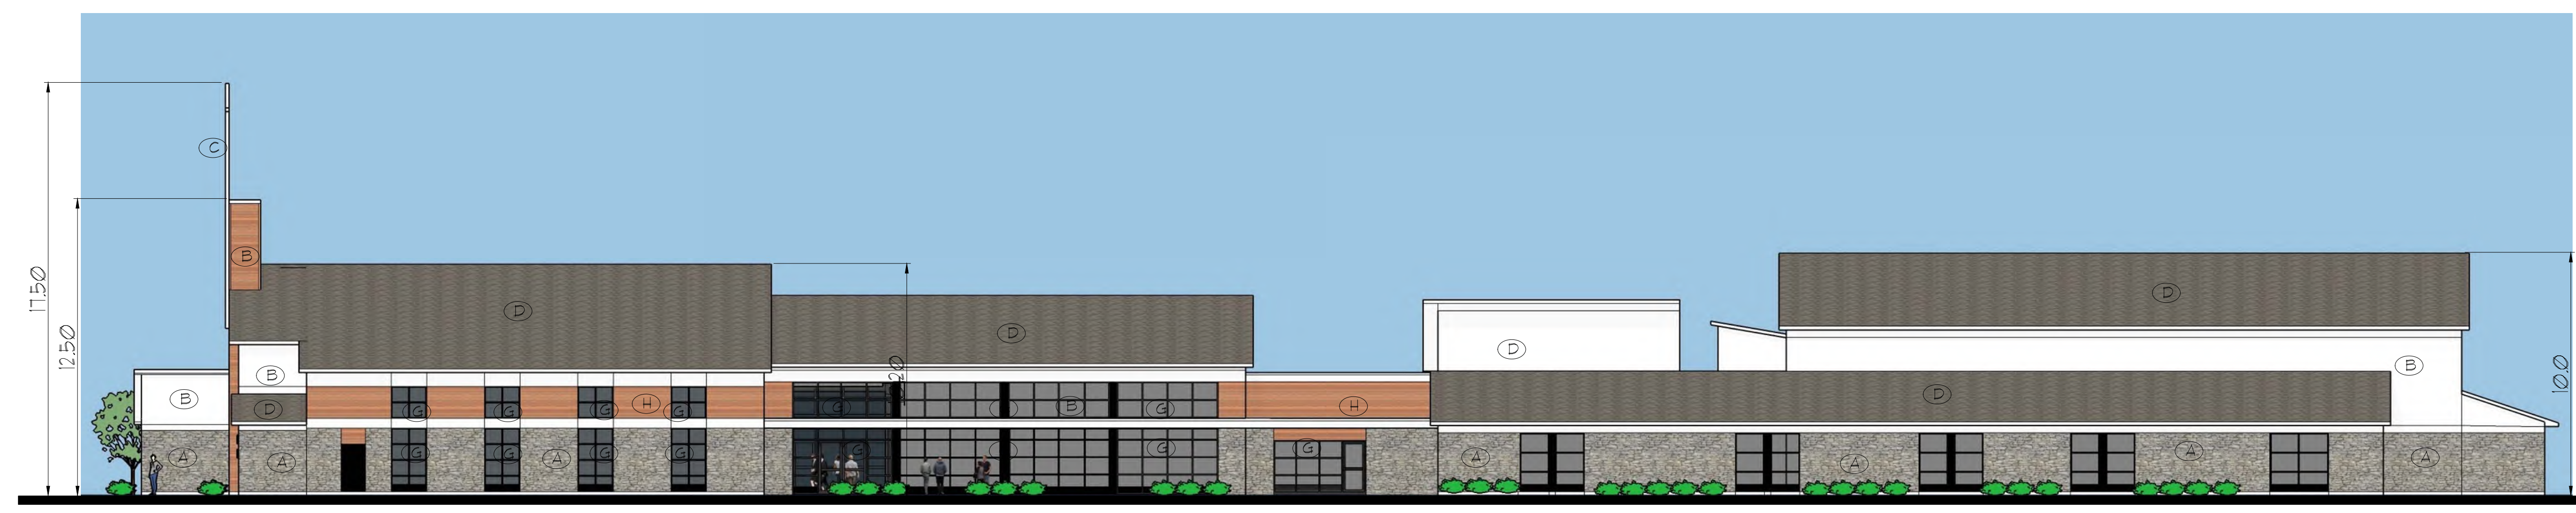
REAR (SOUTHEAST) ELEVATION
SCALE 1:150

- (A) STONE
- (B) STUCCO FINISH (EIFS)
- (C) METAL CROSS
- (D) ASPHALT SHINGLES
- (E) DOOR & WINDOW (TINTED GLASS)
- (F) GARAGE DOOR & MAN DOOR
- (G) AVI PROTEK E ETCHED (BIRD SAFE GLASS) PATTERN 211 VERTICAL
- (H) WOOD LOOK METAL SIDING

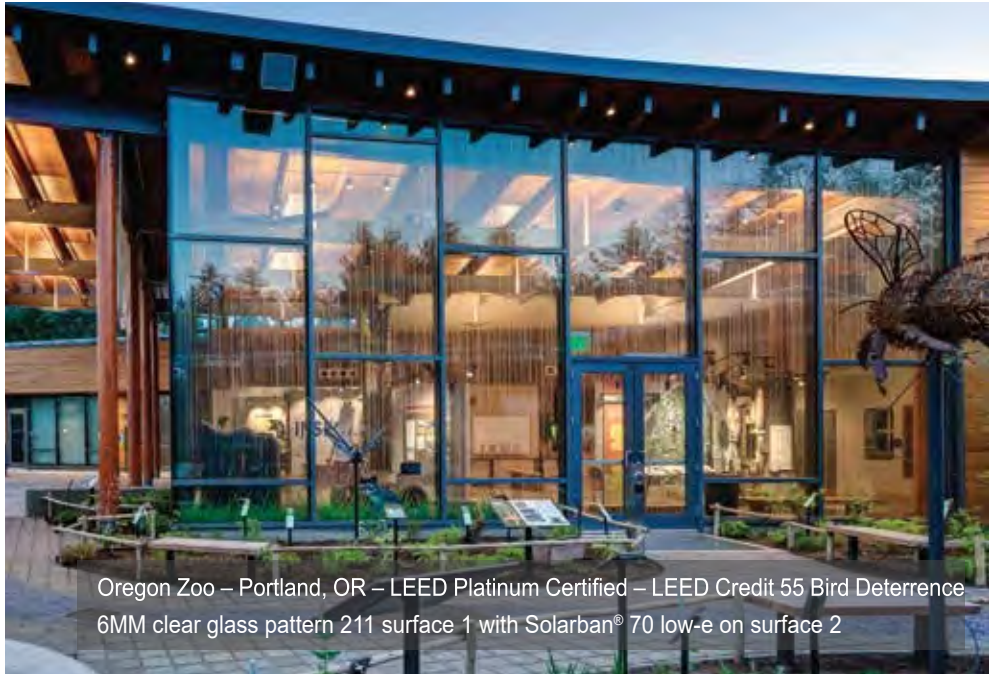
Oregon Zoo – Portland, OR – LEED Platinum Certified – LEED Credit 55 Bird Deterrence
6MM clear glass pattern 211 surface 1 with Solarban® 70 low-e on surface 2

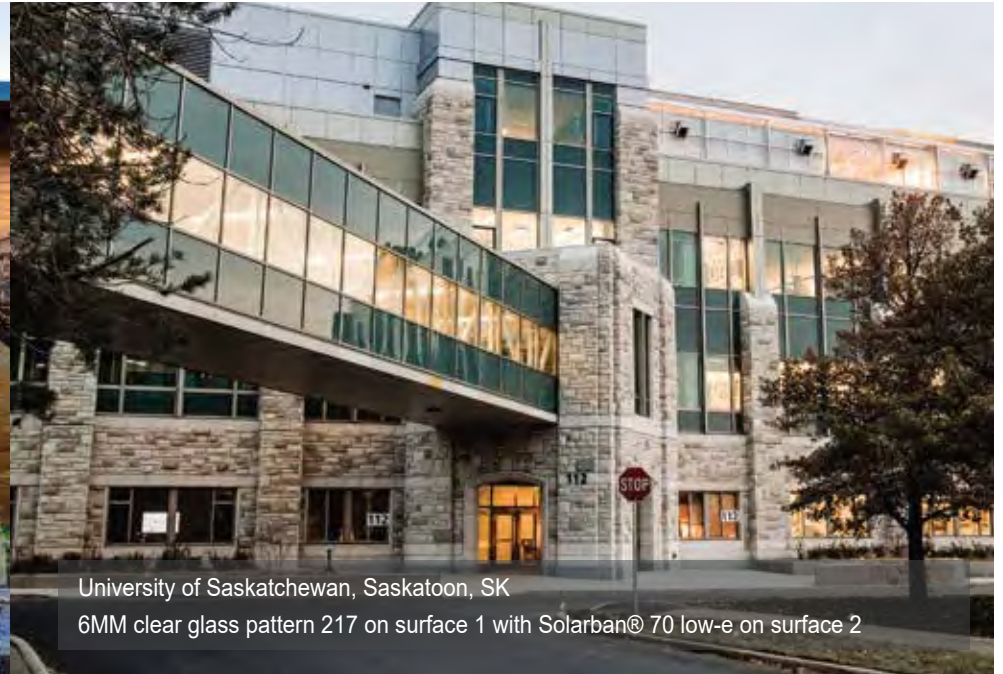
University of Saskatchewan, Saskatoon, SK
6MM clear glass pattern 217 on surface 1 with Solarban® 70 low-e on surface 2

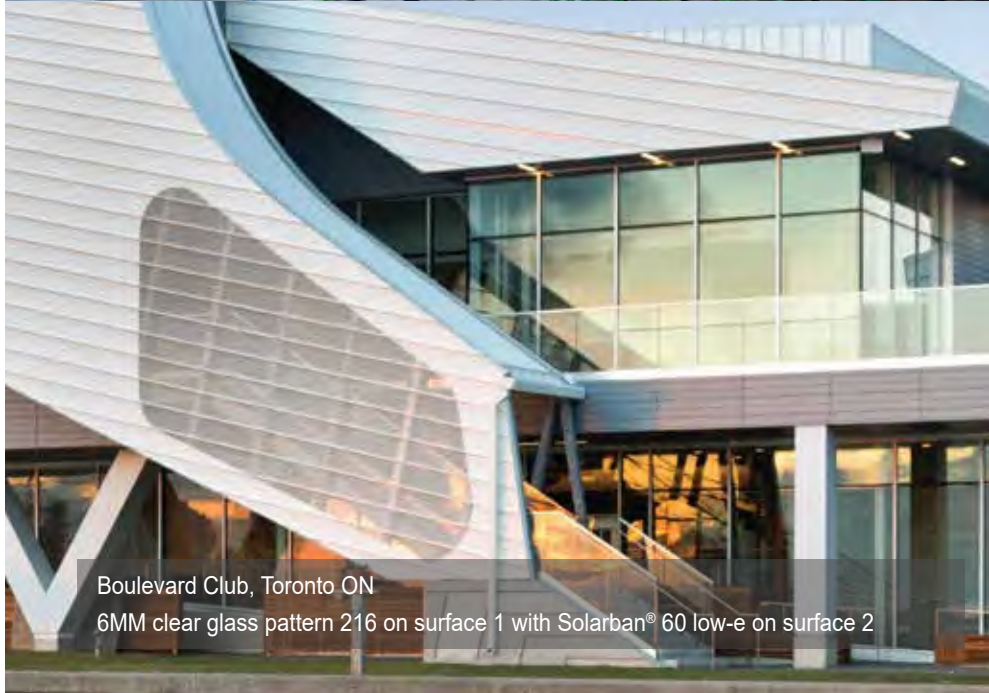
Boulevard Club, Toronto ON
6MM clear glass pattern 216 on surface 1 with Solarban® 60 low-e on surface 2

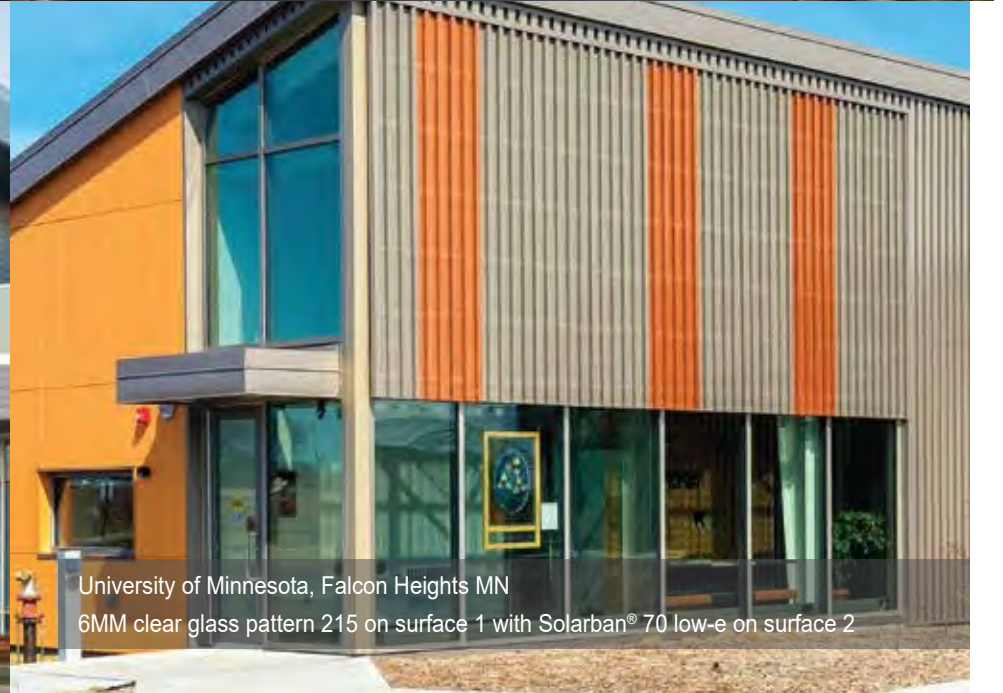
University of Minnesota, Falcon Heights MN
6MM clear glass pattern 215 on surface 1 with Solarban® 70 low-e on surface 2
