Geotechnical Investigation

Final Report, Revision 2

Proposed Commercial Development
100 Bill Leathem Drive,
Ottawa, Ontario

OTT-24002636-A0

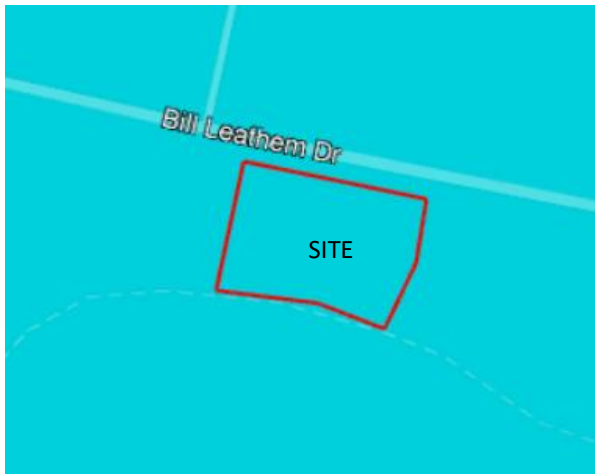
Image 1 – Surficial Geology

The surficial geology was reviewed via the Google Earth applications published by the Ontario Ministry of Energy, Northern Development and Mines available via www.mndm.gov.on.ca/en/mines-and-minerals/applications/ogsearch/surficial-geology and was last modified on May 23, 2017. The map indicates that beneath any fill the site is underlain by fine-textured glaciomarine deposits consisting of silt and clay and minor sand and gravel. The surficial deposits are shown in Image 1 below.

■ Fine-textured glaciomarine deposits:
silt and silty clay, minor sand and gravel

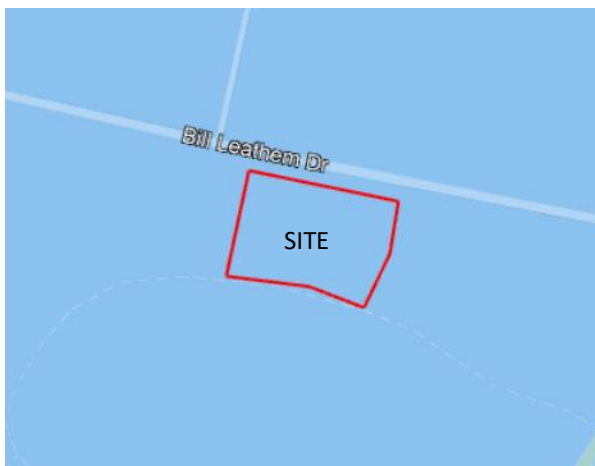
Image 2 – Bedrock Geology

The bedrock geology was reviewed via the Google Earth applications published by the Ontario Ministry of Energy, Northern Development and Mines available via <http://www.geologyontario.mndm.gov.on.ca/mines/data/google/MRD219/geology/doc.kml> and published in 2007. The map indicates sandstone, dolomitic sandstone and dolostone of the March formation.

■ March Formation: Sandstone, dolomitic
sandstone, dolostone

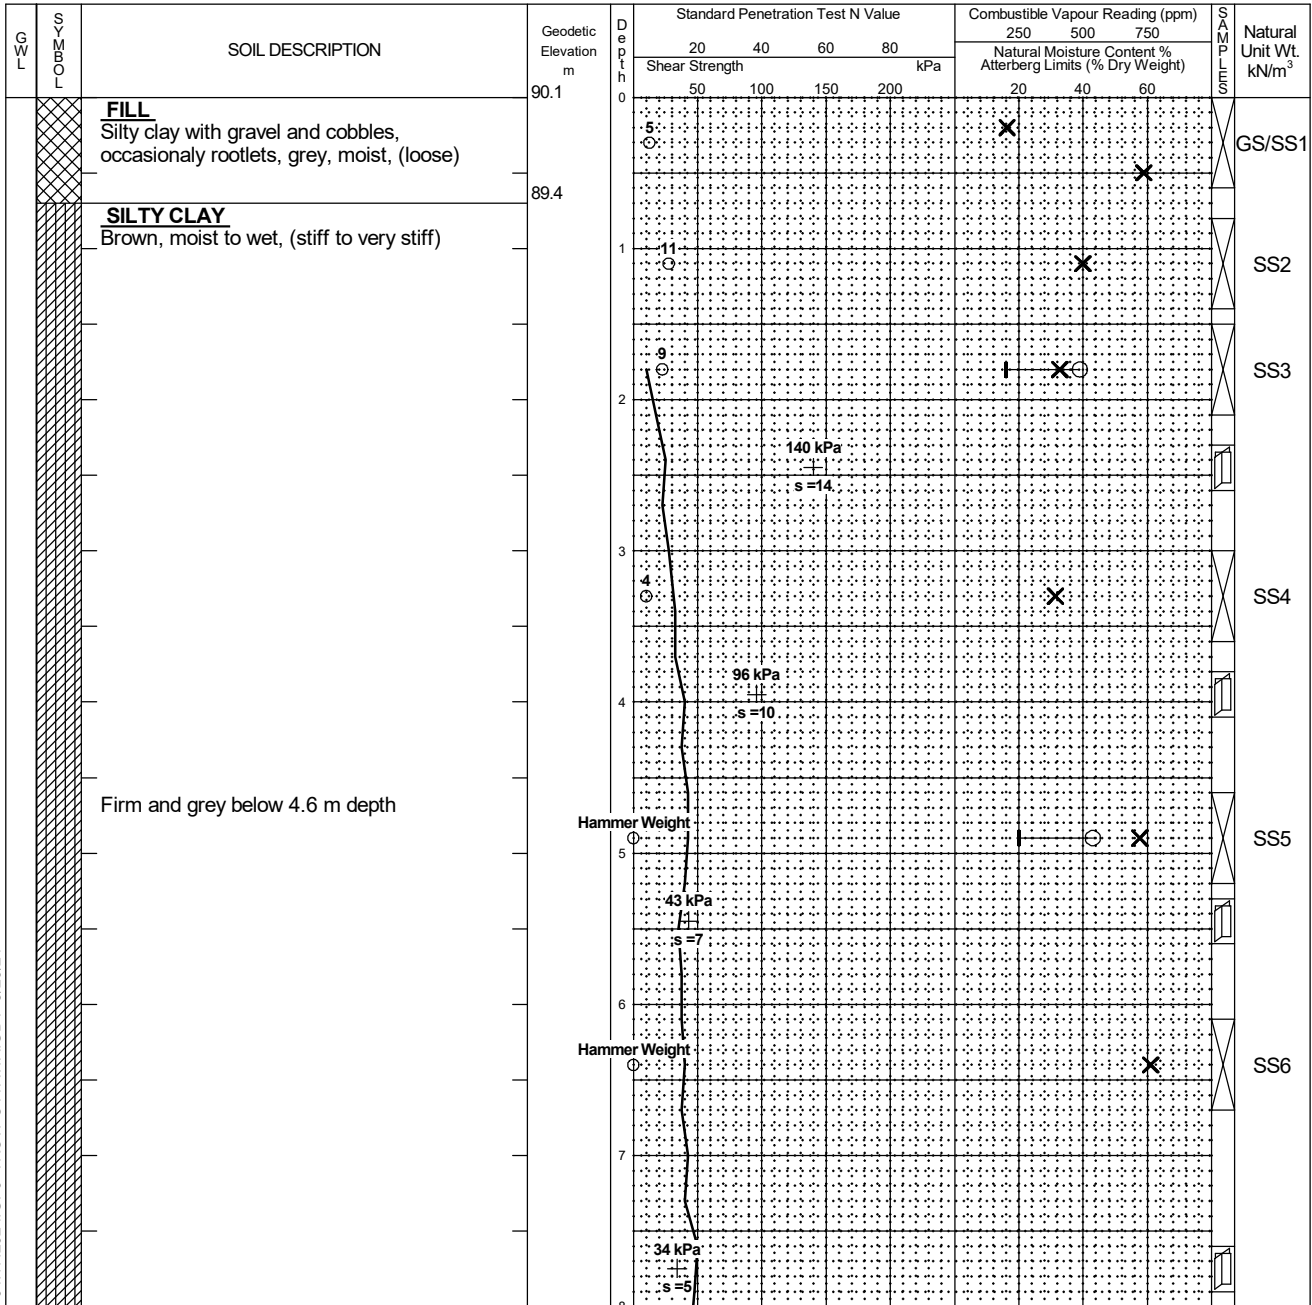
A detailed description of the subsurface conditions and groundwater levels from this geotechnical investigation are given on the attached Borehole Logs, Figure Nos. 3 to 7 inclusive. The borehole logs and related information depict subsurface conditions only at the specific locations and times indicated. Subsurface conditions and water levels at other locations may differ from conditions at the locations where sampling was conducted. The passage of time also may result in changes in the conditions interpreted to exist at the locations where sampling was conducted.

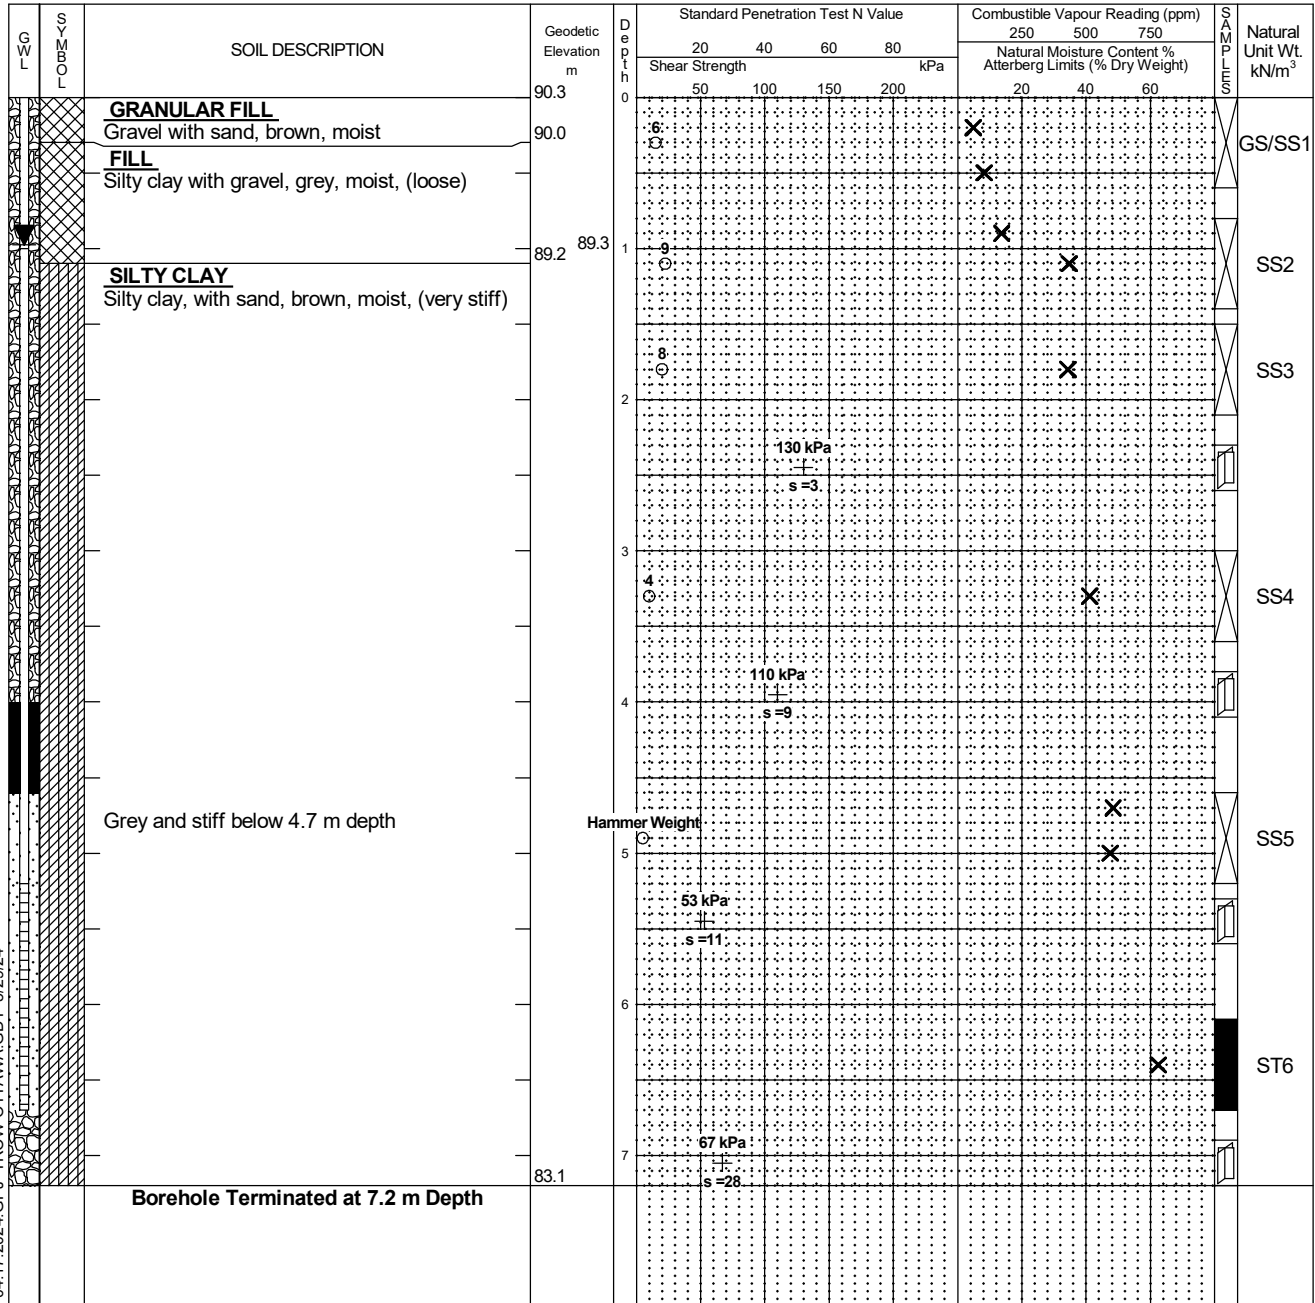
Figure No. 5
 Page. 1 of 1

- NOTES:
- Borehole data requires interpretation by EXP before use by others
 - A 19 mm diameter peizometer was installed upon completion.
 - Field work was supervised by an EXP representative.
 - See Notes on Sample Descriptions
 - Log to be read with EXP Report OTT-24002636-A0

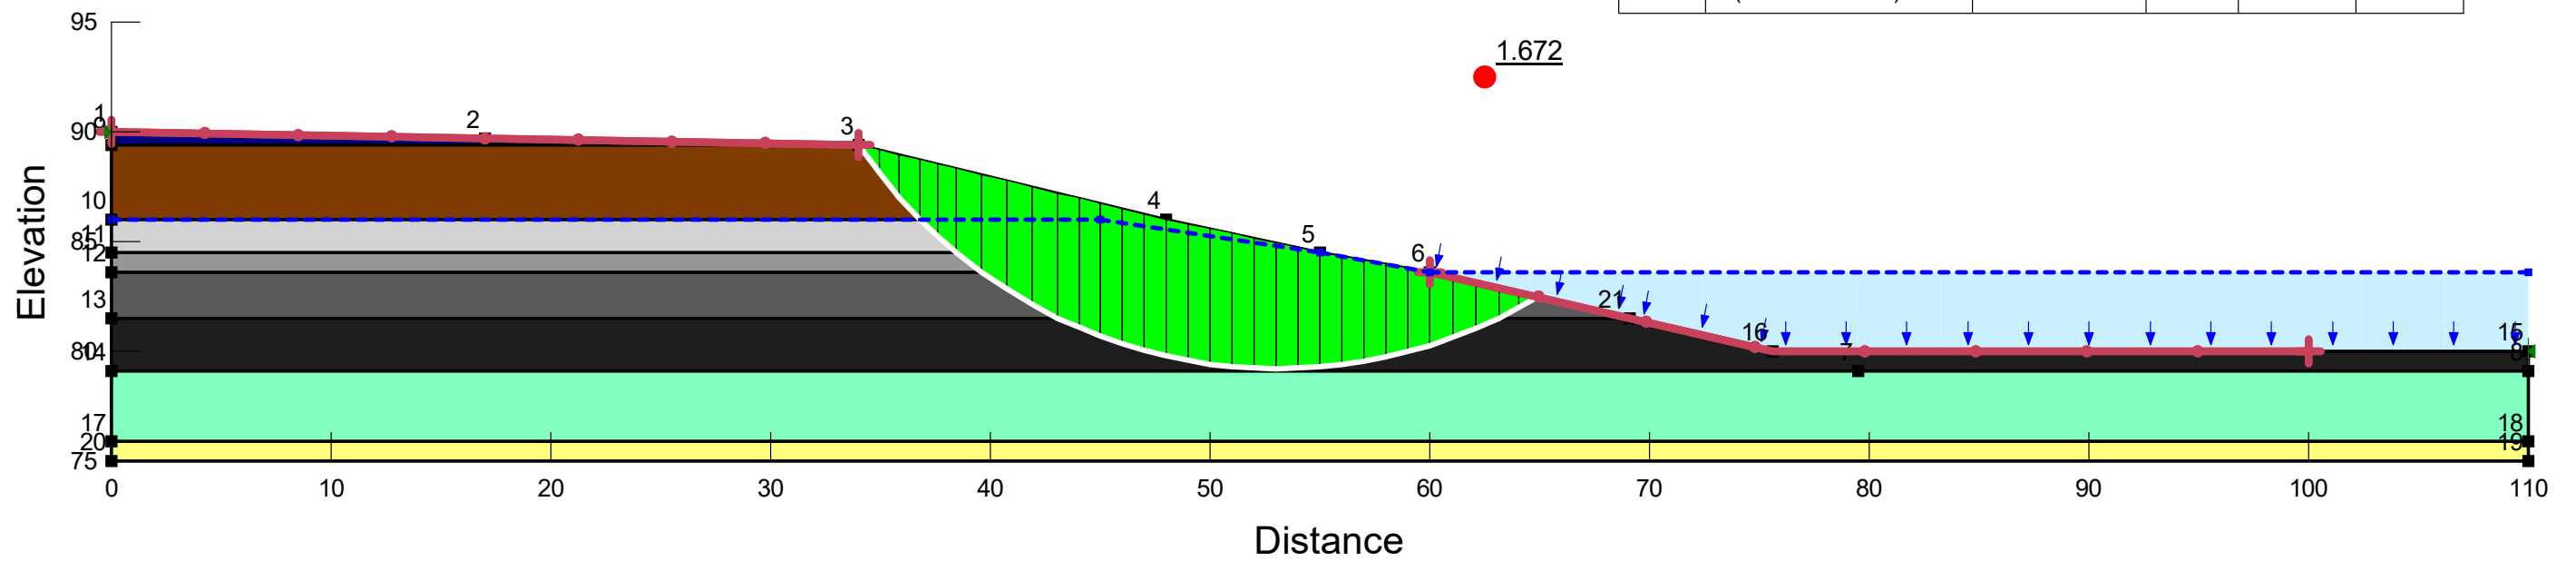
Section A-A'

| Color | Name | Slope Stability Material Model | Unit Weight (kN/m³) | Effective Cohesion (kPa) | Effective Friction Angle (°) |
|---|---|---|---|---|---|
| ■ | Unweathered Clay Layer 3 (Effective Stress) | Mohr-Coulomb | 16.5 | 0.5 | 28 |
| ■ | Unweathered Clay Layer 4 (Effective Stress) | Mohr-Coulomb | 16.5 | 0.5 | 28 |

The stability of the existing slopes at the site under consideration were analyzed with GeoStudio/Geo-slope office, Version 24.1.0.1406 using the Morgenstern-Price Method. A total of two cross-sections were analyzed, Sections A-A' and Section B-B', first under the existing conditions and then the analysis repeated applied a distributed loading of 12.5 kPa to represent the applied building loading.

Current practice in the industry and the City of Ottawa requires a Factor of Safety (FOS) of 1.5 for static loading conditions, both effective stress and total stress analyses, and a Factor of Safety (FOS) of 1.1 for seismic loading conditions (Mitchell 1983). A review of the slope stability analysis indicates that the sections meet the requirements listed above. The analysis was carried out based on the proposed building location, set back approximately 19 m from the existing slope, and the analyzed slope stability sections met the acceptable factor of safety for static and seismic loadings. If the location of the building is to be moved closer to the existing slopes, this office should be contacted, and further analysis would be required. It is understood that section 4.9.3 of the City of Ottawa Official Plan requires a minimum setback of 15 m from the edge of a stable slope and this setback distance should be considered the minimum design setback for the development.

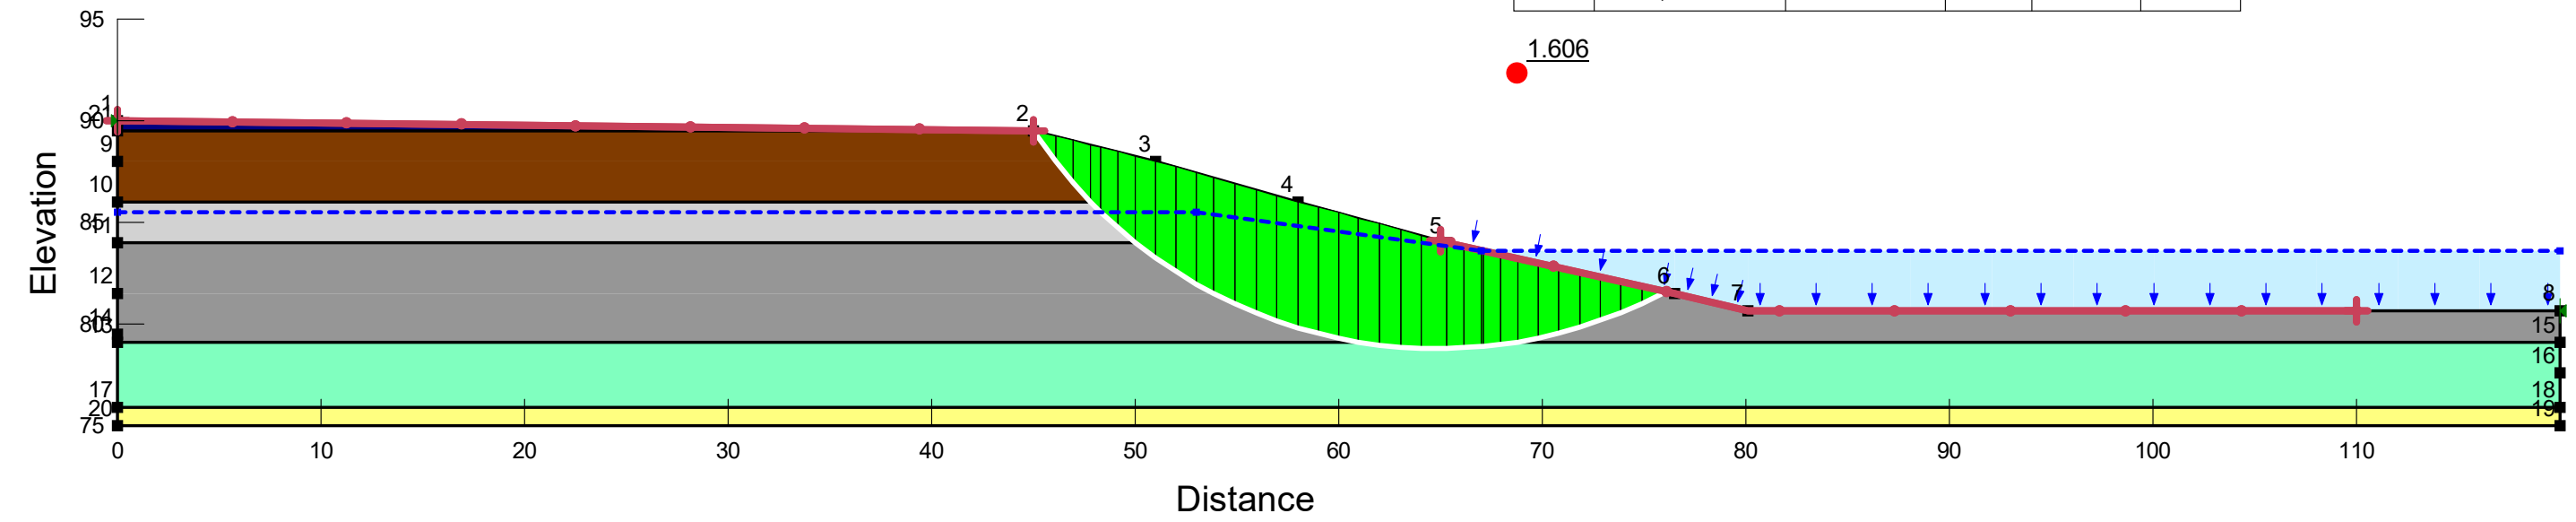
Section B-B'

| Color | Name | Slope Stability Material Model | Unit Weight (kN/m³) | Effective Cohesion (kPa) | Effective Friction Angle (°) |
|---|---|---|---|---|---|
| ■ | Unweathered Clay Layer 1 (Effective Stress) | Mohr-Coulomb | 16 | 0.5 | 28 |
| ■ | Unweathered Clay Layer 2 (Effective Stress) | Mohr-Coulomb | 16.5 | 0.5 | 28 |

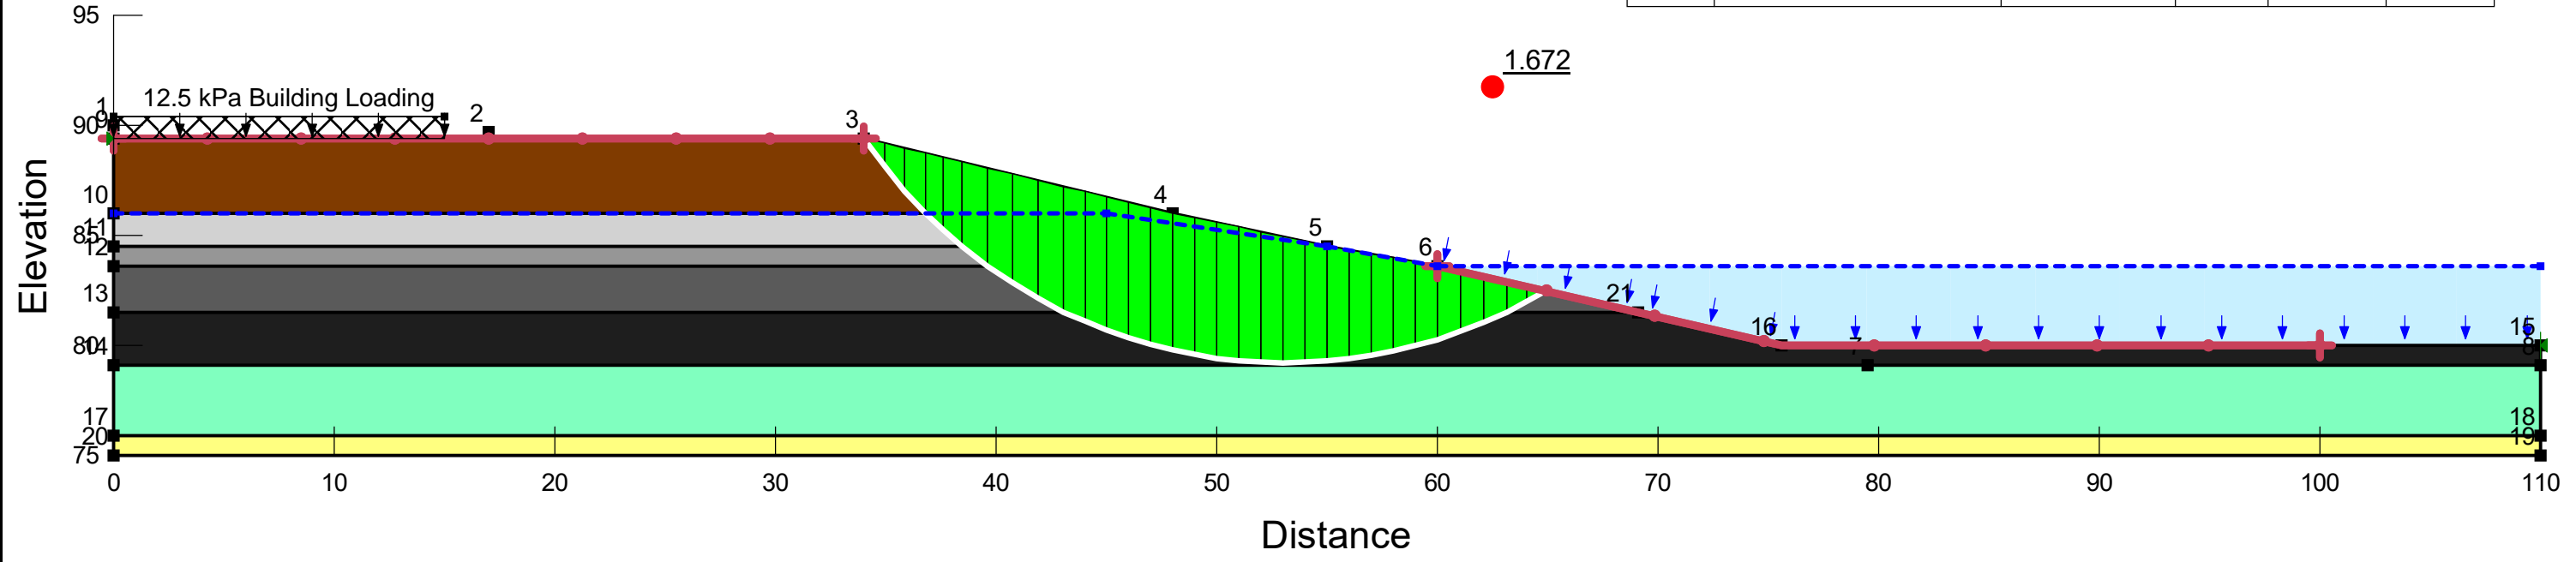
| <h1>Section A-A'</h1> | | <p>EXP Services Inc. t: +1.613.688.1899 f: +1.613.225.7337 2650 Queensview Drive, Suite 100 Ottawa, ON K2B 8H6 Canada www.exp.com</p> <p>• BUILDINGS • EARTH & ENVIRONMENT • ENERGY • • INDUSTRIAL • INFRASTRUCTURE • SUSTAINABILITY •</p> | project no. OTT-24002636-A0 |

| Color | Name | Slope Stability Material Model | Unit Weight (kN/m³) | Effective Cohesion (kPa) | Effective Friction Angle (°) |
|---|---|---|---|---|---|
| ■ | Unweathered Clay Layer 3 (Effective Stress) | Mohr-Coulomb | 16.5 | 0.5 | 28 |
| ■ | Unweathered Clay Layer 4 (Effective Stress) | Mohr-Coulomb | 16.5 | 0.5 | 28 |

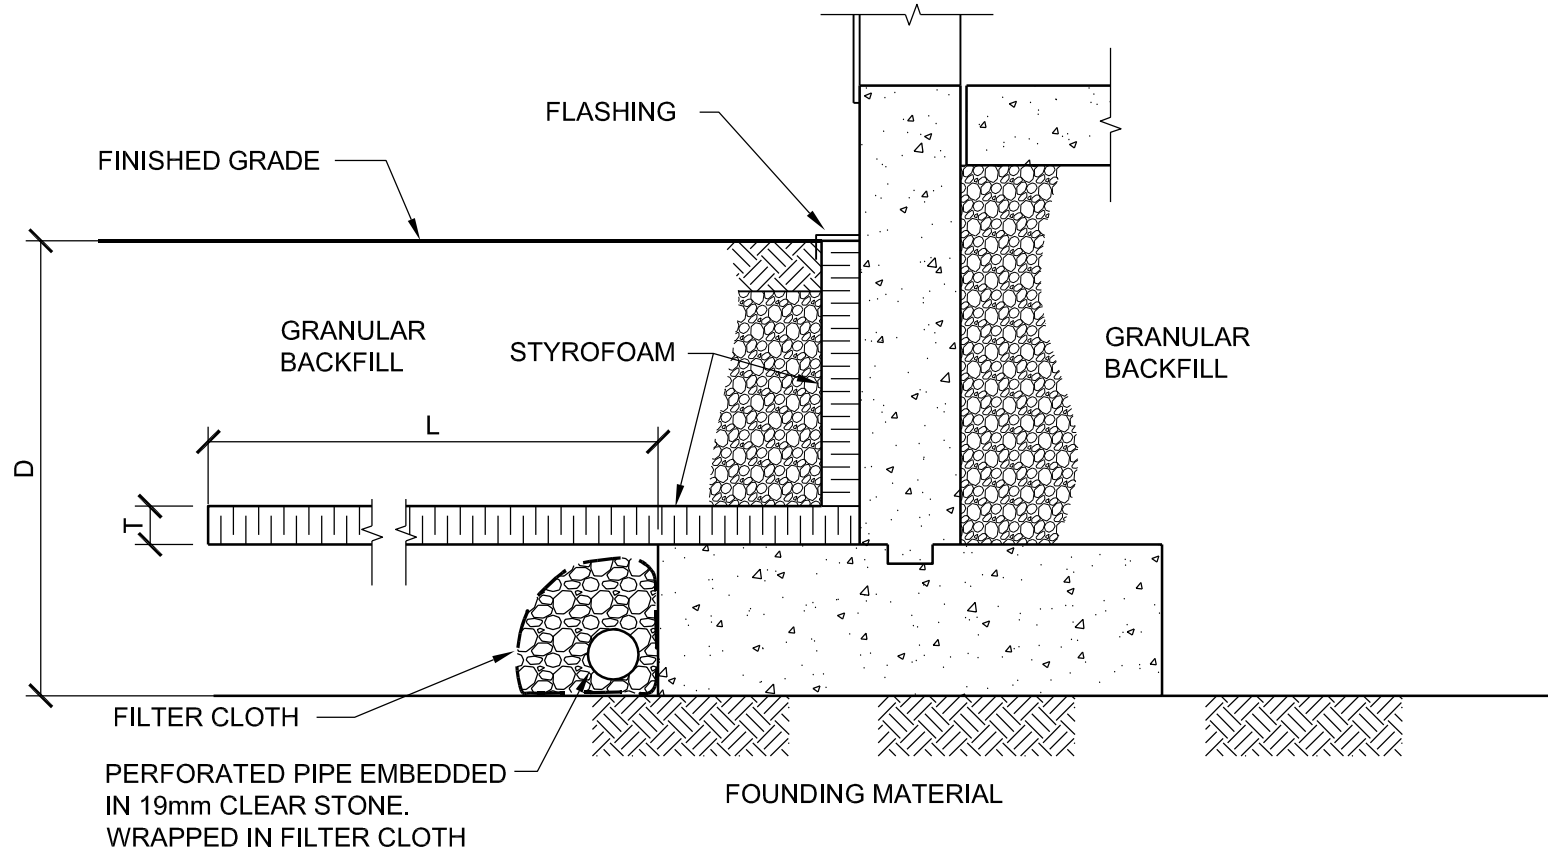
Appendix B – Foundation Insulation for a Heated Structure

NOTES:
REFER TO ATTACHED TABLE FOR DIMENSIONS FOR A GIVEN SOIL COVER "D"

A minimum of 1.5 m of earth cover should be provided to the footings of heated structures to protect them from damage due to frost penetration. The frost cover should be increased to 2.1 m for unheated structures if snow will not be removed from their vicinity. If snow will be removed from the vicinity of the unheated structures, the frost cover should be increased to 2.4 m. Rigid insulation thermally equivalent to the required soil cover may be used instead of the soil cover. Where earth cover is less than the minimum required, an equivalent combination of earth fill and rigid polystyrene insulation (e.g. styrofoam HI-60 or equivalent) should be provided (Table VII). The Styrofoam should be placed along the exterior foundation wall from the finished exterior grade to top of footing, on top and sides of the footing and should extend laterally for a sufficient distance from the edge of the footings. The insulation details should be reviewed by EXP.

Table VII: Insulated Foundation Design Summary of Heated Structures
