Geotechnical Investigation and Hydrogeological Assessment

600 March Road, Kanata (Ottawa), Ontario

First Gulf

06 March 2024

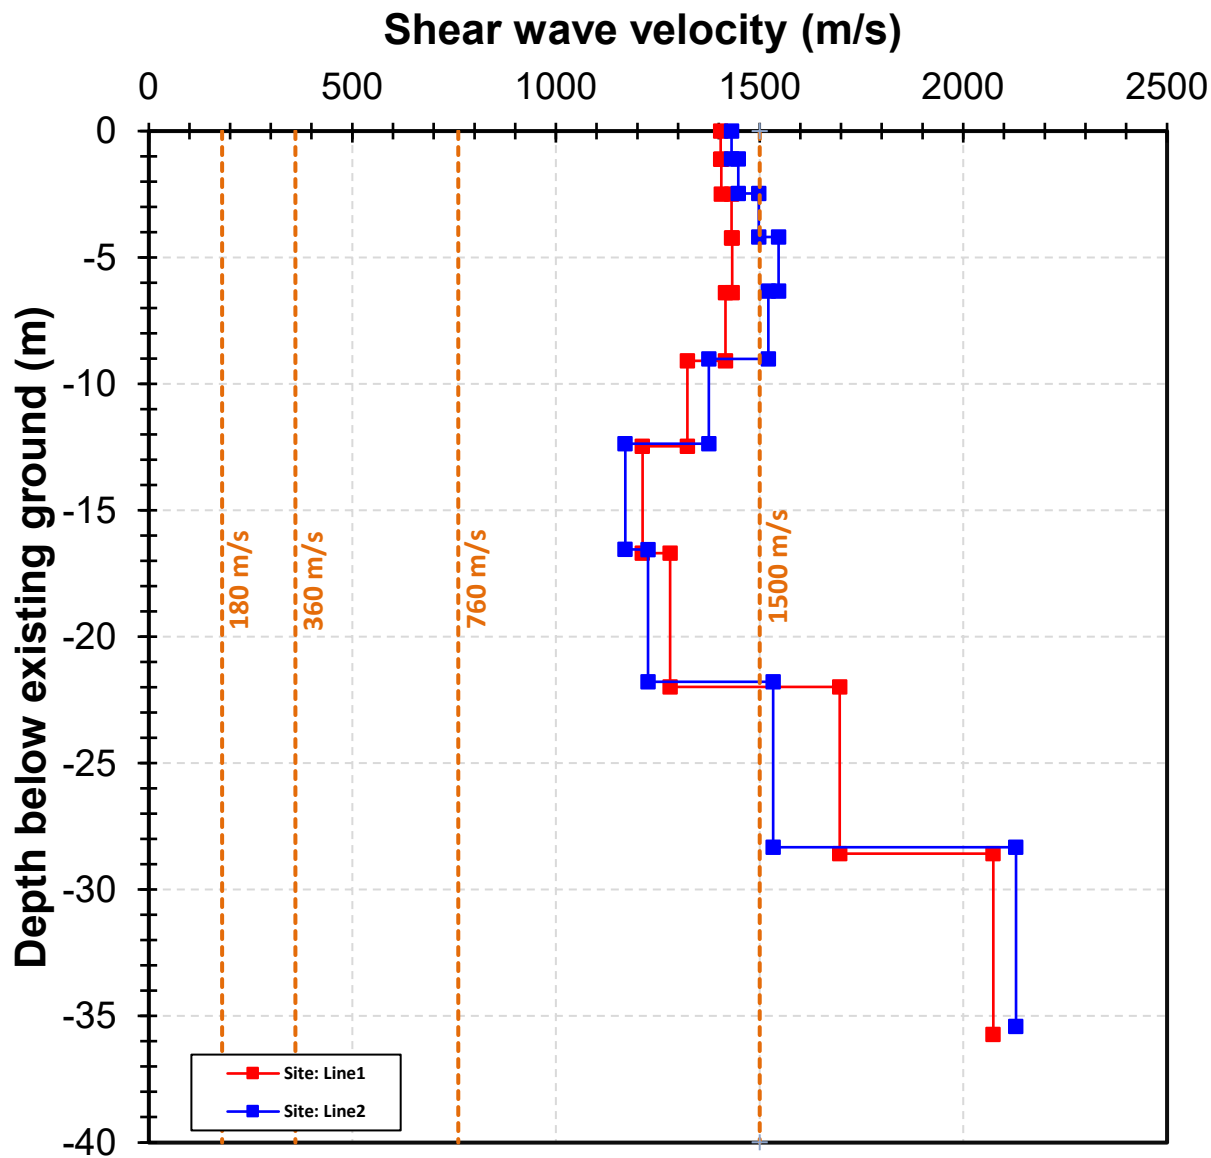
Shear wave velocity versus depth
