# **Phase I – Environmental Site Assessment**

266 Park Street  
Ottawa, Ontario

Prepared for Concorde Properties

Report: PE5651-2  
May 14, 2024

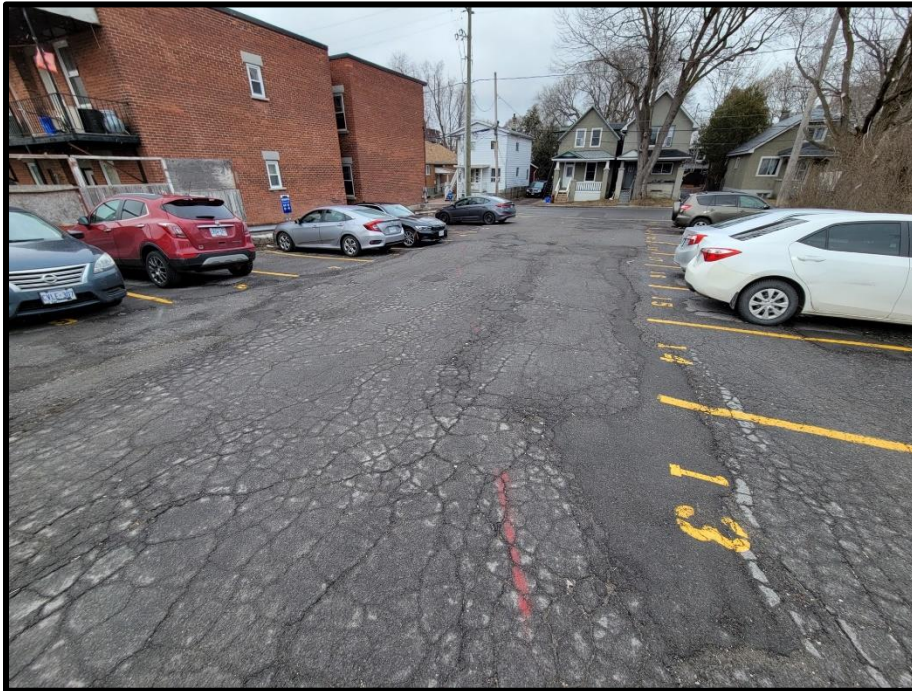
**Photograph 1:** View of the western portion of the Phase I Property, facing east.
